MECHANICAL INSPECTION

16230 Jersey Dr
Jersey Village TX 77040

FEBRUARY 8, 2021

PROPERTY INSPECTION REPORT

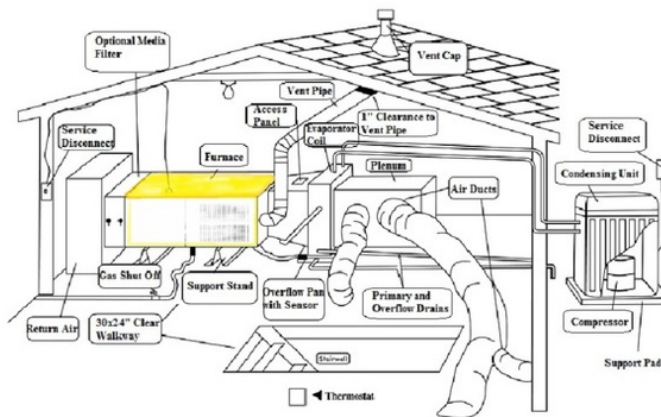
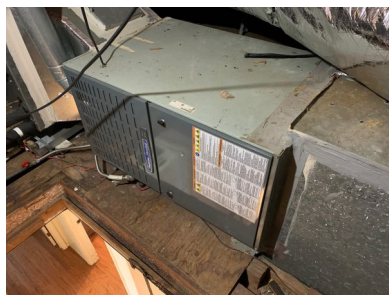
The heating for the property was provided the following natural gas-fired equipment:

<u>ZONE</u>	<u>BRAND</u>	<u>BTU</u>	<u>DATE</u>	<u>LOCATION</u>
House	American	80,000	2013	Attic

Heating Equipment - Functional:

The heating equipment was observed to be operating and functional at the time of the inspection. The heating equipment responded to the thermostat and the equipment appeared to be heating the air adequately.

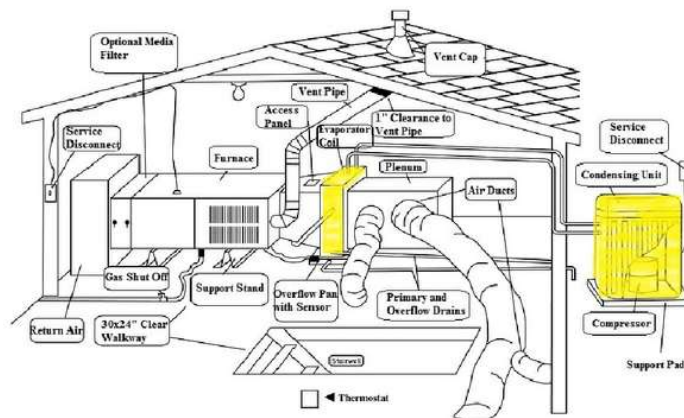
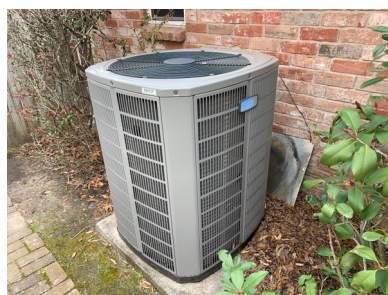
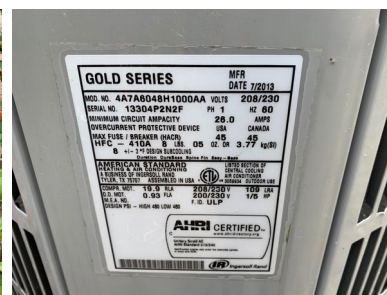
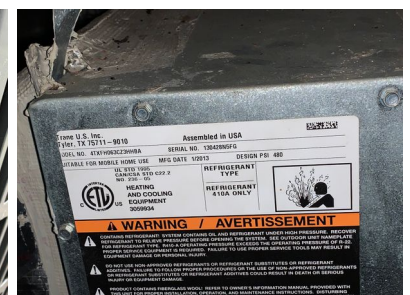
The type of air conditioning for the property is a forced air split system. The cooling equipment for the property was as follows:

Zone	Brand	Size/Age Condenser	Size/Age Coil	Temp Drop Degrees
House	American	4-ton 2013	5-ton 2013	20

Condensing Unit Equipment - Functional:

The condensing unit equipment was functional at the time of the inspection. The equipment responded to the corresponding thermostat, and the compressor components and fan motor components were operating.

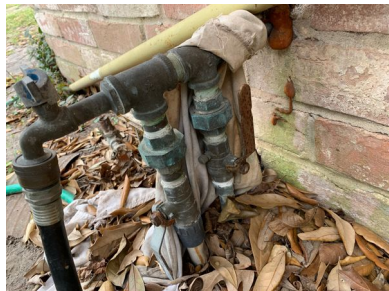
East

The shut-off valve for the main inlet water line was located at the exterior of the house.

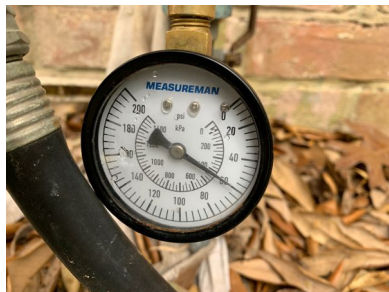
Static Water Pressure :

The static water pressure to the house at the time of the inspection was measured with a pressure gauge at the hose bibb nearest the shut off valve, and the static pressure was observed to be 60 psi.

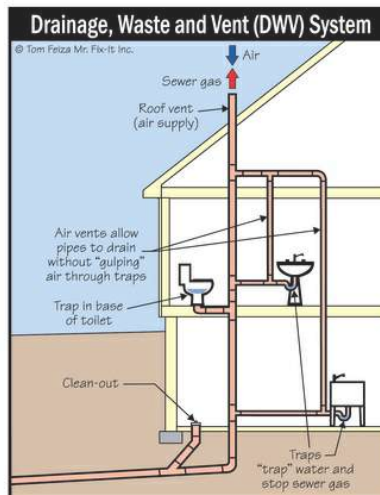
1: Cleanout drains to yard

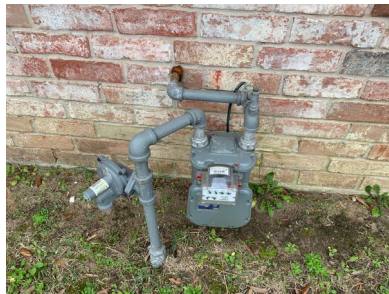
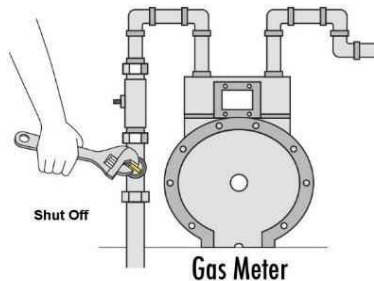
Rear

The main gas shut off valve was located at the inlet side of the gas service meter.

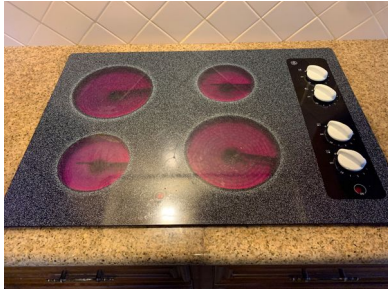
The electric cooktop was functional at the time of the inspection and responded to the controls. All of the elements and controls were operational at the time of the inspection.

Limited life:

Due to the age and/or condition of the equipment, it is our opinion that the equipment has only a limited amount of life remaining.
