STRUCTURAL INSPECTION

16230 Jersey Dr
Jersey Village TX 77040

FEBRUARY 8, 2021

REF: CONDITION OF PROPERTY SURVEY

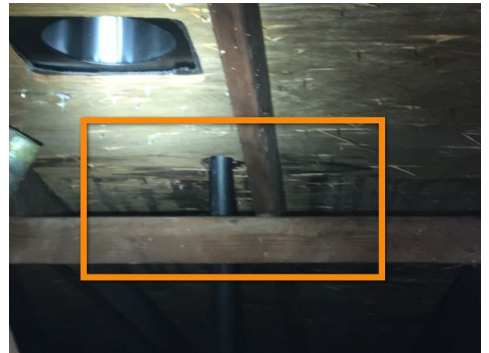
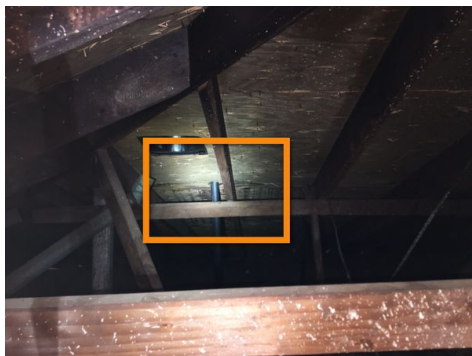
Sewer vent at the west side of the attic

ATTIC ROOF DECKING AND/OR FRAMING MEMBERS

Contact a qualified professional.

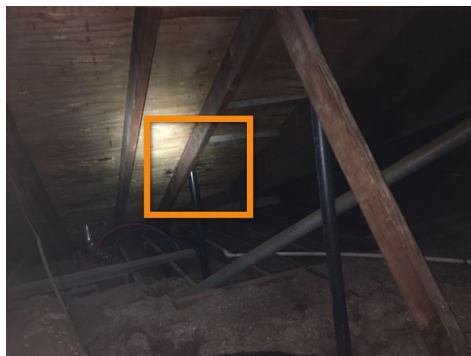
Sewer vent over the hallway bathroom

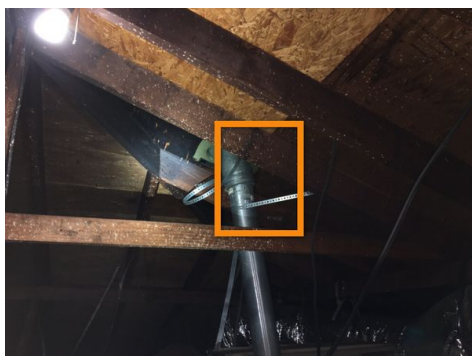
Furnace flue pipe
