INSPECTION REPORT

Property Address: 2903 Greens Ferry Court, Richmond, TX 77406
Inspection Date: 03/05/2020

Inspection Number: 20200305-1
Inspection Type: REI-7-5

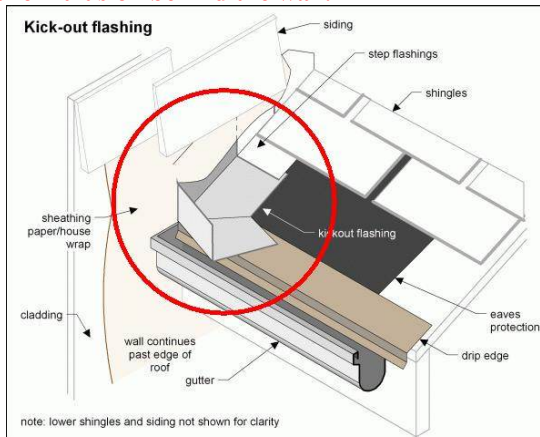
Kick-out flashing was not installed where the vertical wall and roof plane meet on the home. Flashing is important for shedding water; recommend review by qualified roofing contractor for corrections as needed to prevent moisture intrusion behind the wall.

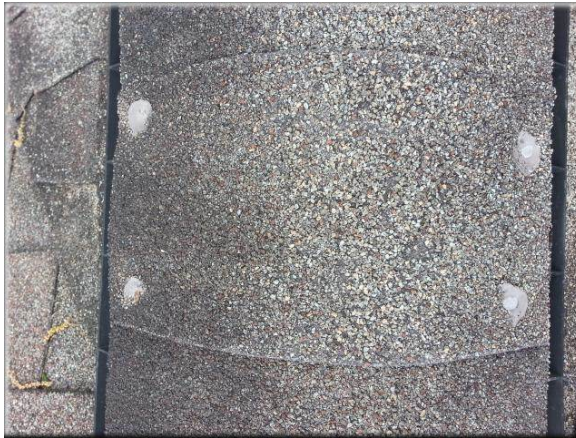
The lead roof jacks covering the waste stacks were not folded over or are deteriorated around the vent pipe openings, which will allow water to run down the outside of the pipe into the attic; recommend corrections to prevent moisture intrusion to the attic.

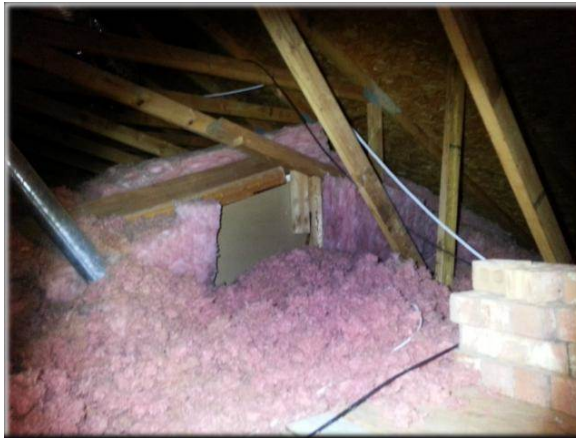
The attic flooring does not comply with accepted industry specifications for floor sheathing. Accessing the attic could result in injury. The attic should have an unobstructed passageway from the access to the service side of all equipment. The flooring should be solid (minimum 3/4 floor decking), continuous, and not less than 24 inches wide. On the control side of the equipment and on other sides where access is necessary for servicing, a level work platform extending a minimum of 30 inches from the edge of equipment with a 36-inch high clear working space should be provided. This should be repaired for safety so a worker or anyone else does not fall through the ceiling while working on equipment.

Dry staining present on the attic flooring suggests prior leaks. Recommend consulting the seller to determine if known leaks have occurred.

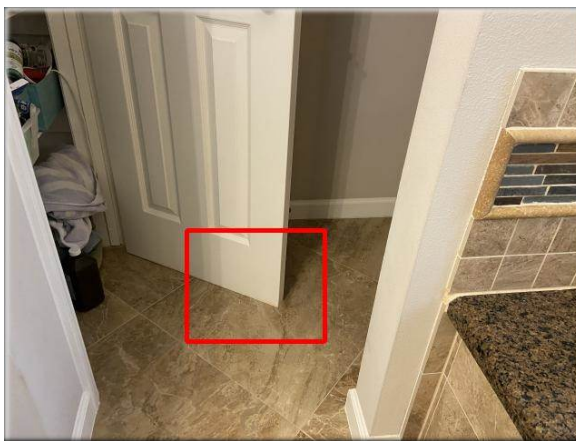
The master bathroom linen closet does hits the flooring and does not operate as intended.

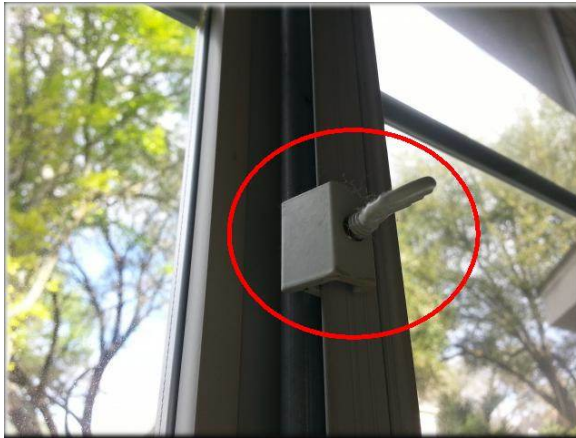
Solar screens were installed on some of the windows limiting our ability to view the windows; recommend consulting sellers for additional information if concerned.

Replace the window screen in the living room, breakfast room and kitchen.

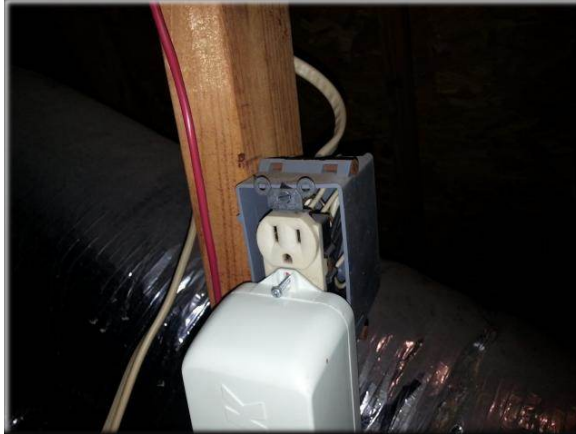
The electrical cover plate in the Attic is damaged/missing. Recommend replacement.

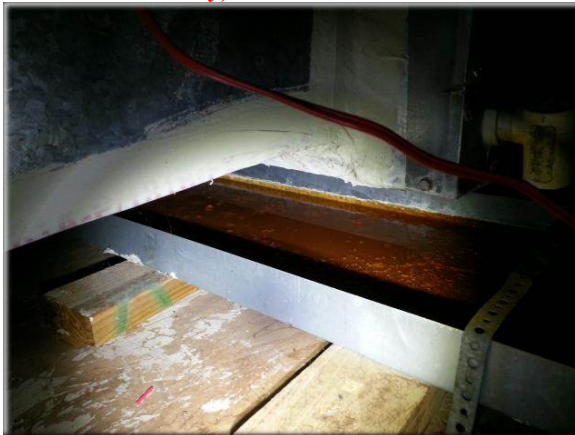
Water observed in the overflow pan for the Attic evaporator coil. It appears a leak is present at the A/C coil condensation pan. (front attic unit mainly)

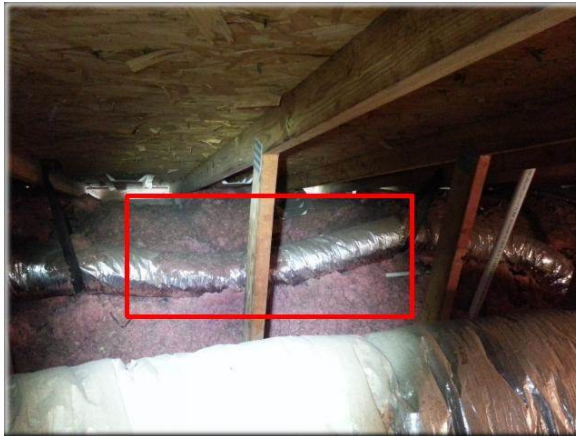
The ductwork is lying on the insulation in the attic at partial areas. Current standards now require the ducts to be properly suspended from the rafters above the insulation at intervals no greater than 5' and the hanger material should be at least 1 1/2" wide so it doesn't reduce the internal diameter of the duct. The maximum permissible sag is 1/2" per foot of spacing between supports. With older homes, this may not have been a requirement when this home was built. If ducts are replaced, make sure they are installed to today's standards.

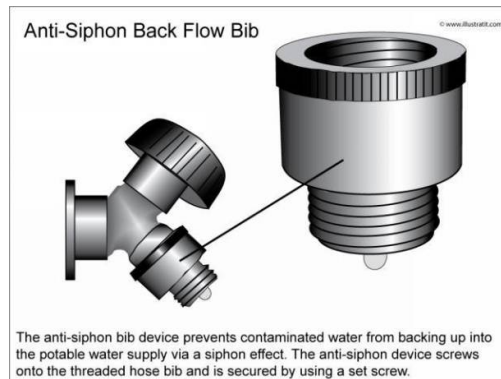
Current standards require a back flow preventer be attached to each outside faucet. This prevents water from backing up from the hose to the potable household water; recommend installing a backflow preventer on all exterior faucets.

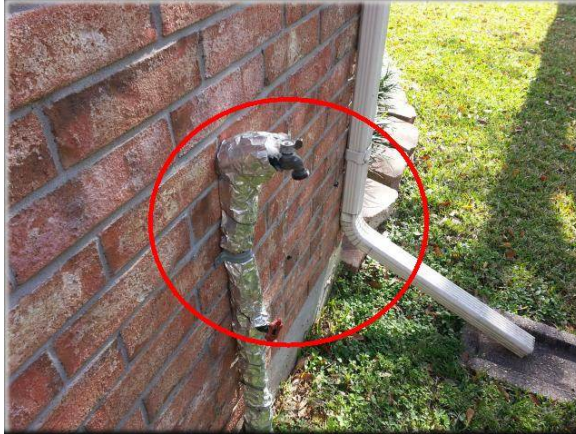
Low water pressure at the front left exterior. Recommend review by a licensed plumber.

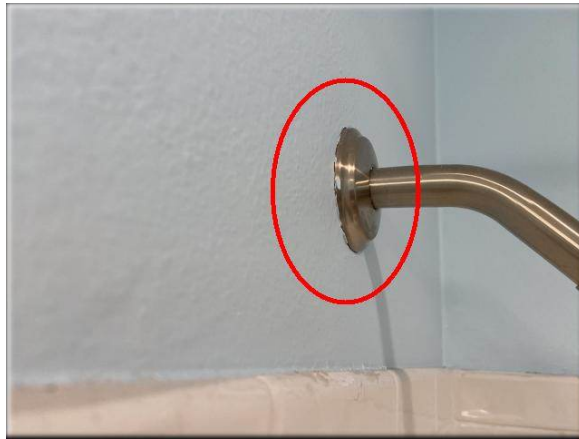
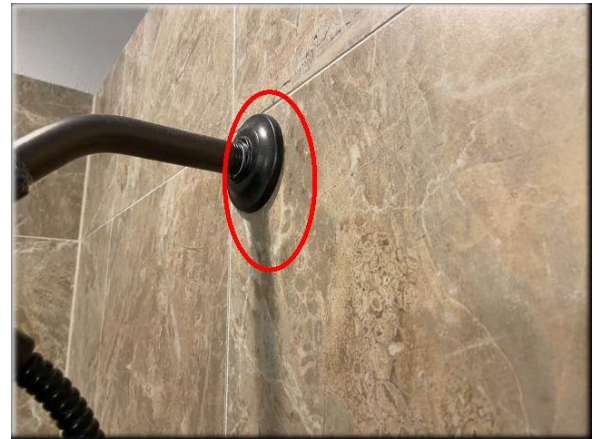
The faucet valve is installed backwards causing the hot and cold water to be reversed for the bathroom shower/bathtub in the upstairs bathroom. This is a possible safety concern; recommend review for repair or replacement as necessary.

The shower head trim is not caulked at the shower walls, which may result in water penetration to the interior structure and deterioration of the wall; recommend caulking around shower heads, faucets and tub spouts to prevent wall damage. Failure to keep these areas sealed can cause deterioration and moisture damage to the interior walls, which is not visible to the inspector at the time of inspection.

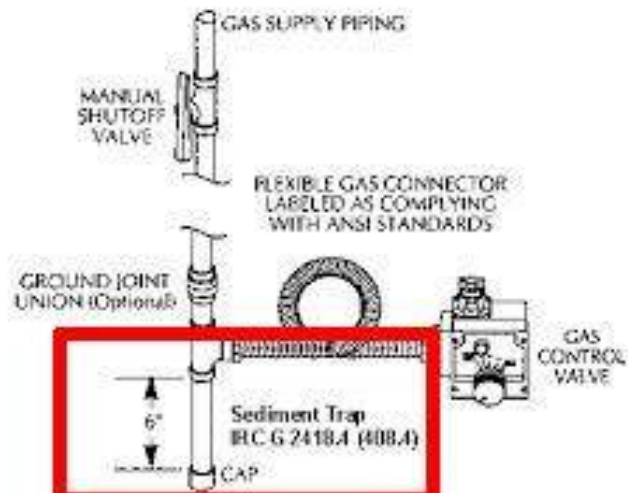
GAS PIPING WITH FLEXIBLE CONNECTOR

The fuel type is gas with shut-off valve for the heater. A sediment trap is not installed on the gas line for this appliance; recommend installing drip leg to help prevent moisture or debris from affecting combustion and burner operation. See illustration below.

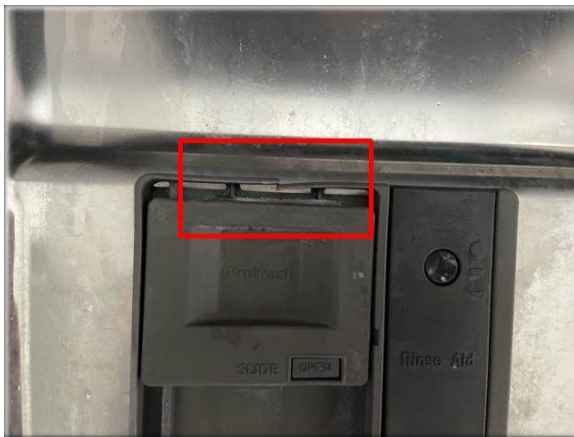
Drain line hose from dishwasher should have a high point as indicated here to help prevent grey water from re-entering dishwasher. Hose needs to be well secured.

The dishwasher soap dish is cracked.
