Property Inspection Report

241 Lake Livingston Blvd., Livingston , TX 77351
Inspection prepared for: Dori Rhodes
Real Estate Agent: Sara Jimenez - RE/MAX Signature The Mosely Team

Date of Inspection: 3/29/2021 Time: 9:00 am
Age of Home: 46 yrs - 1975 yr built - Size: 816 sq ft
Weather: Clear and Sunny

One story pier & beam frame house built on grade having 2 bedrooms, 1 bathroom and detached Carport.

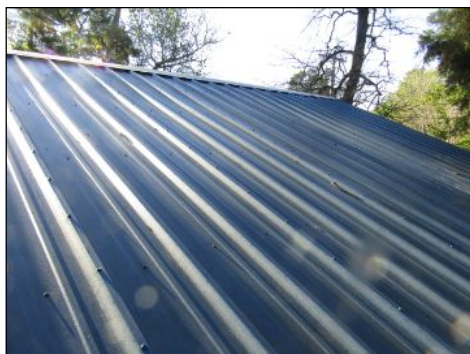
Roof appears to be in good condition.

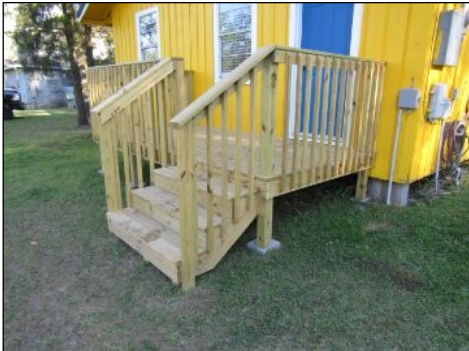
Front wood porch/deck appear in like new condition.

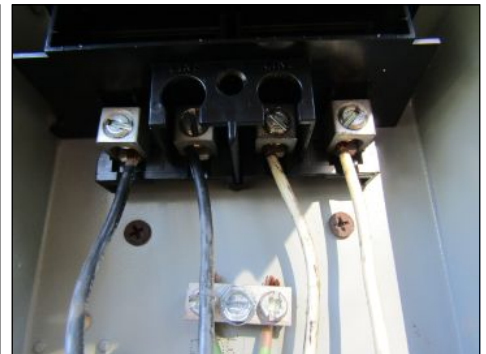
Appear functional and properly installed.
