BRYAN & BRYAN INSPECTIONS

Inspection Report For:
307 Sorrelwood, League City, TX 77573

Inspection Date: 3/24/2017

Prepared By: Rene Guajardo TREC#5945

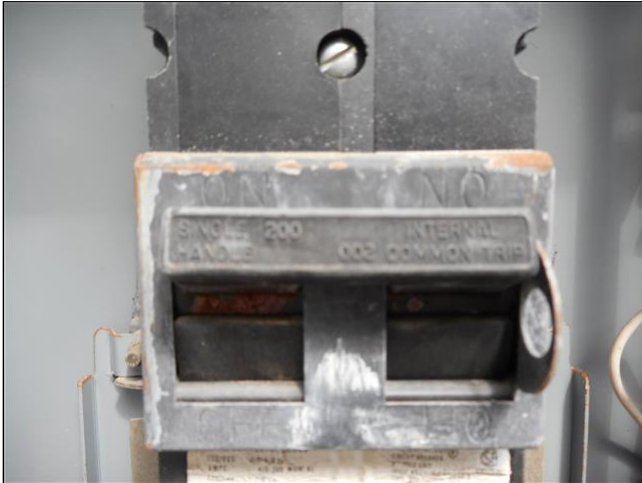
(1) General Photo of the Distribution Panel Arc-fault safety protection is not installed for all of the living and bedroom areas. This protection was required by the National Electric code for homes built after 2008. The Texas Real Estate Commission requires inspectors to list as "deficient" any arc-fault protection not installed in these areas; regardless of the homes age.

White wires connected to breakers should be marked as hot with black or red electrical tape.

"Double lugged" neutral wires on the breaker box neutral bar observed (improper): one neutral wire per connector is allowed.

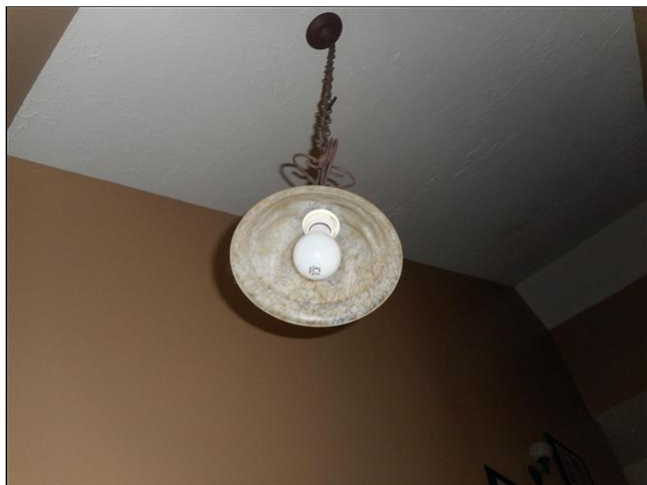
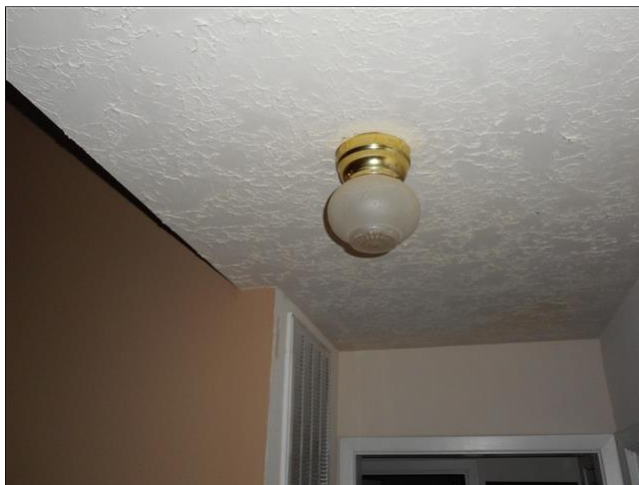
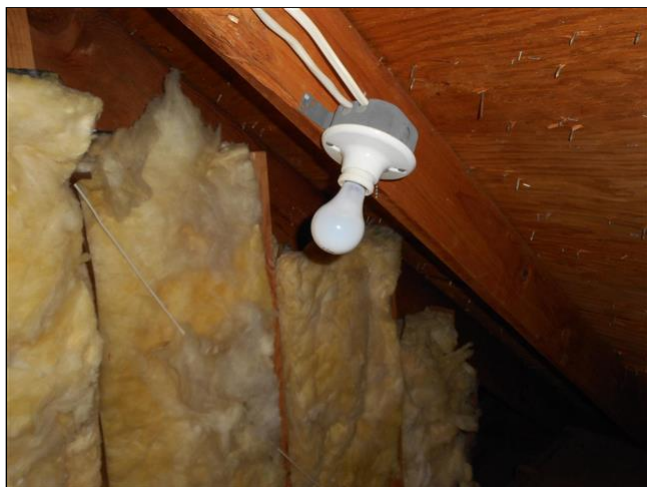
(4) Lights are not functioning. This may be a result of a bad bulb: test with new bulb and remedy if needed.
Location(s): front entrance, top of stairs, attic crawl space

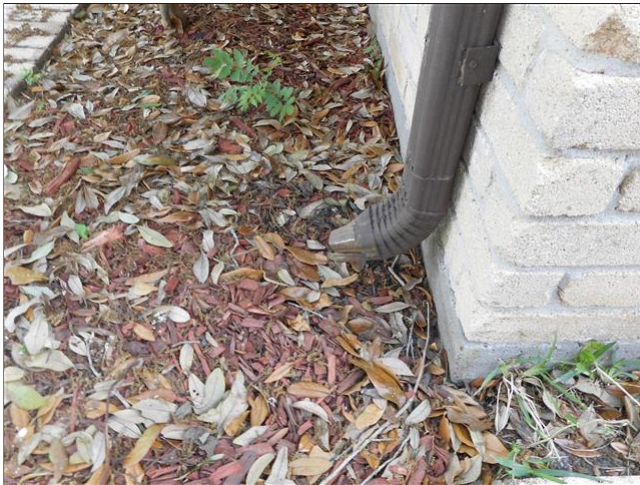
Replacement of any missing splash blocks at the base of all guttering downspouts is recommended to prevent soil erosion.

Gutters should be cleared of debris for proper drainage.

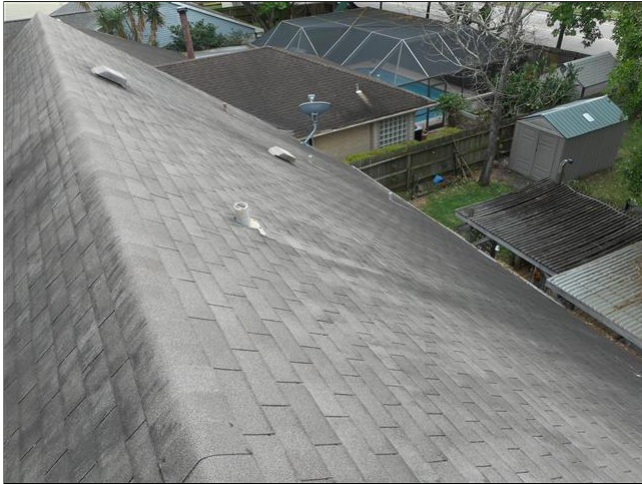
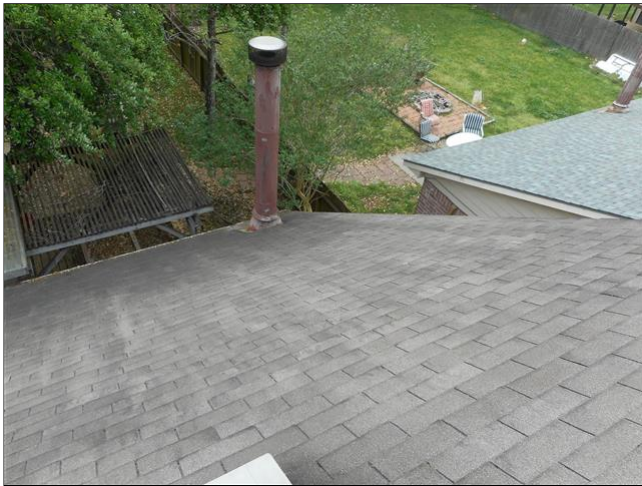
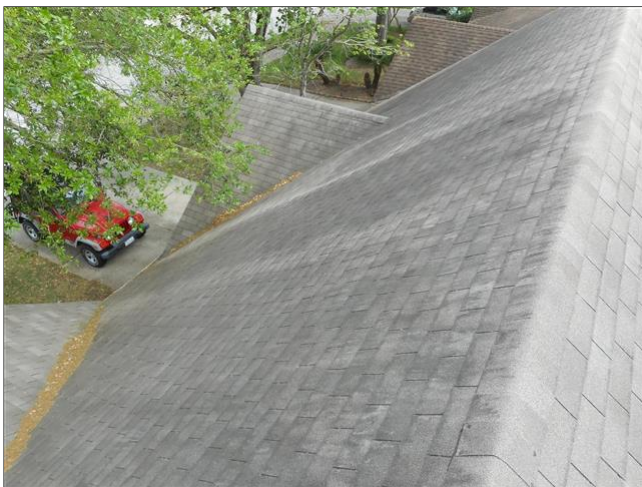
(2) General Photo of Roof Covering

The roof fastening method is not verified. The Inspector reasonably determines that actions of the inspector to ascertain the method of fastening may cause damage to the roofing shingles.

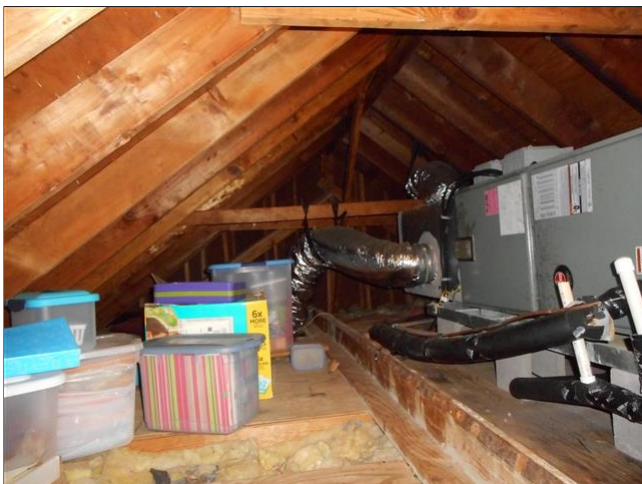
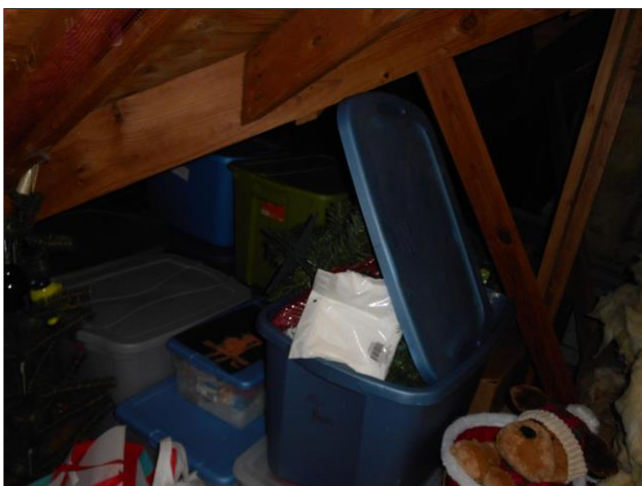
(2) **Note:** Only accessible areas of the attic are inspected. The inspector does not crawl/walk over areas that may be unsafe or not easily accessible.

(3) Noted vertical batt insulation that appears to have pulled away from the wall. For maximum R value, the insulation should be installed flush to the drywall.

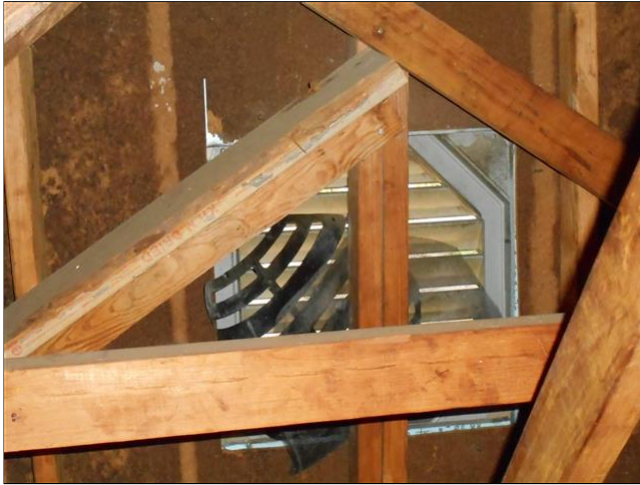
- (4) The attic ladder door is not proper insulated or weather-stripped. This will help with keeping hot air inside the attic and not be pulled into the home.
- (5) The screening on the attic gable vent has been damaged. This may allow access to rodents or other pest.

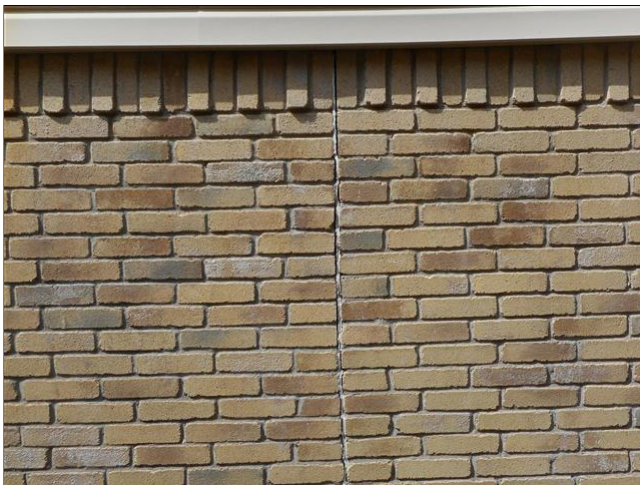
(2) Cracks in exterior brick veneer consistent with normal settlement was observed at various areas of exterior. These are considered cosmetic at this time. Monitor as needed. Monitor. If the cracks continue to widen, consult a qualified contractor or professional engineer

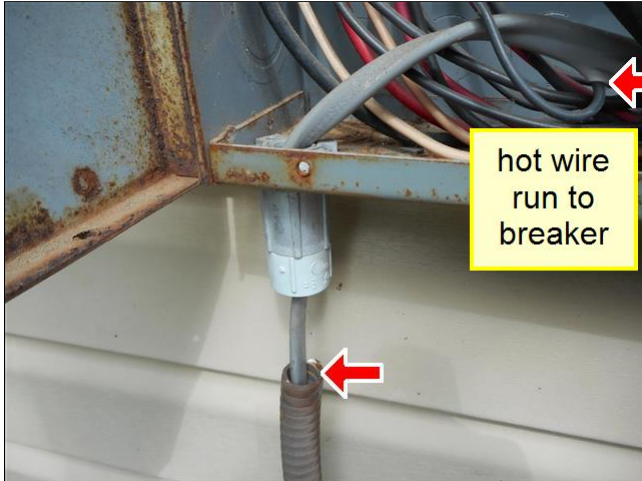
(2) Conduit is not sealed under service panel.

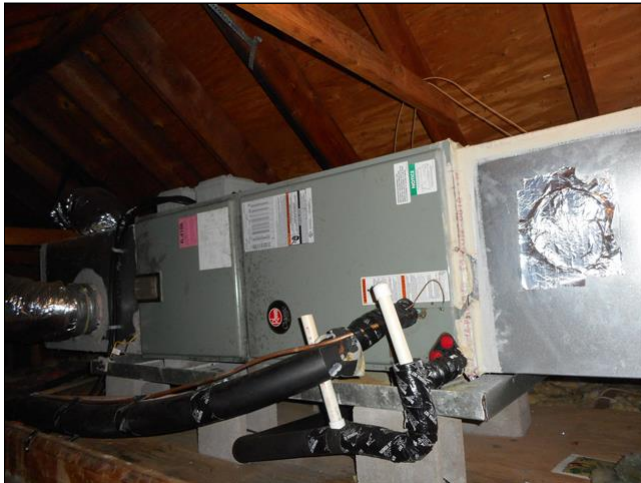
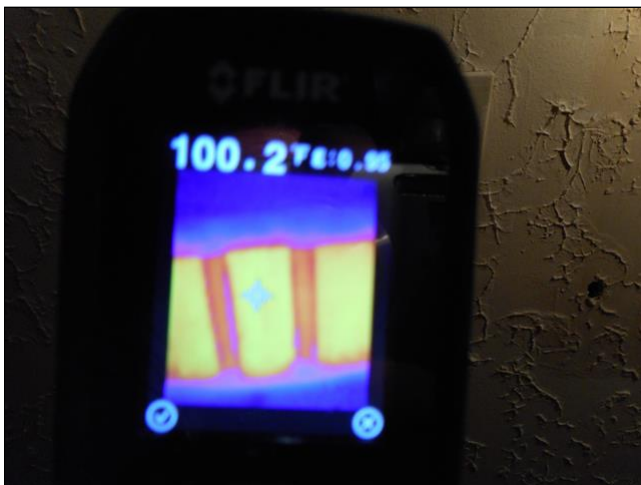
General Photo of Furnace Unit **Note:** The furnace(s) is functioning as intended and cycled properly on the "cool down" cycle at the time of inspection.

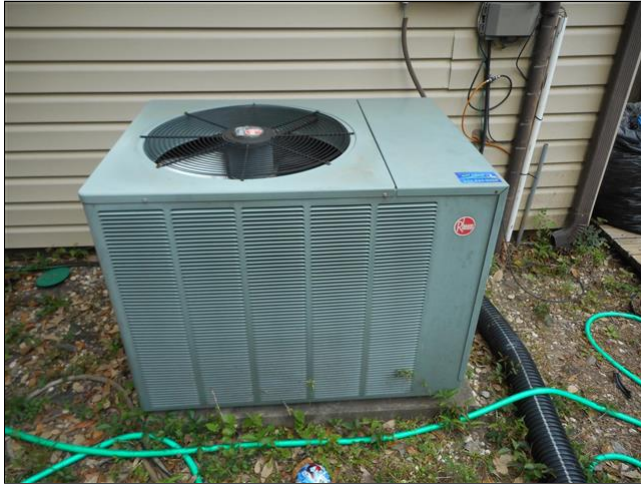
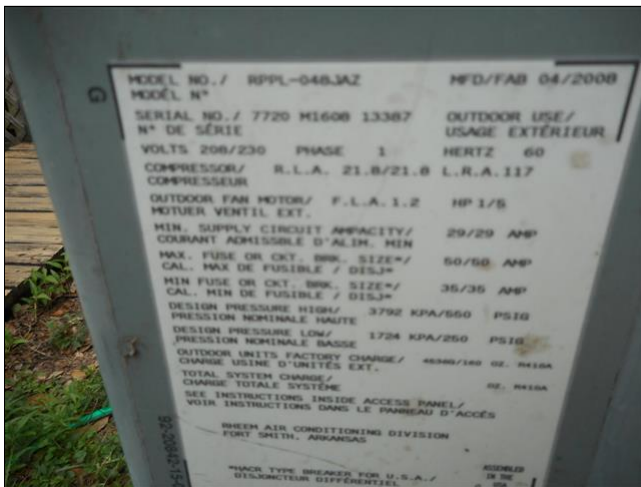
General Photo of Exterior Condenser Operation of the unit shows the unit is cooling at the time of the inspection. Due to the age of the system, routine maintenance should be considered.

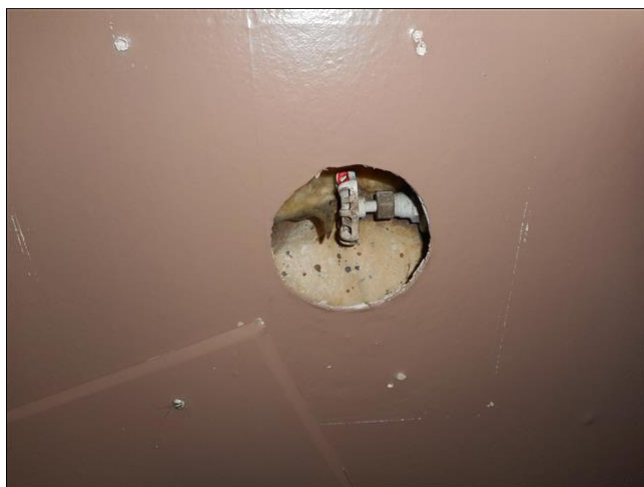
(1) General Photo of Main Shut-Off Valve

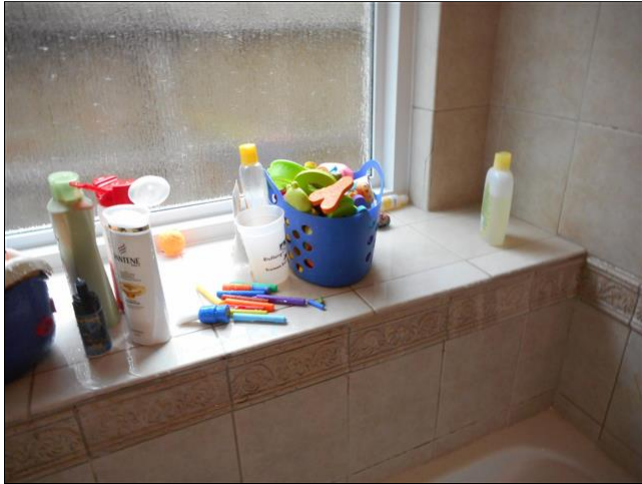
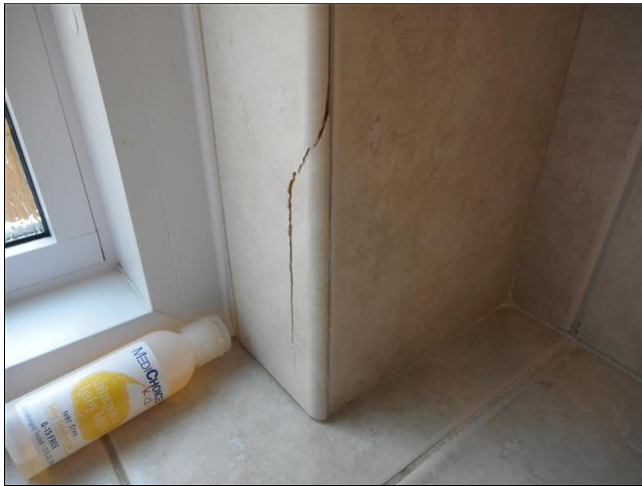
(3) The master shower window stool does not have proper slope towards the tub to direct water away from the window. Water was observed penetrating through window frame during shower use. Cracked tile was observed at right side of window.

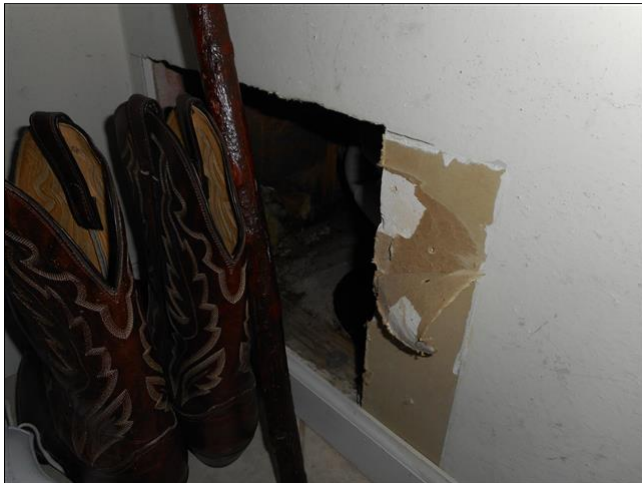
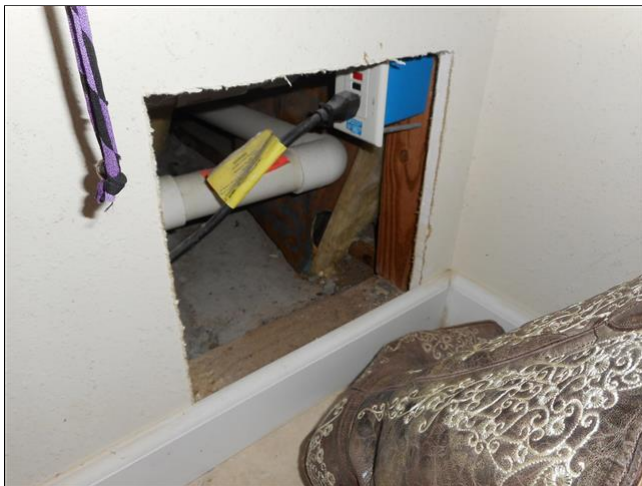
(5) Access panel covers are missing from master bathtub area.

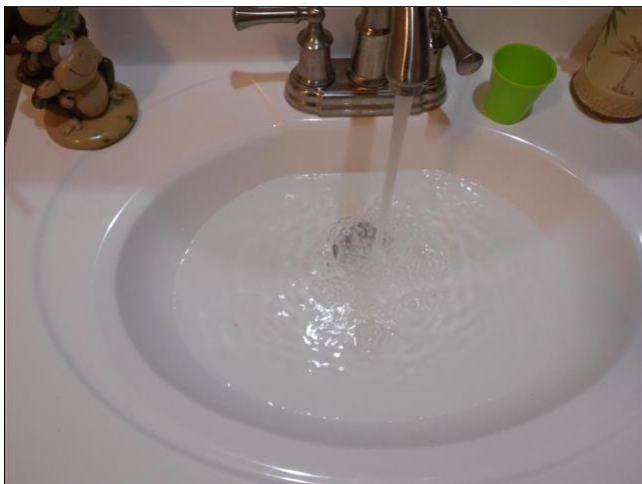
- (1) **Note:** No leaks were observed when all accessible plumbing fixtures were operated, filled, and drained.
- (2) Slow drainage was indicated. The cause could not be determined. Evaluate and remedy as needed.

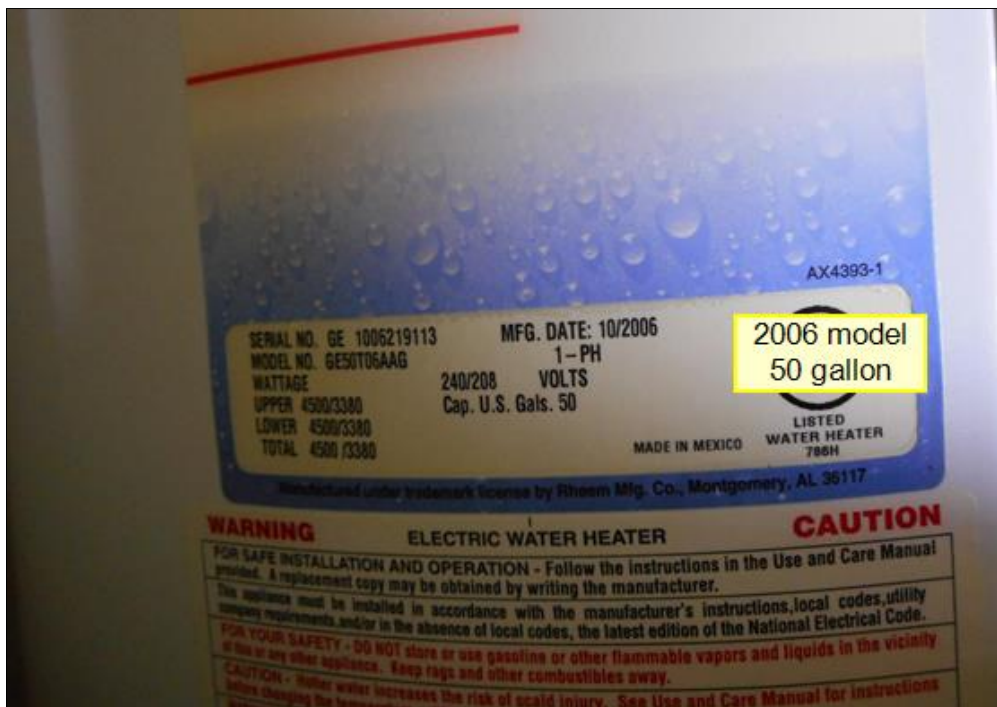
(1) General Photo of the Water Heater

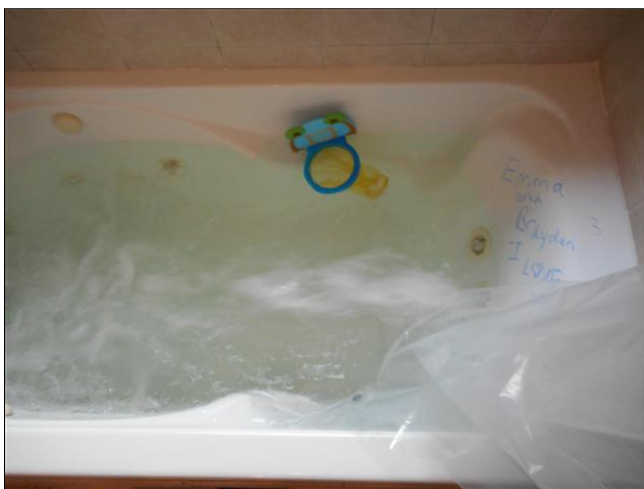
Note: The whirlpool tub is functioning properly at this time and the motor is properly ground fault protected.

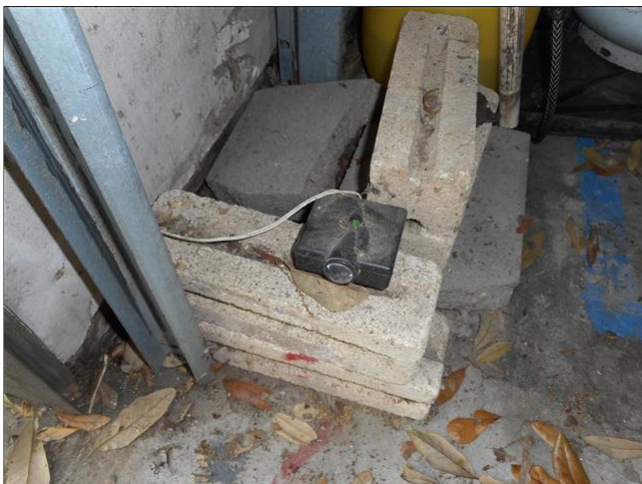
The safety beam sensors are improperly located.

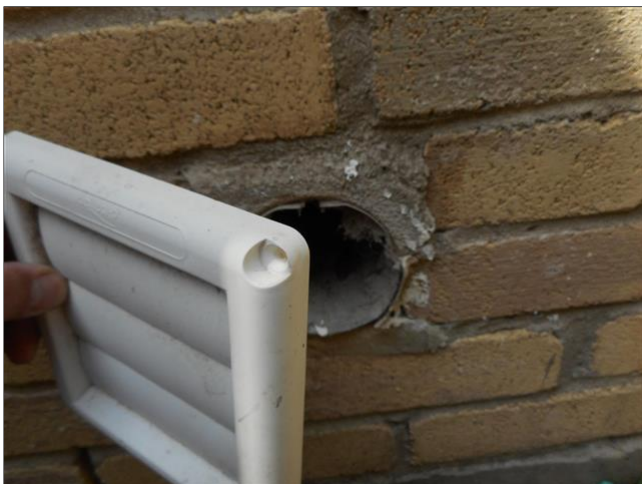
Cleaning of the dryer exhaust vent is recommended as normal maintenance and to prevent excessive lint build-up in the line. Vent cover should be secured.
