PROPERTY INSPECTION REPORT

Concerning: 2412 Helena St., Houston, TX. 77006
(Address or Other Identification of Inspected Property)

By: Rudolph Depena & Martha Kaplan Lic. 5191/5863 04-10-2018
(Name and License Number of Inspectors) (Date of Inspection)

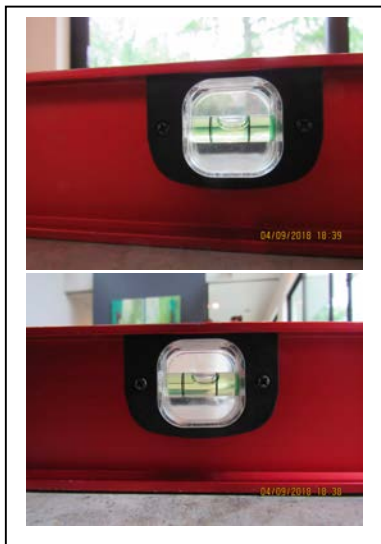
- Entry indicated approx. 3/16" slope in an easterly direction.
- Dining room indicated approx. 3/16 to 1/4" in a southerly direction.

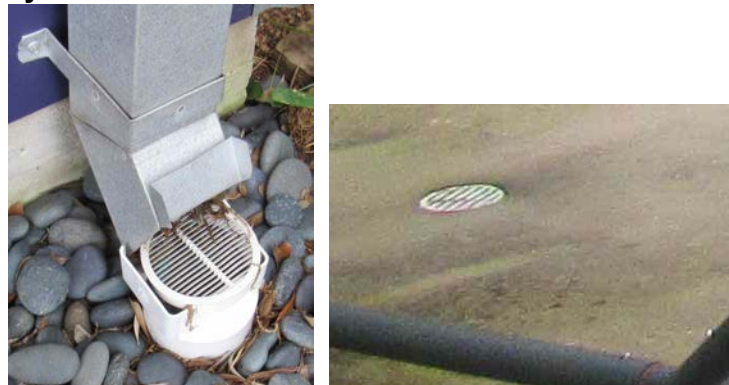
Present conditions: This property is not viewed with builder's swale. A Drain system is viewed at the north side with downspout discharging to underground pipe and a grate over pipe at the concrete slab at the east side from the pool area. It is recommended to clean the drain pipes for a proper function of this system.

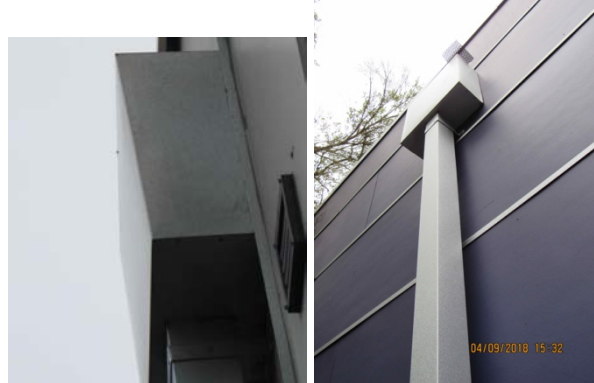
Downspouts are connected with "Scupper" collector box at roof level. Recommend to clean Scuppers periodically for their proper function. See roof covering section for additional comments.

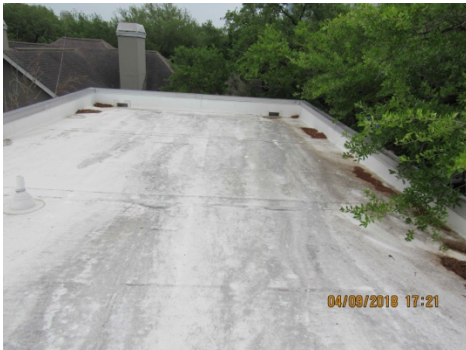
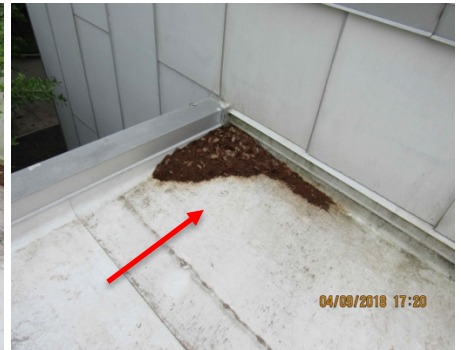
D - Roof surface is accumulating debris within the east slope, retaining water. This may be attributed to the trees branches present over the roof envelope. The “scuppers” get full of debris and system gets clogged with heavy rain, permitting water pool/retention in great amount over roof surface.

Debris needs to be cleaned at all times and observation of those areas of retention for proper storm water discharge. Cut tree branches over the roof area. **Professional in the field to further assess roof surface when debris is removed.**

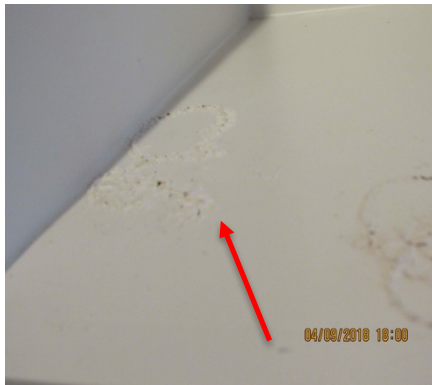
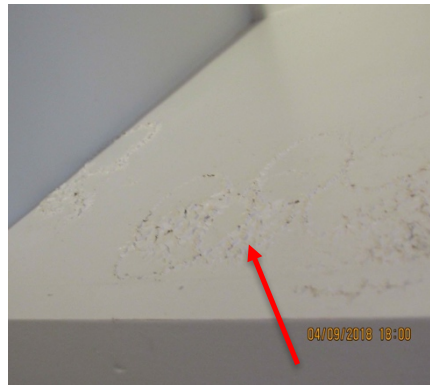
- **Damage to the paint surface at a master closet shelves.** Restore surface as needed.
- **Interior closet located next to the door from house to garage is in need of base molding element.**

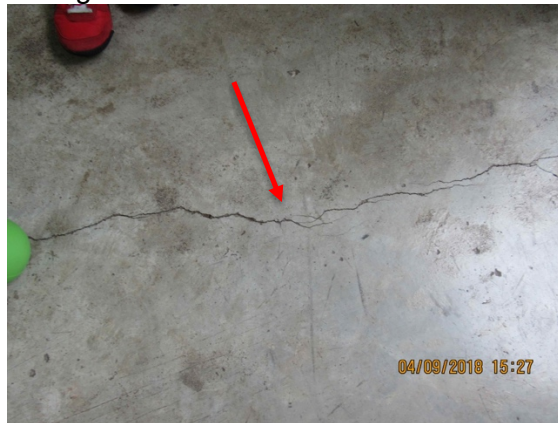
D - Bare concrete flooring at the first-floor is visualized with fractures, in need of sealant. Prevent soil vapors transmission to the confine space.

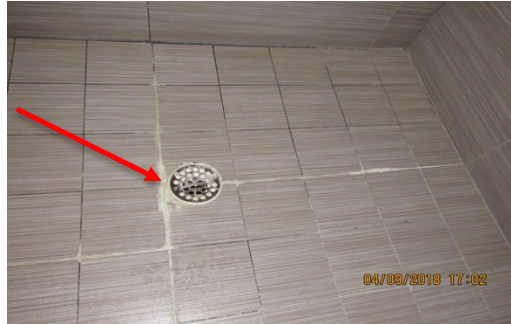
D - Grout fracture appears to have been repaired, applying with what appear to be caulk with latex product at the N.E. bathroom. Adequate grout restoration is needed, not limited to the replacement of floor tile if needed. See interior wall section for further comments.

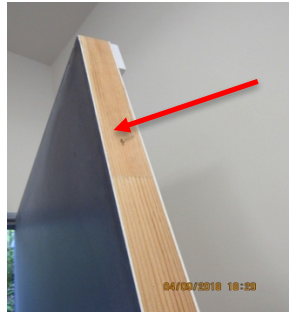
D - Rear exterior door from the garage has frame shaved-off. Door should be rebalanced. Door is considered damage, replace it. Door is recommended to be replaced if closing function problem continues.

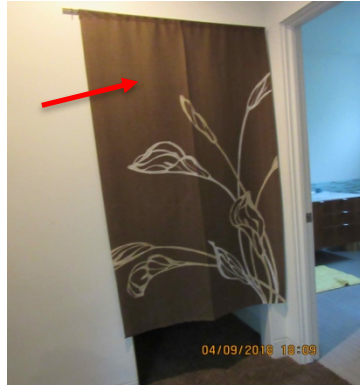
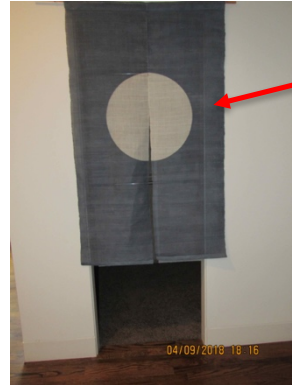
D - Two missing closet doors at second floor, currently with a curtain. Recommend installation of doors.

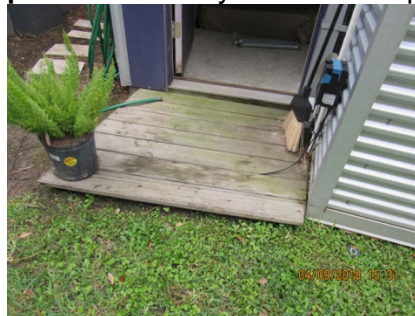
NOTE: Wood deck at the N.W. area of the garage is considered a conducive condition due to the contact to soil and structure perimeter. See your termite report.

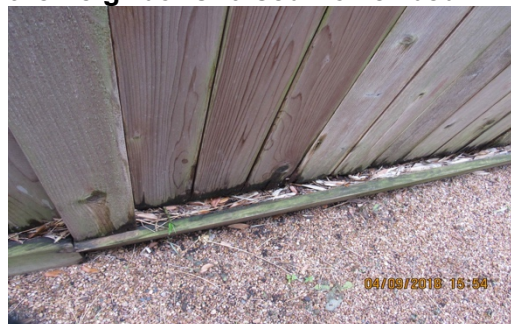
Bottom board of the south fence is being damage (pushed out), due to the neighbor's raised flower bed.

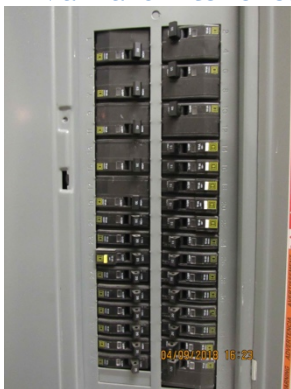
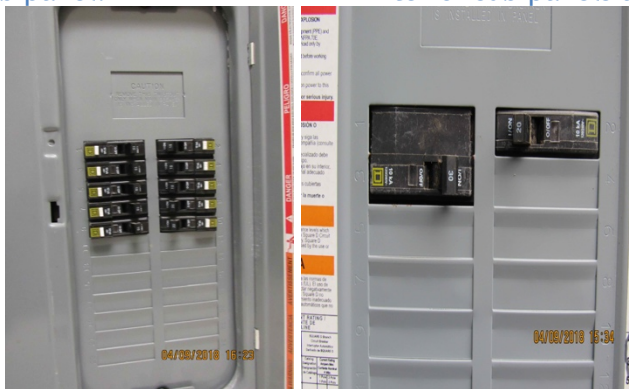
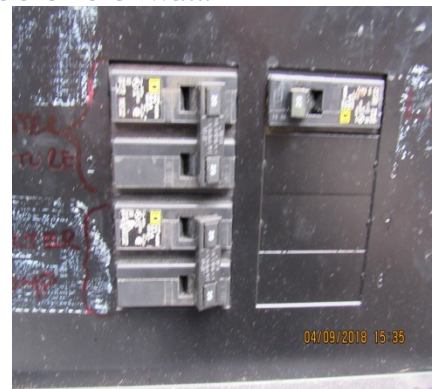
Main and interior sub panel.

Exterior sub panels at the north wall.

Antioxidant is recommended if AL (aluminum) conductors at the service entrance wires with entrance lugs when present. This is to prevent overheating or corrosion.

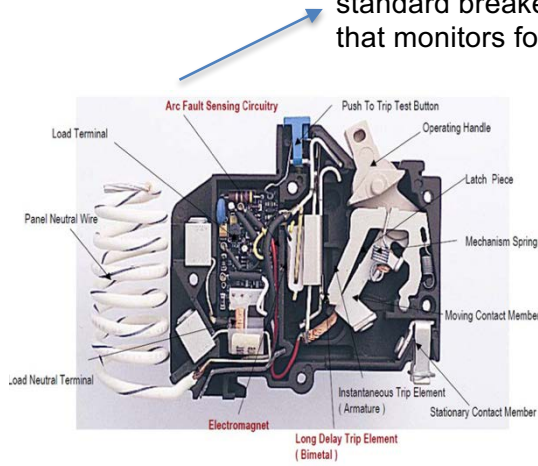
Terminals end entering the breakers were tested for Hot spots. Acceptable even temperature approx. 77 degrees was noted. Ambient temperature was 75 degrees at time of the inspection.

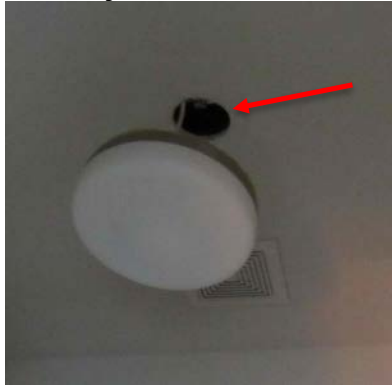
D - Hanging ceiling light fixtures from the electrical wire is viewed at the Laundry room. Install and secure light fixture to the ceiling.

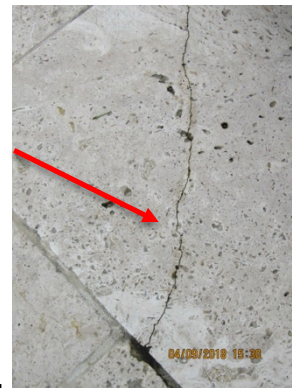
D - Multiple Coping stones-tiles with fractures are in need of seal or replacement.

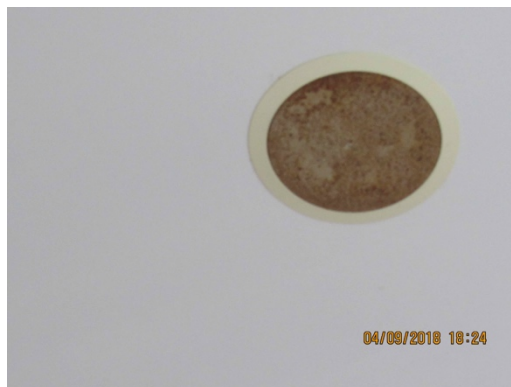
Speaker screen mesh cover located at the soffit of the covered patio appears with corrosive surface.
