Home Inspection Report

5101 Bataan Road
Houston, Texas 77033

Semora Inspections LLC

Prepared For: Mike Thomas
Concerning: 5101 Bataan Road Houston, Texas 77033
Inspection Date: 09/14/2018

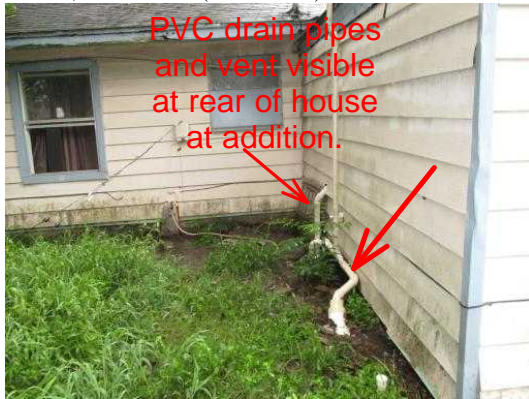
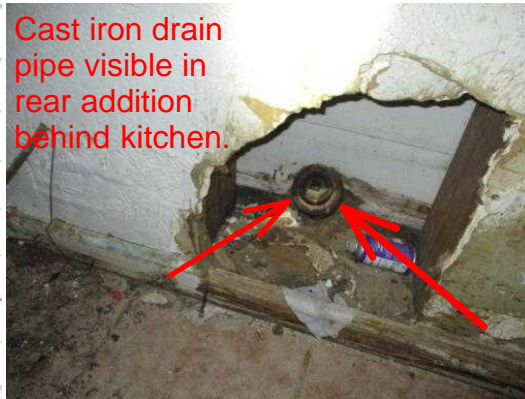
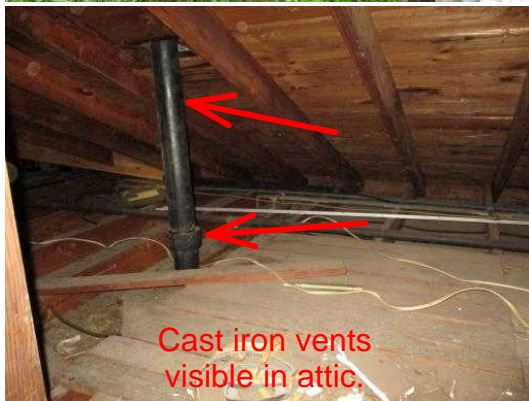
B. Drains, Wastes, and Vents (continued)

- PVC drain pipes and vent visible at rear of house at addition.
- Cast iron drain pipe visible in rear addition behind kitchen.
- Cast iron vents visible in attic.
