HOME INSPECTION REPORT

Prepared For:	Ken Valka <small>(Name of Client)</small>
Concerning:	6878 Kingston Cove Ln, Willis, TX, 77318 <small>(Address or Other Identification of Inspected Property)</small>
By:	Mickey Oetken - SI <small>(Name and License Number of Inspector)</small>
	2-23-2021 <small>(Date)</small>
	Jeff Oetken Trec License Number 23908 <small>(Name, License Number of Sponsoring Inspector)</small>

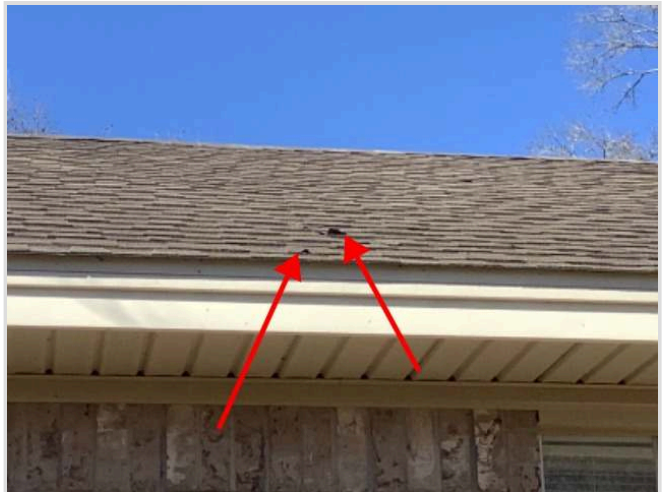
Shingles are lifting left side of house

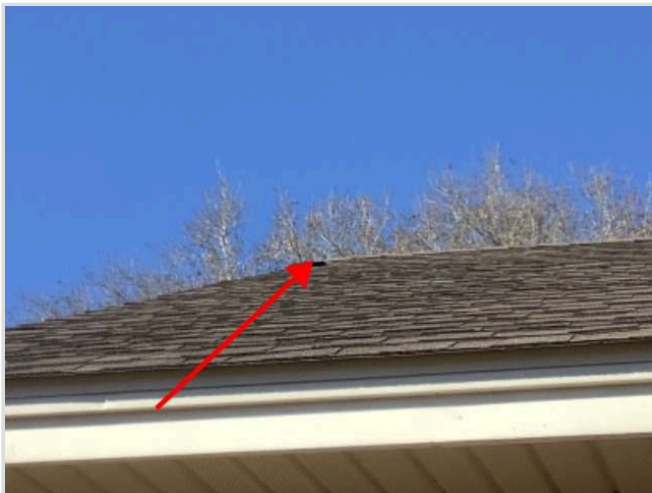
Shingle lifting left side of house

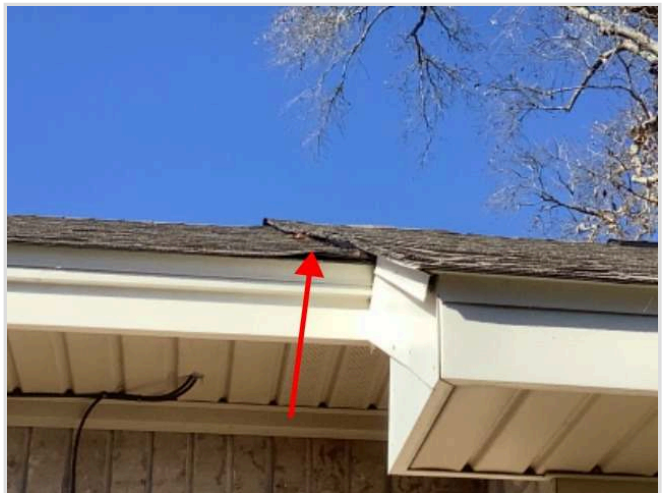
Shingles lifted to the left of garage

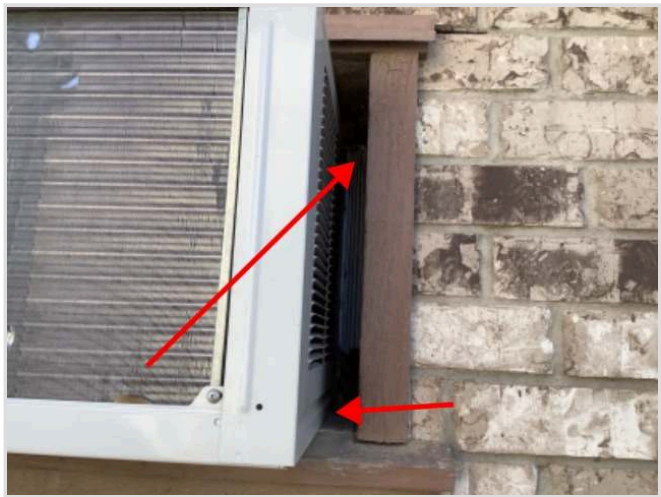
AC window unit is not sealed around the perimeter.

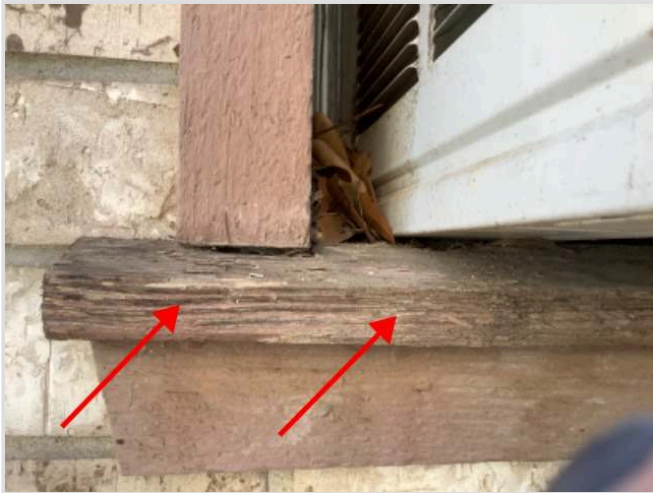
Around window AC unit

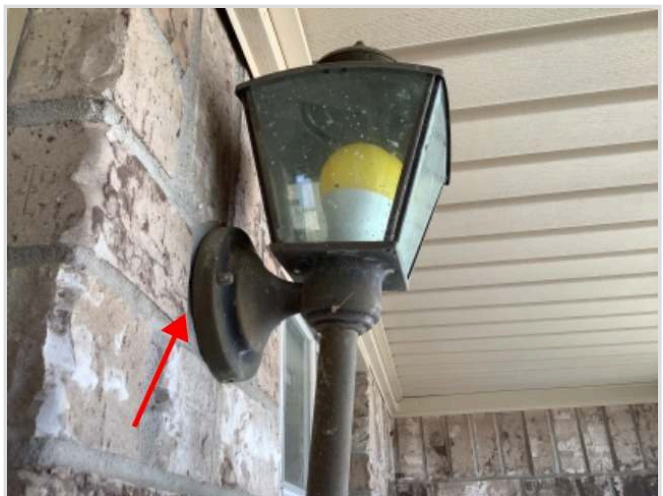
Area around base of all light fixtures on the exterior need to be sealed to prevent water intrusion

Seal around base of light fixture

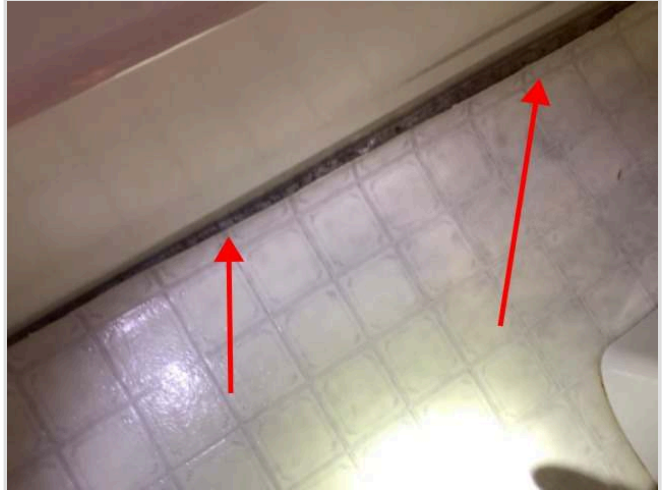
The flooring consist of carpet, tile and vinyl and appears to be in good condition at the time of inspection. Possible wood destroying insects in the hall closet. Refer to pest report. The linoleum is peeling up around the tub in the master bathroom. There is evidence of past moisture damage in the master bedroom ceiling and wall as well as a nail pop. There is no current moisture noticed in the ceiling at this time. There is a nail pop in the ceiling in the converted garage room.

Linoleum is peeling up around the master tub

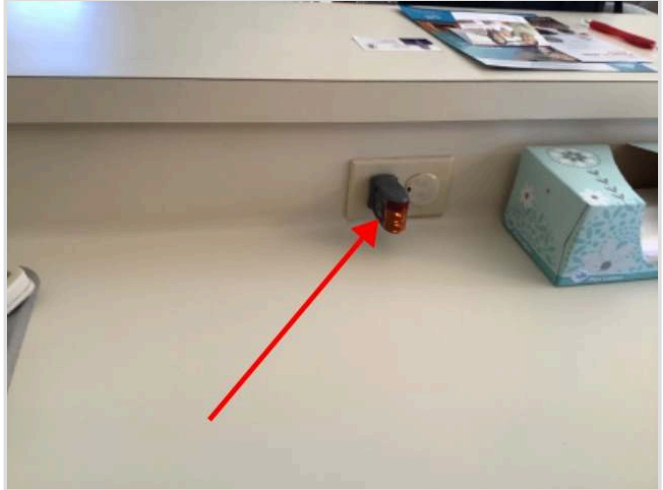
Outlets in kitchen are not GFCI protected.

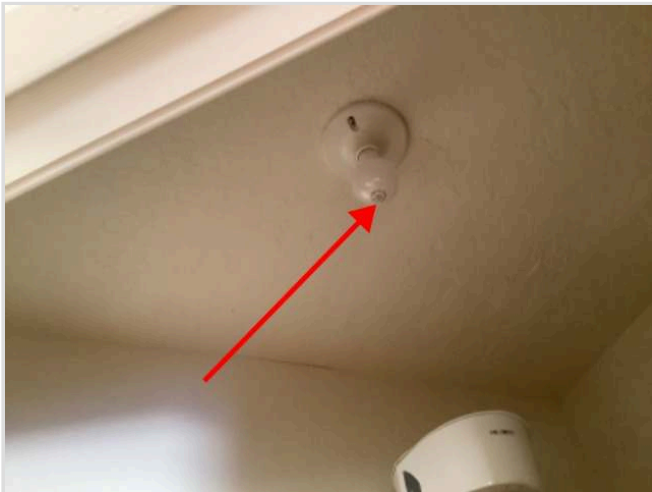
Unprotected lightbulb in kitchen pantry

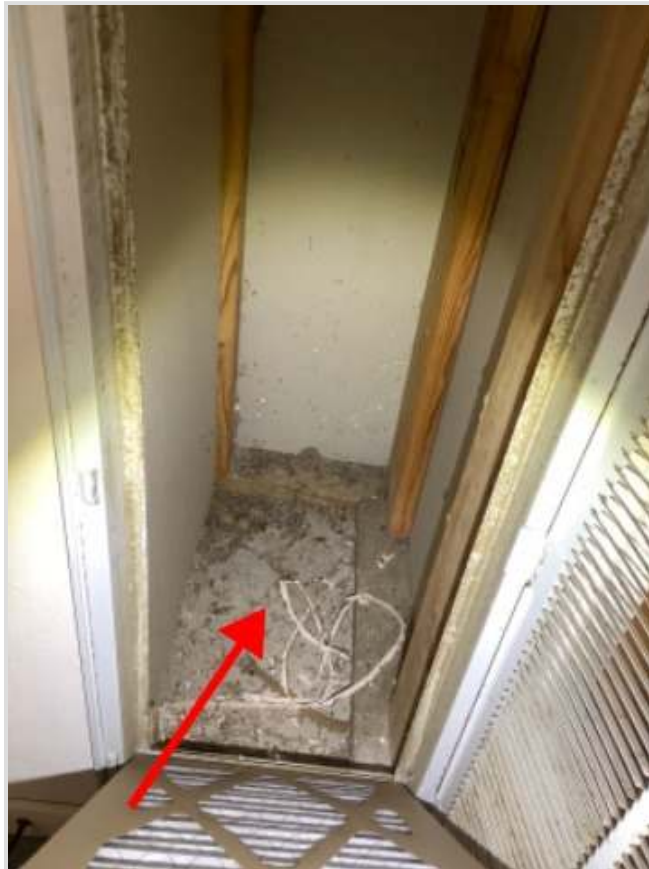
The air supply vent was full of debris and should be cleaned as a maintenance item.

Dirty supply air intake vent in hallway
