Web Presentation

Property Address: 12511 Wickwild Circle, Montgomery, TX 77356

JASE Home Inspections

**Jason Autrey T.R.E.C. #20981
15529 Queen Elizabeth Ct.
Montgomery, Tx. 77316
281-906-7168**

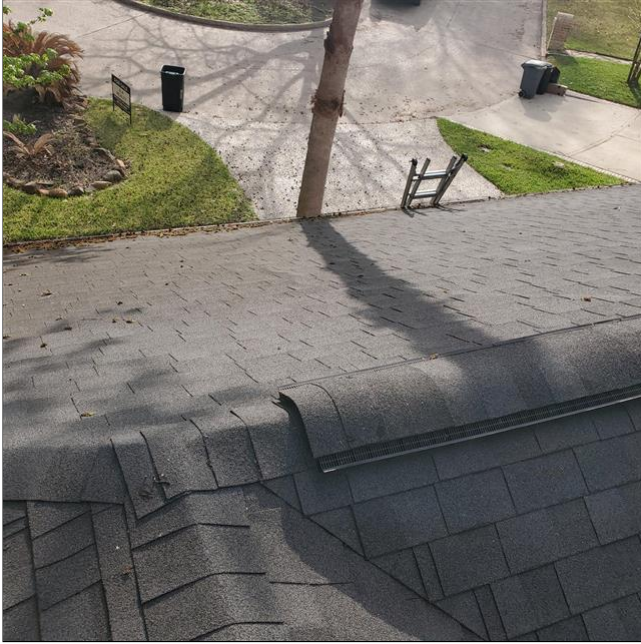
C. Item 1(Picture) Roof overview.

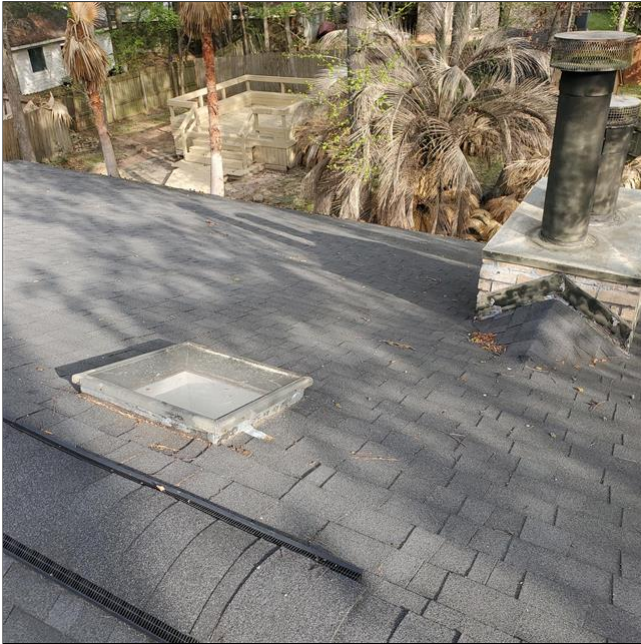
C. Item 2(Picture) Roof overview.

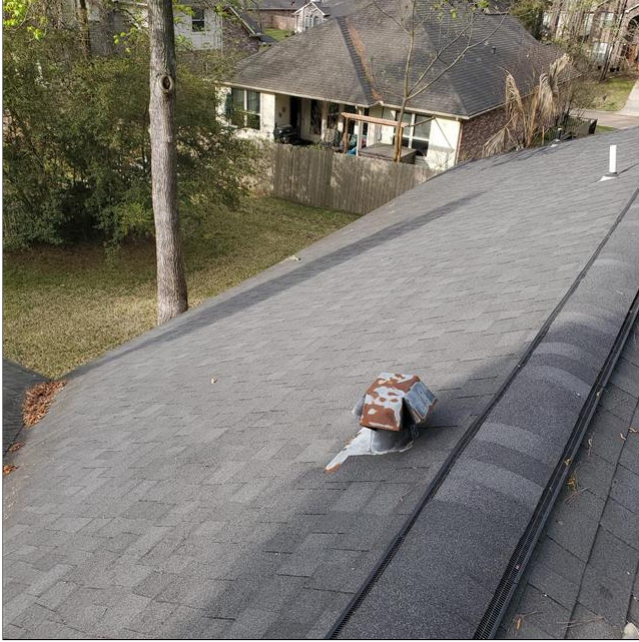
C. Item 3(Picture) Roof overview.

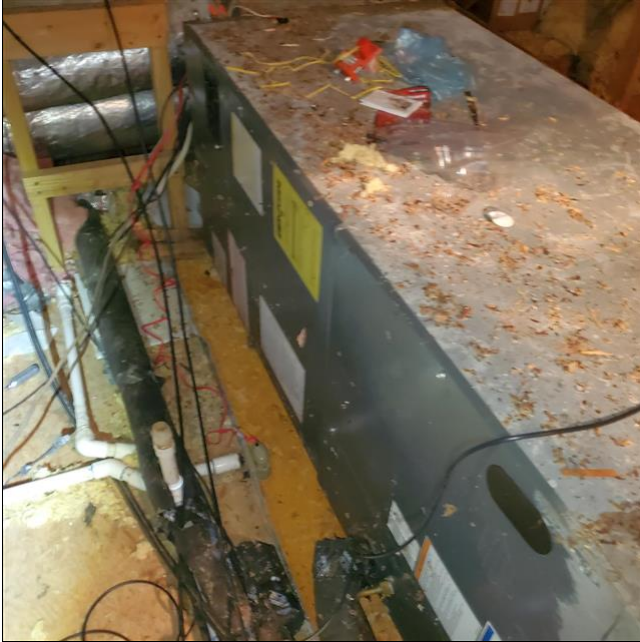
A. Item 1(Picture) Overview of heating system.

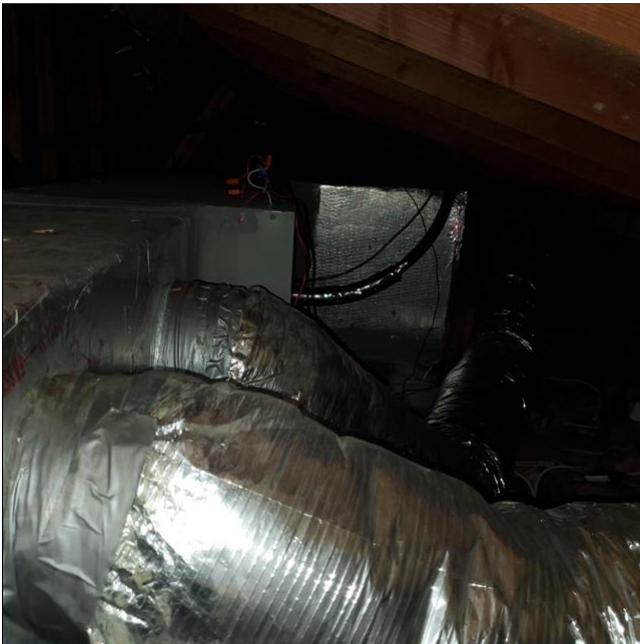
A. Item 2(Picture) Overview of second heating system.

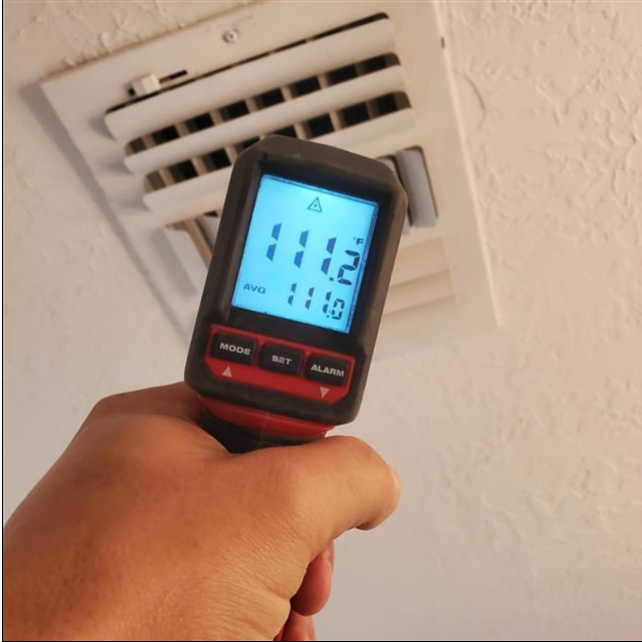
A. Item 3(Picture) Heating system #1 warming the home.

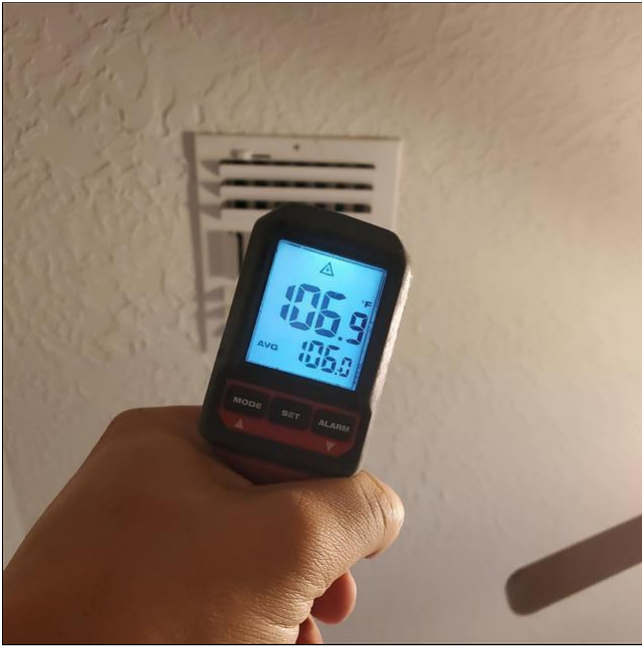
A. Item 4(Picture) Heating system #2 warming the home.

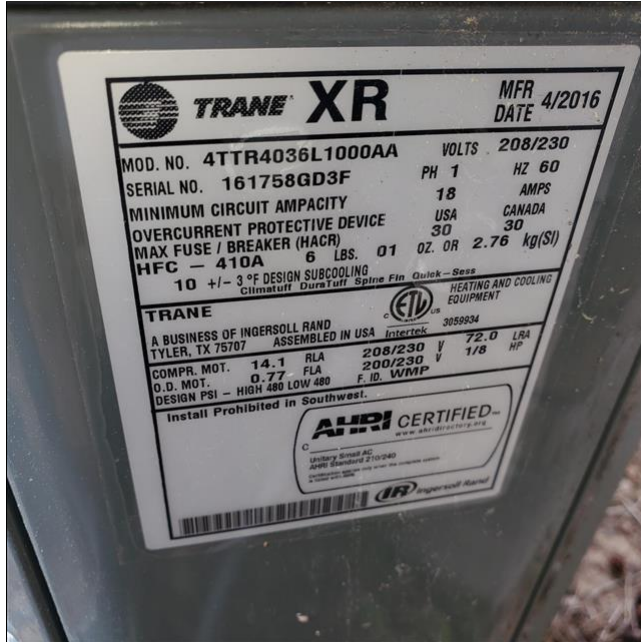
B. Item 1(Picture) AC for the gameroom and master suite manufactured in 2016.

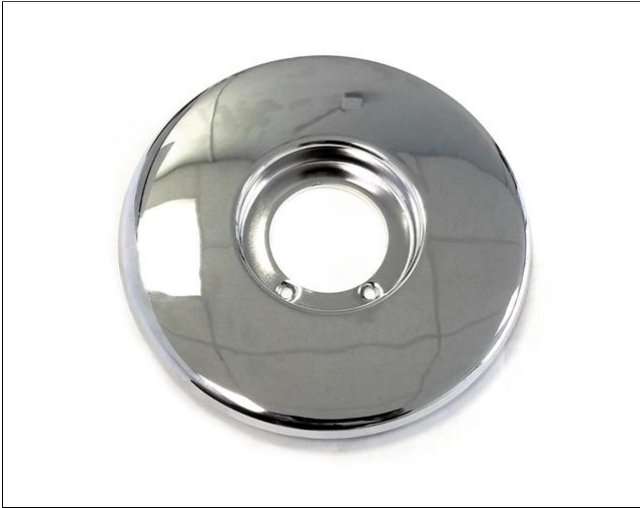
A. Item 4(Picture) Photo from online shows what is missing.

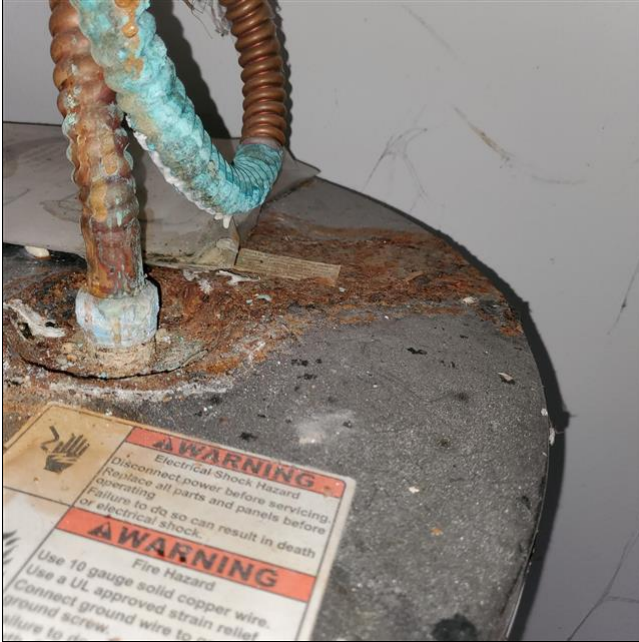
C. Item 6(Picture) Rust at top.

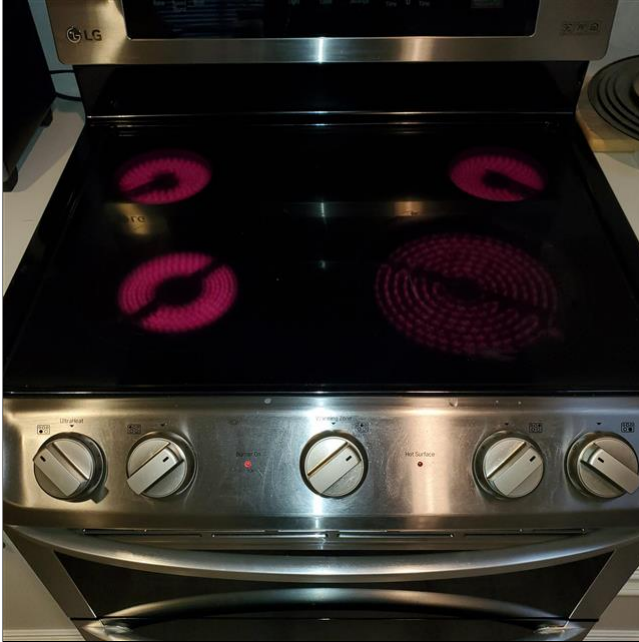
D. Item 1(Picture) Electric burners working.
