BPG Inspection, LLC

**3146 Castlewood Street
Houston TX 77025**

Client(s): Martin
Inspection Date: 3/28/2021
Inspector: Steve Fusselman , TREC 10405

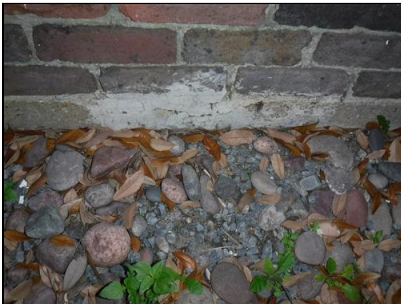
No parging is present on the exposed foundation face. This exterior mortar application aids in shedding of cascading water, filling in minor imperfections and prevents absorption of some moisture into foundation. This component is standard and typically installed on common era houses.

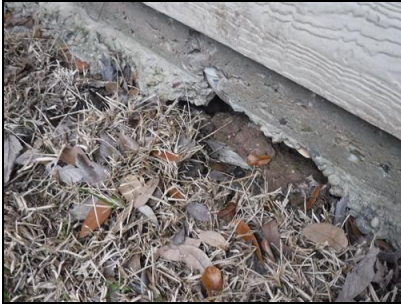
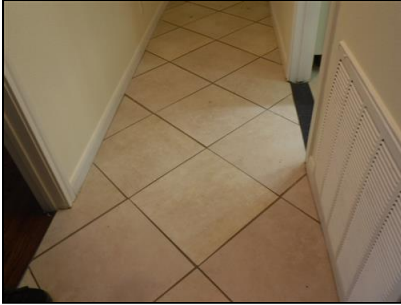
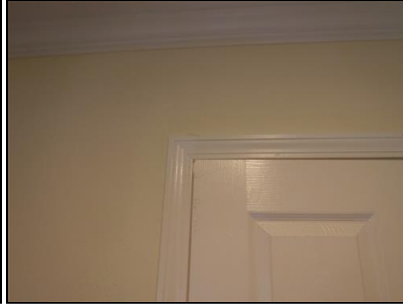
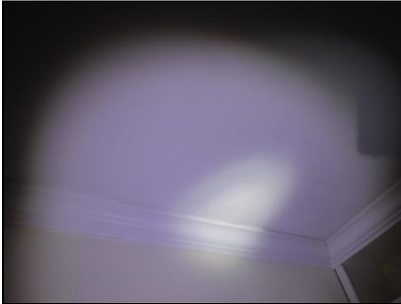
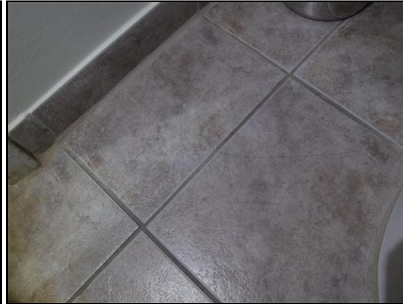
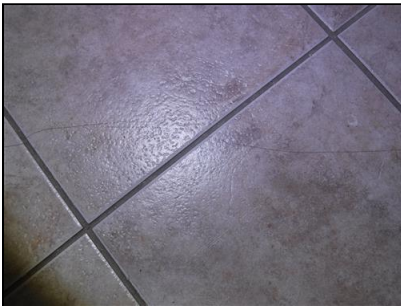
At the time of inspection the foundation appeared to have some movement considered beyond normal, exceeding acceptable tolerances. Observations made to support this opinion are listed, but not limited to the following: Significant cracks observed on the exterior foundation; Changes in the floor elevation; Step cracks in exterior veneer wall covering; Interior Sheetrock cracks and/or stress indicators; Doors will not close

properly, stick or bind in jamb and washout of foundation area at rear exterior. A professional engineer should be consulted to evaluate the current integrity of the foundation and propose necessary repairs (if any).

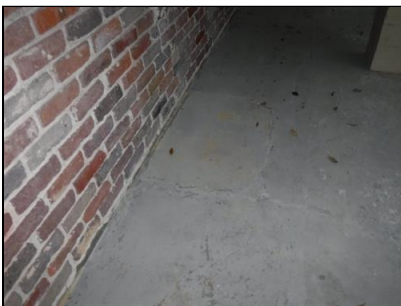
Previous repairs to the foundation have been disclosed and/or were detected. Refer to the seller for any documentation and possible warranties for further information.

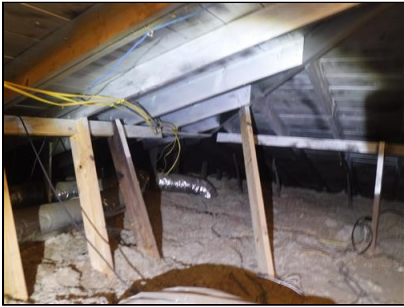
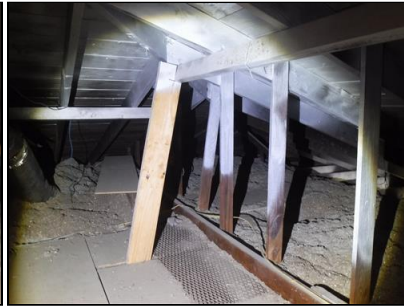
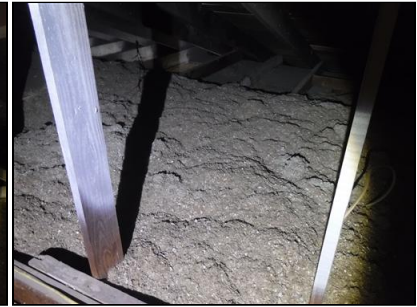
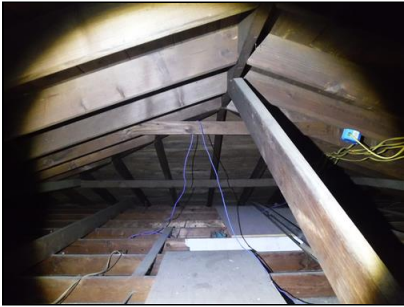
- 10. Insulation in contact with can lighting with no I.C. (in contact) rating observed. 3 inch clearance needed. Insulation dams may be installed to create required gap while reducing energy loss.

Insulation in contact with can lighting with no I.C. (in contact) rating observed. 3 inch clearance needed. Insulation dams may be installed to create required gap while reducing energy loss.

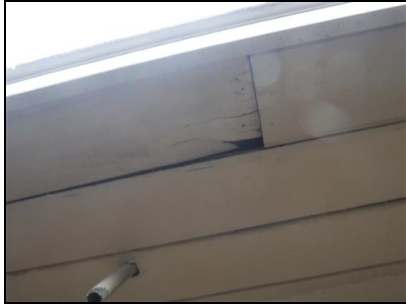
Noted multiple areas of siding board damage. Recommend having areas repaired as needed.

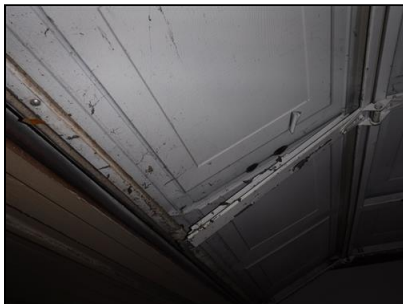
- 12. The door from inside garage to inside the home is not a solid core or metal clad, fire rated door. Replacement is recommended to meet modern standards.

The door from inside garage to inside the home is not a solid core or metal clad, fire rated door. Replacement is recommended to meet modern standards.

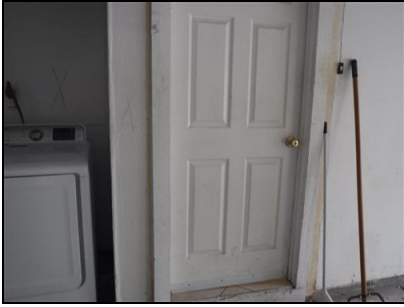
- 13. The occupant door leading from the attached garage into the house is not self closing. I recommend installing/ adjusting self closing hinges on the door leading from the garage to the living space as a safety feature to prevent exhaust gases (car, appliance) from entering the house.

The occupant door leading from the attached garage into the house is not self closing. I recommend installing/adjusting self closing hinges on the door leading from the garage to the living space as a safety feature to prevent exhaust gases (car, appliance) from entering the house.

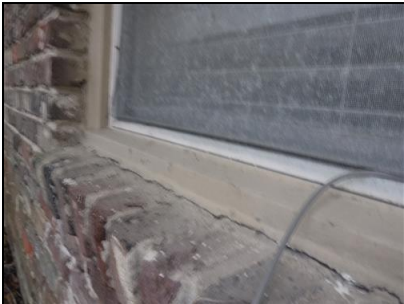
Torn screens observed in various areas of exterior. Have a contractor evaluate all screens and repair or replace as necessary.

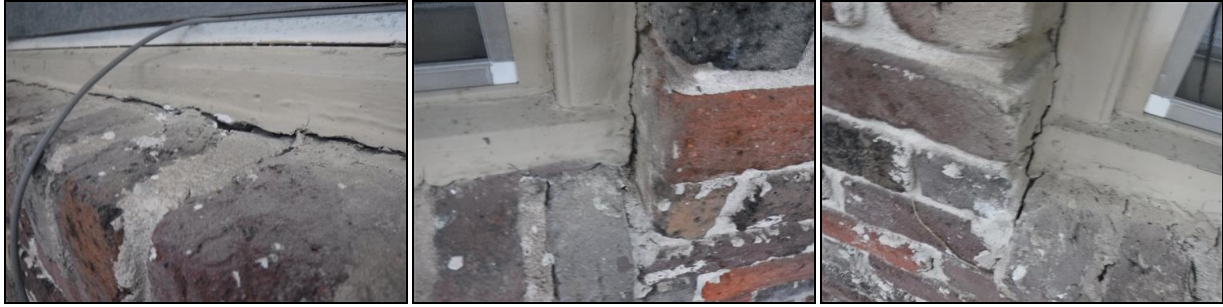
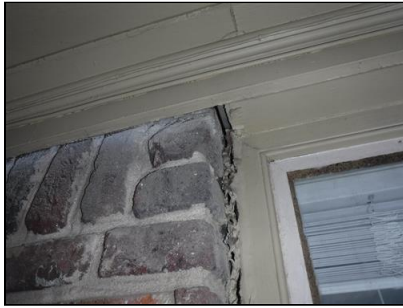
Noted several exterior brick window ledges with deteriorated and missing mortar. Area has potential to be point of water infiltration into home and to home wood structural members which over time can cause damage. Recommend having brick window ledges properly and fully sealed with mortar to reduce risk of water infiltration.

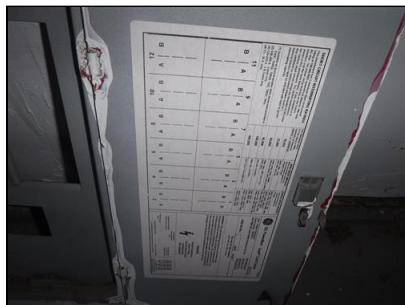
All breakers should be properly labeled to identify branch circuits controlled

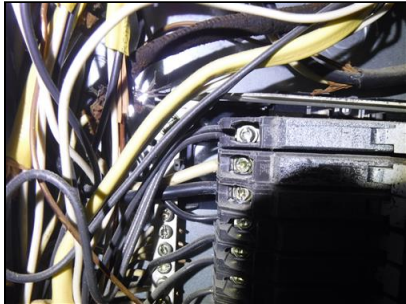
Multiple wires are installed on an individual circuit breaker terminal(s). This "double tapping" is an improper short-cut wiring technique and can be a safety hazard. Only one wire should be connected to each breaker. A qualified electrician should correct all double taps.

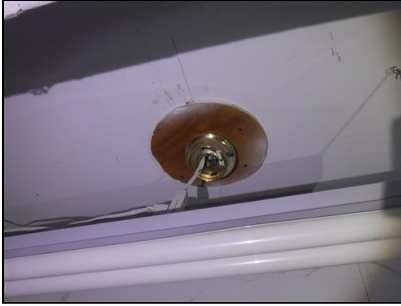
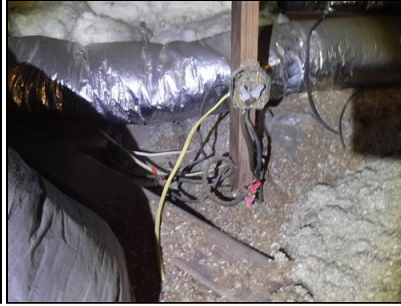
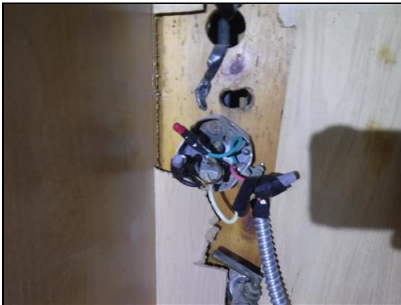
☒ There were exposed connections, open boxes observed in the attic/garage/interior. Secure, enclose in rated enclosures to prevent hazards.

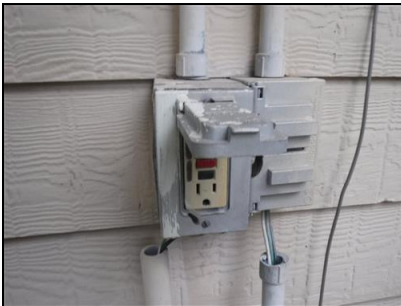
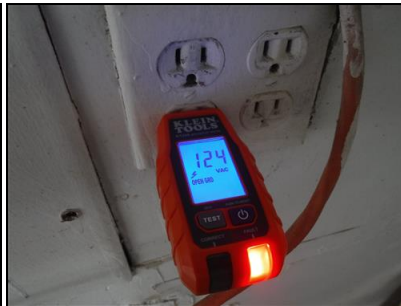
☒ There are no GFCI (Ground Fault Circuit Interrupt) protected outlets in locations called for by today's standards: kitchen, bathrooms, non dedicated garage below 6', exterior outlets,. I recommend updating to current standards.

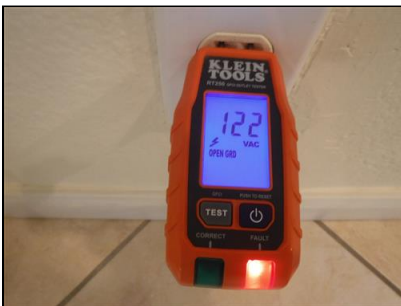
☒ House was originally wired with a two wire system. The majority of the electrical outlets and fixtures are not grounded.

☒ Home is wired with original 2-wire non-grounded branch circuits. Three prong outlets identified, as having an "open ground" are modern three slotted receptacles attached to an older two-wire system. This creates the appearance of a grounded outlet without providing the safety of a ground wire. Correction is to eliminate the deception by installing two slotted type receptacles, providing a ground wire or providing properly installed

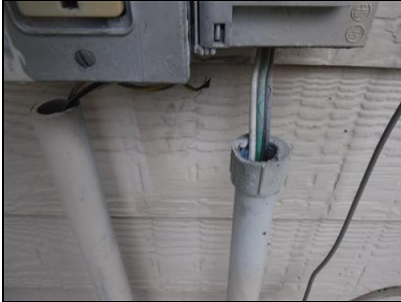
Conduit damaged at rear. Recommend full repair as needed to properly conceal wiring.

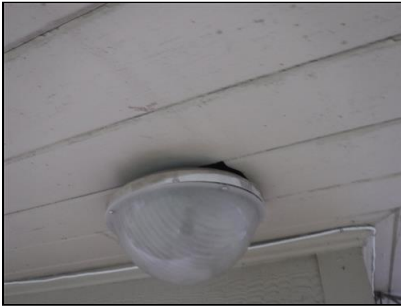
Loose fixture at rear exterior not well installed. Recommend repairing as needed.

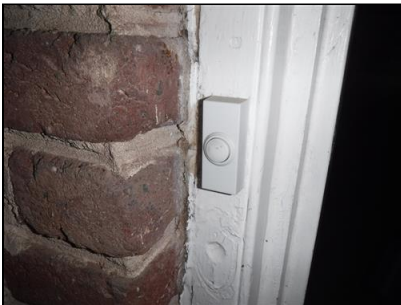
Doorbell system not operational at time of inspection. Recommend full repair or replacement as needed.

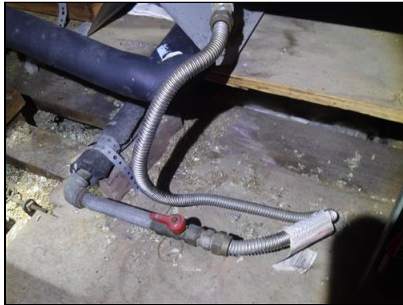
Gas supply to unit is missing a sediment trap, or drip leg as called for by current standards.

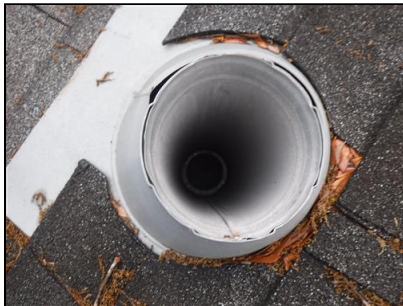
Furnace flue at roof top is missing extension and area is prone to allowing rain water into area. Recommend having HVAC technician further evaluate and repair as needed.

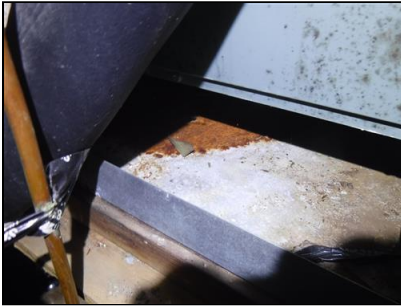
⚠ Rust was observed in the secondary drain pan. This is from excess condensation. This is common for cooling systems that are installed in a interior closet, or even in the attic. Ensure air flow is not restricted (dirty filters) and the condensation drain line is periodically flushed to prevent drain line blockage. Consider having the unit serviced by a licensed HVAC technician.

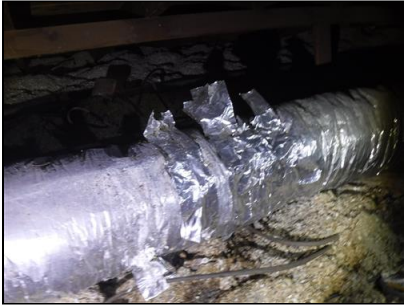
Ducts are damaged in areas of the attic. HVAC technician should repair as necessary.

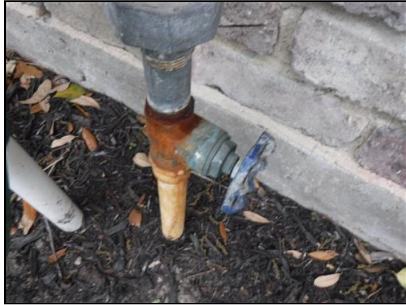
Main shut-off

Supply pipes in Exterior must be properly insulated. Current condition will not protect piping during hard freeze periods

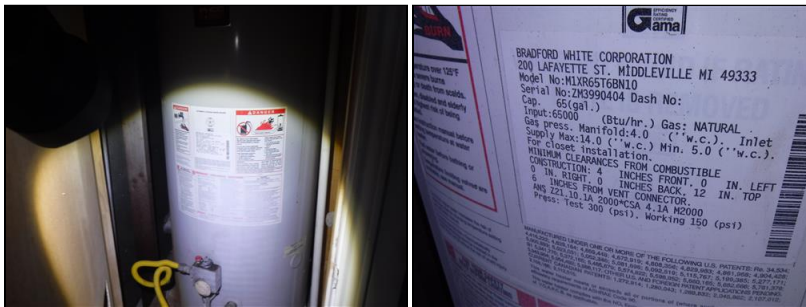
Gas supply to unit is missing a sediment trap, or drip leg as called for by current standards.

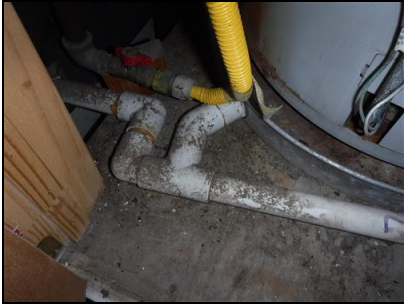
Noted the discharge piping for the water heater T&P valve is plumbed in with PVC. Sch. 40 PVC is only rated for a maximum temperature of 140F and the T&P discharge will be approx. 200F+. Recommend having licensed plumber further evaluate and replace as needed.
