PROPERTY INSPECTION REPORT

Concerning: 14112 Timber Bluff Drive , Pearland, TX 77584
(Address or Other Identification of Inspected Property)

By: Tommy Amonette Lic.#: TREC 22620 03/03/2021
(Name and License Number of Inspector) (Date)

Home Inspection Report

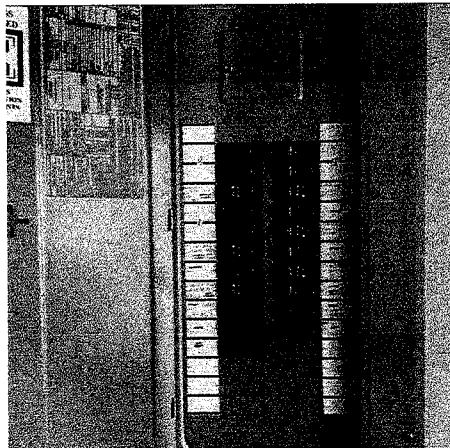
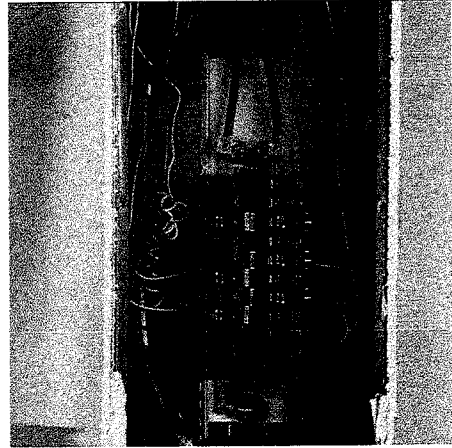
- Breaker panel is rated for 200 max amps, 120/240 single phase service. Panel appears to be working properly at the time of inspection.

****Note, main breaker shutoff is on the West exterior wall of the garage, the breaker panel is inside the garage.****

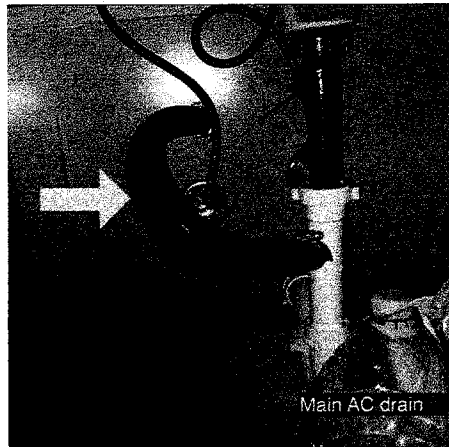
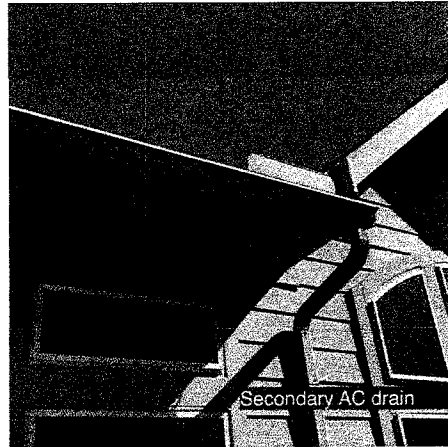
- Possible growth noted on the secondary drain line at the unit in the attic. This was only noted on the line and not on the unit itself **FIXED**

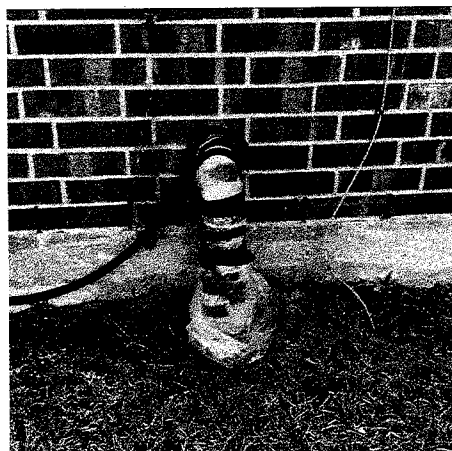
- Main water shut off **FIXED**
