# *Pro House Inspections*

## Property Inspection Report

3210 La Quinta Dr., Missouri City, TX 77459  
Inspection prepared for: Tony Earl and Bridgett Dowdy  
Real Estate Agent: Tywuan Watkins - Diverse City Realty

Date of Inspection: 1/15/2021 Time: 2:00 PM  
Age of Home: 1973 Size: 2900  
Weather: Clear, 60 degrees  
Order ID: 409  
Vacant Home

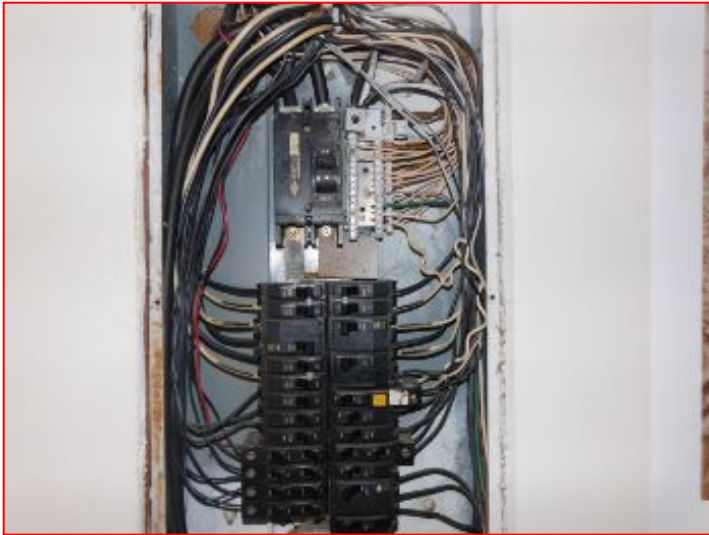
No Problem found

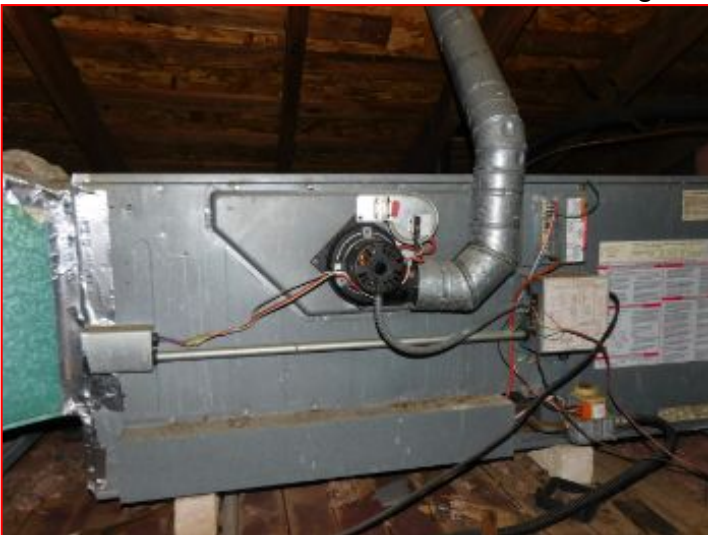
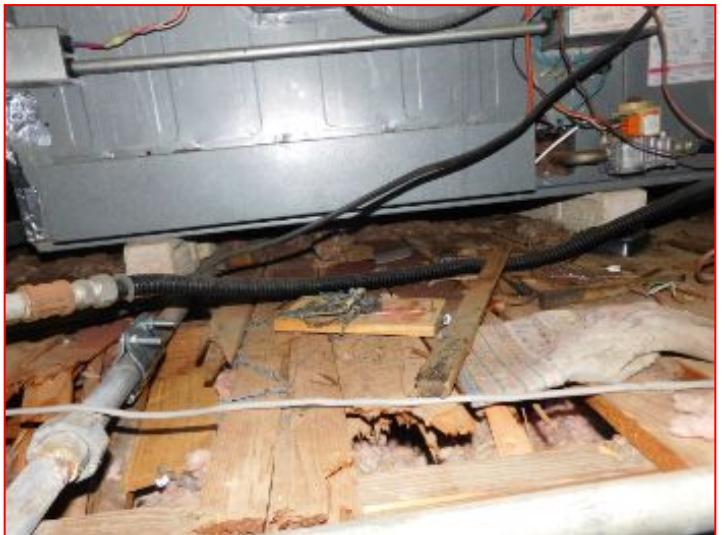
Furnace chimney is in contact or too close with the roof deck in the lower attic area. This area should have a minimum 1" clearance from combustibles and pass above the roof 2 ft" for safety reasons. There is evidence of roof deck overheating,

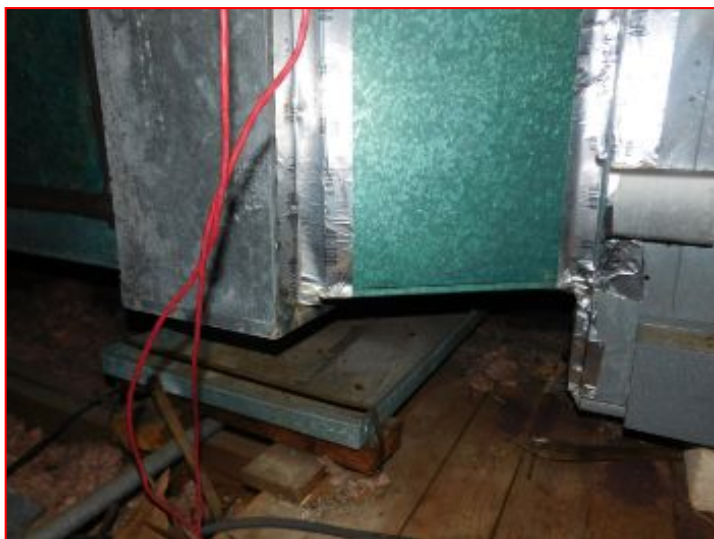
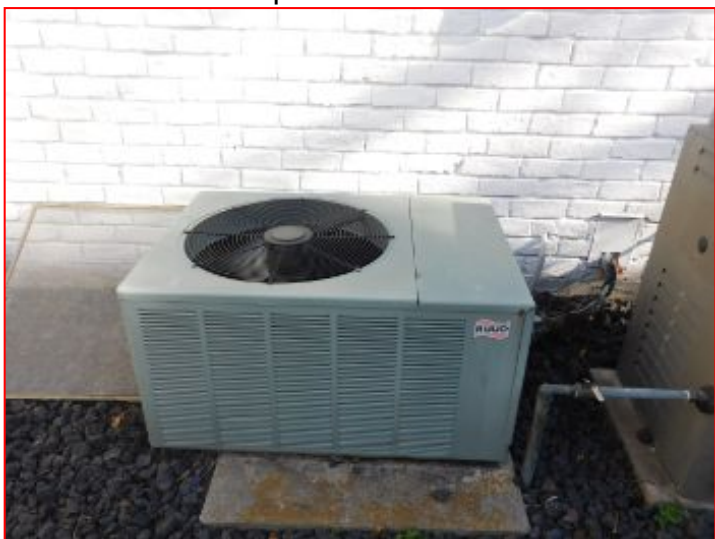
Condensate tray for the system in the attic shows evidence of leakage having occurred in the past. Pan is badly rusted and corroded and may leak when needed. Recommend replacement. Recommend consulting a licensed HVAC contractor to perform corrective action.

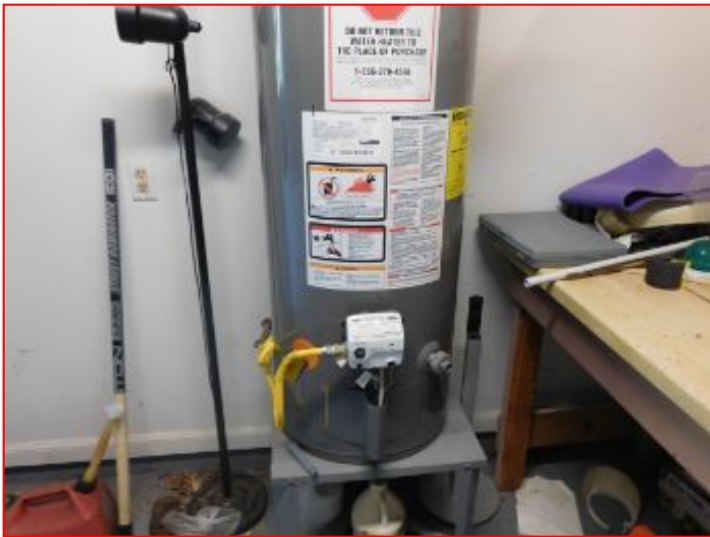
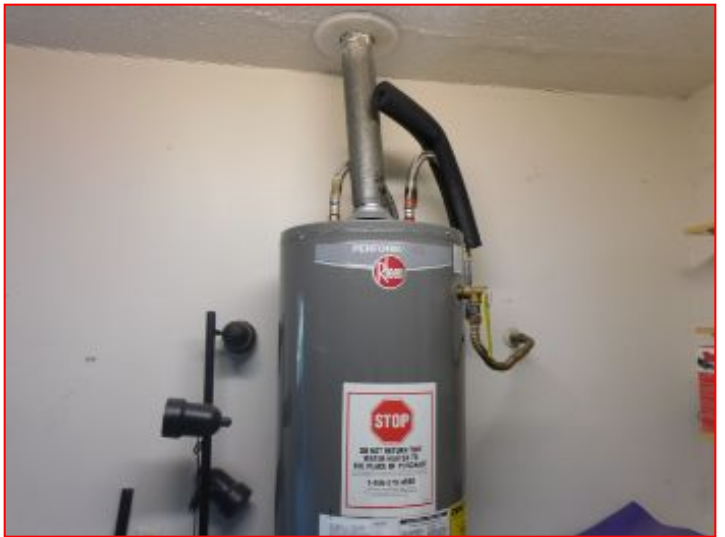
No Problems found.

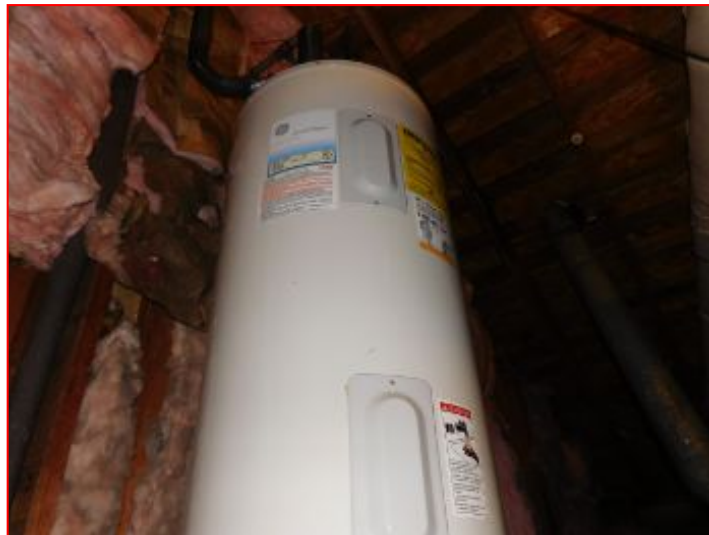
No Problem found

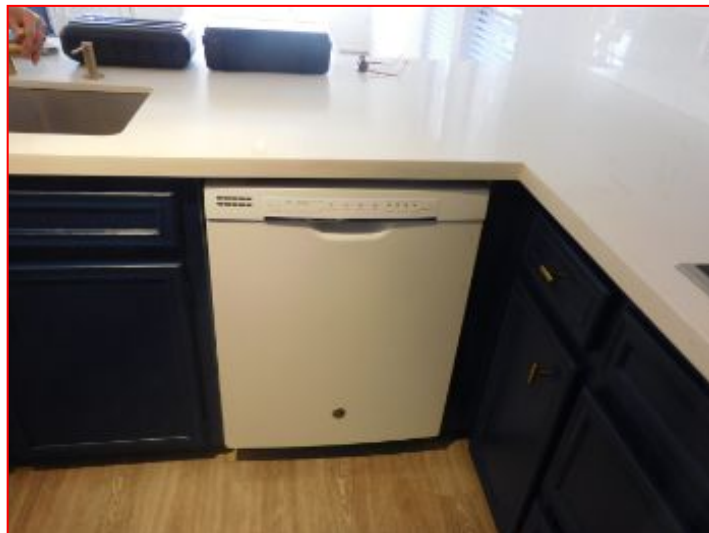
- The dishwasher appears to be in good condition compared to age. It was operated in the normal setting, Ran through a complete cycle and did not leak. The unit appears to operate as designed with no signs of concern. Note: The bottom panel was not removed.

No Problems found.

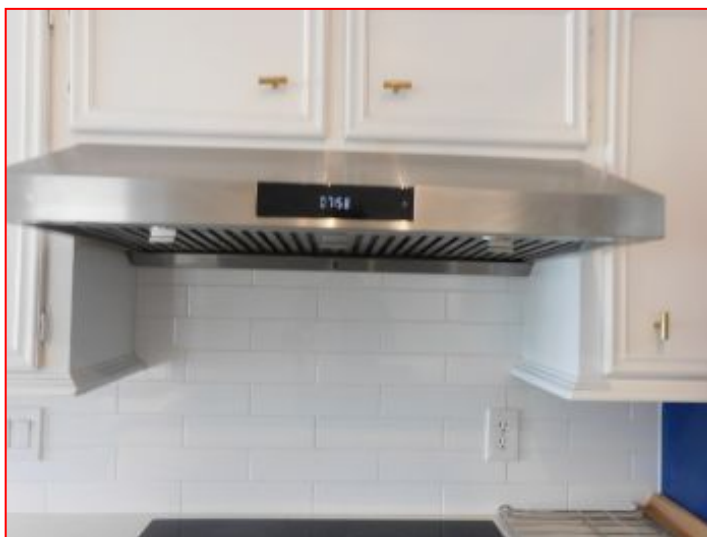
- Exhaust vent appears to be in good condition. It was tested and appears to be functioning as designed with no signs of concern.

No Problems found.

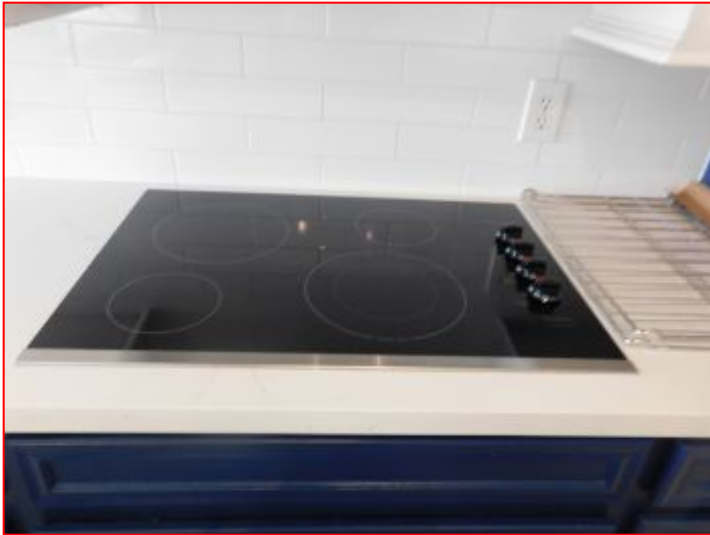
No Problems found.

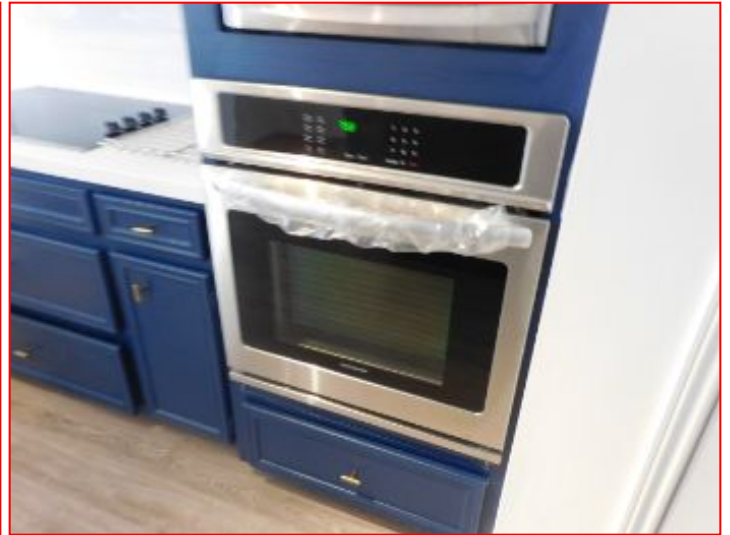
No Problems found.

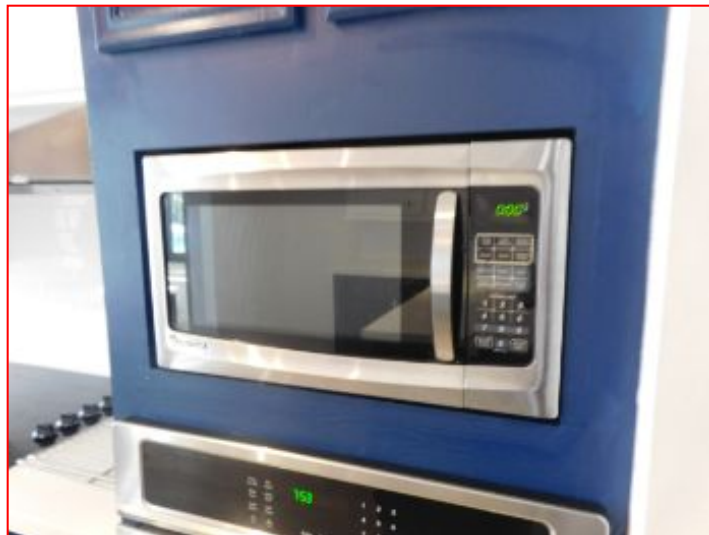
- Microwave oven is in good condition. It was tested by heating water and appears to function properly with no signs of concern. Microwave was not tested for radiation leaks.
- Built-in microwave ovens are tested using normal operating controls. Unit was tested and appeared to be serviceable at time of inspection. Leak and/or efficiency testing is beyond the scope of this inspection. If concerned, client should seek further review by qualified technician prior to closing.

No Problems found.

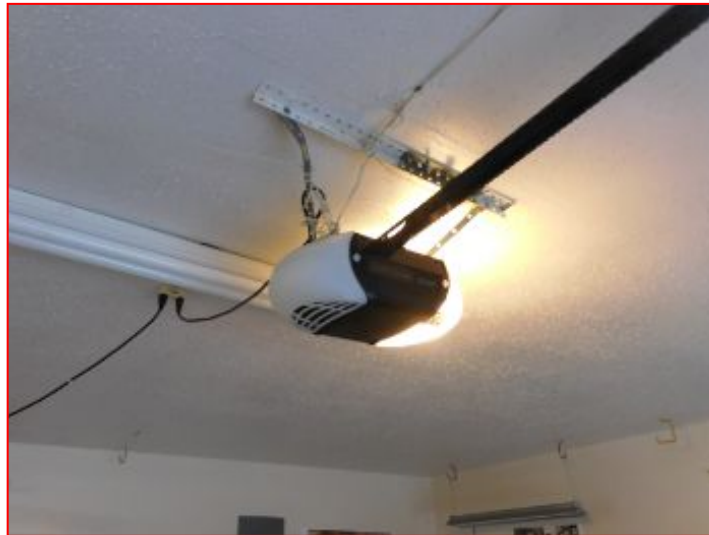
- The garage door is equipped with an electric garage door opener that was in good condition at the time of the inspection. It was tested and reversed when resistance was encountered. No signs of concern or problems were found.

No Problems found.

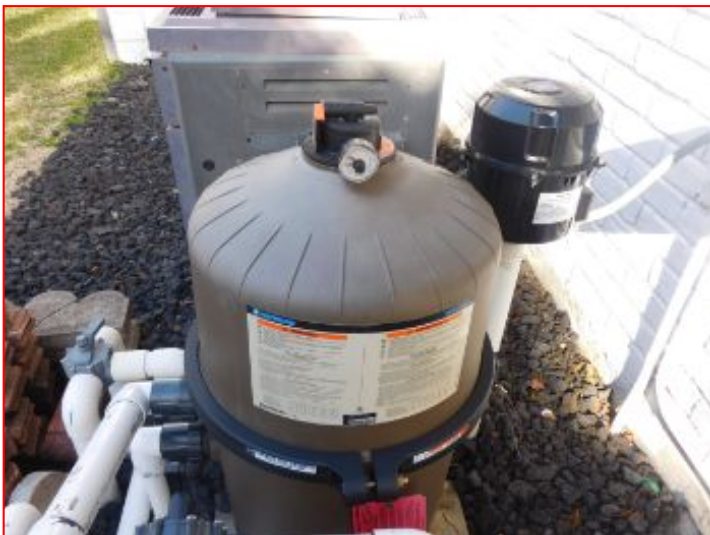
Filter type: Diatomaceous Earth: The filter is in good condition and appears to be operating as designed.

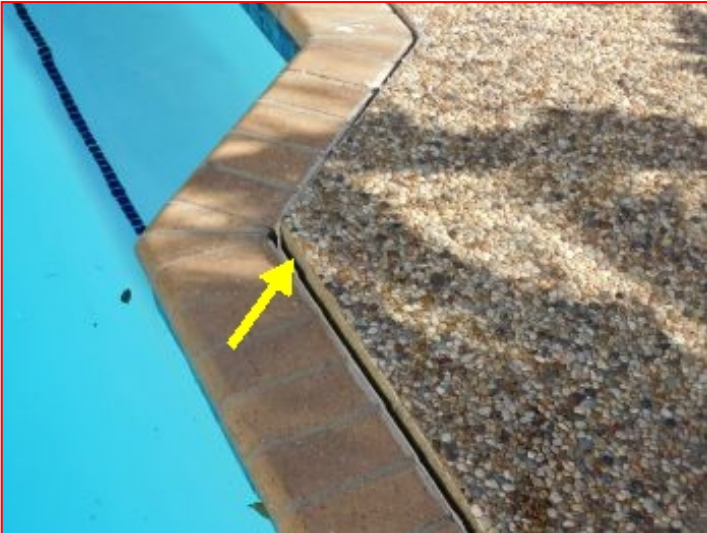
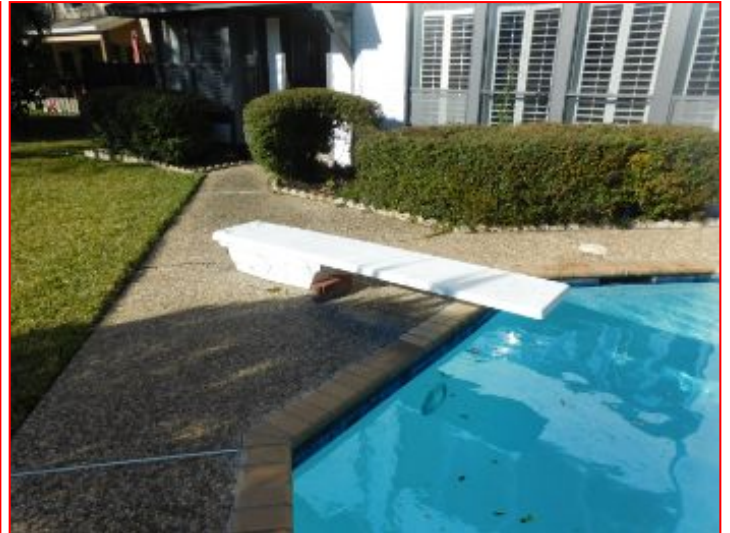
Deck / coping: Decking around the pool area is in poor condition, lifting on the right side of diving board. This may be an indication of a slow underground leak from the pool jet's. Recommend a full underground leak detection and evaluation as to the actual cause and effect proper repairs.
