PROPERTY INSPECTION REPORT

Concerning: 20327 Clydesdale Ridge Drive , Humble, TX 77338
(Address or Other Identification of Inspected Property)

By: Dan Romero Lic.#: 5674 04/17/2021
(Name and License Number of Inspector) (Date)

Home Inspection Report

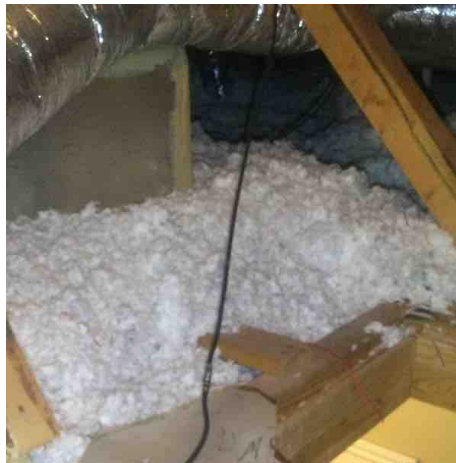
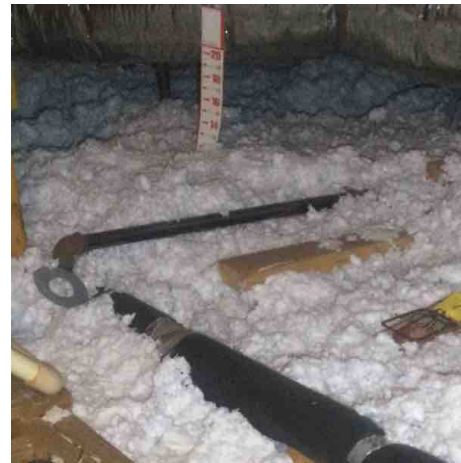
Portions of attic were inaccessible due to inadequate catwalk and vaulted ceiling.

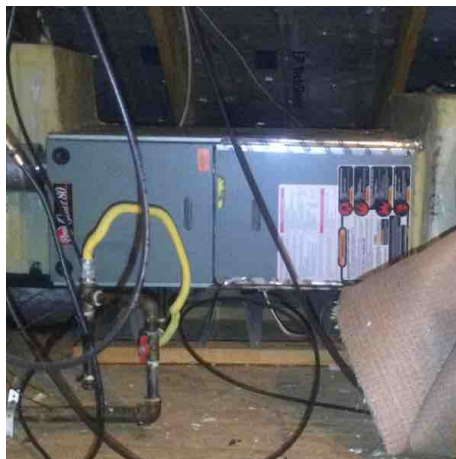
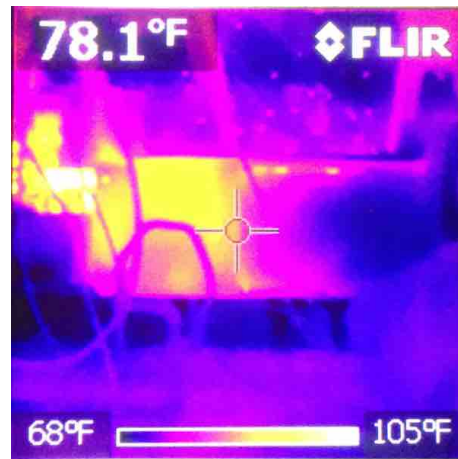
- The home was equipped with an electric furnace, located in the attic space. At the time of the inspection, the unit was functioning as designed as evidenced by a 35 to 40 degree differential between the air supply vent and air return grill.

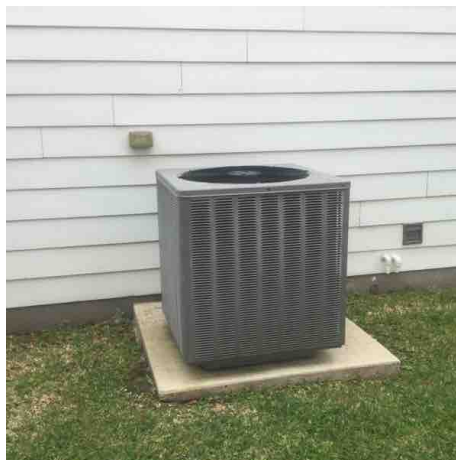
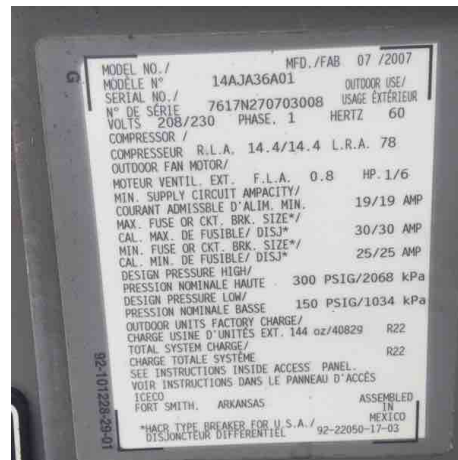
- The home was equipped with one electric unit located at the left side of home.

NAME : RHEEM
 MODEL : 14JA36A01
 SERIAL : 7617N270703008
 TONS : 3
 DATE : 07/2007

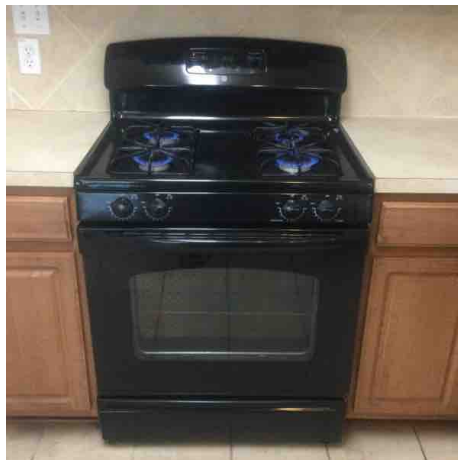
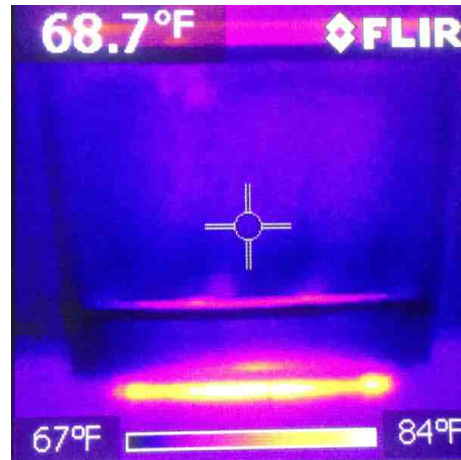
RANGE TOP: GAS

The burners appeared to be functioning as designed.

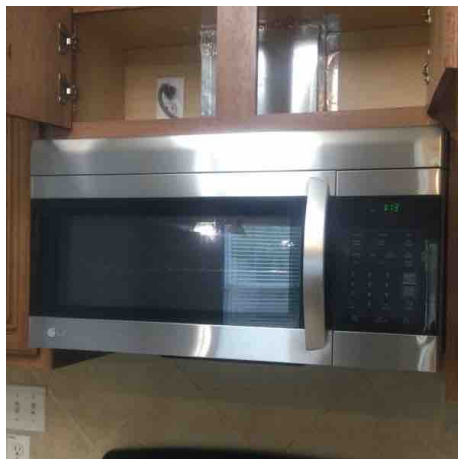
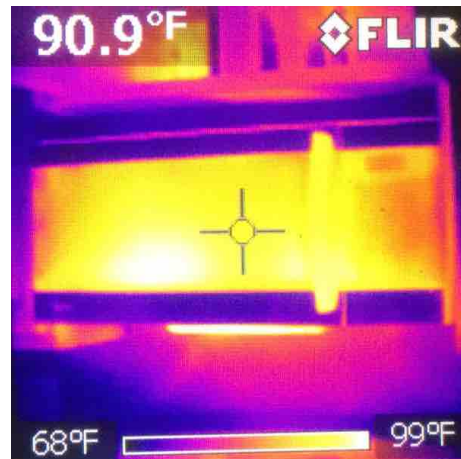
The microwave oven was tested with a microwave tester and appeared to function properly.

The unit was not tested for radiation leaks.
