## Web Presentation

**Property Address:** 2025 Avenue M, Galveston, TX

**Spot On Inspection, PLLC**

# Safety Deficiencies

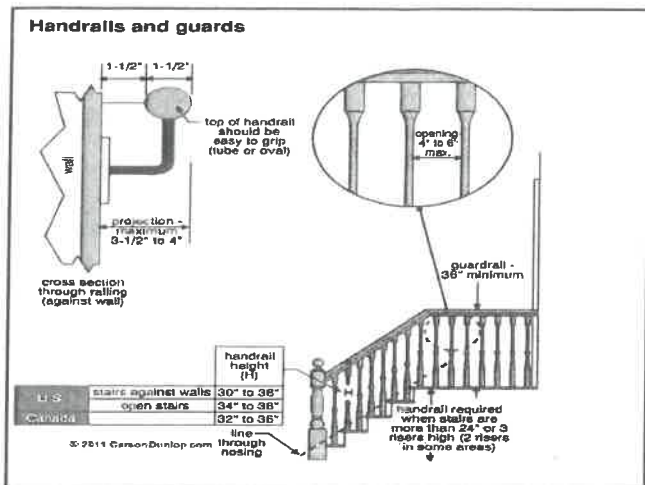
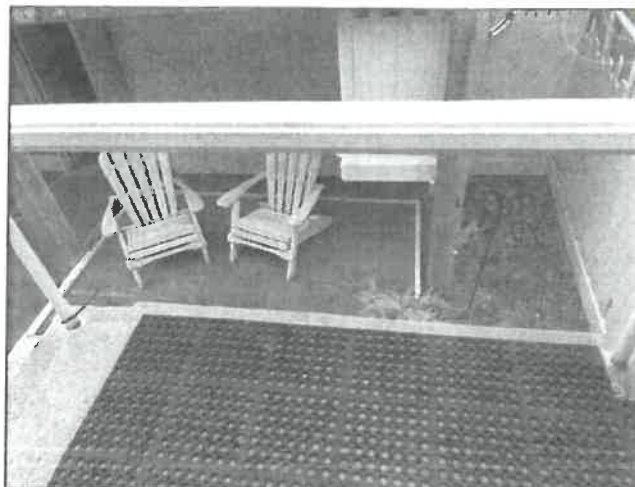
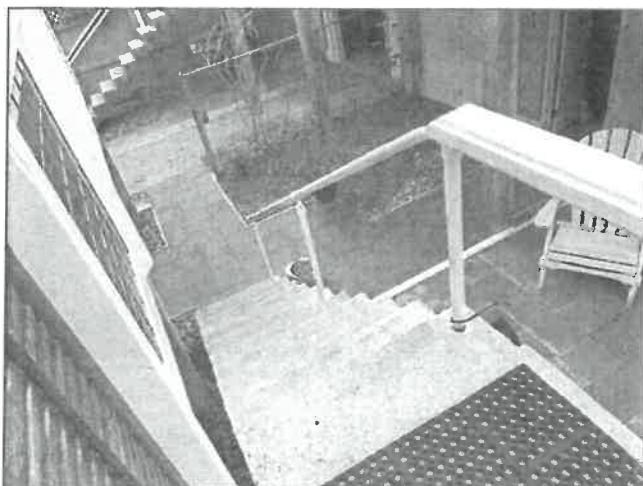
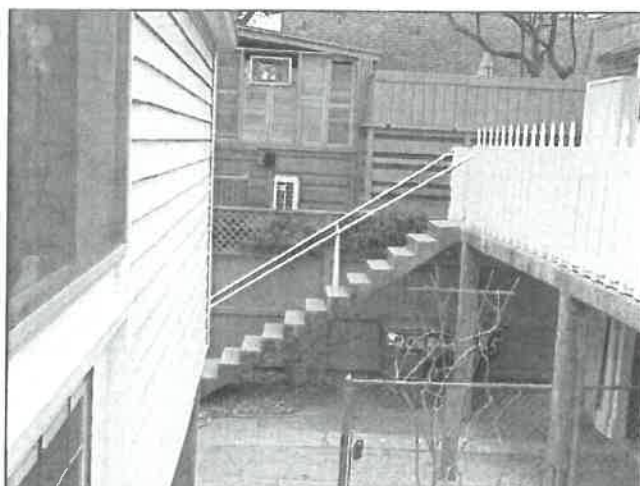
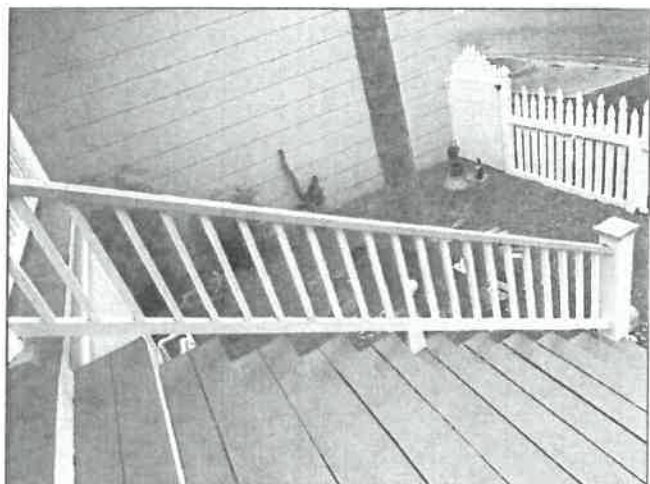
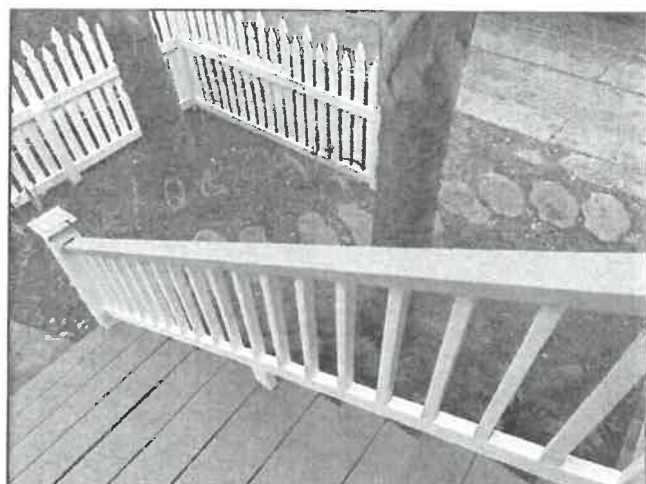
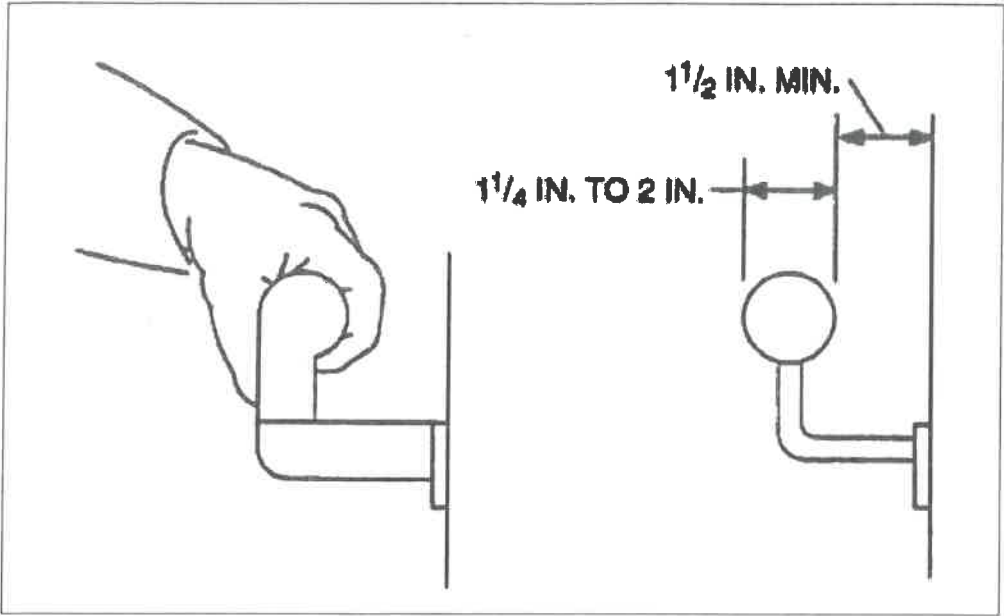
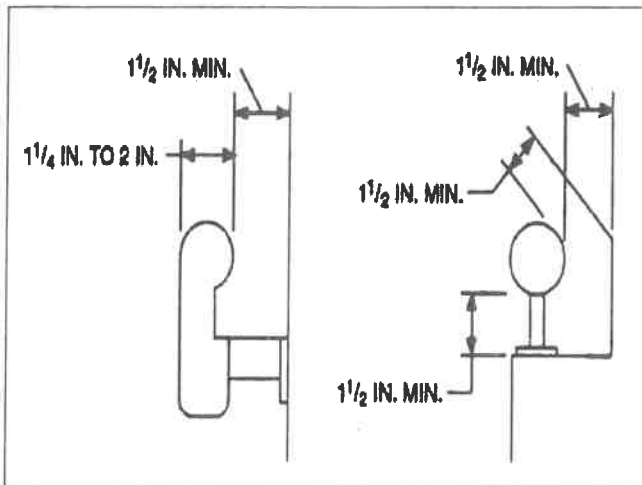
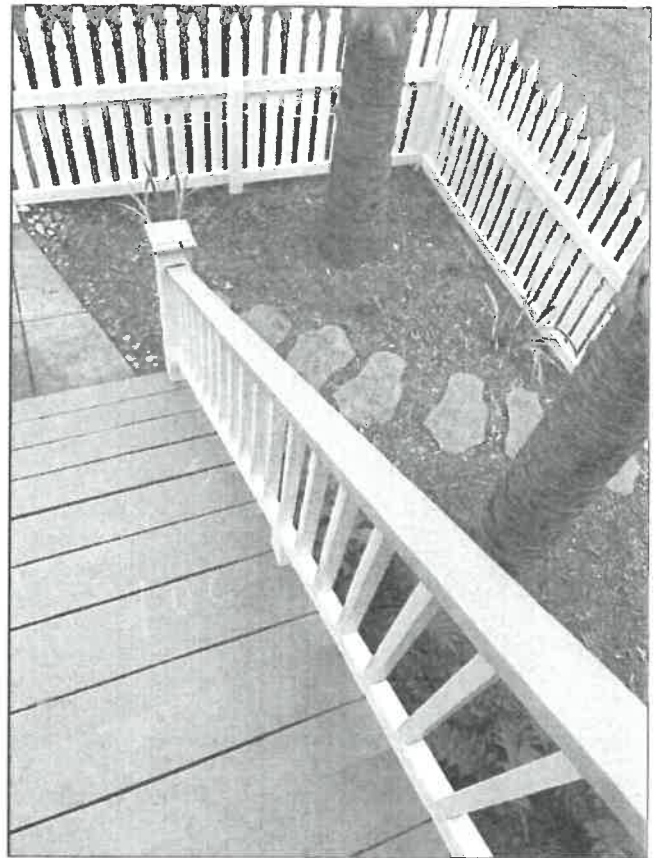
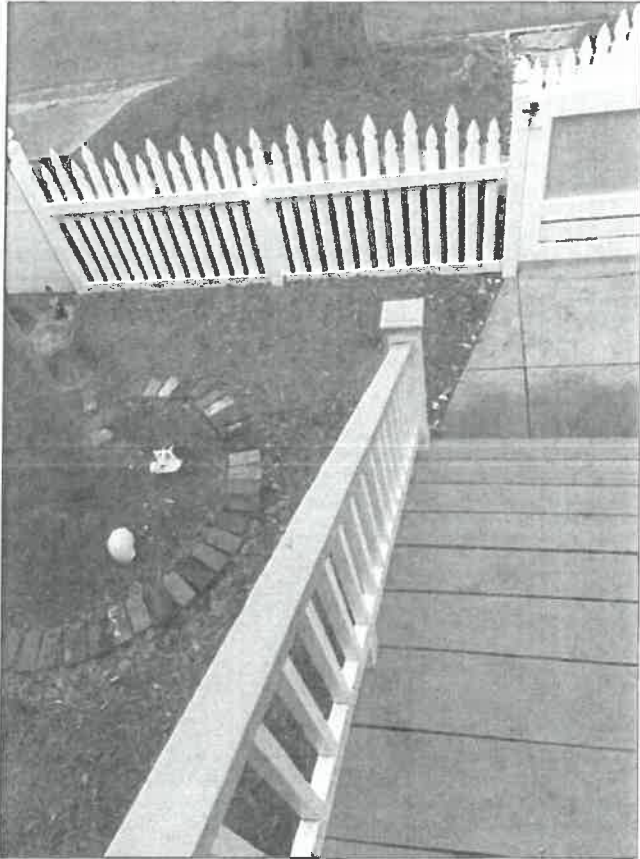
(1) The hand/guard rail for the exterior stairway contains balusters that are spaced more than 4 inches apart. Balusters more than 4 inches apart may allow a small child to become trapped or to fall. This is a safety issue. This is a safety concern. A qualified contractor should be consulted for correction.

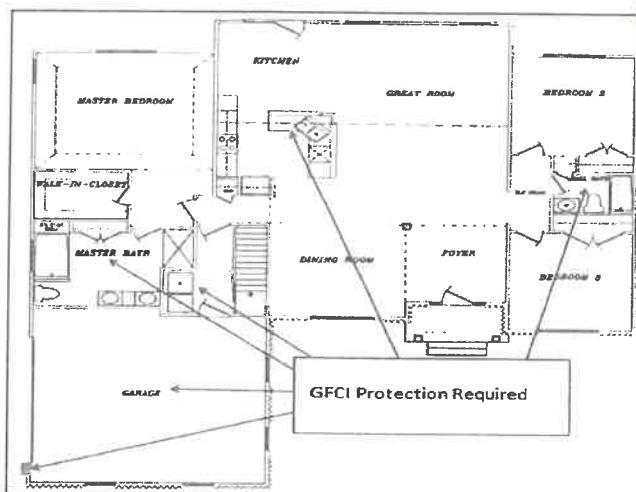
B. Item 2(Picture)

(1) Two plug receptacle(s) in the north apartment kitchen (plug receptacles serving counter space only) are not Ground Fault Circuit Interrupter (GFCI) protected. This is a safety concern. The purpose of GFCI is as a safety device designed to protect humans from electrocution hazards at any place where they are likely to be in prolonged direct contact with electrical devices, especially those devices with motors. They also protect from electrocution hazards near open water receptacles such as sinks, tubs and pools. A licensed electrician should be consulted for installation of appropriate GFCI protection in all kitchen, bathroom, garage, pool area and exterior plug receptacle locations.

*GFCI replaced by owner*

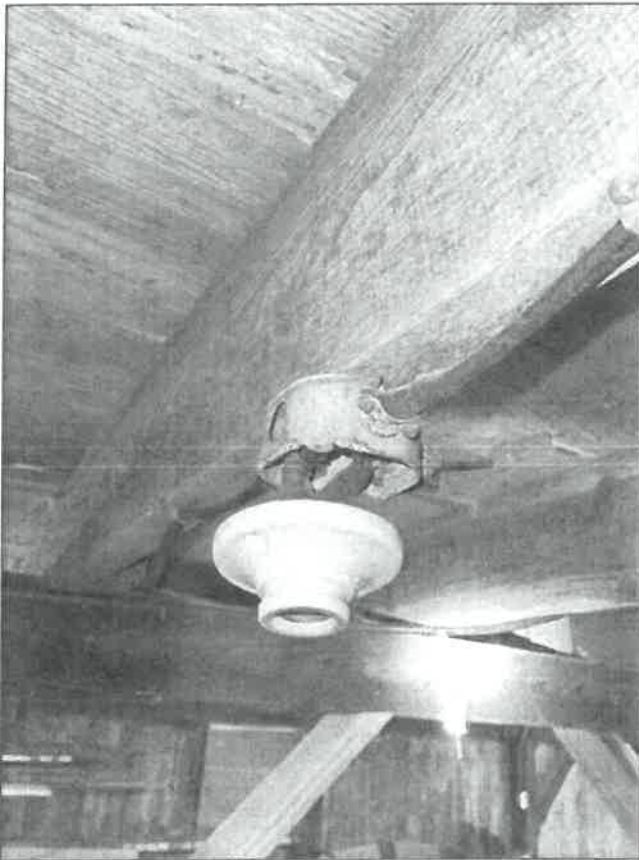
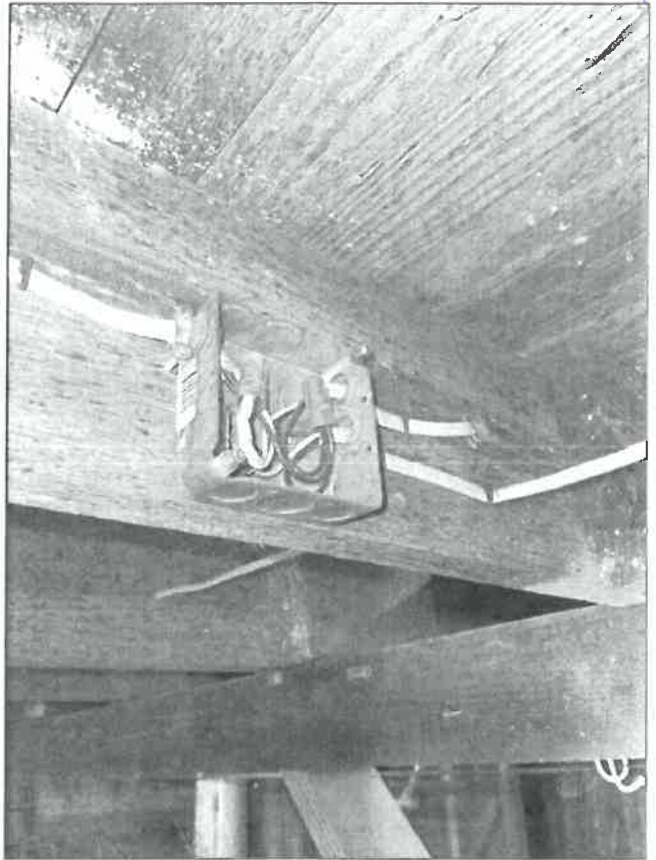
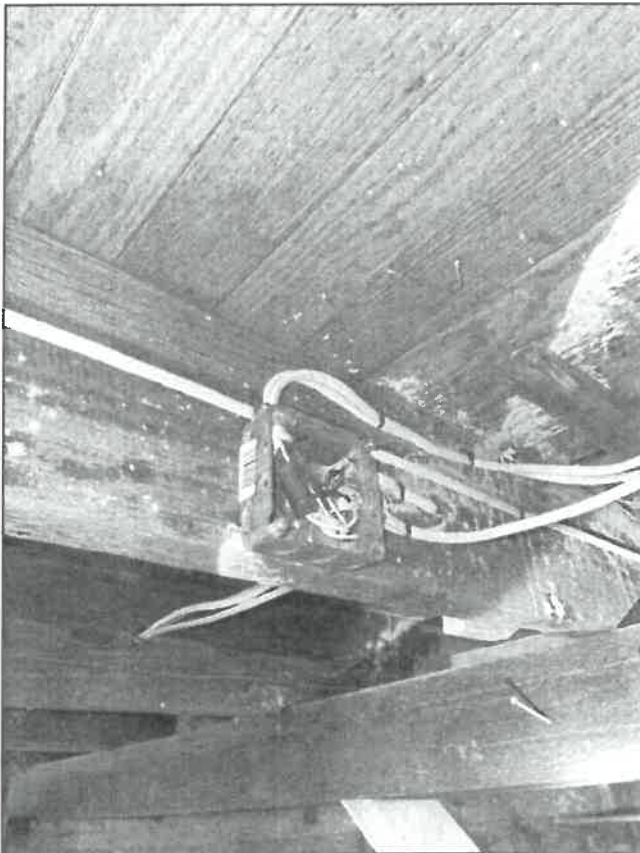
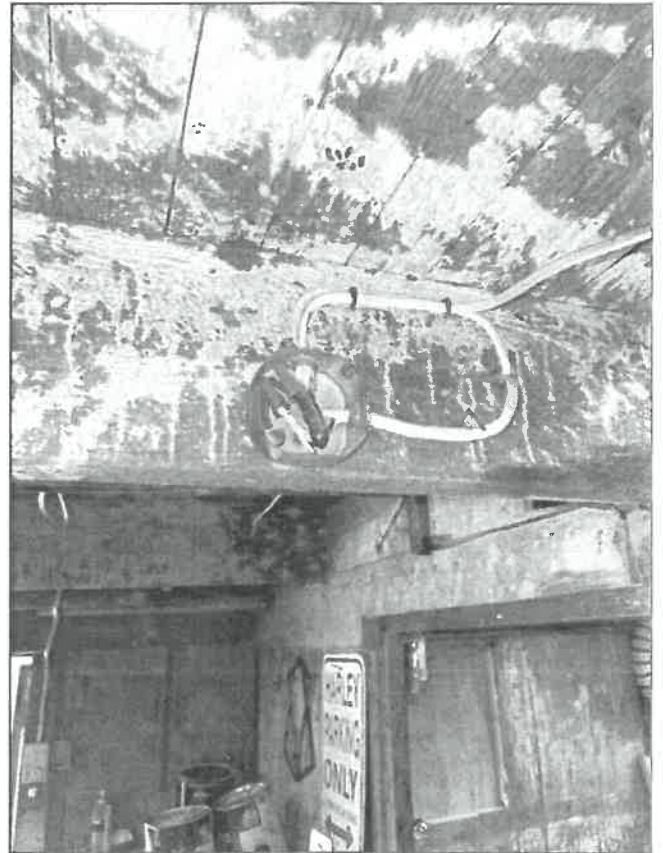
(2) Multiple junction boxes are not properly enclosed.

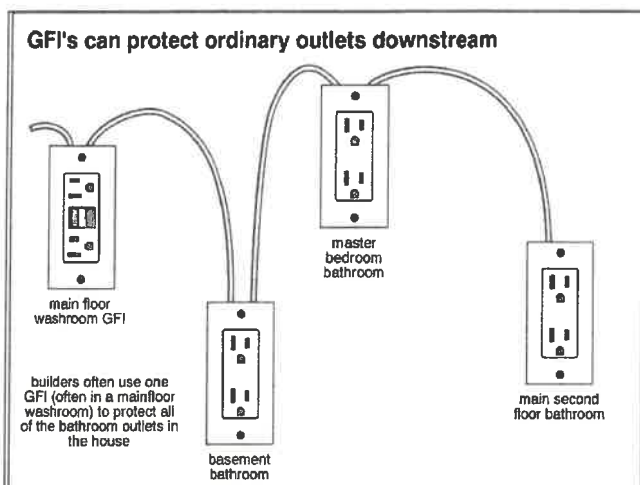
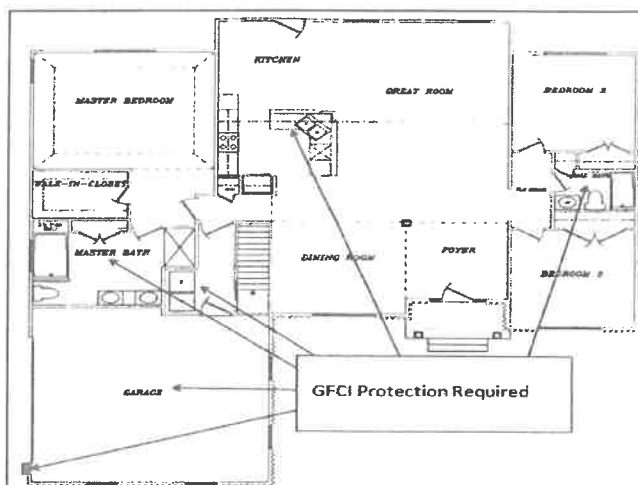
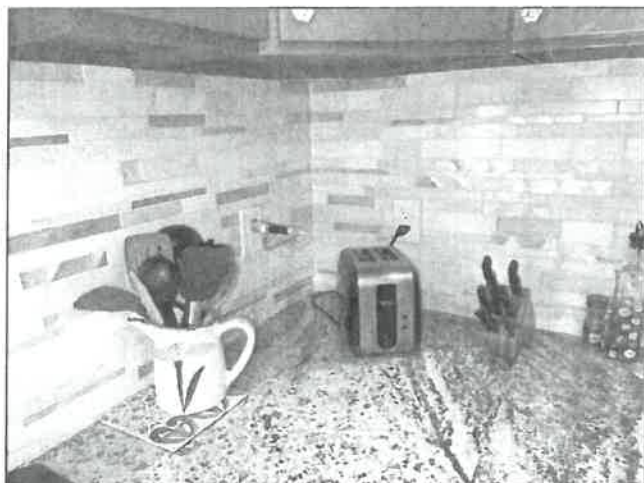
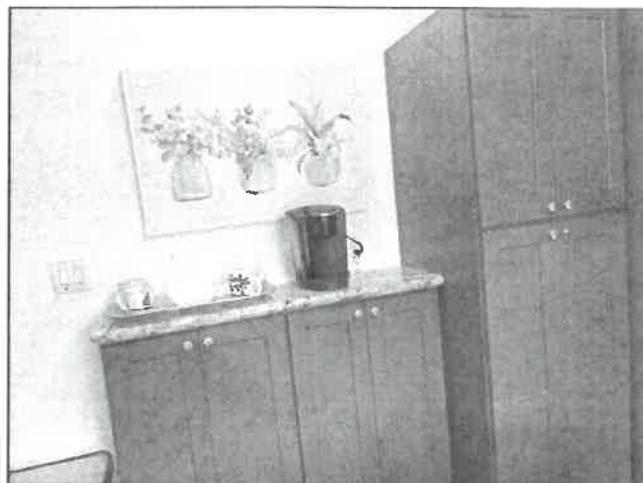
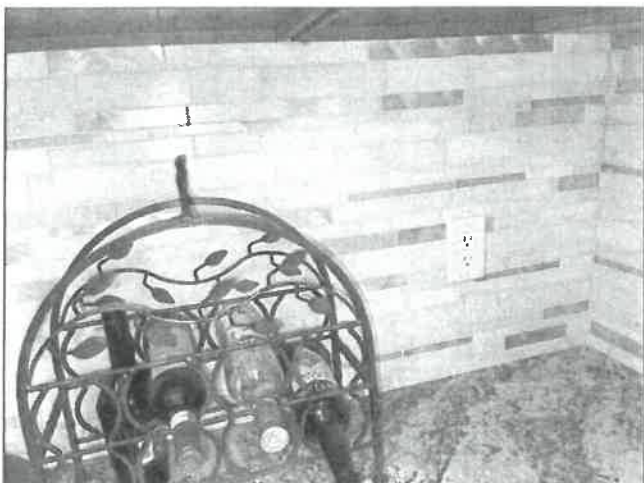
(3) Four plug receptacle(s) in the primary structure kitchen (plug receptacles serving counter space only) are not Ground Fault Circuit Interrupter (GFCI) protected. This is a safety concern. The purpose of GFCI is as a safety device designed to protect humans from electrocution hazards at any place where they are likely to be in prolonged

direct contact with electrical devices, especially those devices with motors. They also protect from electrocution hazards near open water receptacles such as sinks, tubs and pools. A licensed electrician should be consulted for installation of appropriate GFCI protection in all kitchen, bathroom, garage, pool area and exterior plug receptacle locations.

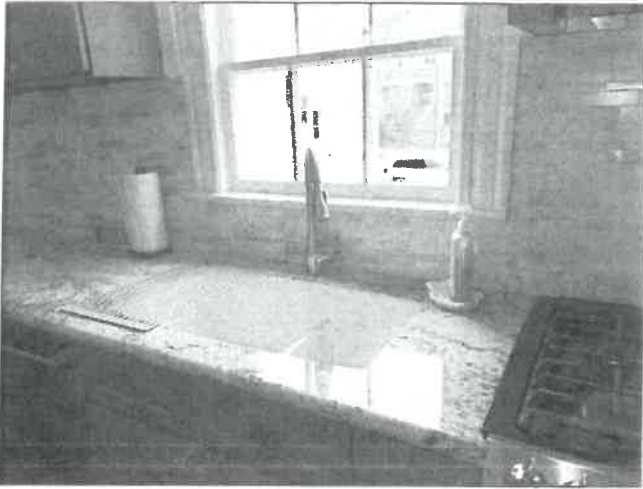
B. Item 13(Picture)

(4) The number of kitchen counter plug receptacle outlets is not adequate in the primary structure. There should be no point on the kitchen counter further than 24 inches from a GFCI protected plug receptacle outlet. A qualified electrician should be consulted for correction.

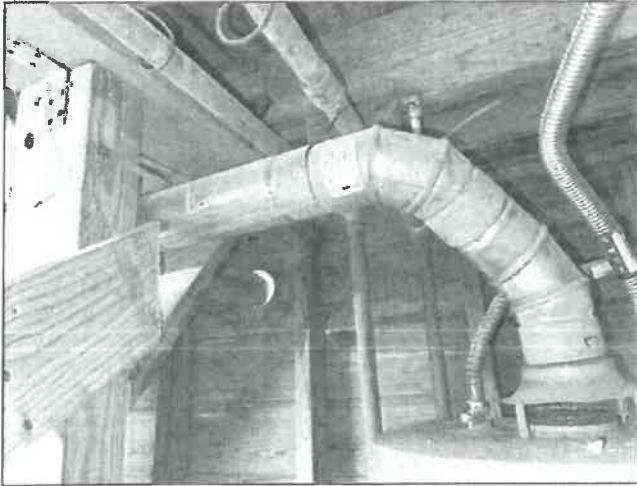
C. Item 1(Picture)

(1) Water heater exhaust flue is not properly installed. This may result in carbon monoxide infiltration into the structure and is a serious health hazard. A qualified plumber should be consulted for correction.

Plumber consulted  
4/2/21. He states this  
is properly installed and  
was inspected by city  
after installation  
08/20/20

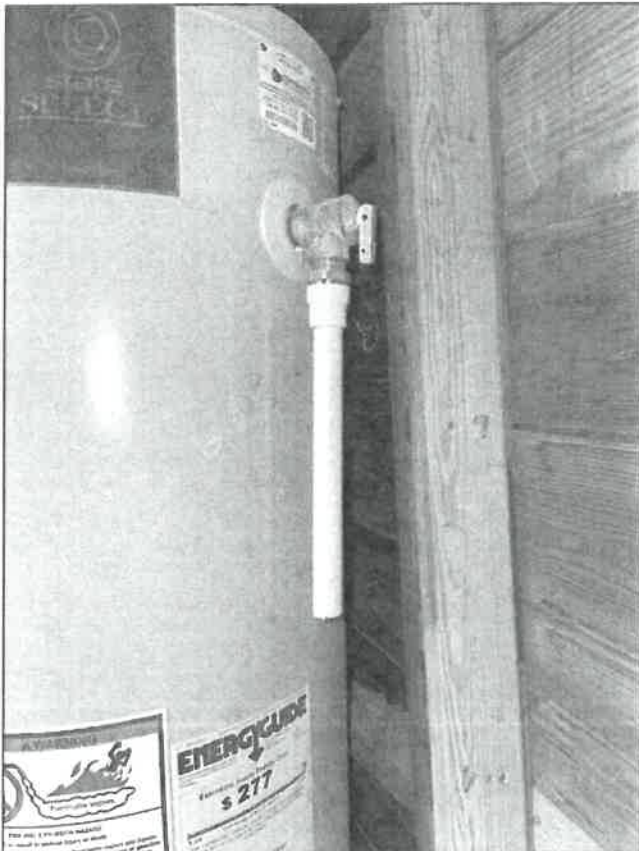
C. Item 2(Picture)

The Temperature and Pressure Relief Valve discharge line should discharge within 6 inches of the surface or into the pan or to the structure exterior.

This is a safety issue. A licensed plumber should be consulted for correction.

4/2/2021  
plumber moved valve  
down. States no pan  
needed if outside  
inspected by city  
08/20/20

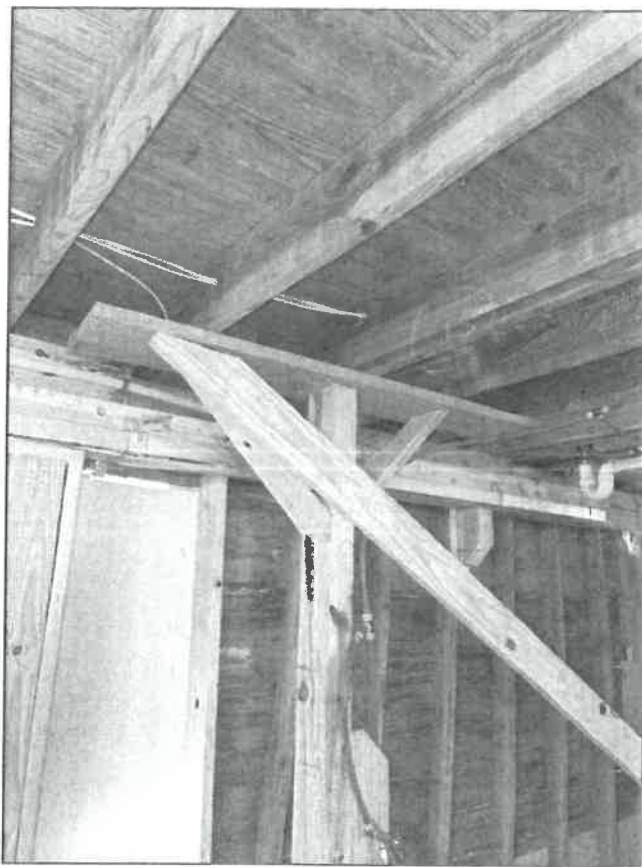
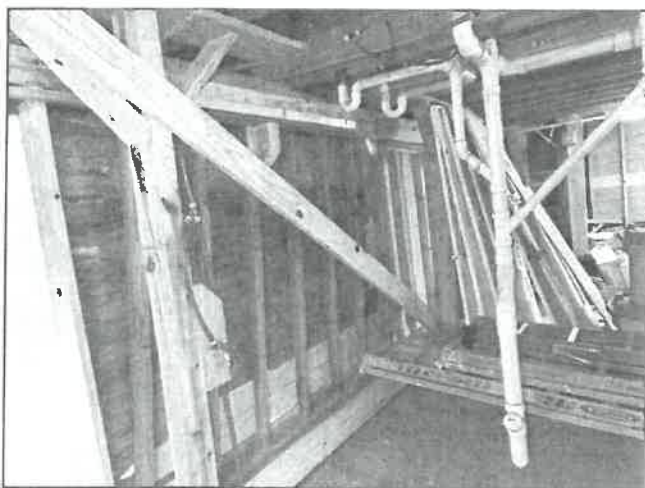
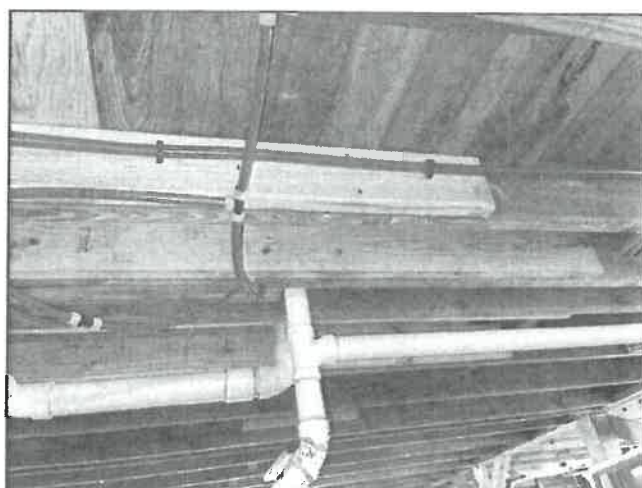
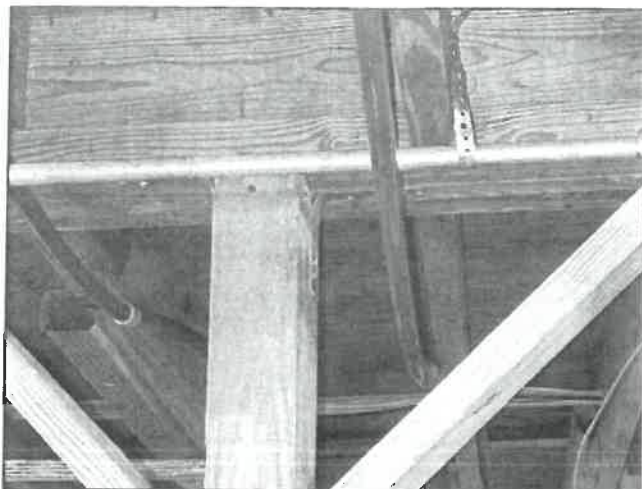
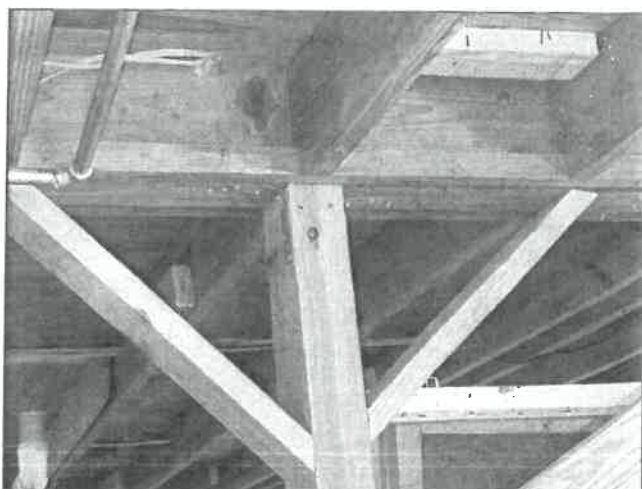
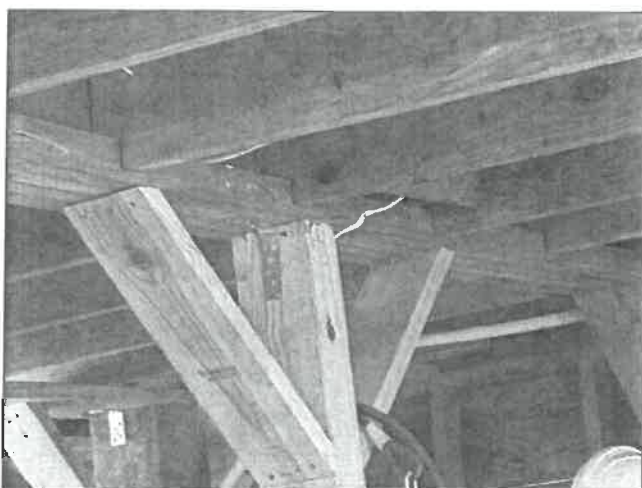
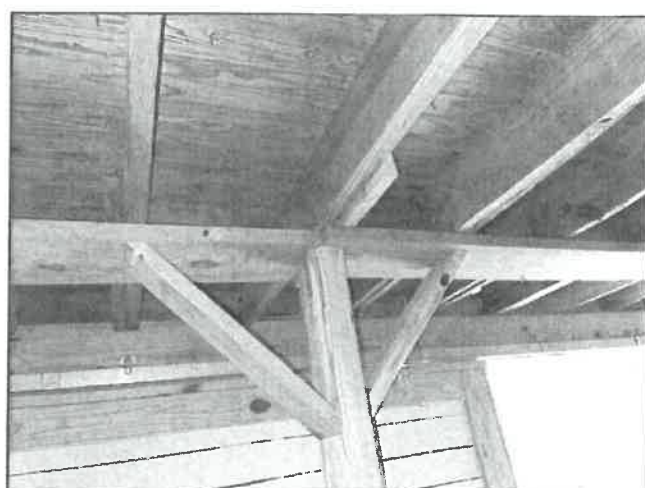
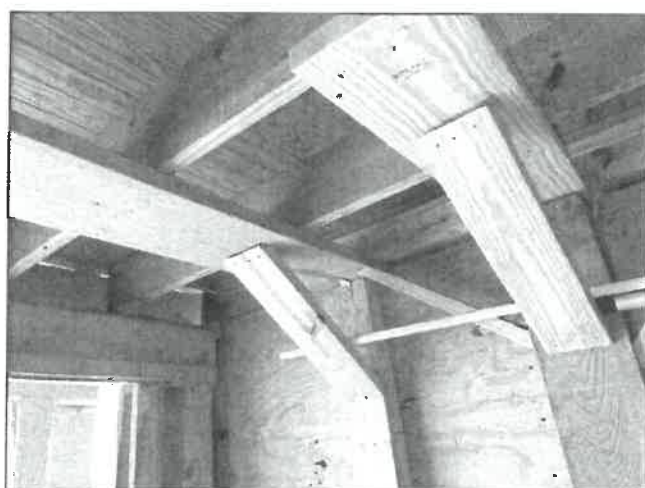
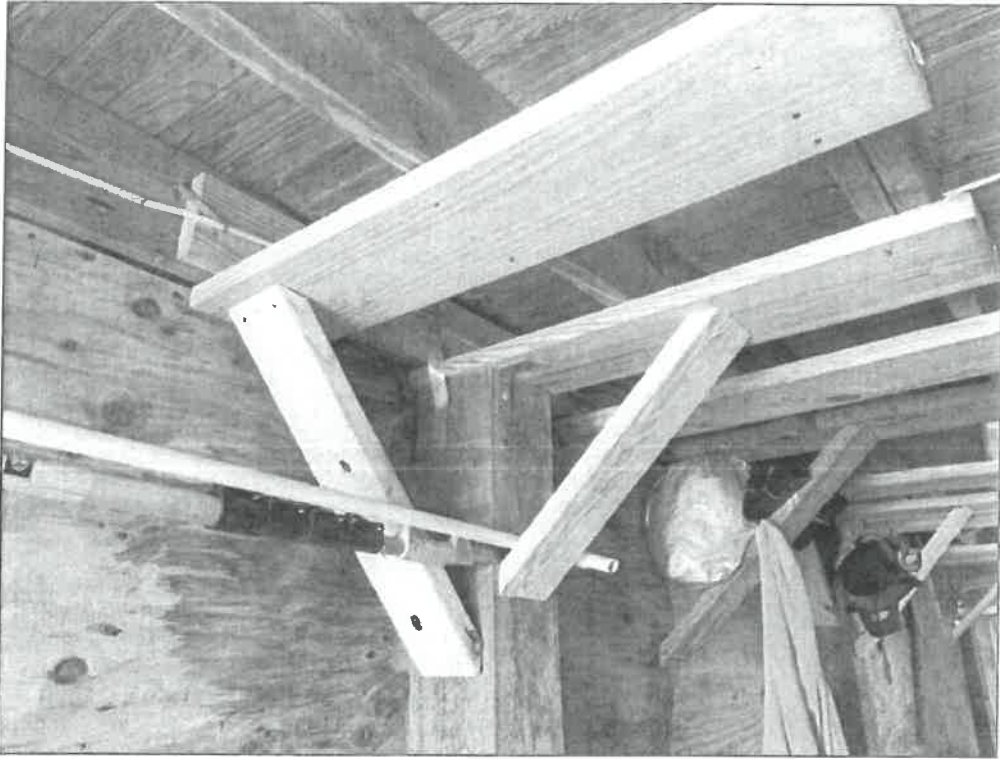
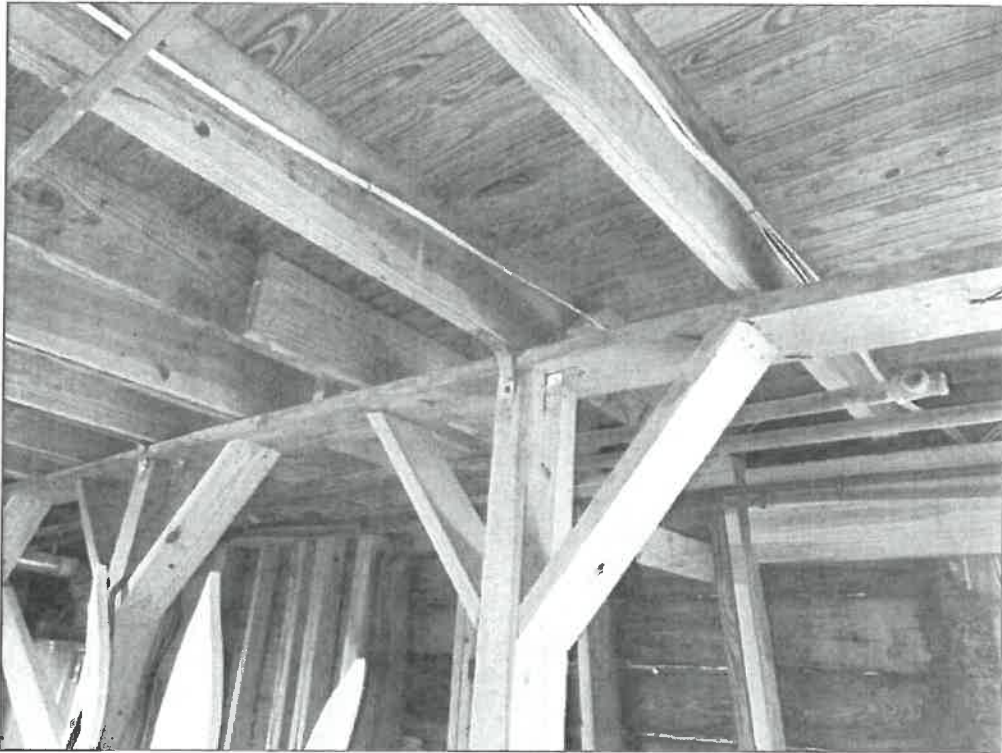
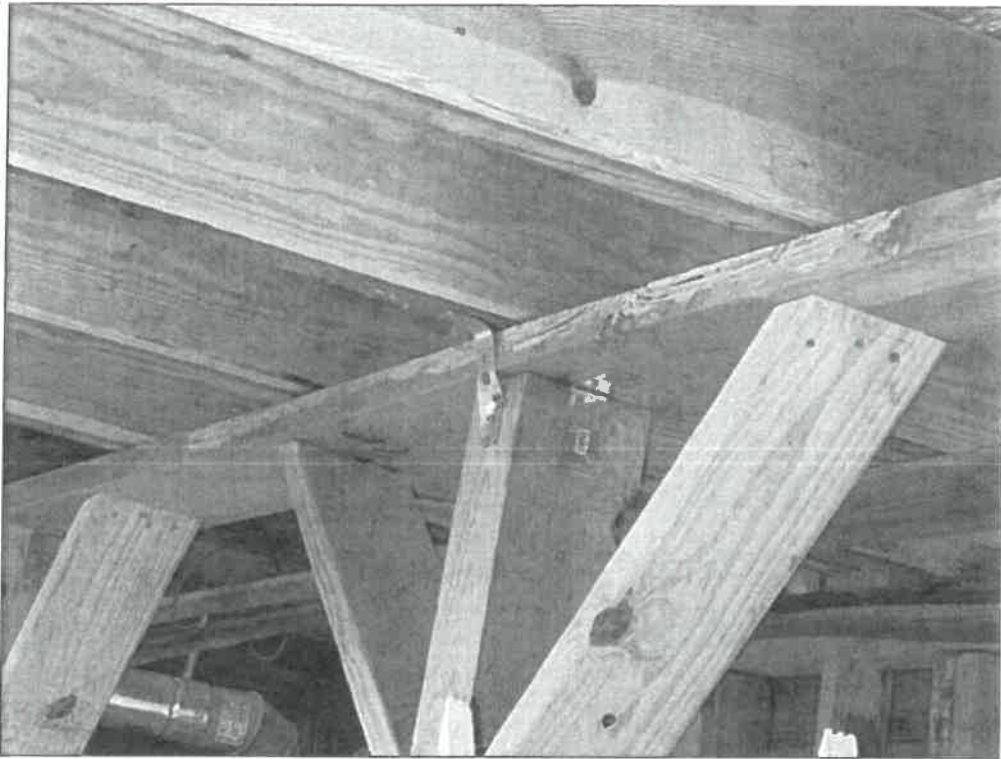
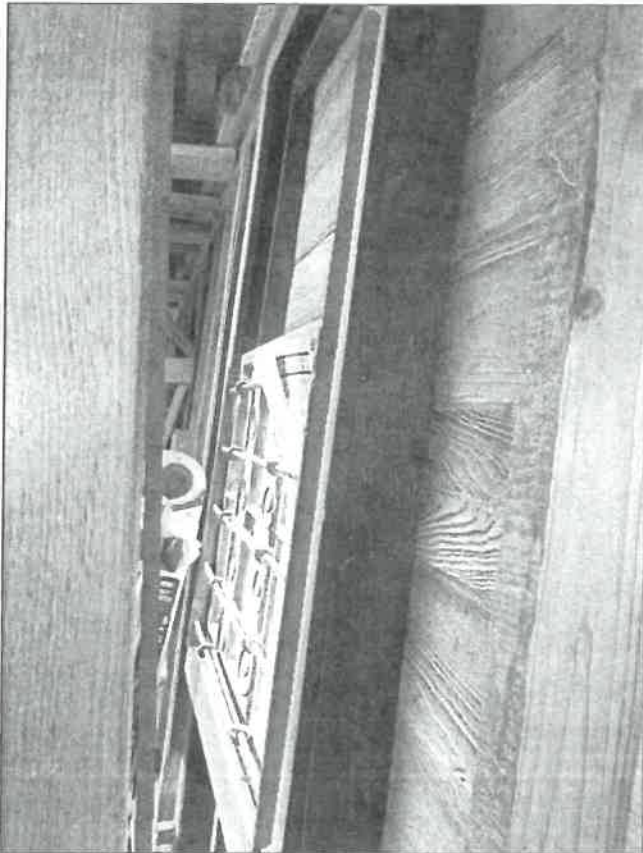
(1) It is the opinion of this inspector that the adequate performance of garage apartments foundation cannot be determined via one time inspection. There are multiple indications of prior structural movement present. The lower half of the north wall is leaning approximately 16 degrees at the Northwest corner. This lean extends across the entire length of this wall. There are extensive structural repairs. These repairs are not in accordance with industry standard practices and may not be sufficient to prevent further structural movement.

The foundation should be evaluated by a qualified structural engineer with experience with this type of foundation system.

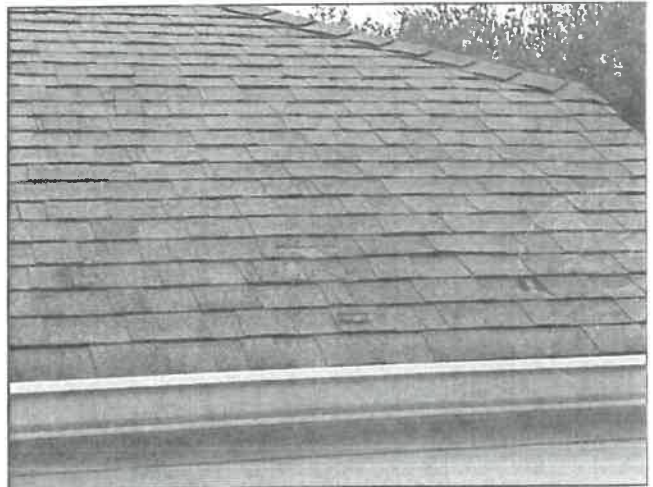
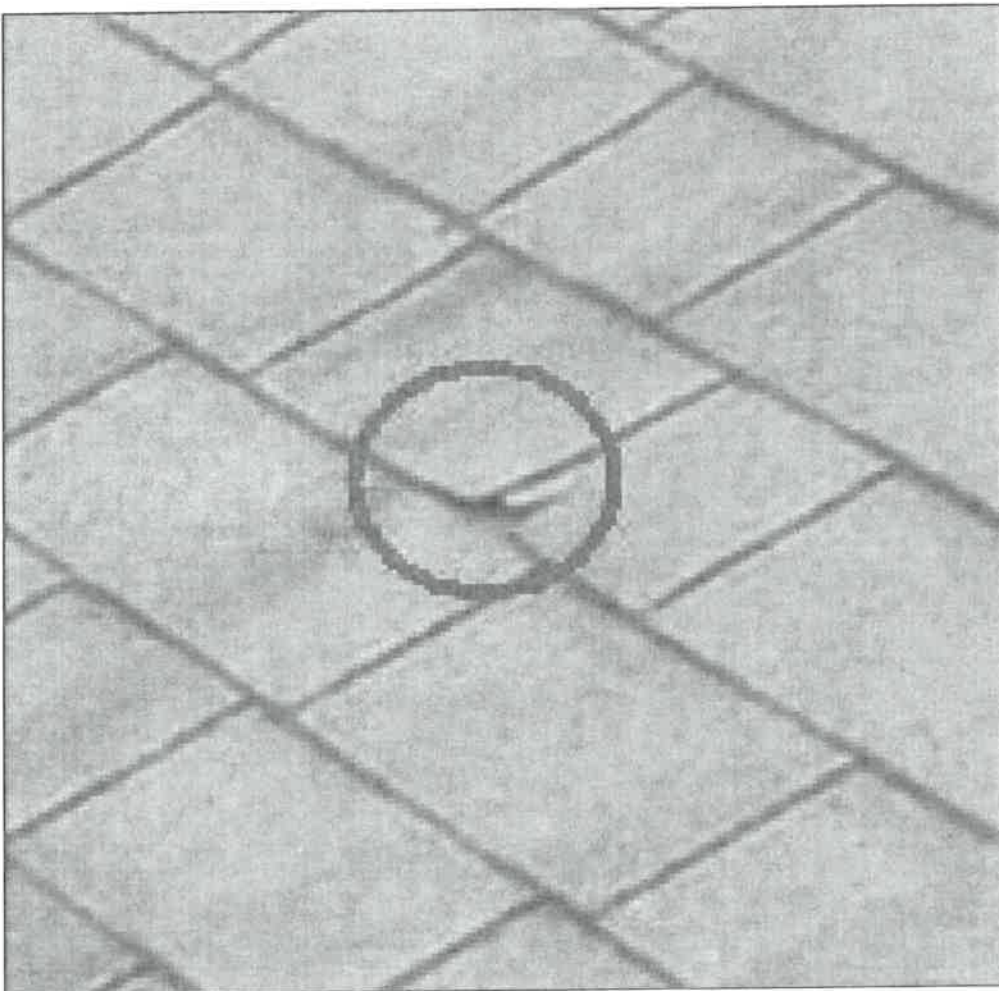
(1) The roof covering has damaged and missing shingles on the west and south roof slope(s). A qualified contractor should be consulted for correction.

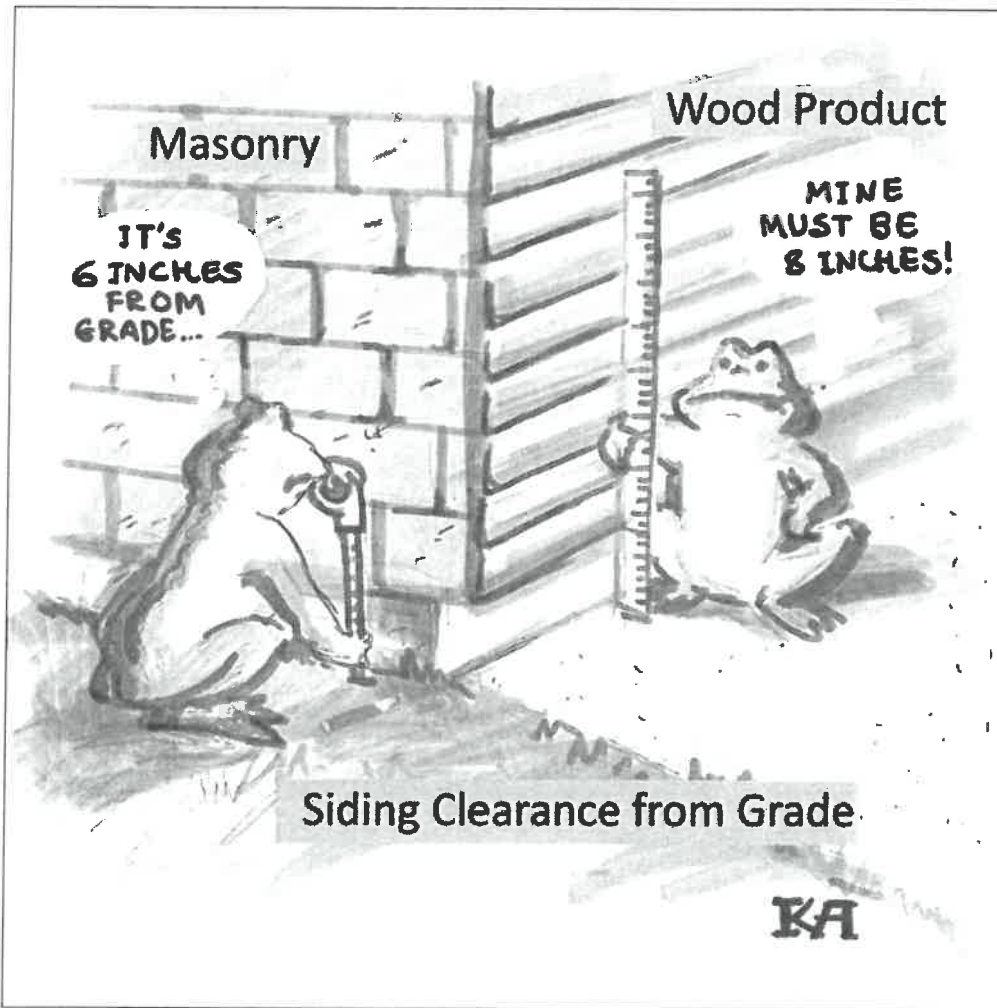
B. Item 1(Picture)

**X** (1) Insufficient exposure above grade at all sides side of house. Moisture intrusion is possible where there is insufficient exposure. Also, insufficient foundation exposure makes detection of Wood Destroying Insects more difficult.

The recommended clearance of masonry siding products (brick, stone, etc.) is 6 inches.

Wood siding clearance is recommended to be 8 inches from soil. Wood products need to be able to dry thoroughly after rain and the extra space aids that process.

Also, do not allow mulch (wood or stone) or vegetation to come in contact with any siding product. And be especially vigilant regarding irrigation spray heads. Do not allow them to spray directly on siding products.

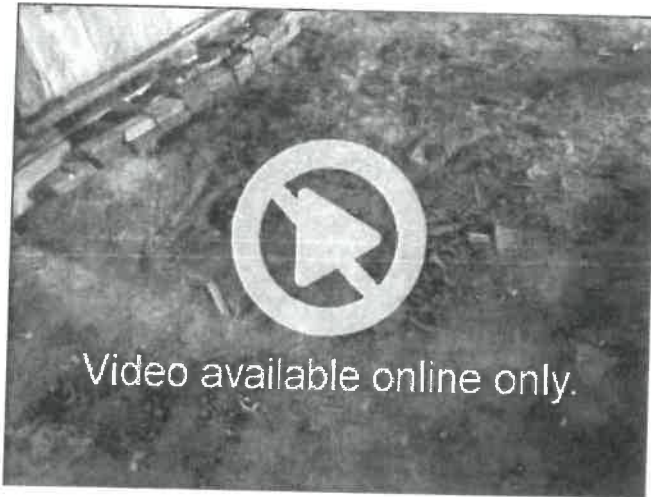
B. Item 3(Video)

**X** (2) There is an area of persistent water puddling on the north side of the primary structure crawlspace. This may be a contributing factor to the moisture intrusion damage present in the crawlspace

In addition, the crawlspace is poorly ventilated. I recommend removing all wood siding and trim products within 8 inches of grade and providing adequate ventilation opening to the crawlspace to facilitate drying

of the crawlspace.

A qualified contractor should be consulted for correction of the water intrusion and ventilation.

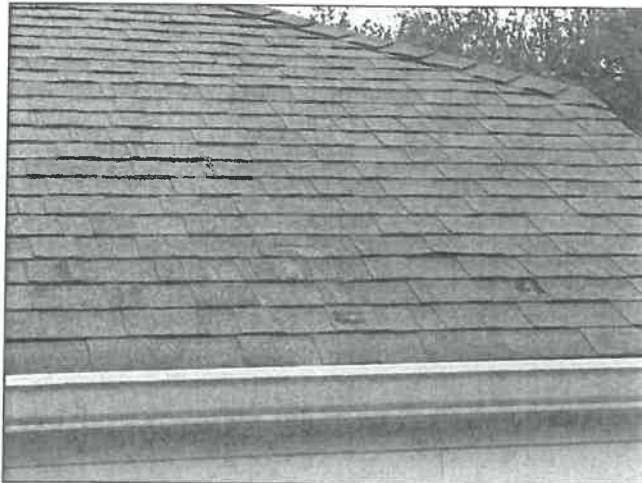
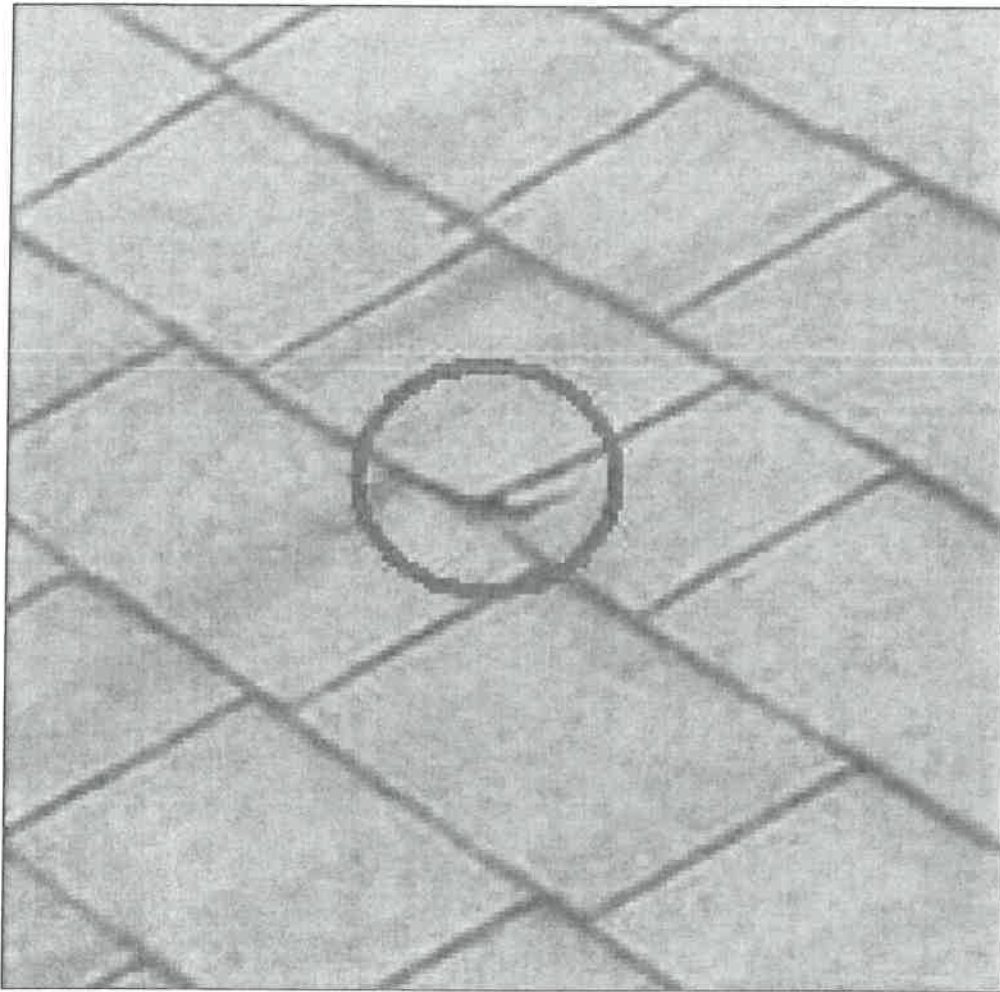
**X** (1) The roof covering has damaged and missing shingles on the west and south roof slope(s). A qualified contractor should be consulted for correction..

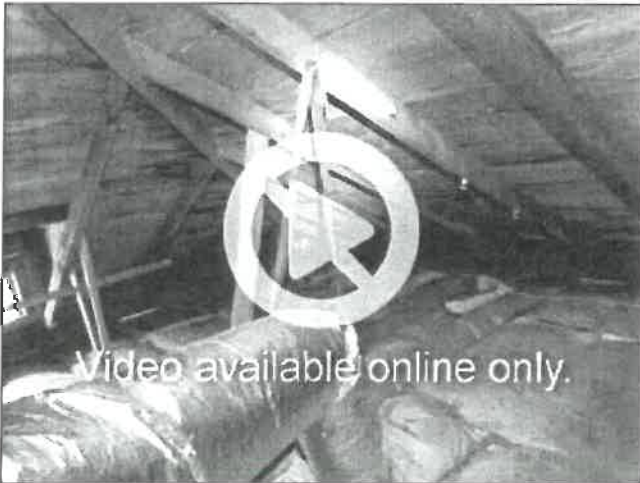
D. Item 2(Video)

(2) Rafter bracing may not be adequate. I recommend the installation of a purlin brace at the mid span of the rafter on each side of the attic.

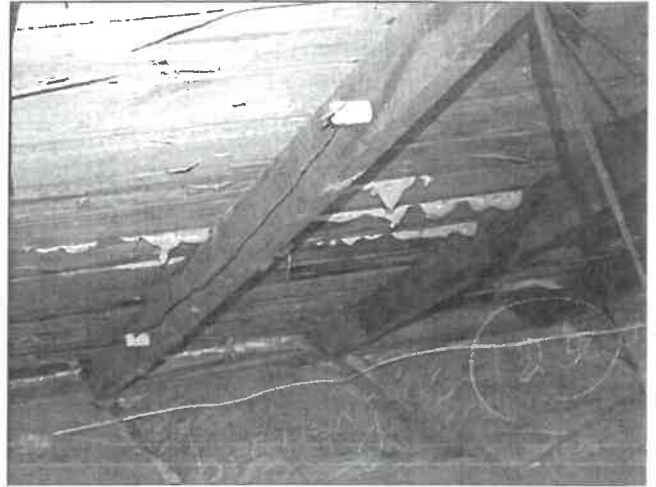
(3) Damaged roof decking at the east end of the attic.

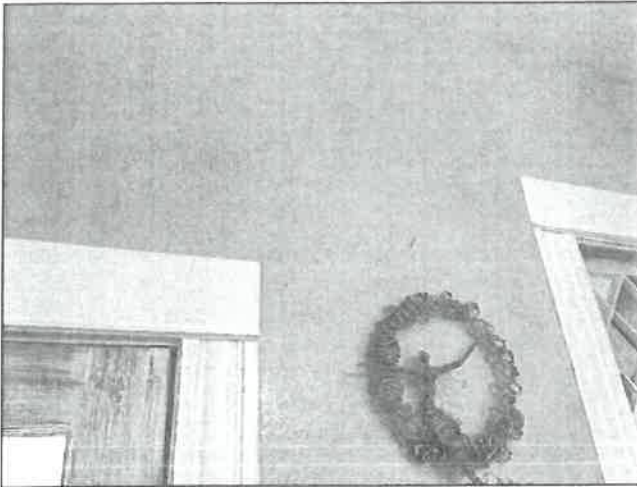
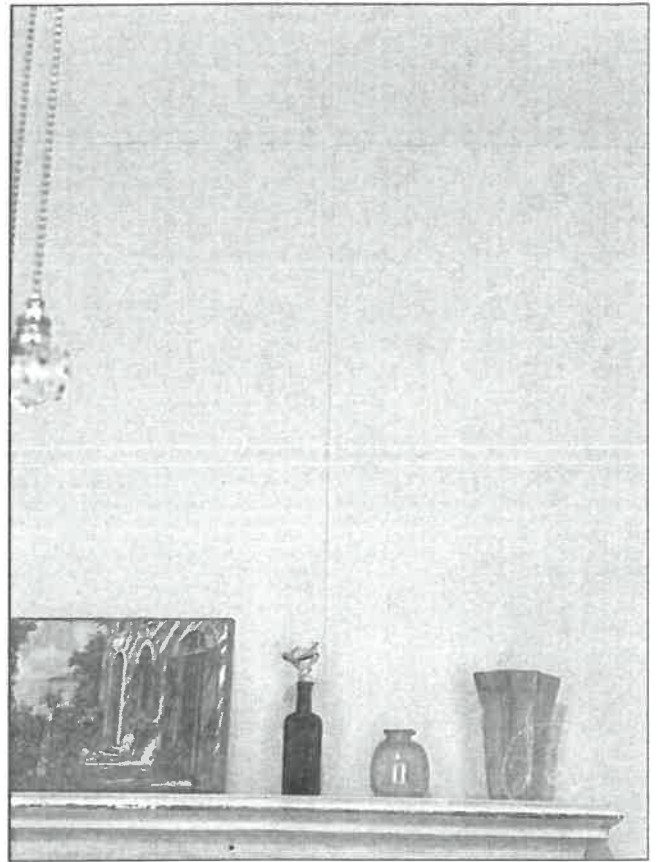
(1) There are repaired and unrepaired cracks in the wall and ceiling cladding throughout the structure. This may indicate prior structural movement that could be ongoing. All cracks should be monitored for change.

(27)  
these are  
sheetrock / taping  
floating issues.  
Seller will not  
address
