## Web Presentation

**Property Address:** 2025 Avenue M, Galveston, TX

**Spot On Inspection, PLLC**

# Safety Deficiencies

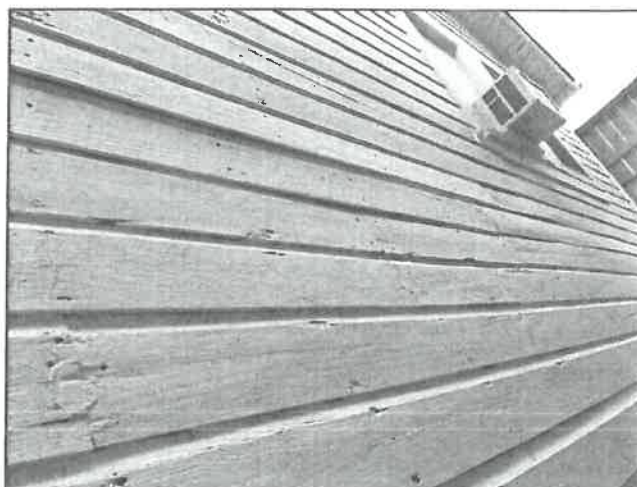
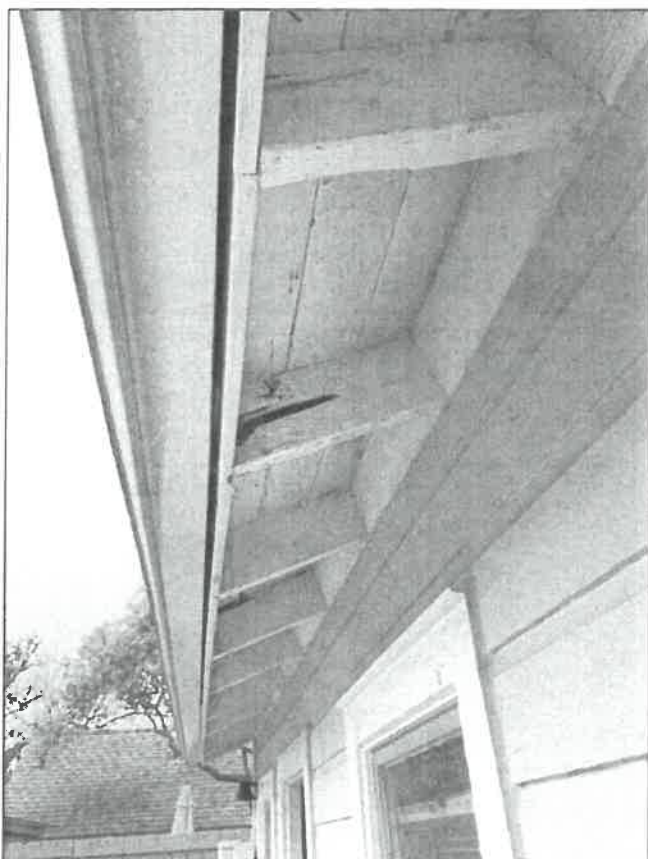
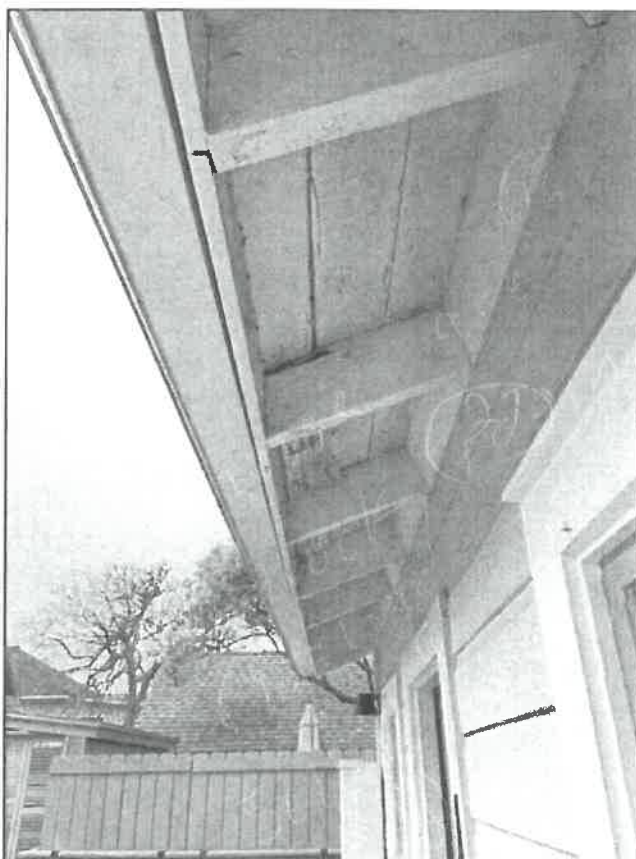
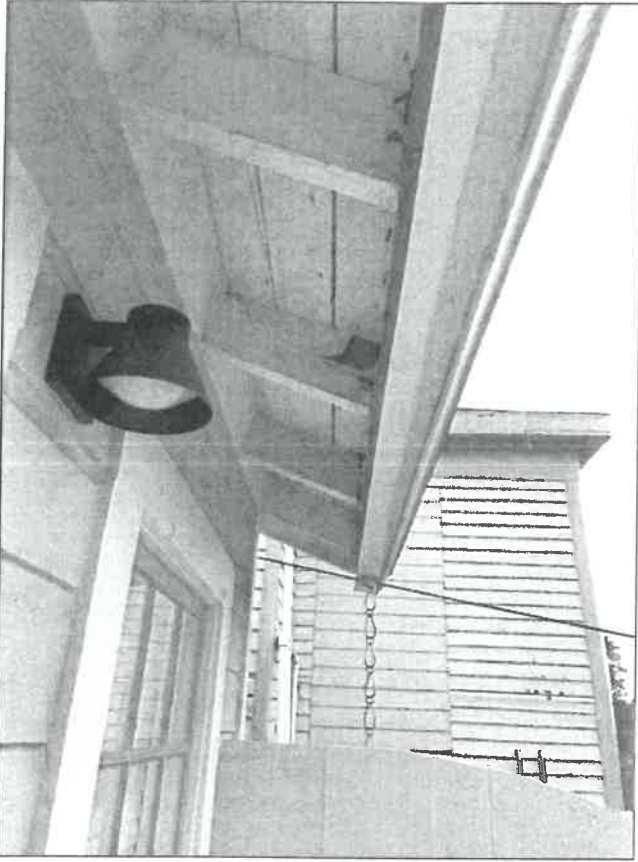
(2) There are multiple examples of wood exterior siding and trim products in poor condition on all sides of both structures. Deteriorated finish is causing moisture intrusion damage in multiple areas. A qualified contractor should

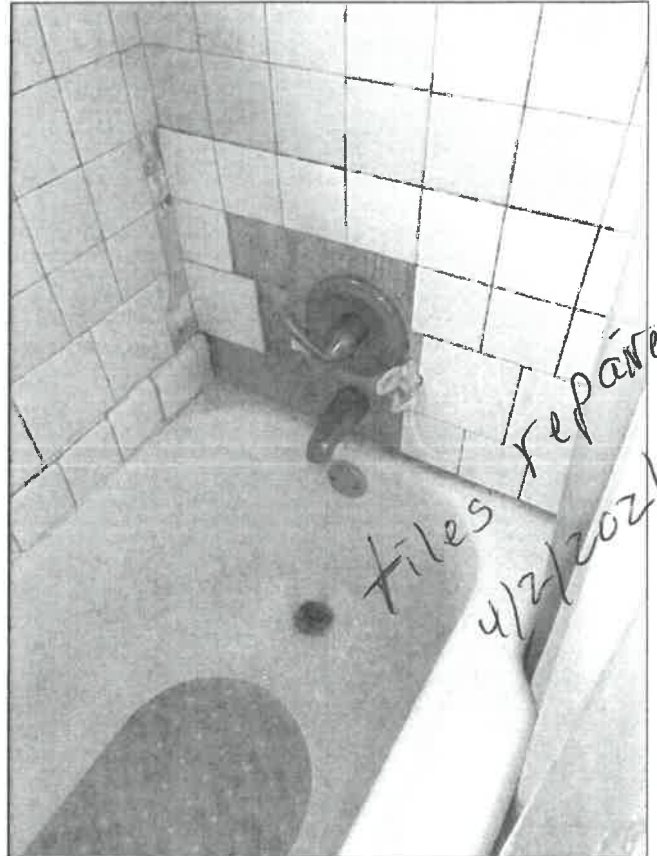
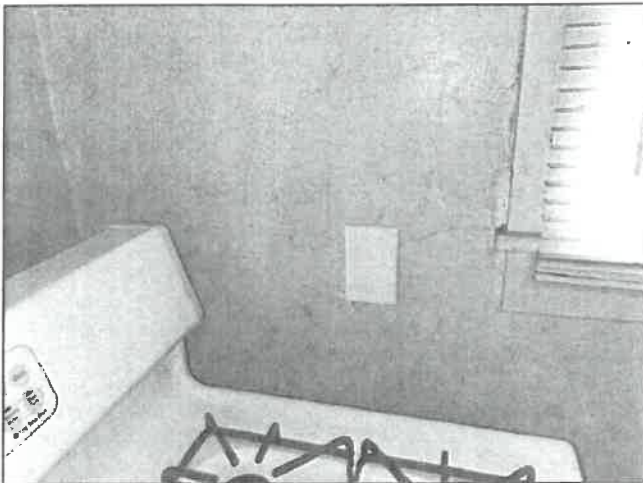
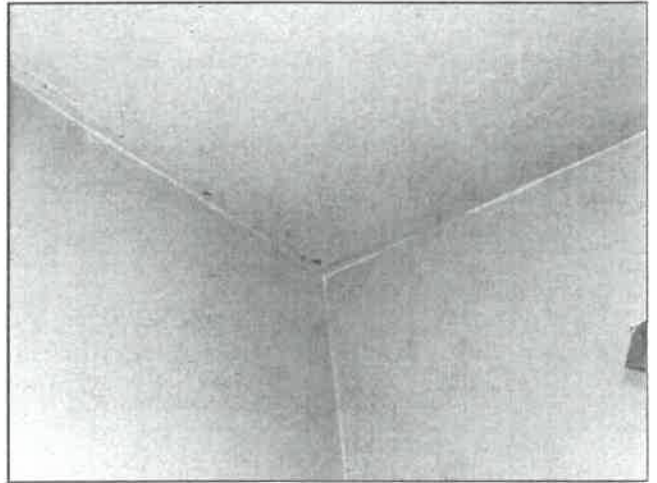
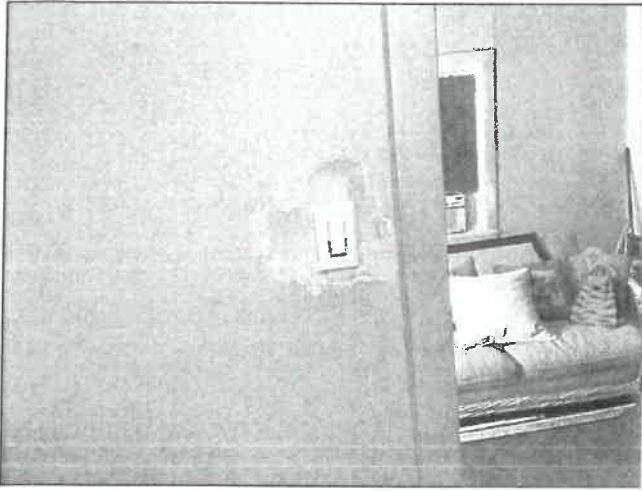
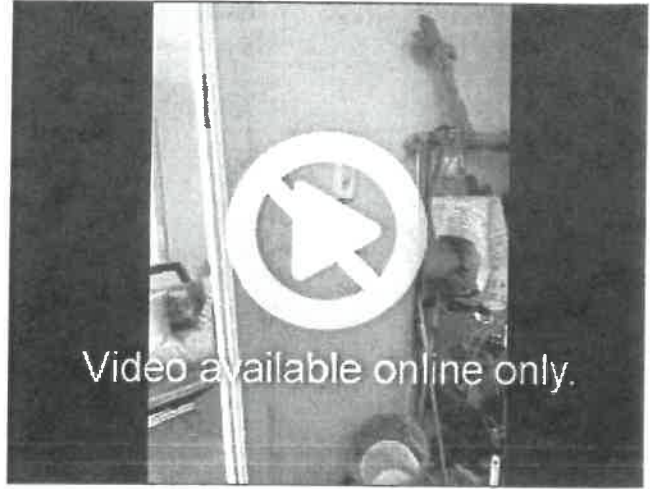
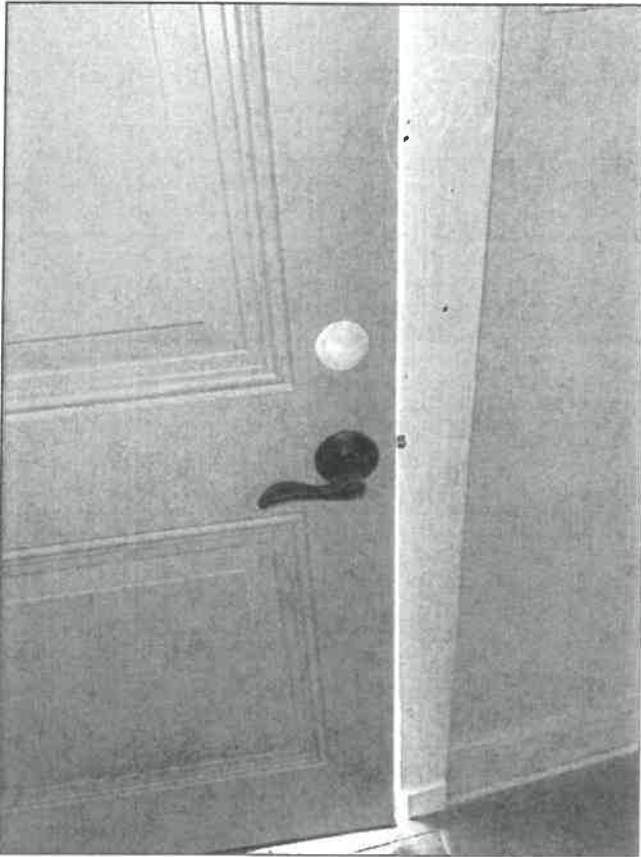
(3) The south apartment is undergoing extensive restoration/remodeling. There are multiple items not currently complete.

Walls to be painted by seller

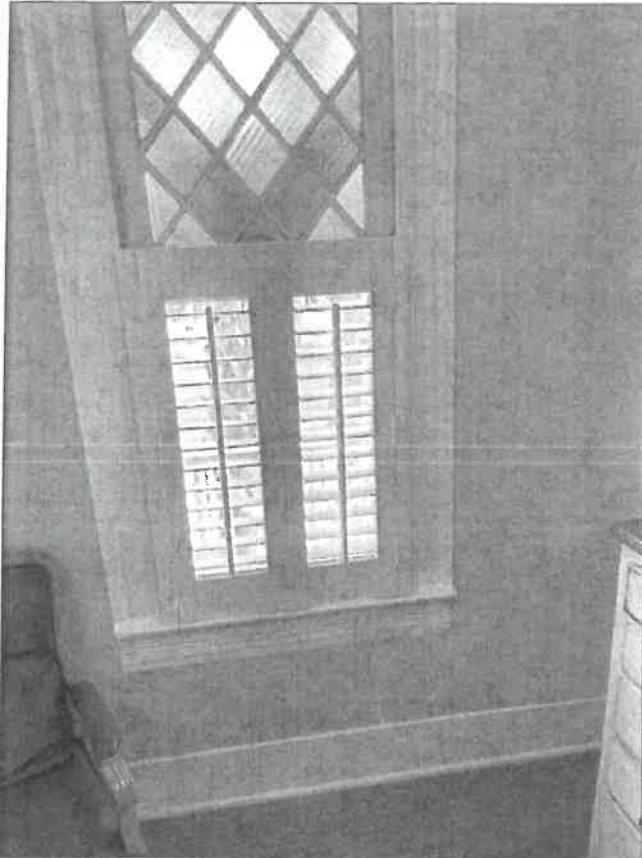
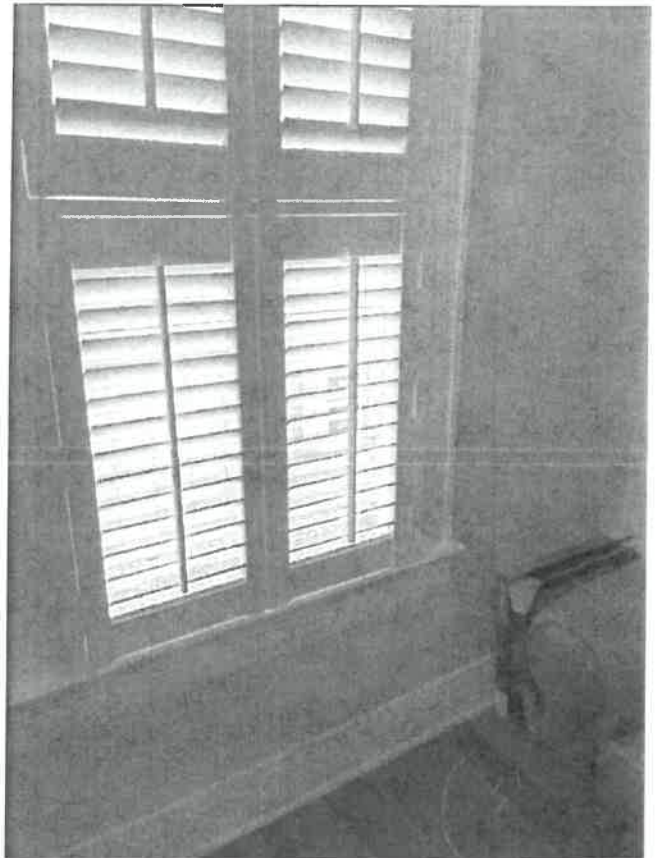
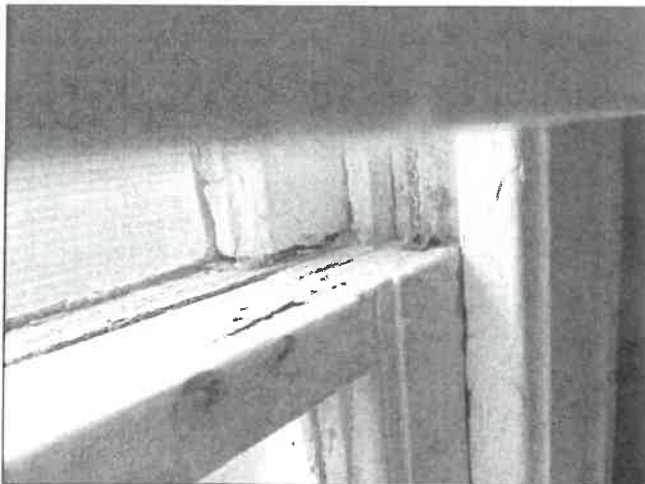
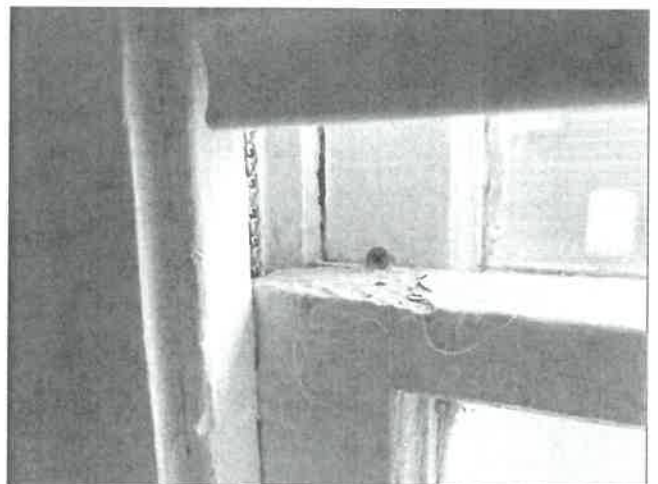
(1) Multiple windows do not open.

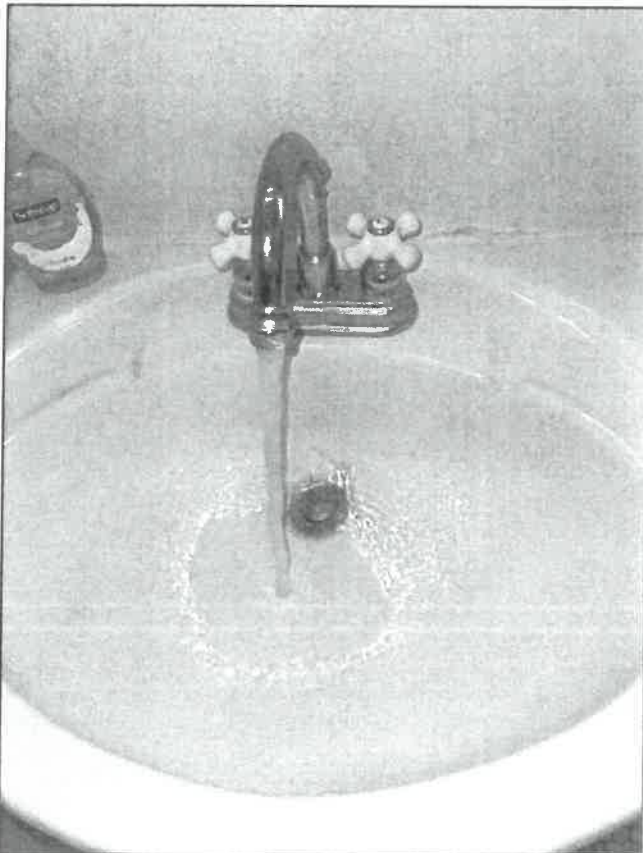
A. Item 2(Picture)

(2) The drain stopper in the second bathroom lavatory does not function.

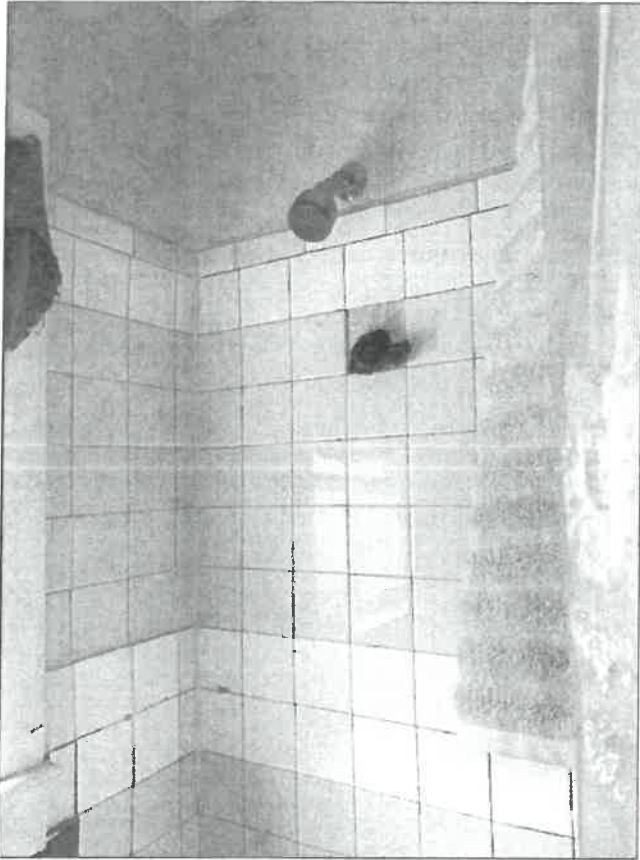
(1) Master shower escutcheon is not properly secured. This may result in moisture intrusion into the structure.

Seller to caulk

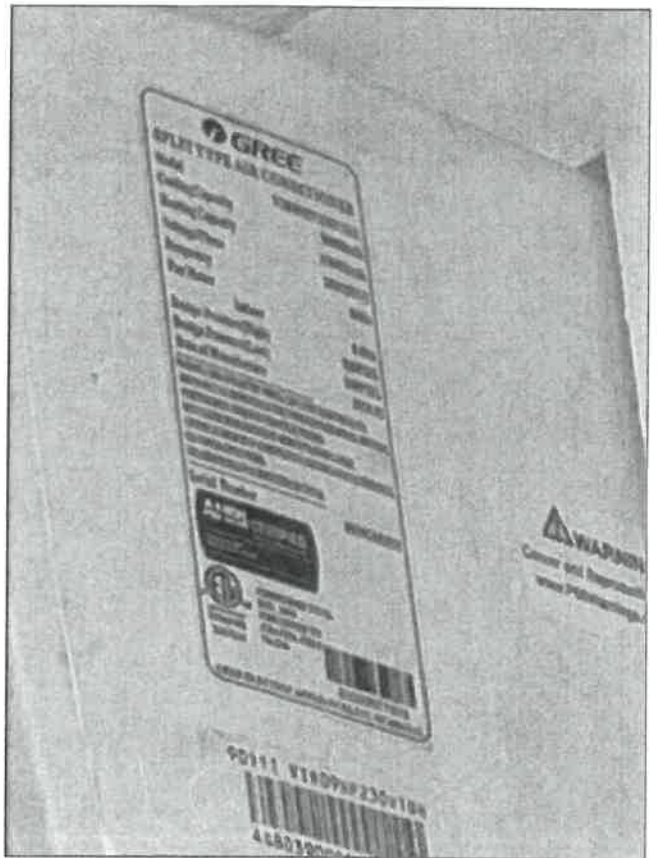
B. Item 6(Picture)

(6) Air conditioning unit dataplate for information only. This unit was manufactured in 2019. This unit is 2 year(s) old.

Expected service life of condenser units is 10-15 years although some units remain in service for much longer. Regular maintenance may increase service life.

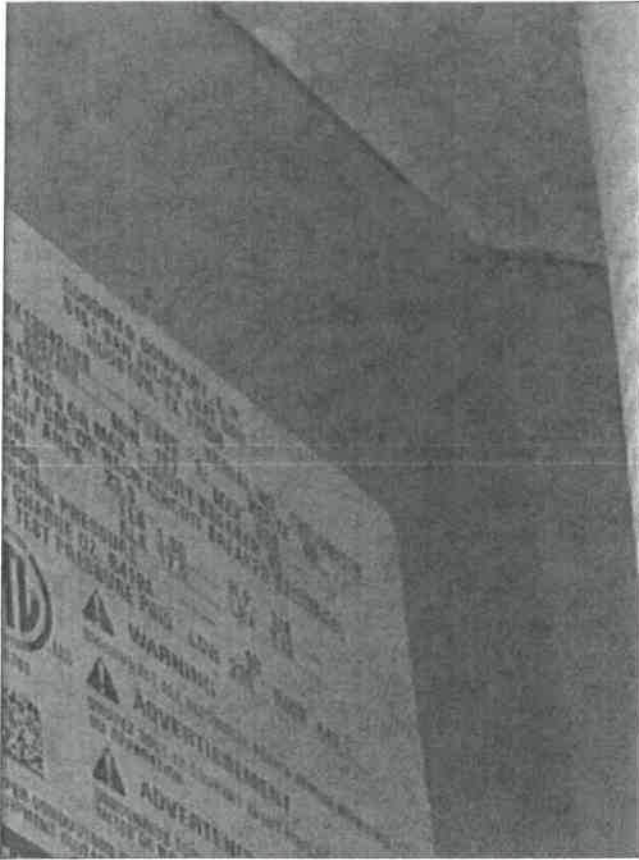
B. Item 7(Picture)

(7) Air conditioning condenser unit dataplate for information only. This unit was manufactured in 2012. This unit is 9 year(s) old.

Expected service life of condenser units is 10-15 years although some units remain in service for much longer. Regular maintenance may increase service life.

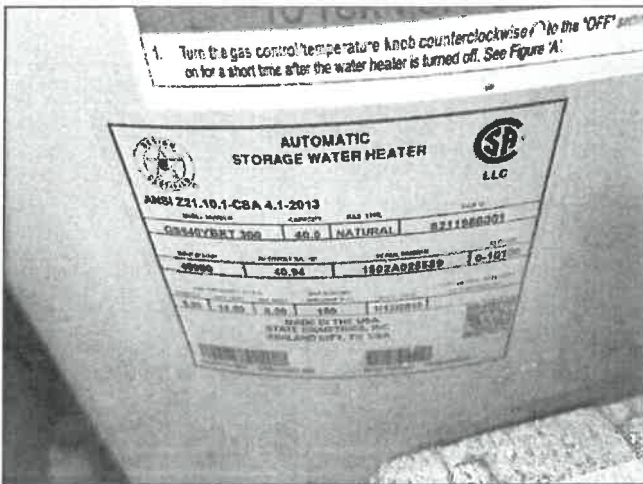
C. Item 4(Picture)

(4) Water heater dataplate(s). Unit(s) manufactured in 2015.

Most tank-type water heaters last 10 to 20 years, with the average age of replacement between 12 and 14 years.

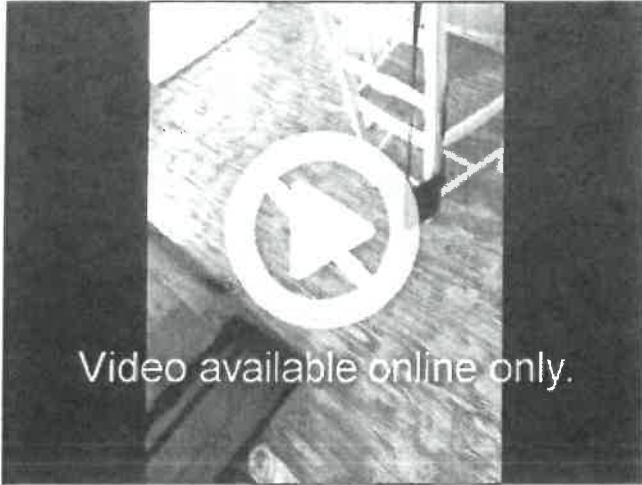
E. Item 16(Video)

(4) North apartment video for information only.

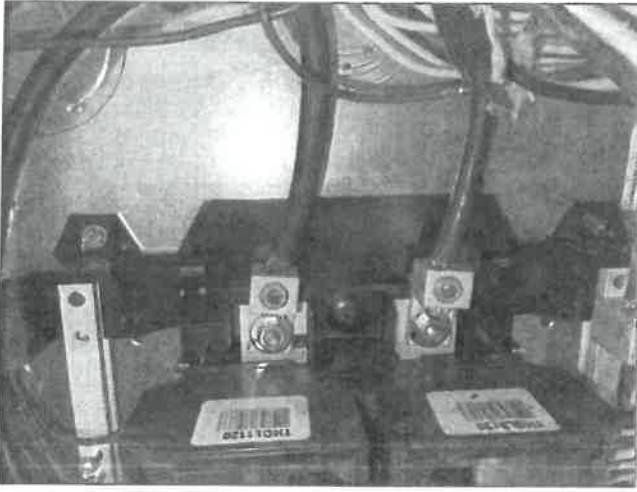
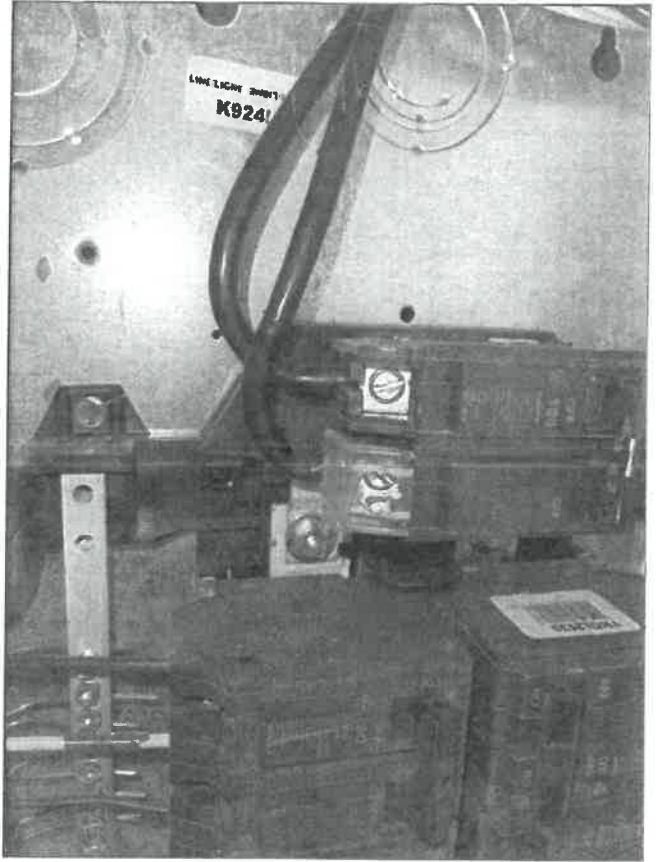
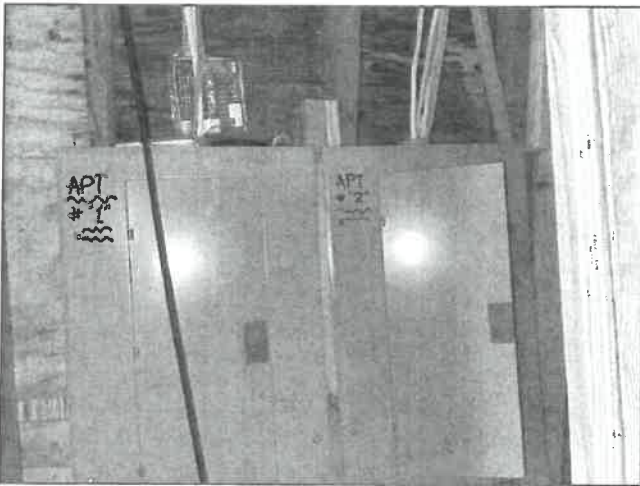
(2) The main electrical service and distribution panel is located inside the structure in the crawlspace. This is for information only.

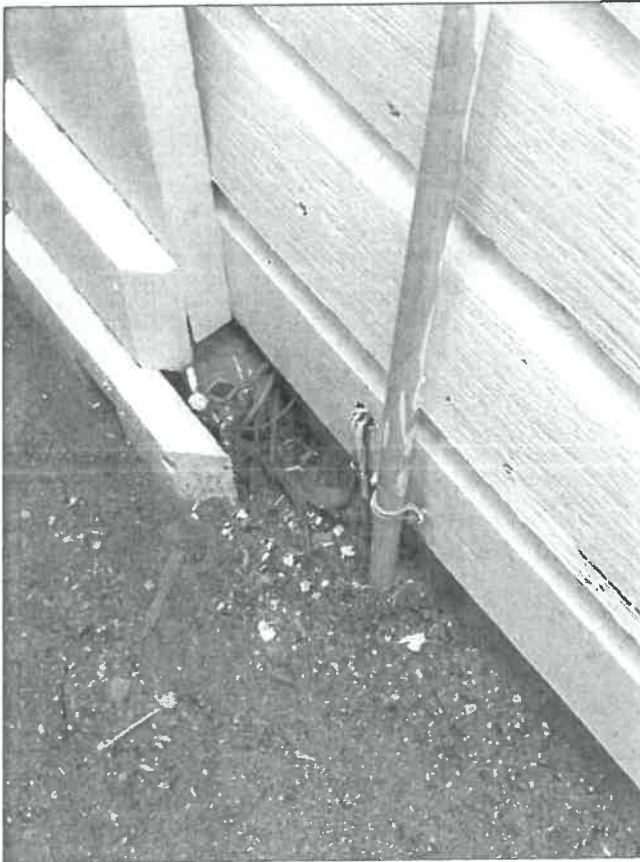
A. Item 4(Picture)

(3) Electrical system grounding electrode. This is for information only.

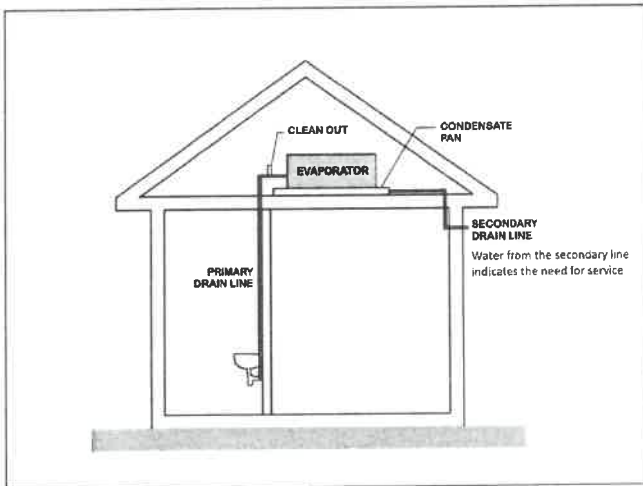
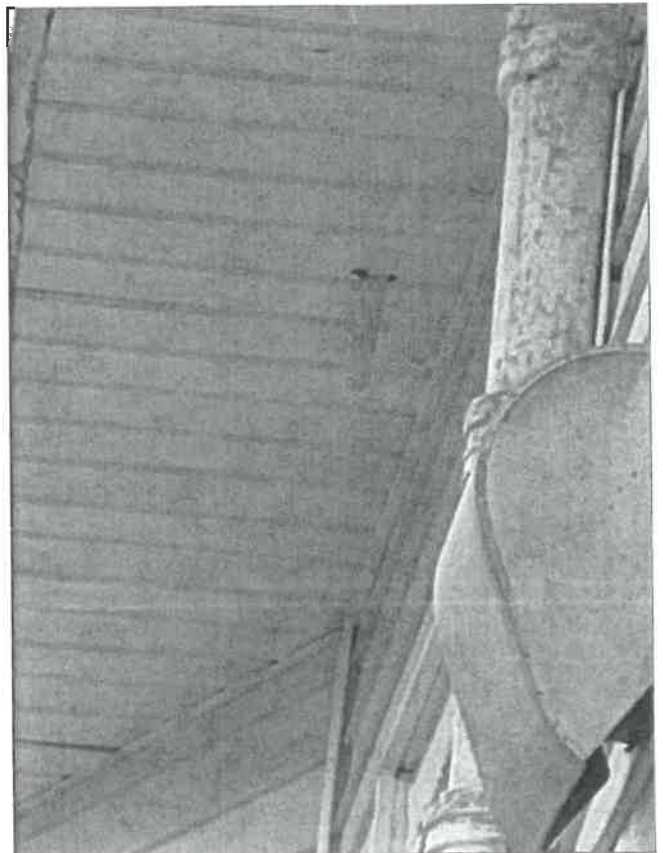
(5) The pipes in the soffit are the secondary condensate drain for the air conditioning system. Water emitting from these drains indicates a problem with the primary drain system. If water is seen, a qualified contractor should be consulted for correction. This is for information only.

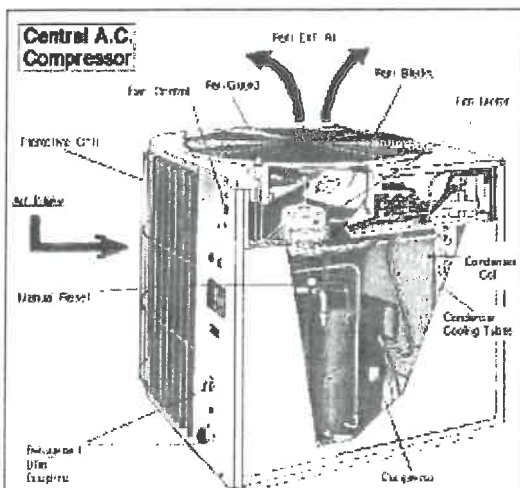
B. Item 8(Picture)

(8) Your home has a split system air conditioning system. The unit outside is the condenser. I recommend the following annual checks before the start of cooling season (March or April in Houston)

I suggest a qualified air conditioning contractor to perform these tasks.

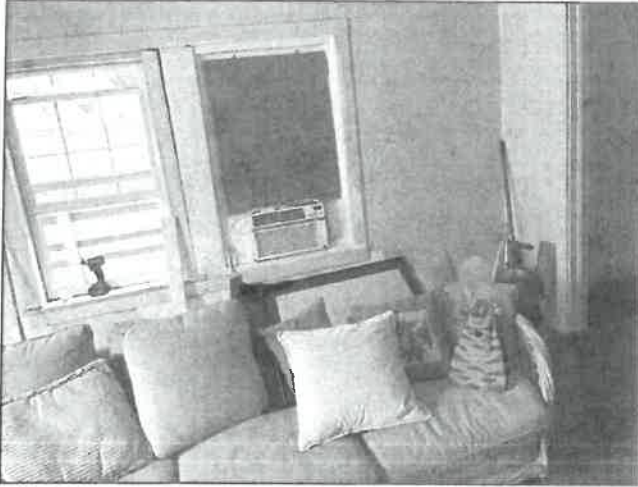
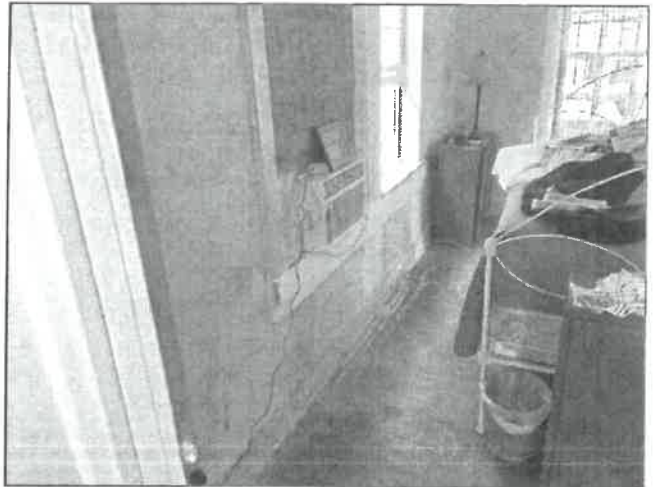
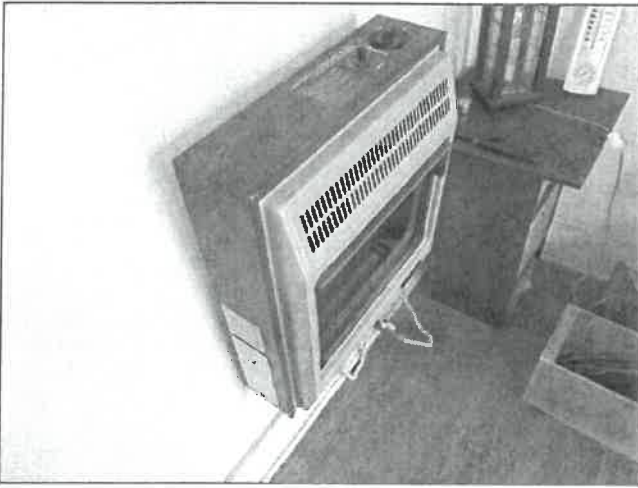
(10) Window units in the south apartment were not operated.

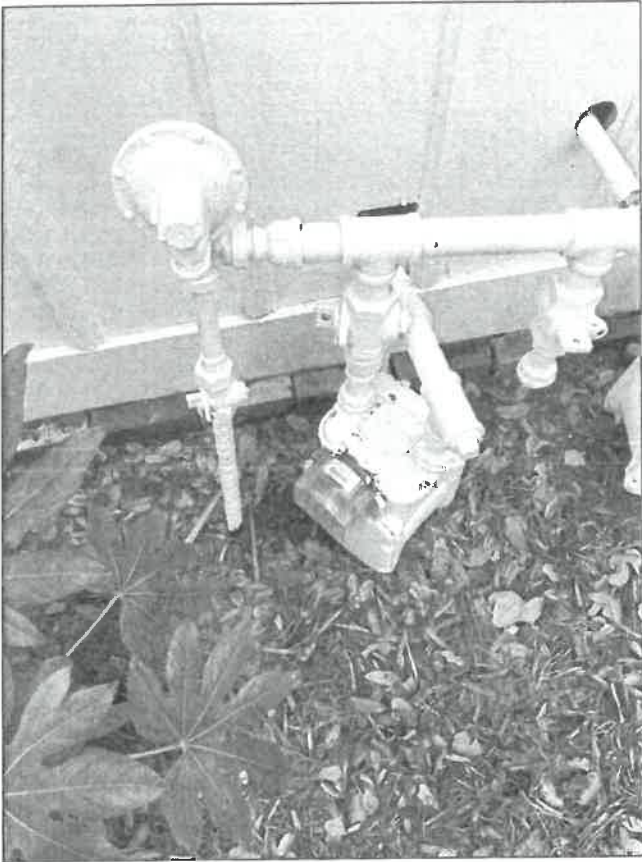
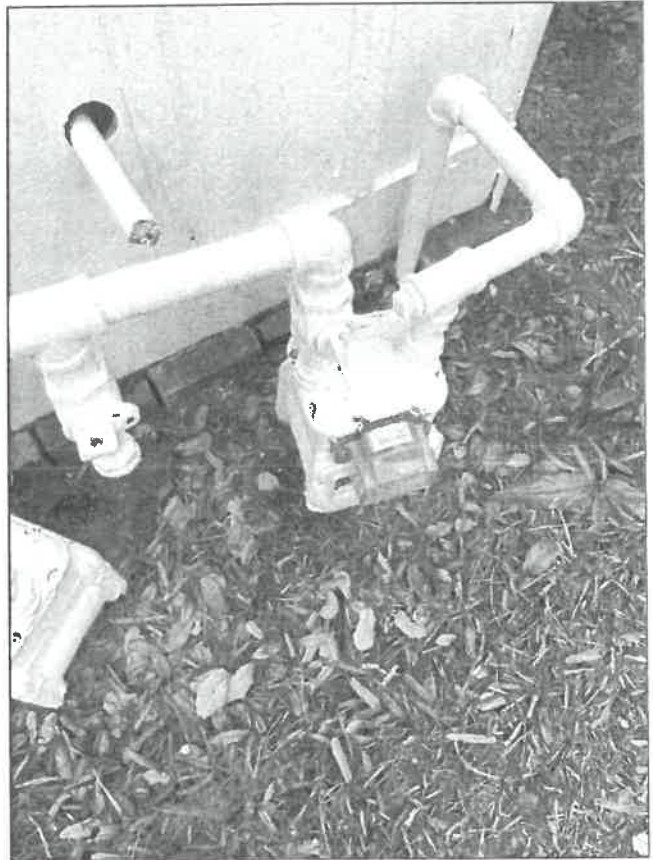
(7) The natural gas shut off valve is located at the gas meter. This is for information only.

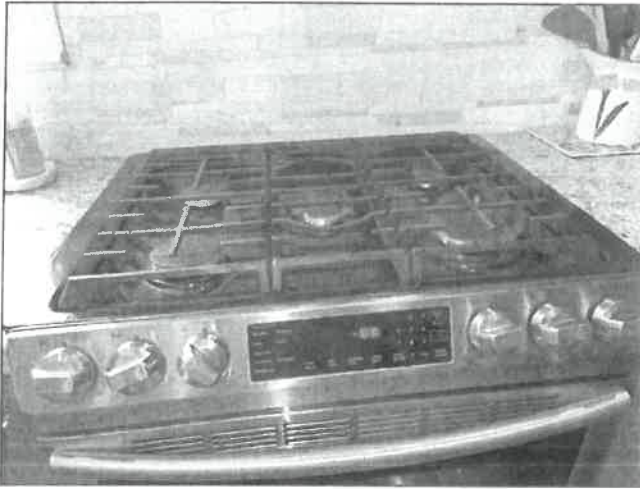
D. Item 1(Picture)

(1) The cooktop was visually inspected and operated using normal controls. No deficiencies noted.

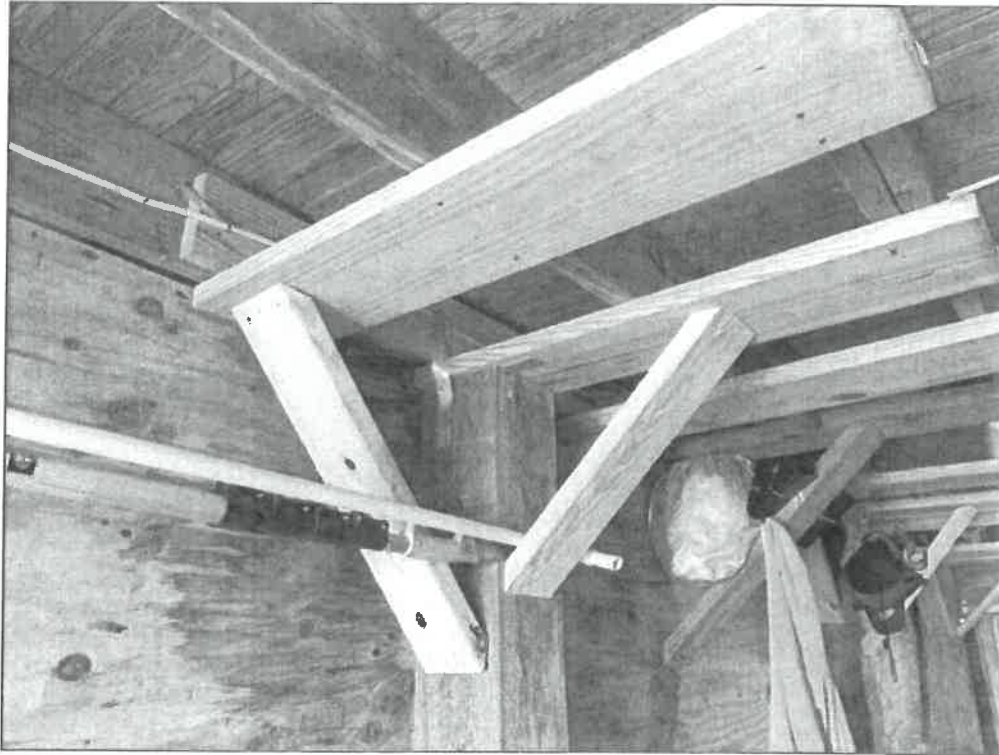
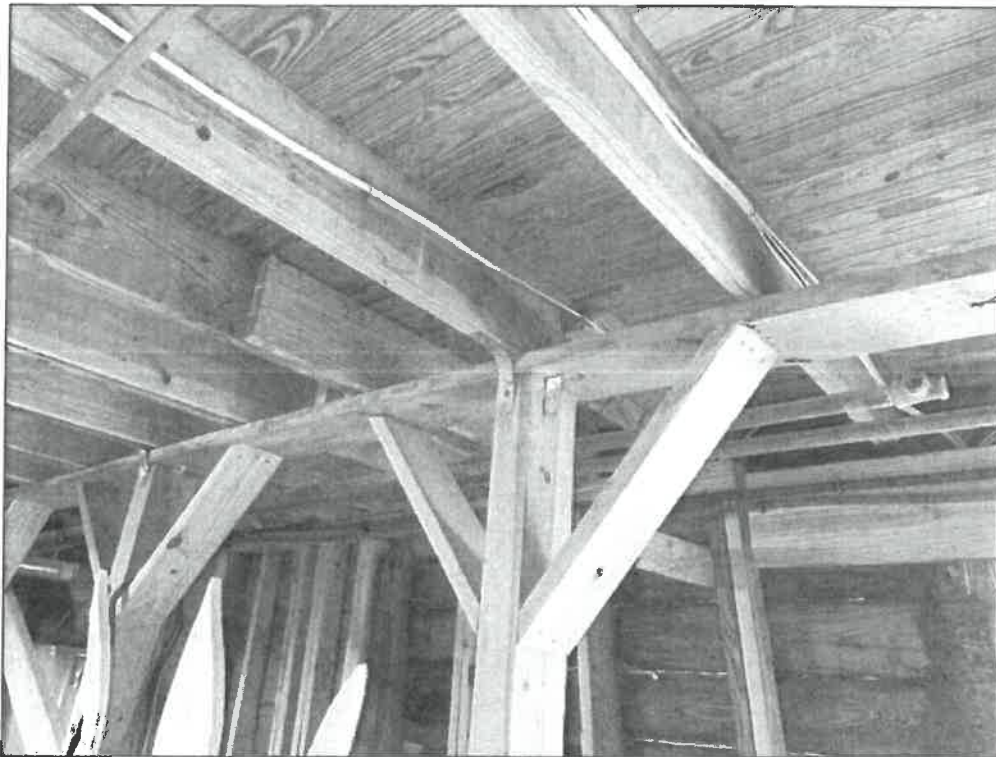
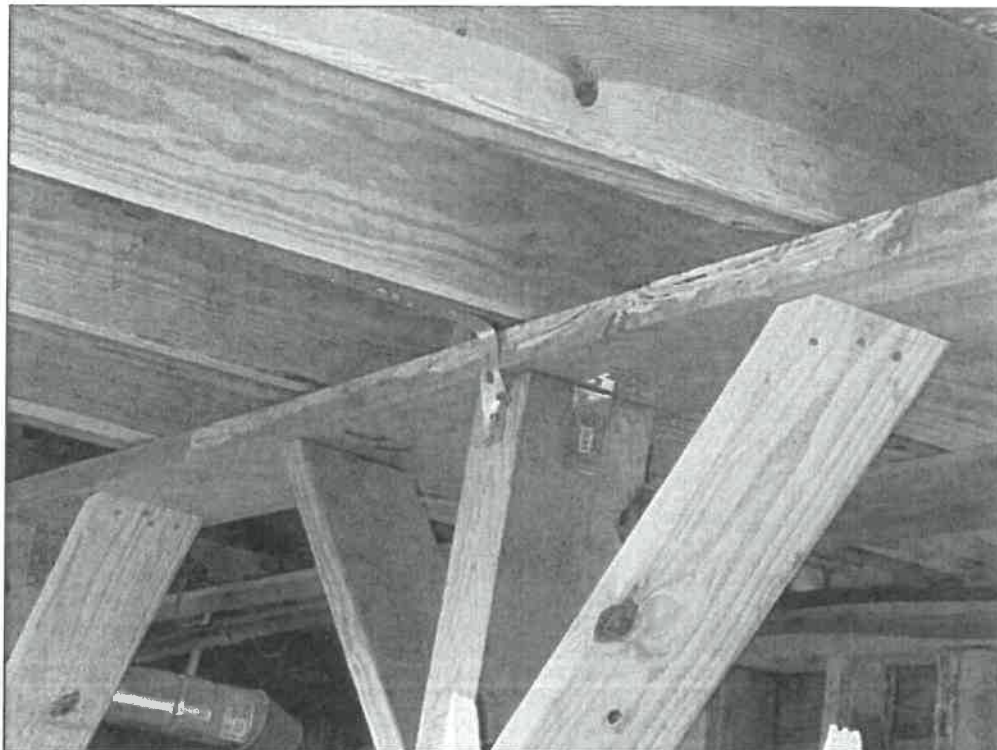
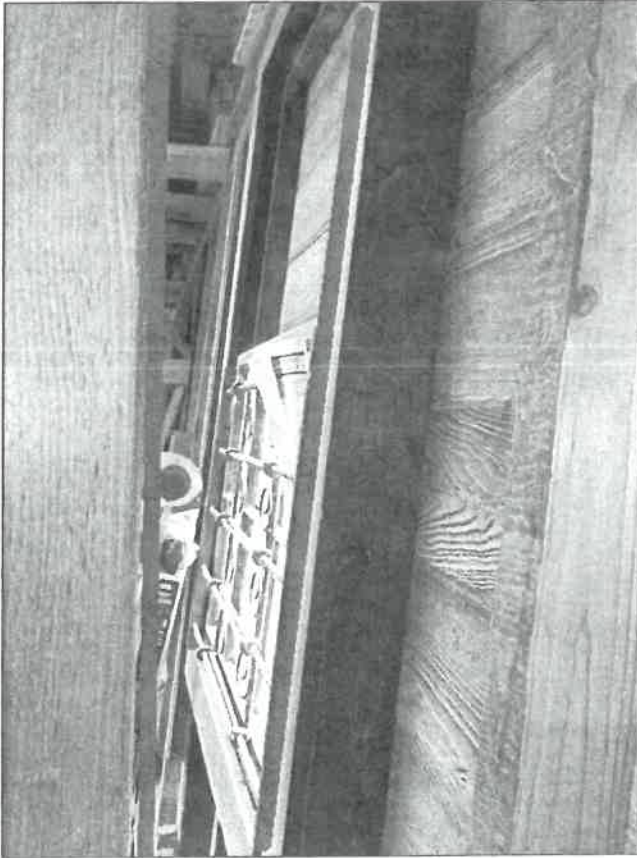
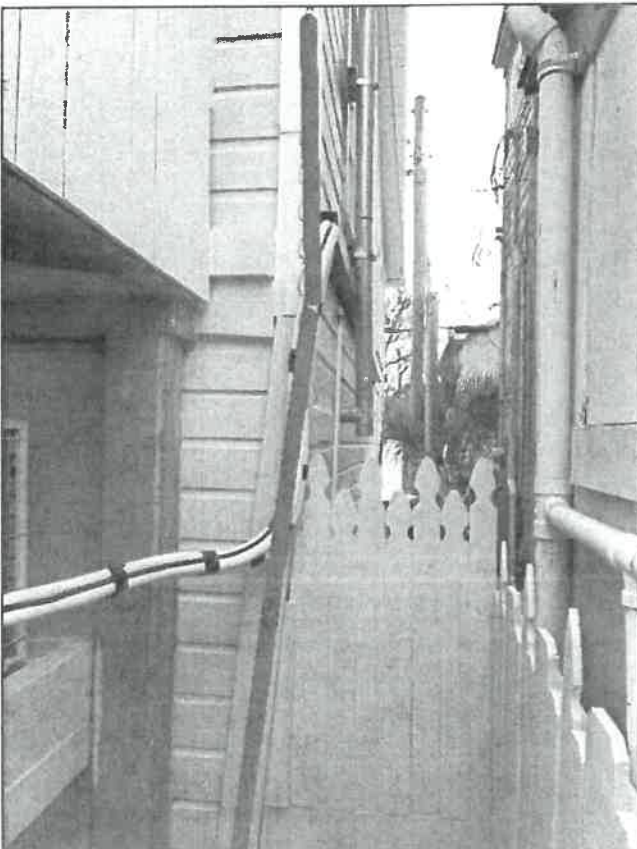
**X** (1) It is the opinion of this inspector that the adequate performance of garage apartments foundation cannot be determined via one time inspection. There are multiple indications of prior structural movement present. The lower half of the north wall is leaning approximately 16 degrees at the Northwest corner. This lean extends across the entire length of this wall. There are extensive structural repairs. These repairs are not in accordance with industry standard practices and may not be sufficient to prevent further structural movement.

The foundation should be evaluated by a qualified structural engineer with experience with this type of foundation system.

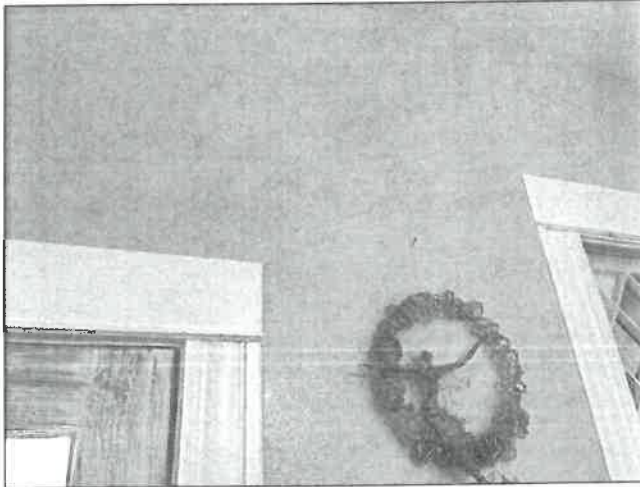
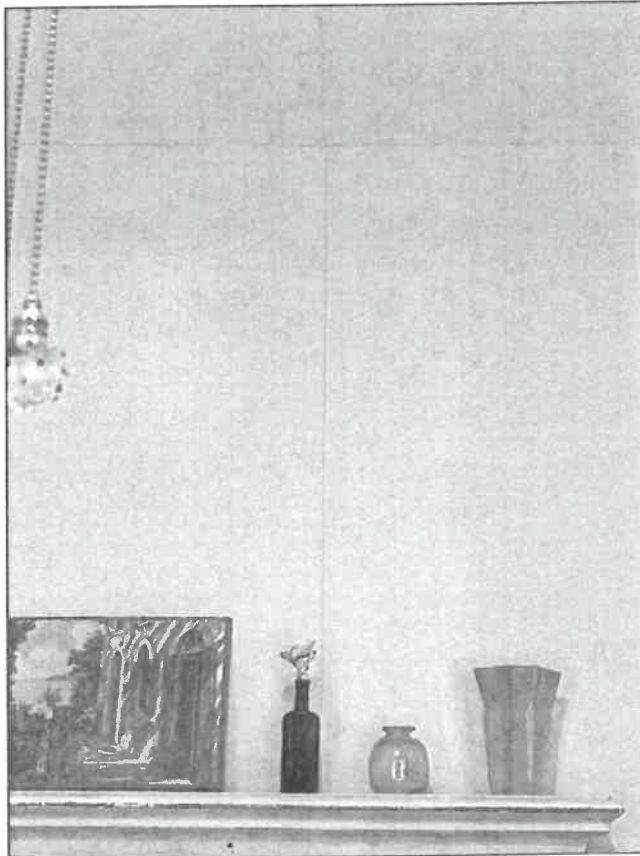
**X** (1) There are repaired and unrepaired cracks in the wall and ceiling cladding throughout the structure. This may indicate prior structural movement that could be ongoing. All cracks should be monitored for change.

taping issue

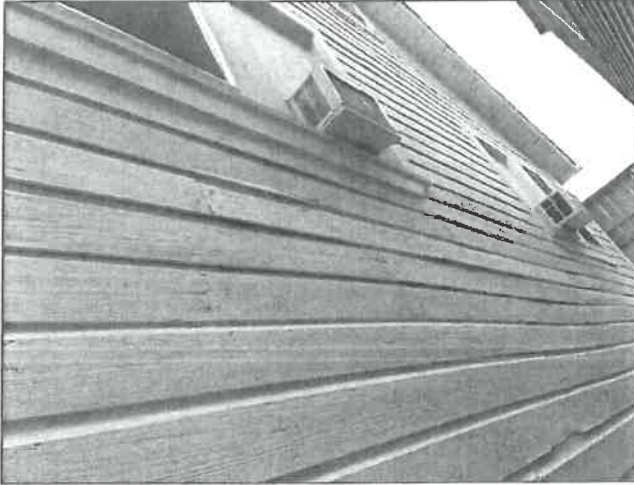
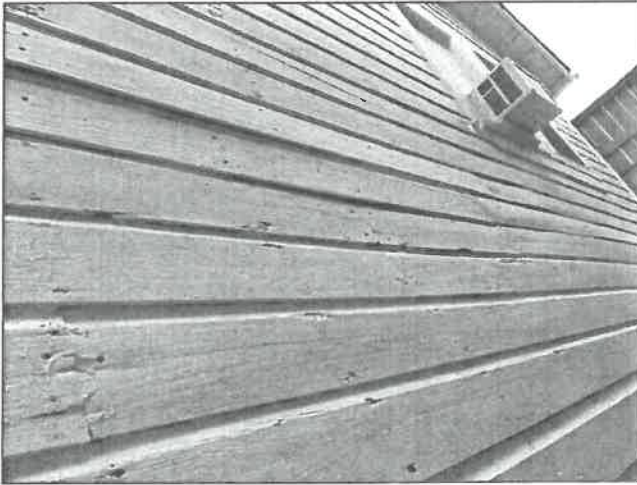
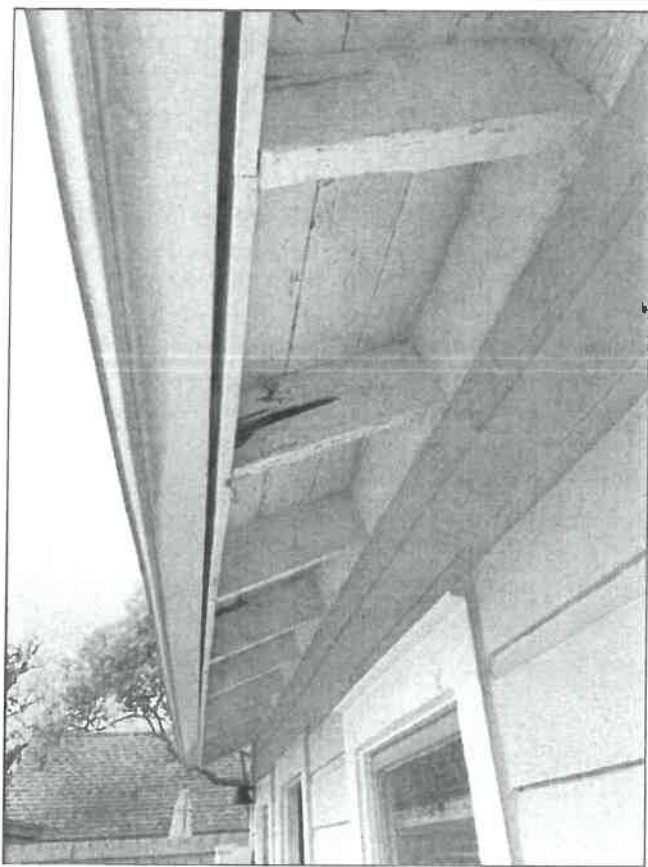
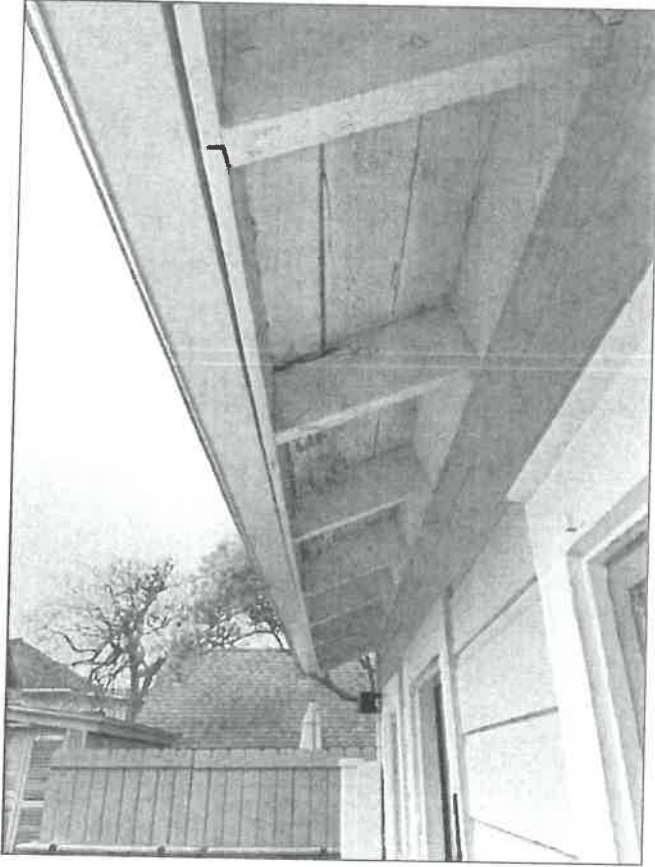
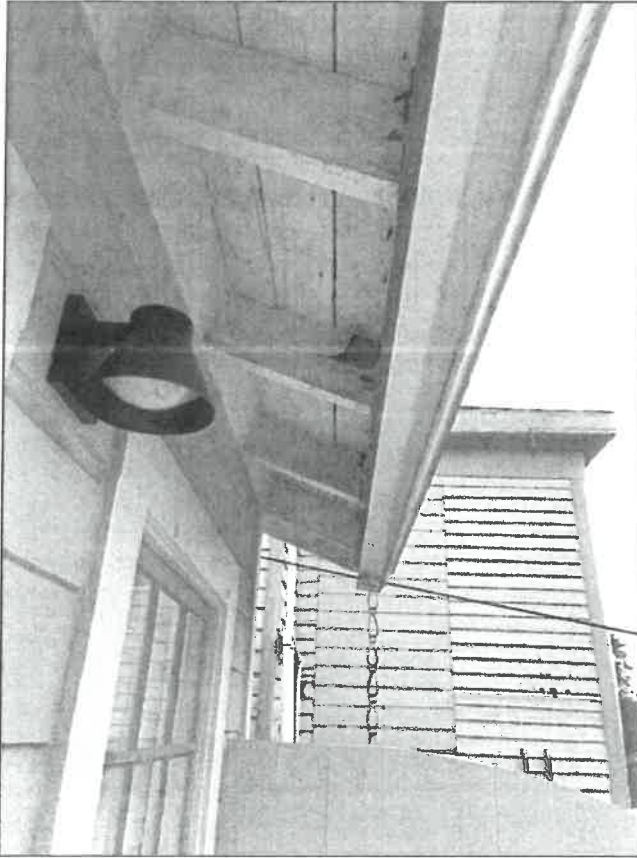
**X** (2) There are multiple examples of wood exterior siding and trim products in poor condition on all sides of both structures. Deteriorated finish is causing moisture intrusion damage in multiple areas. A qualified contractor should be consulted for correction.

these windows - all  
new 2/2021 with  
frames replaced with  
wood preservative treated  
with preservative treated  
weather  
replaced with  
original wood prime  
& treated for weather  
caulked.
