## Web Presentation

**Property Address:** 2025 Avenue M, Galveston, TX

**Spot On Inspection, PLLC**

# Safety Deficiencies

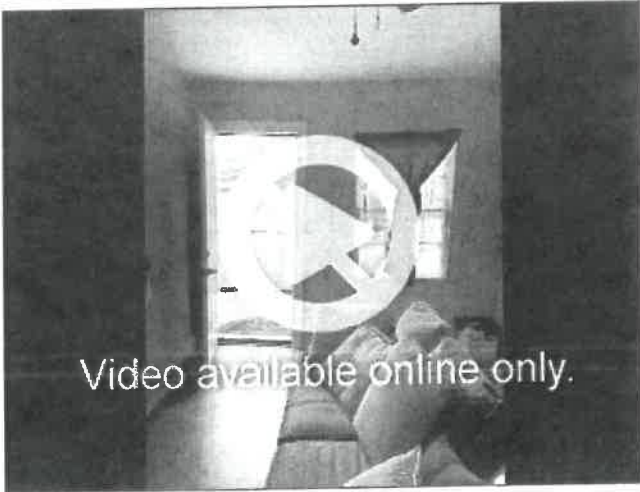
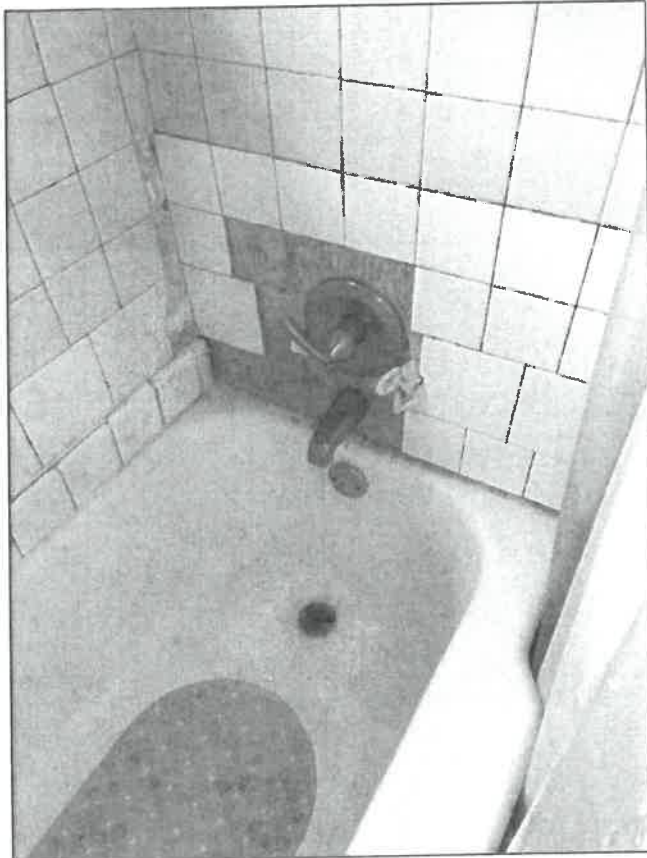
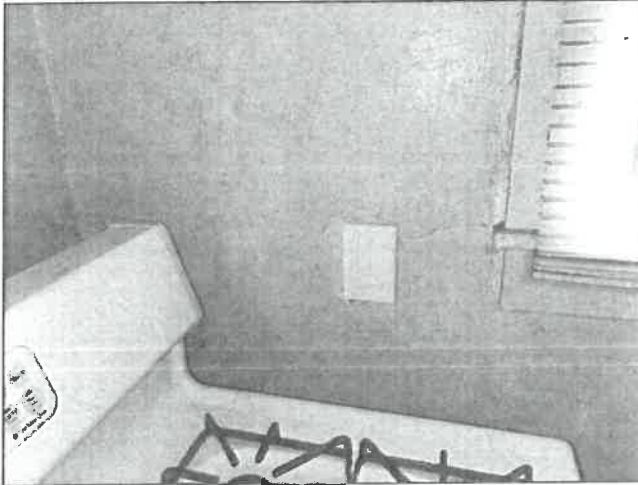
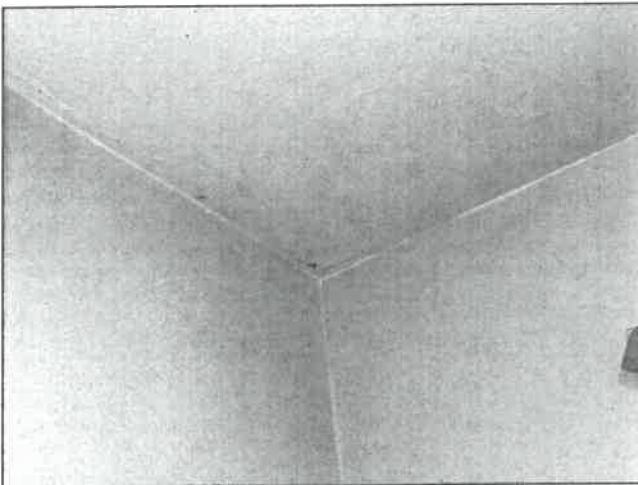
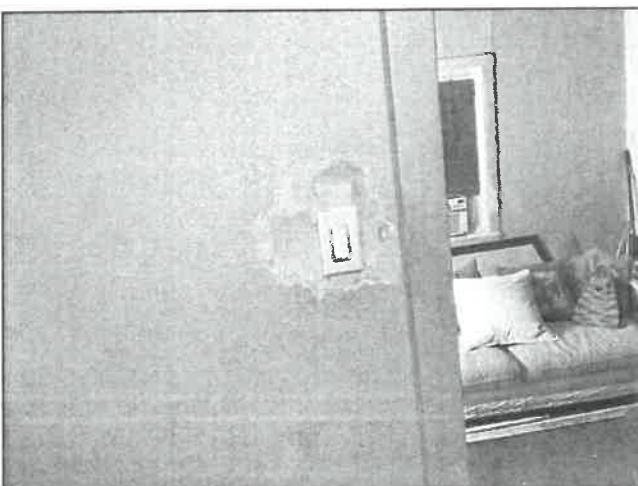
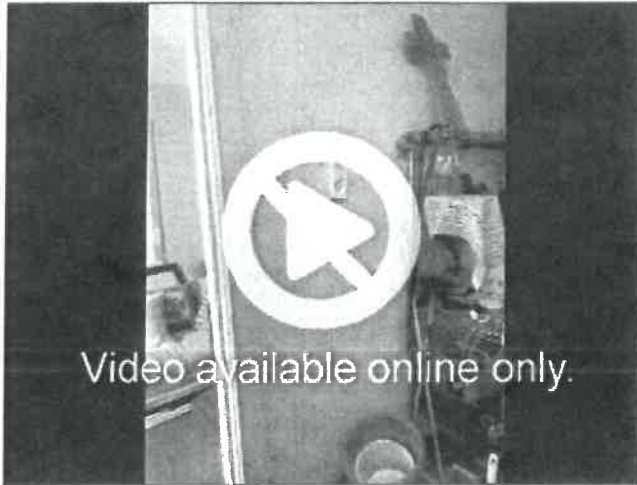
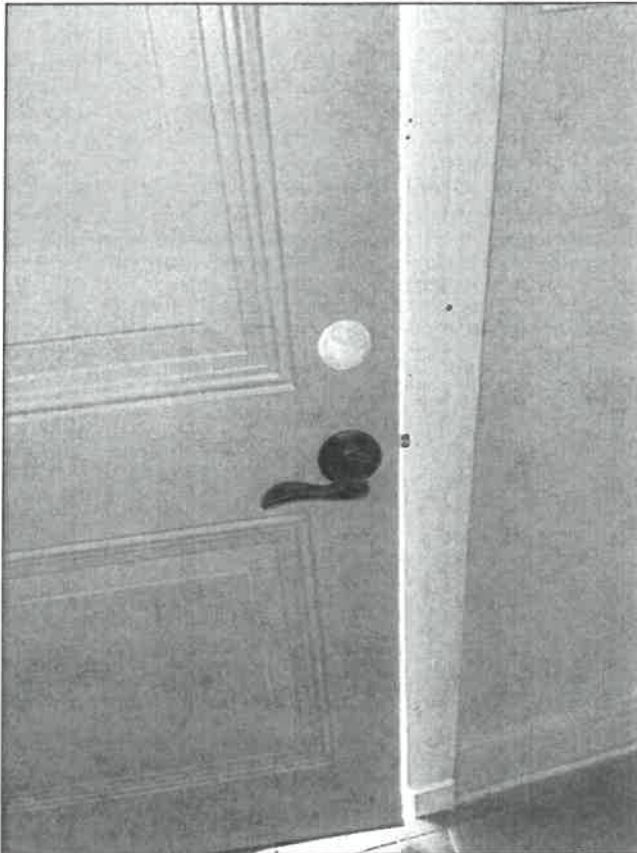
**X** (3) The south apartment is undergoing extensive restoration/remodeling. There are multiple items not currently complete.

tile work  
has completed  
04/02/2021

apartment to be  
painted in next  
2 weeks ??

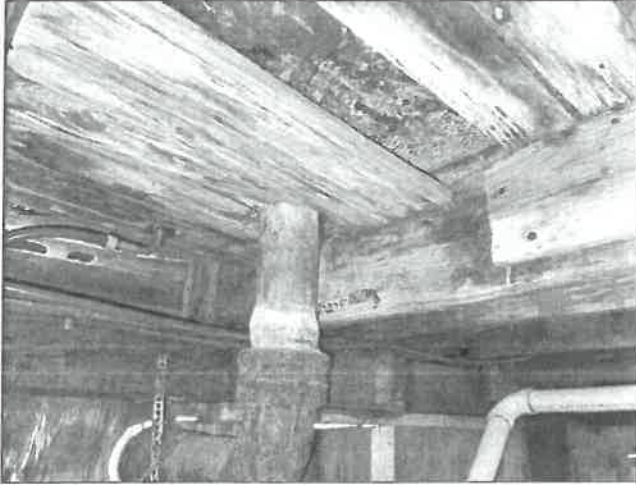
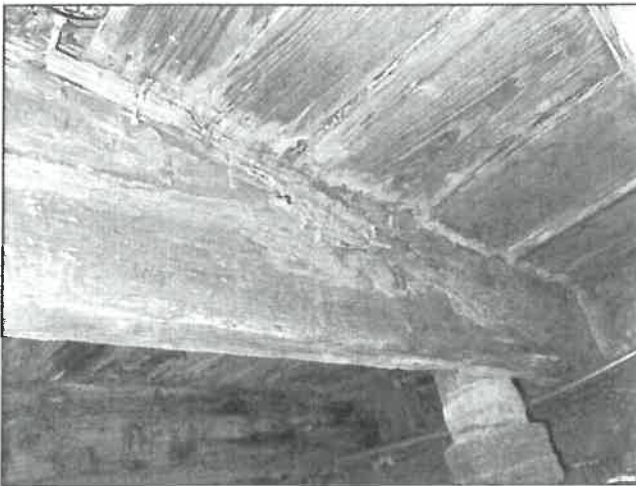
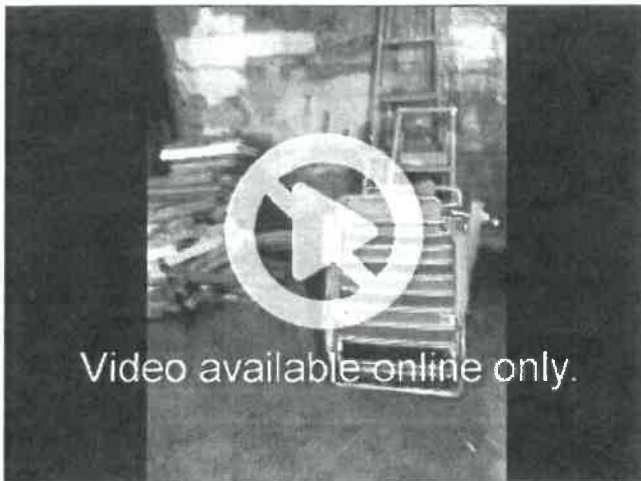
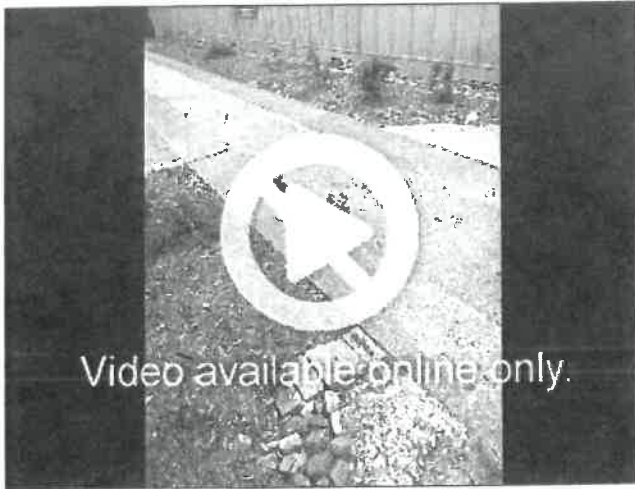
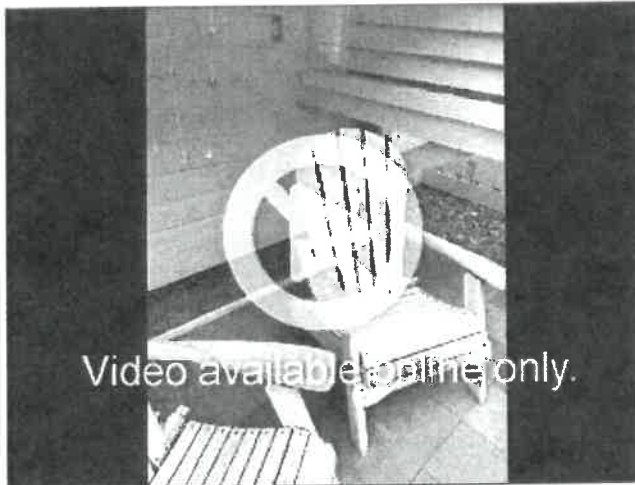
**X** (1) Floors throughout both structures are not level. There are several planes of displacement throughout the structures. This indicates prior foundation or structural movement that may be ongoing.

**X** (2) There are areas of moisture intrusion damage in the subfloor and crawlspace skirting of the primary structure. A qualified contractor should be consulted for correction of all damaged areas. I recommend removal of all wood siding and trim products within 8 inches of the grade level and repair of all damaged structural components

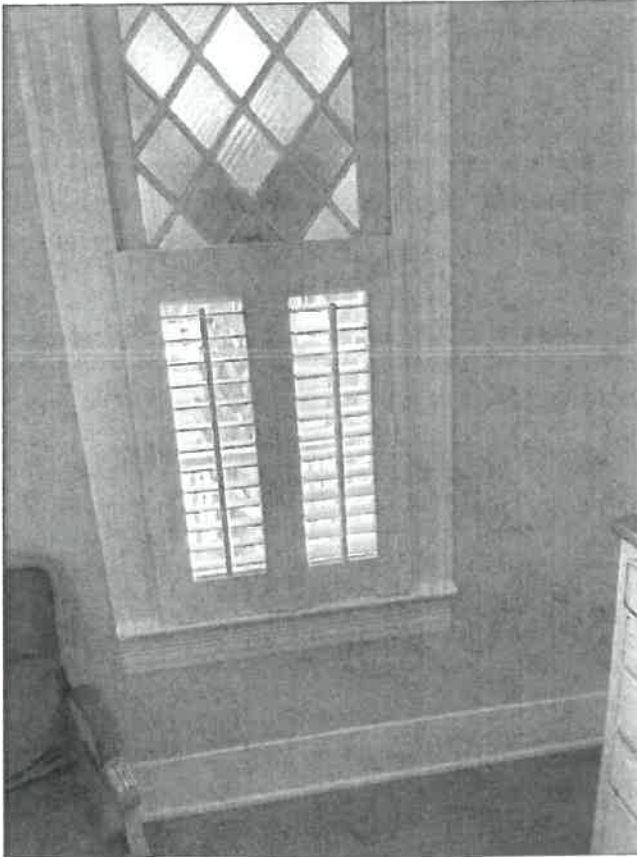
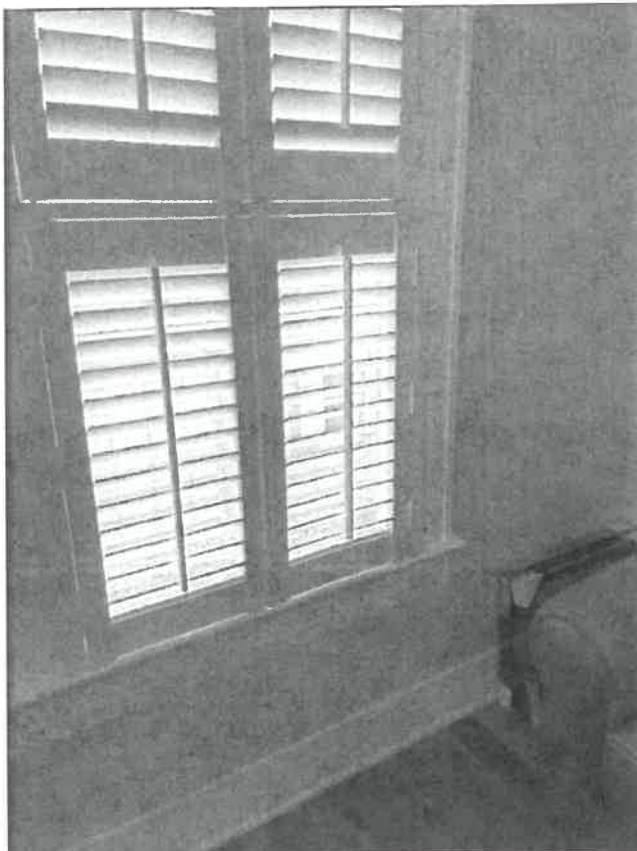
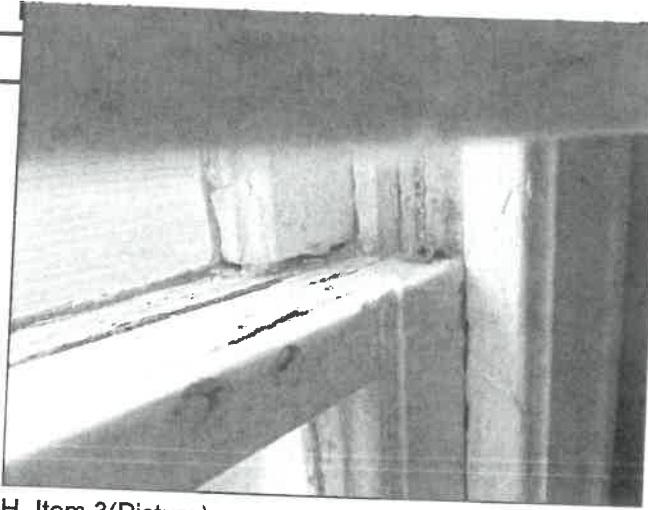
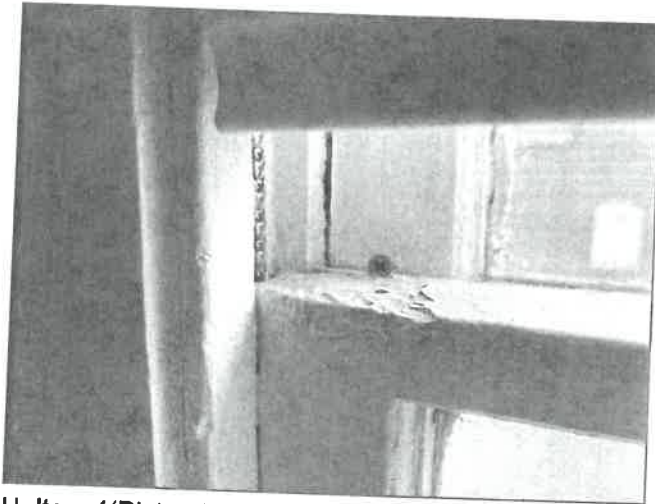
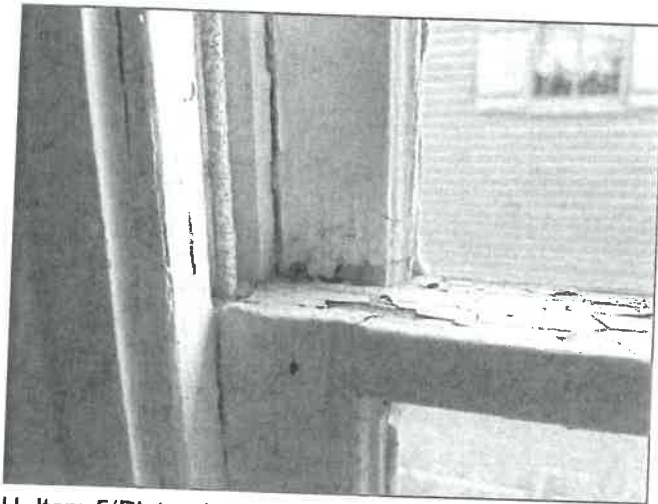
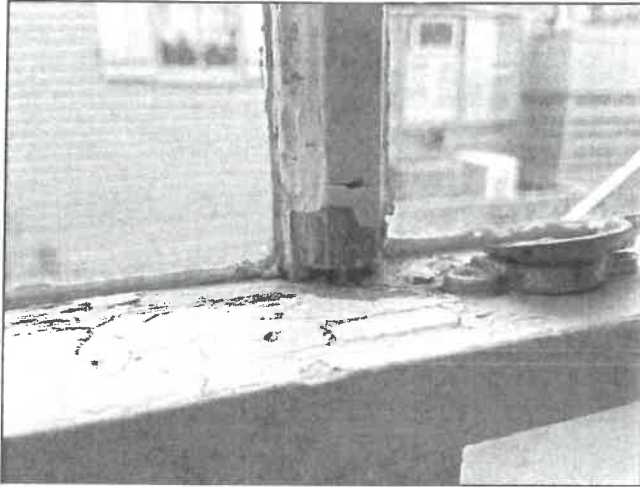
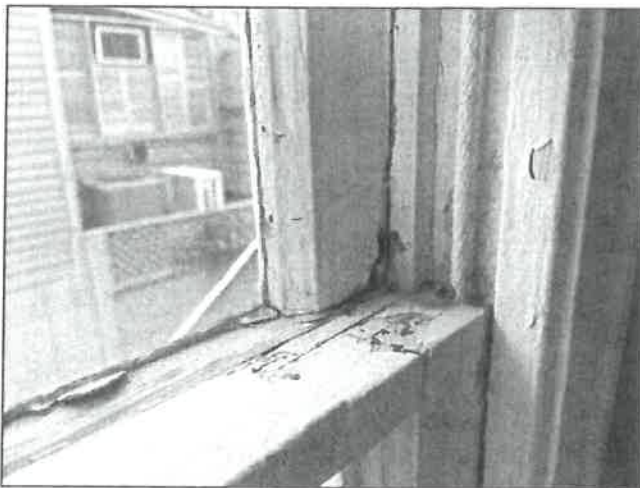
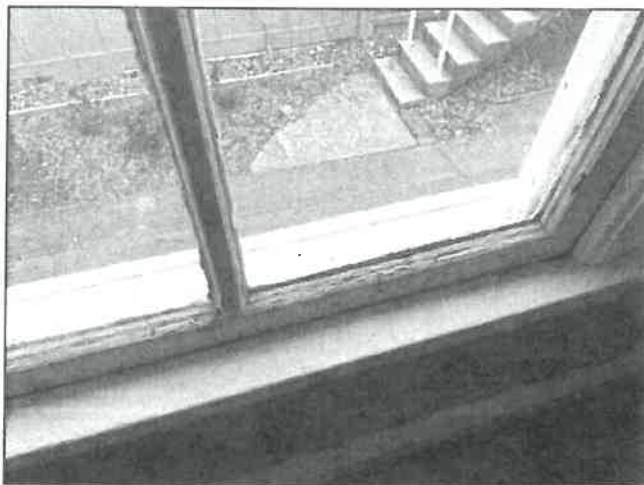
(2) Multiple windows have missing or damaged insect screens.

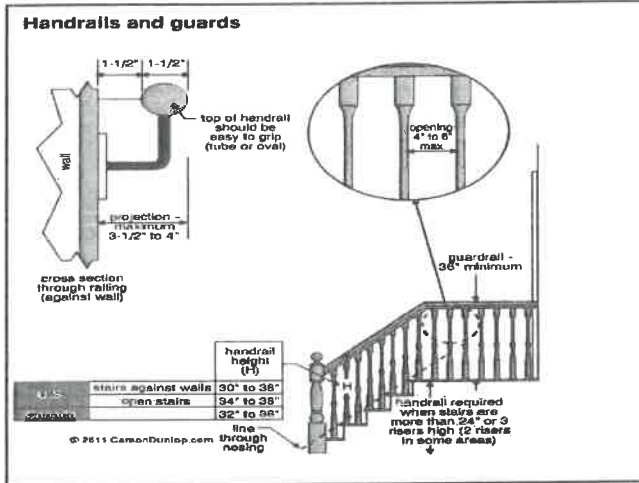
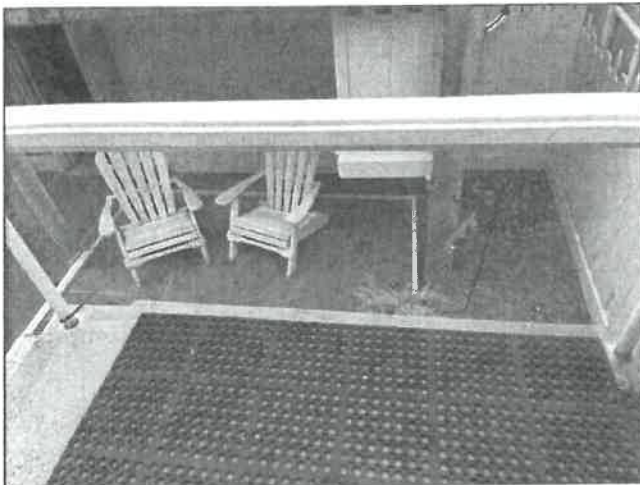
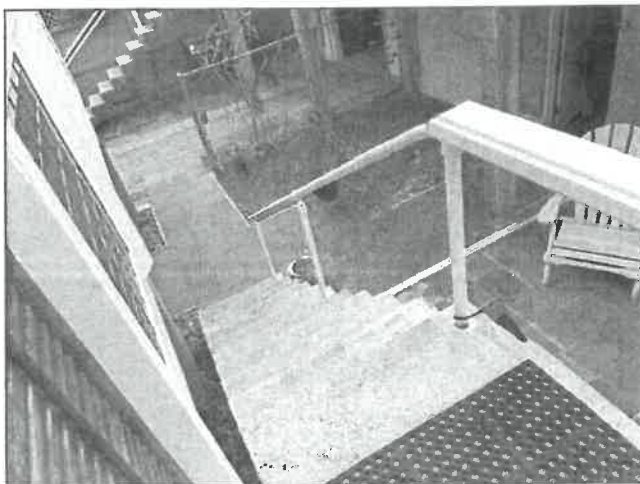
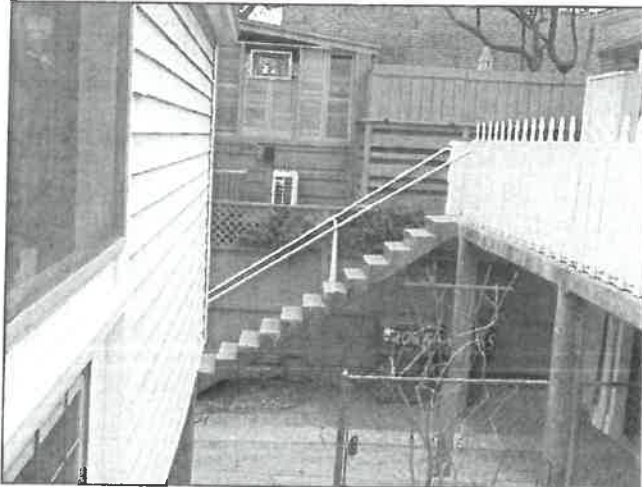
**+** (1) The hand/guard rail for the exterior stairway contains balusters that are spaced more than 4 inches apart. Balusters more than 4 inches apart may allow a small child to become trapped or to fall. This is a safety issue. This is a safety concern. A qualified contractor should be consulted for correction.

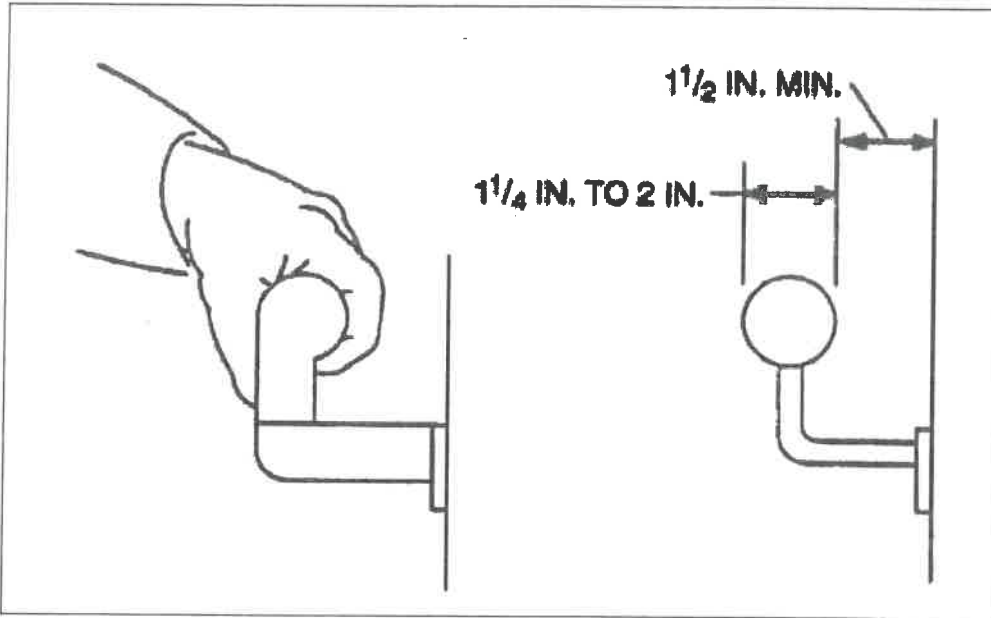
I. Item 7(Picture)

(2) The exterior stairway handrail does not meet the grasp ability requirements. This is a safety issue. A qualified contractor should be consulted for correction

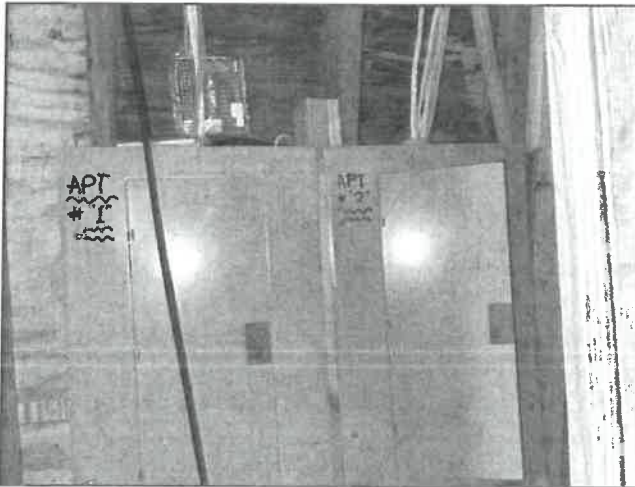
A. Item 3(Picture)

**IN**  
**FO** (3) Electrical system grounding electrode. This is for information only.

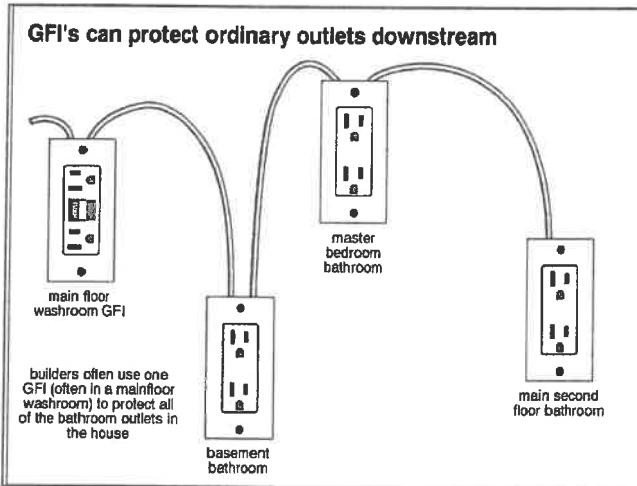
B. Item 8(Picture)

⊕ (3) Four plug receptacle(s) in the primary structure kitchen (plug receptacles serving counter space

only) are not Ground Fault Circuit Interrupter (GFCI) protected. This is a safety concern. The purpose of GFCI is as a safety device designed to protect humans from electrocution hazards at any place where they are likely to be in prolonged direct contact with electrical devices, especially those devices with motors. They also protect from electrocution hazards near open water receptacles such as sinks, tubs and pools. A licensed electrician should be consulted for installation of appropriate GFCI protection in all kitchen, bathroom, garage, pool area and exterior plug receptacle locations.

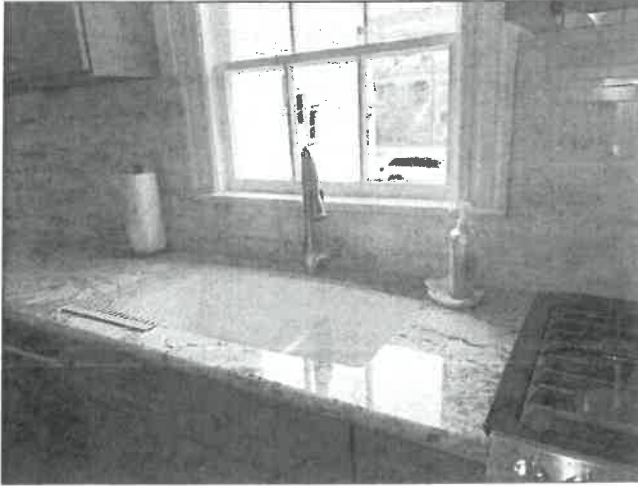
B. Item 13(Picture)

(4) The number of kitchen counter plug receptacle outlets is not adequate in the primary structure. There should be no point on the kitchen counter further than 24 inches from a GFCI protected plug receptacle outlet. A qualified electrician should be consulted for correction.

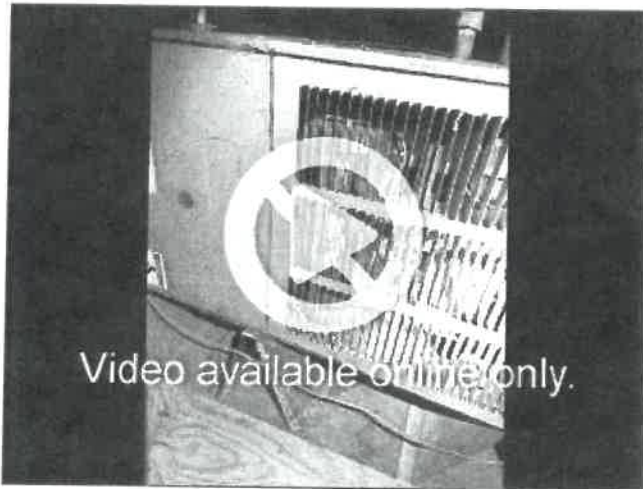
A. Item 1(Video)

**IN**  
**FO** (1) The primary structure and north apartment furnace was operated using normal controls. Heat output was adequate and no deficiencies were noted. This is for information only.

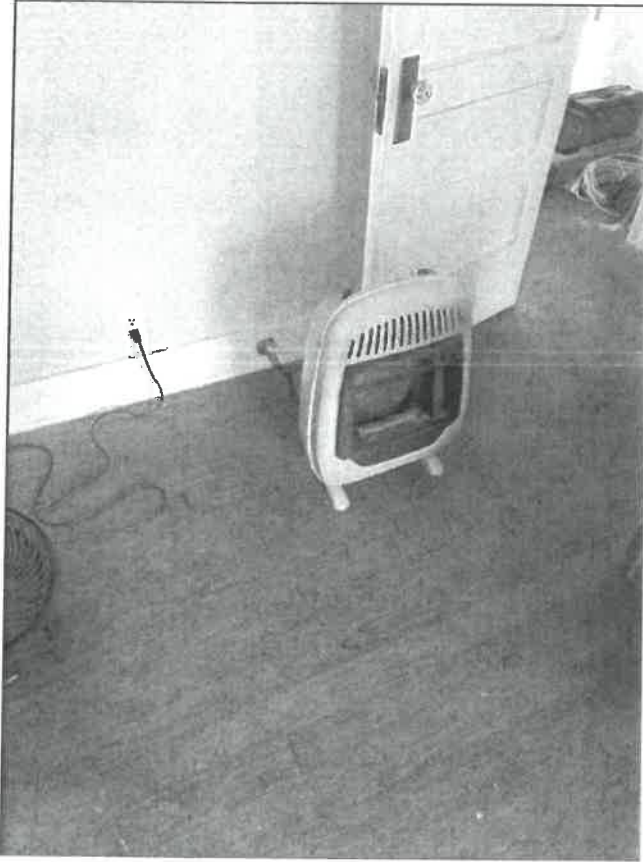
A. Item 2(Picture)

**+** (2) South apartment heating sources were not inspected. These are unventilated natural gas devices not meeting current safety requirements. I recommend removal.

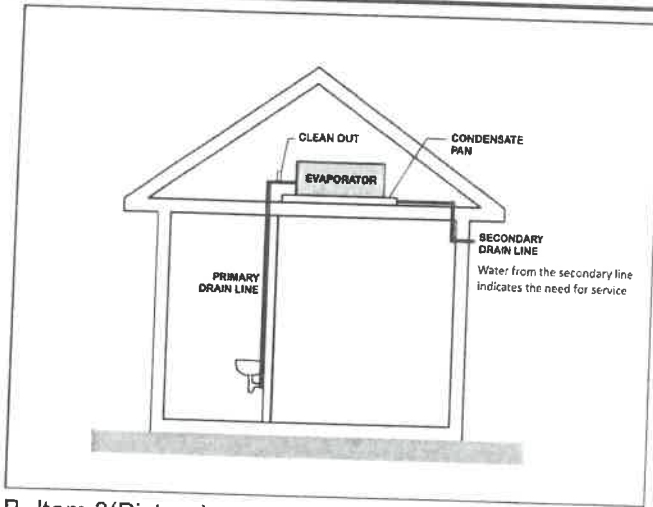
B. Item 3(Picture)

**IN**  
**FO** (5) The pipes in the soffit are the secondary condensate drain for the air conditioning system. Water emitting from these drains indicates a problem with the primary drain system. If water is seen, a qualified contractor should be consulted for correction. This is for information only.

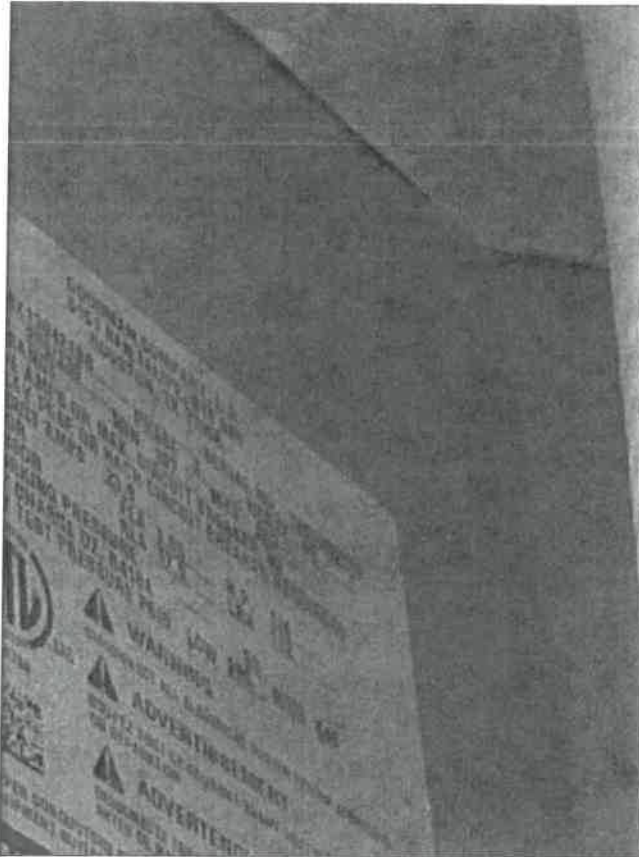
B. Item 7(Picture)

🔍 (7) Air conditioning condenser unit dataplate for information only. This unit was manufactured in 2012. This unit is 9 year(s) old.

Expected service life of condenser units is 10-15 years although some units remain in service for much longer. Regular maintenance may increase service life.

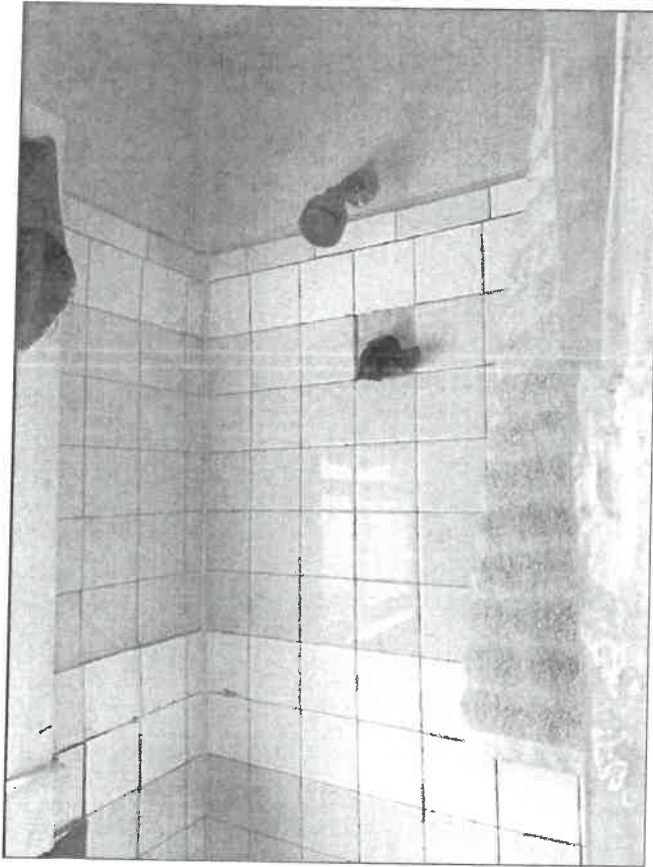
A. Item 3(Picture)

✘ (3) South apartment plumbing fixtures are incomplete.

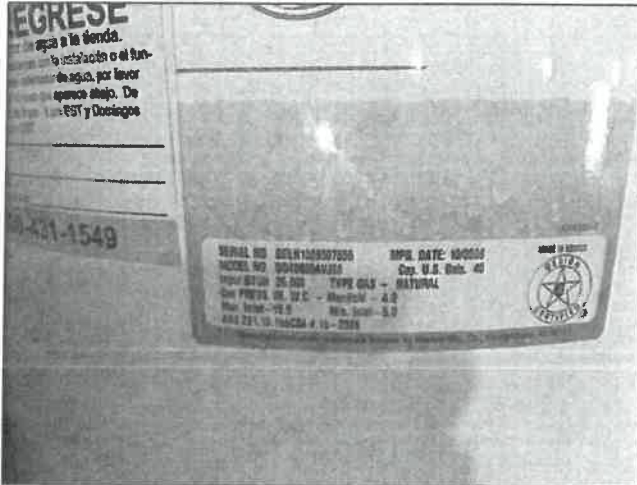
C. Item 3(Picture)

🔍 (4) Water heater dataplate(s). Unit(s) manufactured in 2015.

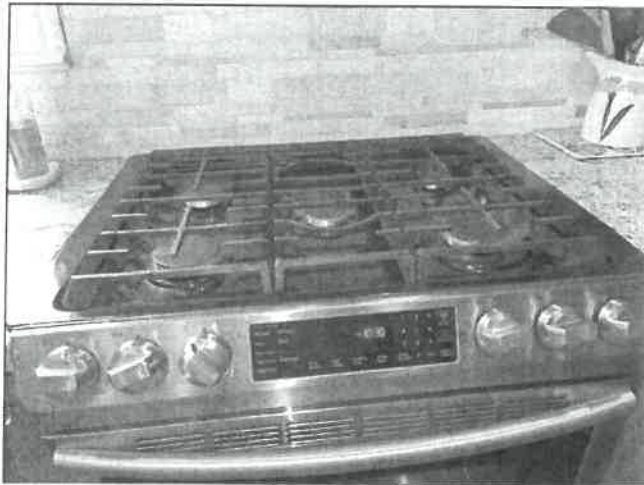
D. Item 1(Picture)

FO (1) The cooktop was visually inspected and operated using normal controls. No deficiencies noted.

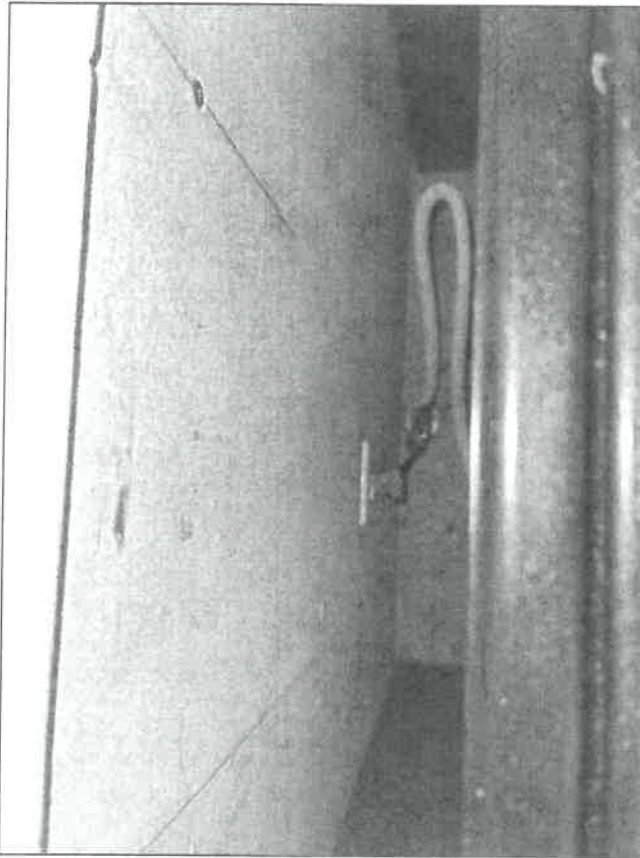
D. Item 3(Picture)

(3) There is no anti-tip device installed on the range oven combination. A qualified contractor should be consulted for correction.
