Property Inspection Report

18511 Purdy Court, Houston, TX 77084
Inspection prepared for: Raed
Date of Inspection: 4/4/2021 Time: 8:30am
Weather: Cloudy
The outside temperature is 57°.

Inspector: Zachary Hernandez
License #24019
Houston, TX
Phone: 832-557-5624
Email: hernzachary@gmail.com

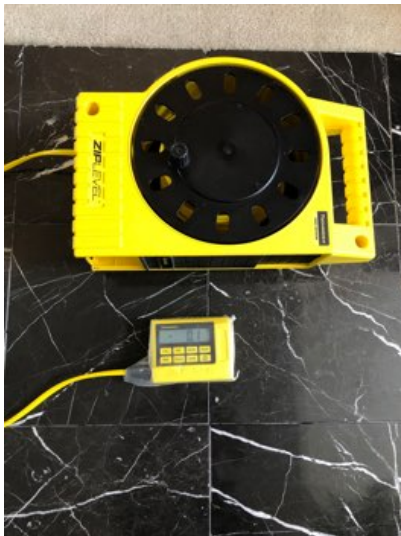
The foundation was inspected with a digital level. No deficiencies were found.

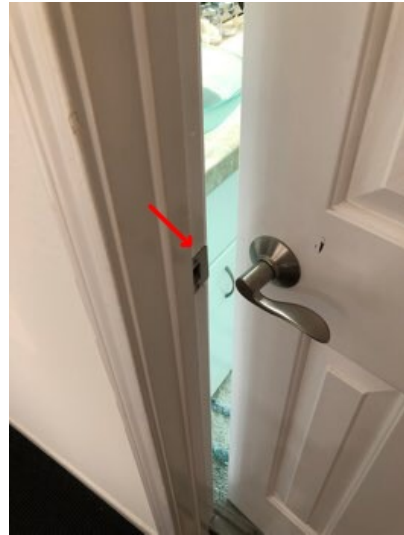
The door does not latch at the kitchen, second-floor bathroom, second-floor front left bedroom closet.

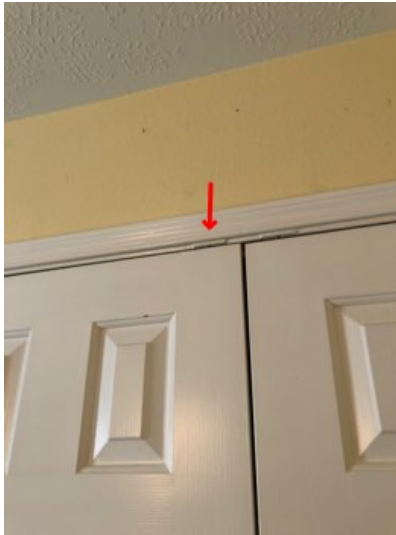
The door does not latch at the kitchen, second-floor bathroom, second-floor front left bedroom closet.

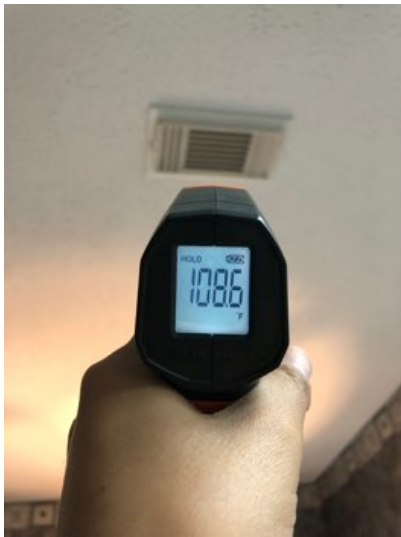
Heater was functioning.

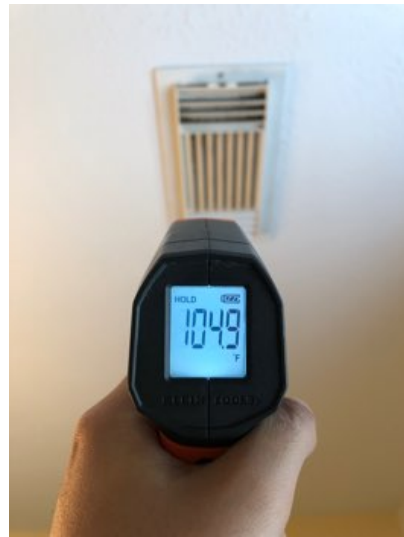
Heater was functioning.

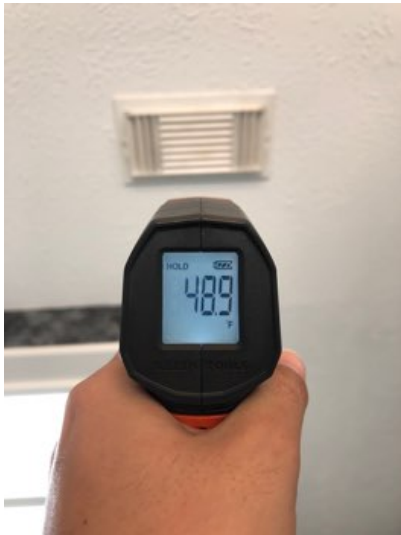
Cooling system was functioning.

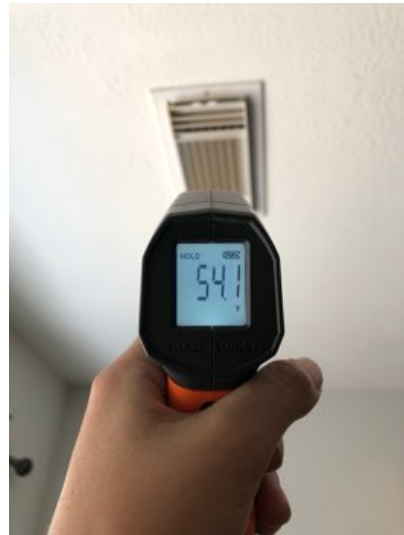
Cooling system was functioning.

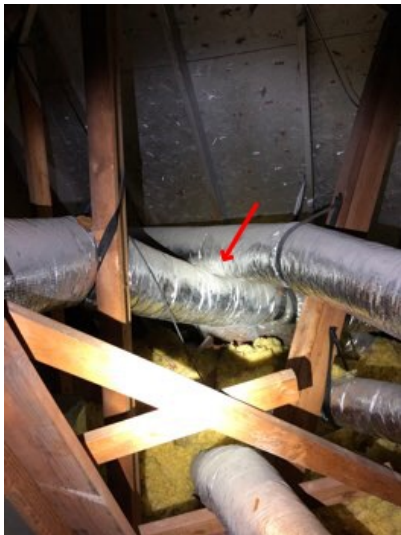
There were ducts in contact with one another.
