RedFish Inspections

Property Inspection Report

10 Bishops Ct, Sugar Land, TX 77479
Inspection prepared for: Lenre Ikpeekha
Real Estate Agent: Jane Lam - RE/MAX Southwest

Date of Inspection: 5/24/2021 Time: 1:00 PM - 5:00 PM
Age of Home: 30 years old Size: 3890 sqft
Weather: Cloudy

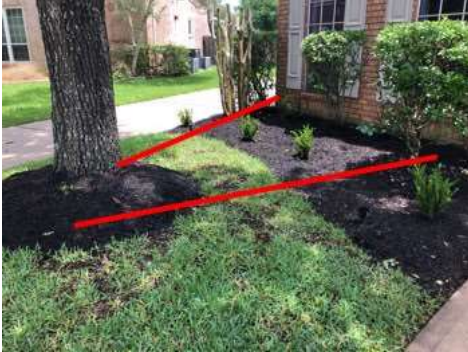
Front: tree roots near foundation

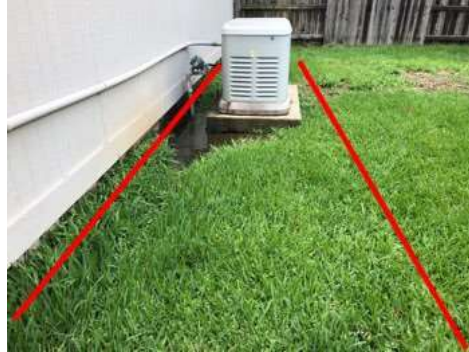
Garage rear: insufficient grading

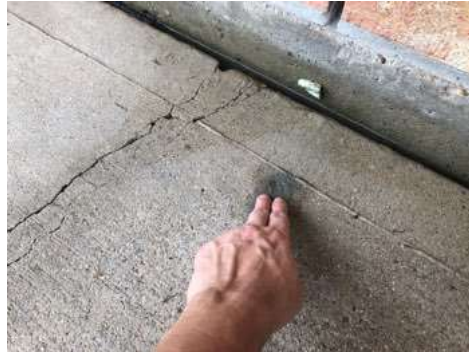
Rear: evidence of prior wood destroying insect treatment

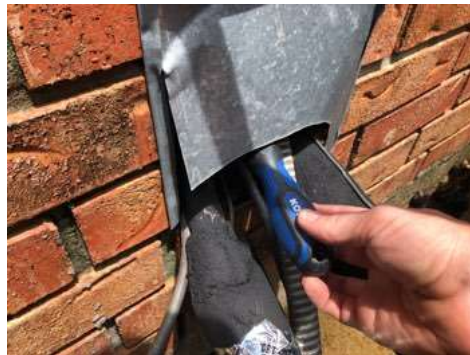
Right: hole in wall at AC lines

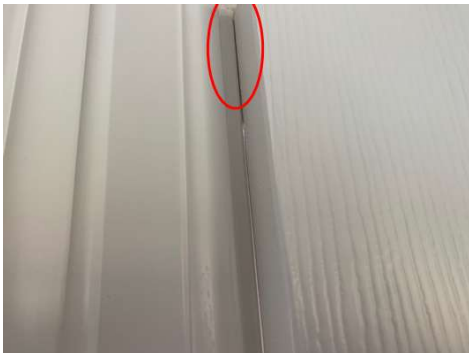
Bedroom 1: rubbed on frame

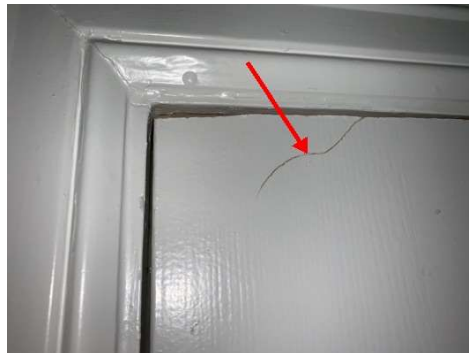
Bathroom 2: Damaged door

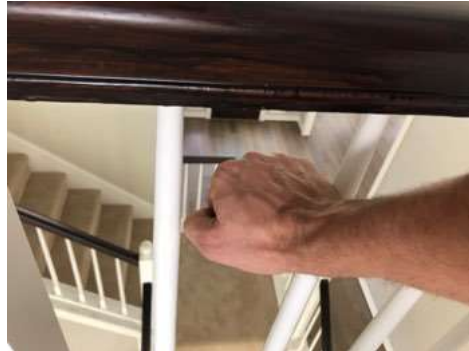
Guardrail: Spindles more than 4" apart

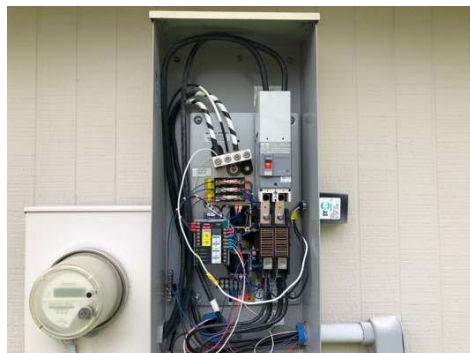
An ungrounded conductor (hot) was improperly identified. We recommend having this permanently re-identified.

Multiple neutral at the neutral bar were under the same terminals. Today's standards require having each neutral conductor to have its own terminal. We recommend having this improved/repared.

Garage rear: service panel with dead front removed

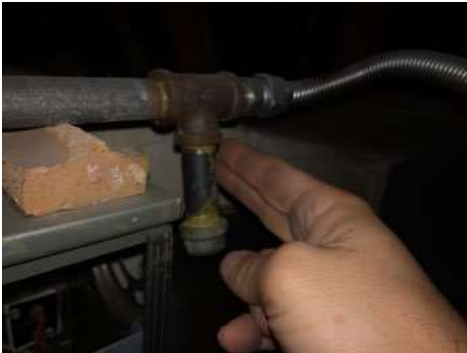
The furnace sediment trap was installed in such a way so as to be mostly ineffective in trapping sediment in the gas piping system. In this case, the sediment is likely to blow past the trap. The trap serves to capture sediment before it enters the appliance and its absence may clog a valve or cause an

equipment malfunction. Traps at all gas appliances are required by today's commonly accepted construction standards; service by a licensed plumbing or mechanical contractor is recommended, but immediate service is not critical.

Improper drip leg installation

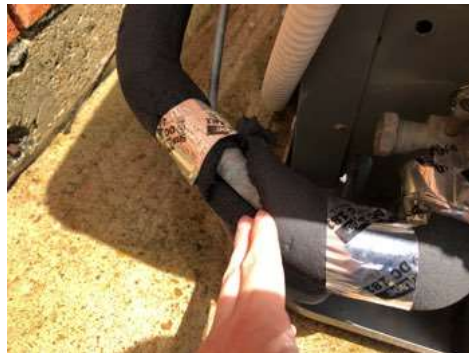
The refrigerant line insulation was old and deteriorated. We recommend having this replaced for added efficiency and to prevent condensation from forming on the cold line and dripping on the attic insulation.

Both units: Old and deteriorated refrigerant line insulation

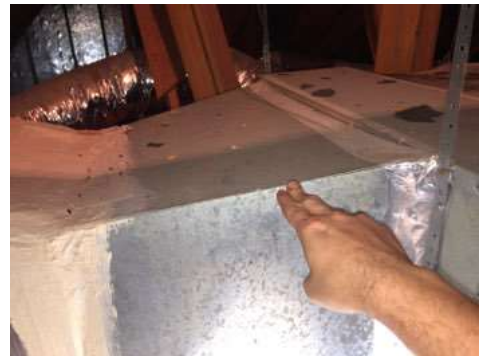
The evaporating coils had been sealed. Cutting the seal goes beyond the scope of the home inspection. We were unable to view the condition of the coils. This was observed at unit 1.

Unit 1: evaporator coils sealed

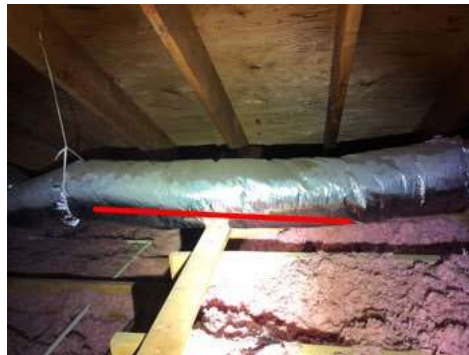
Air ducts were placed on the attic floor. Today's standards do not allow this practice anymore as thermal bridging could create condensation inside the ductwork. We recommend having the strapped and elevated.

Duct on attic floor

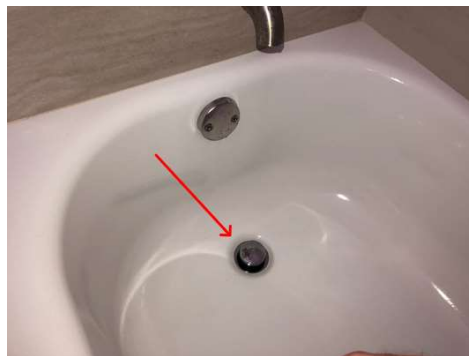
Bathroom 2 : inoperable stopper

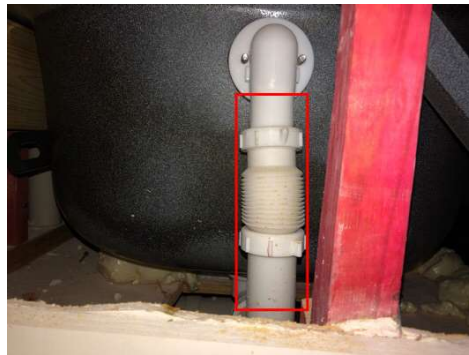
There was an unapproved, flexible, corrugated drainpipe that will contribute to blockages at a bathroom sink(s). We recommend this be replaced with the proper drain material. We observed this in bathroom 2 tub overflow.

Bathroom 2: corrugated piping tub overflow drain

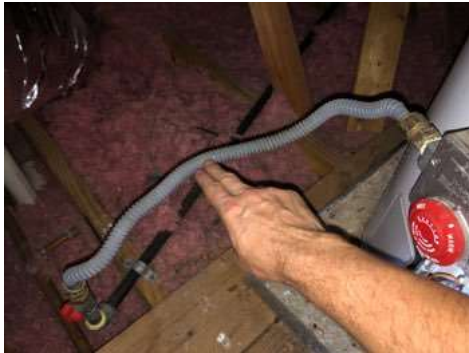
Both units: missing drip leg

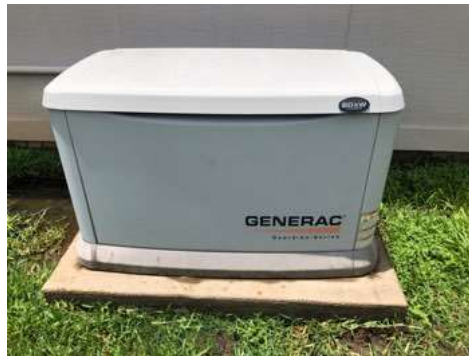
The house was equipped with a emergency whole house generator system. The inspection of such system went beyond the scope of this inspection and our knowledge. We recommend you consult with a certified technician.

Garage rear: whole house generator
