HouseCheck

Property Inspection Report

5331 Dumfries Dr, Houston, TX 77096
Inspection prepared for: Jim Sherry
Real Estate Agent: -

Date of Inspection: 12/4/2019 Time: 2:00 PM
Age of Home: 1960 Size: 2315
Order ID: 1572

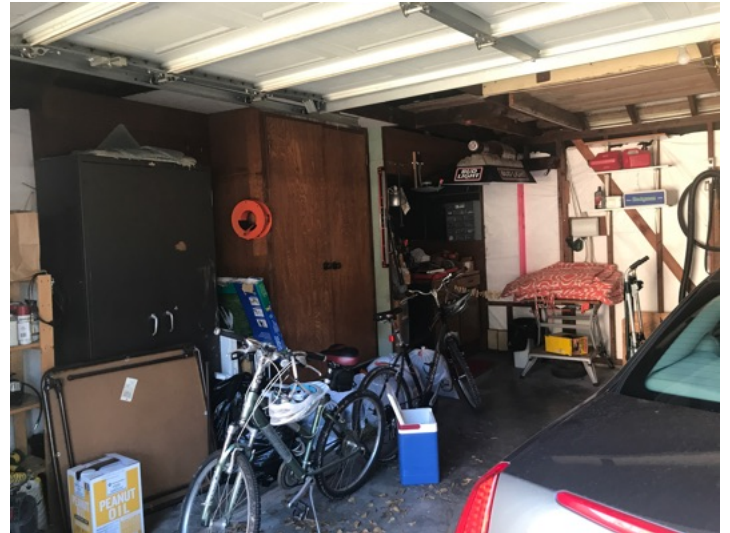
Heavy storage in garage restricted inspection

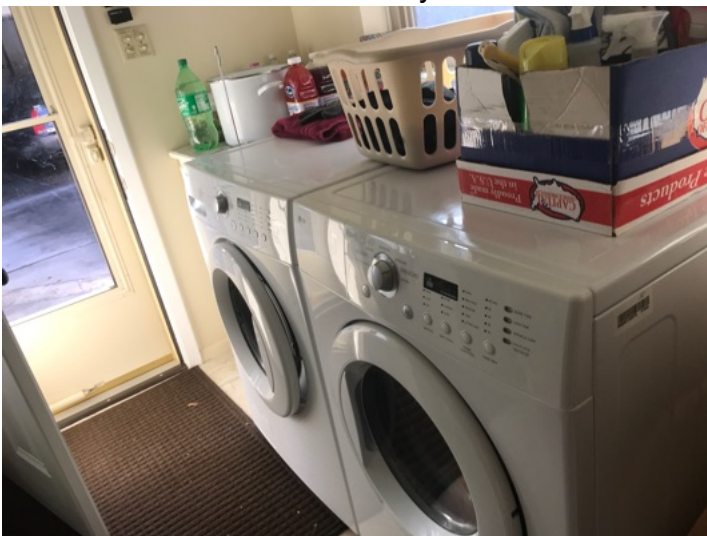
Washer/dryer restricting inspection

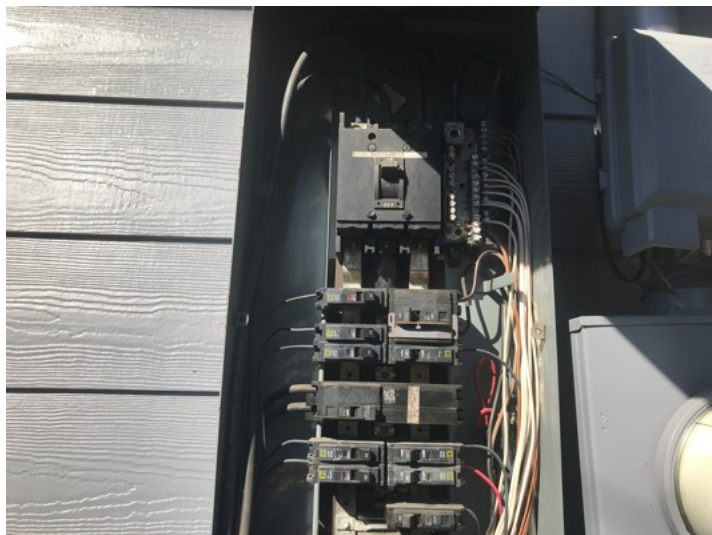
Main service panel at rear of garage

- **Double taps** observed to the neutral bus at the subpanel. This configuration is improper, as it can cause electrical arcing or overheating. Recommend further evaluation by a licensed electrician.
- The breakers at the exterior service panel are not fully/properly labeled.
- All deficiencies noted should be evaluated and repaired by a licensed electrician.

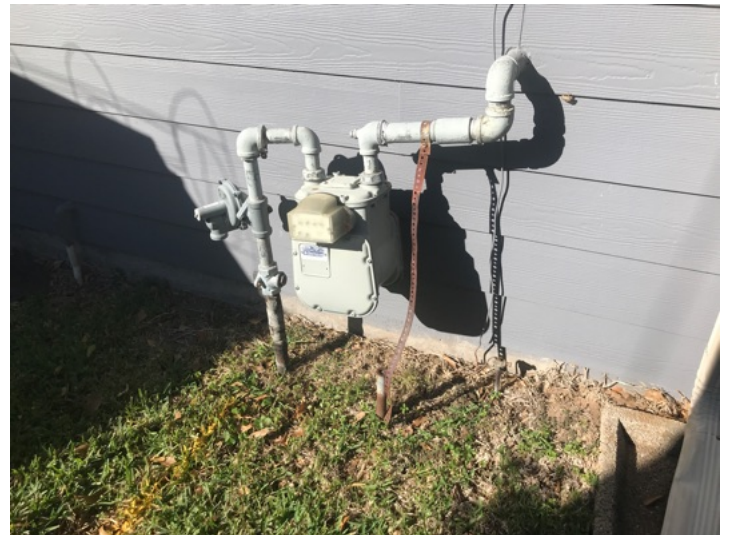
- Static Water Pressure Reading: 64 PSI
- Plumbing Supply Material(s): PEX
- The exterior gas meter does not appear to be bonded. Recommend further evaluation by a licensed electrician.
- Observed faucet at right side of house inoperative.
- Damaged faucet found at left rear corner of garage.
- Hall Bathroom - The toilet short-cycles and does not flush properly. In some cases, this requires holding down of the flush lever for a full flush cycle. Recommend properly repair toilet by a qualified tradesman.
- All deficiencies noted should be evaluated and repaired by a licensed plumber.

Gas meter at rear side of garage

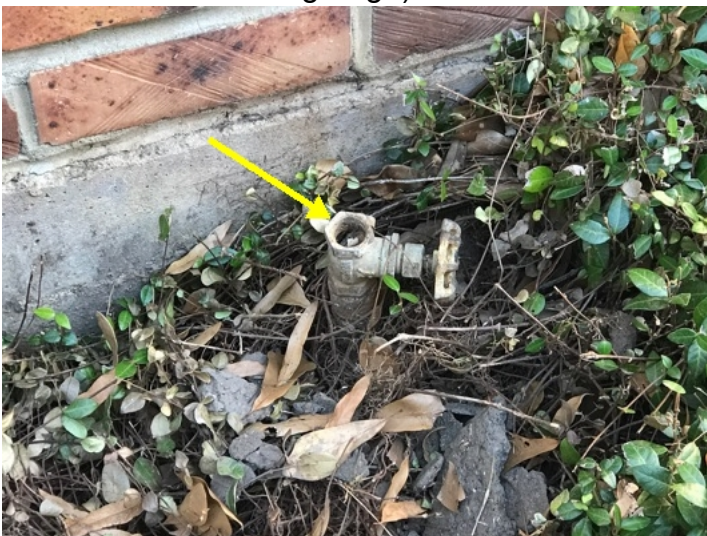
Faucet at right side of house inoperative

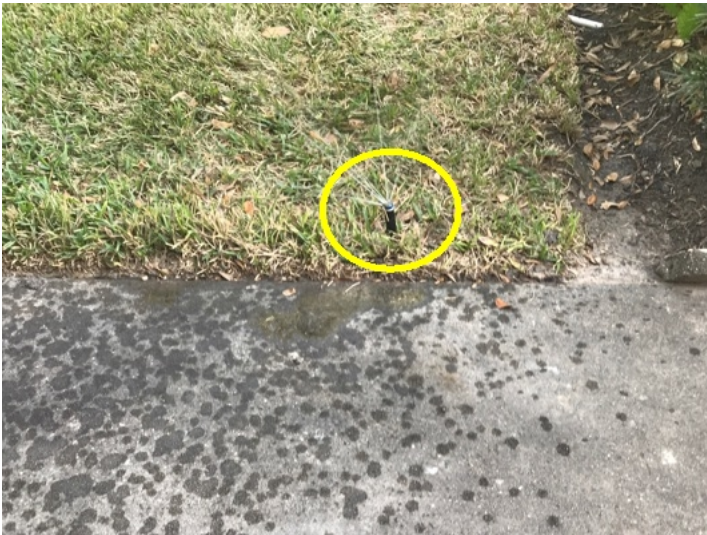
Zoned two

Sprinkler head would not oscillate

- Excessive over-spray present to the following Zones: 2, 4, 5
- Observed sprinkler head on zone #2 would not oscillate.
- All deficiencies noted should be evaluated and repaired by a licensed irrigation professional.
