# HIGHLAND HOME INSPECTIONS

JULY 27, 2020

# PROPERTY INSPECTION REPORT

Concerning: 3114 Fairmont Ct, Sugar Land TX 77478

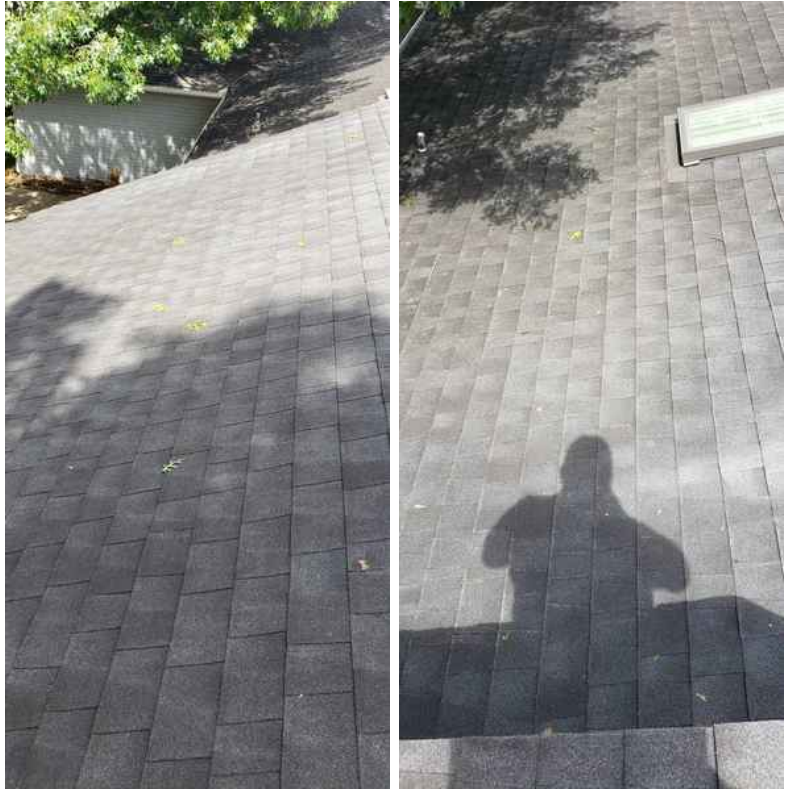
*Previous Repairs:*

Evidence of repairs were visible on the roof, which are typically an indication of previous leakage. I am unable to determine the condition of underlying materials in this area.

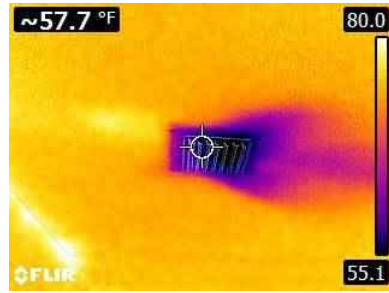
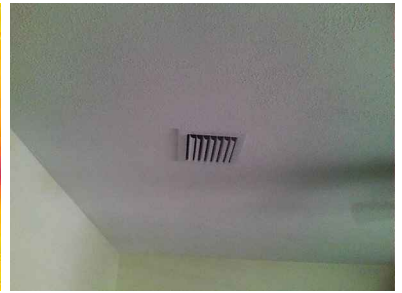
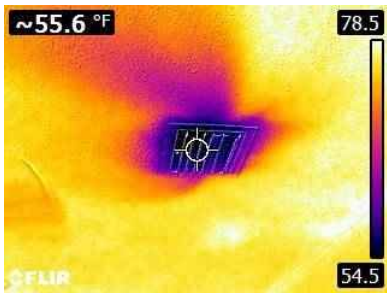
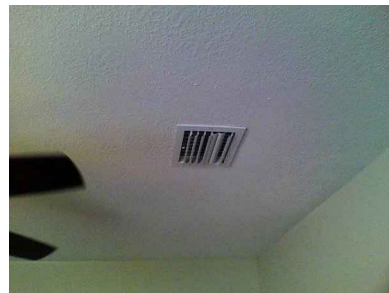
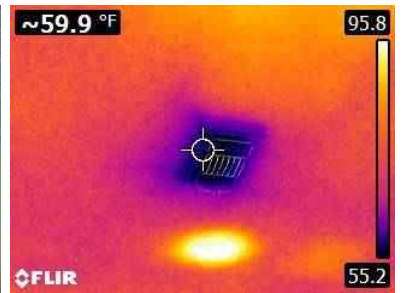
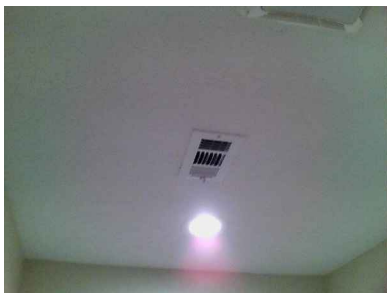
No.	Returns	Reading
1		72.4
2		75.9
3		0
4		0
5		0
Return Average		30
No.	Temp	Readin Drop
1	58	-28
2	56	-26
3	60	-30
4	57	-27
5	60	-31
6	59	-29
7	60	-30
8	64	-34
9	59	-30
10	58	-28
11	59	-30
12	57	-28
13	60	-31
14	55	-25
Average =		-29
Pass/Fail		Fail

Recommendation: Contact a qualified professional.

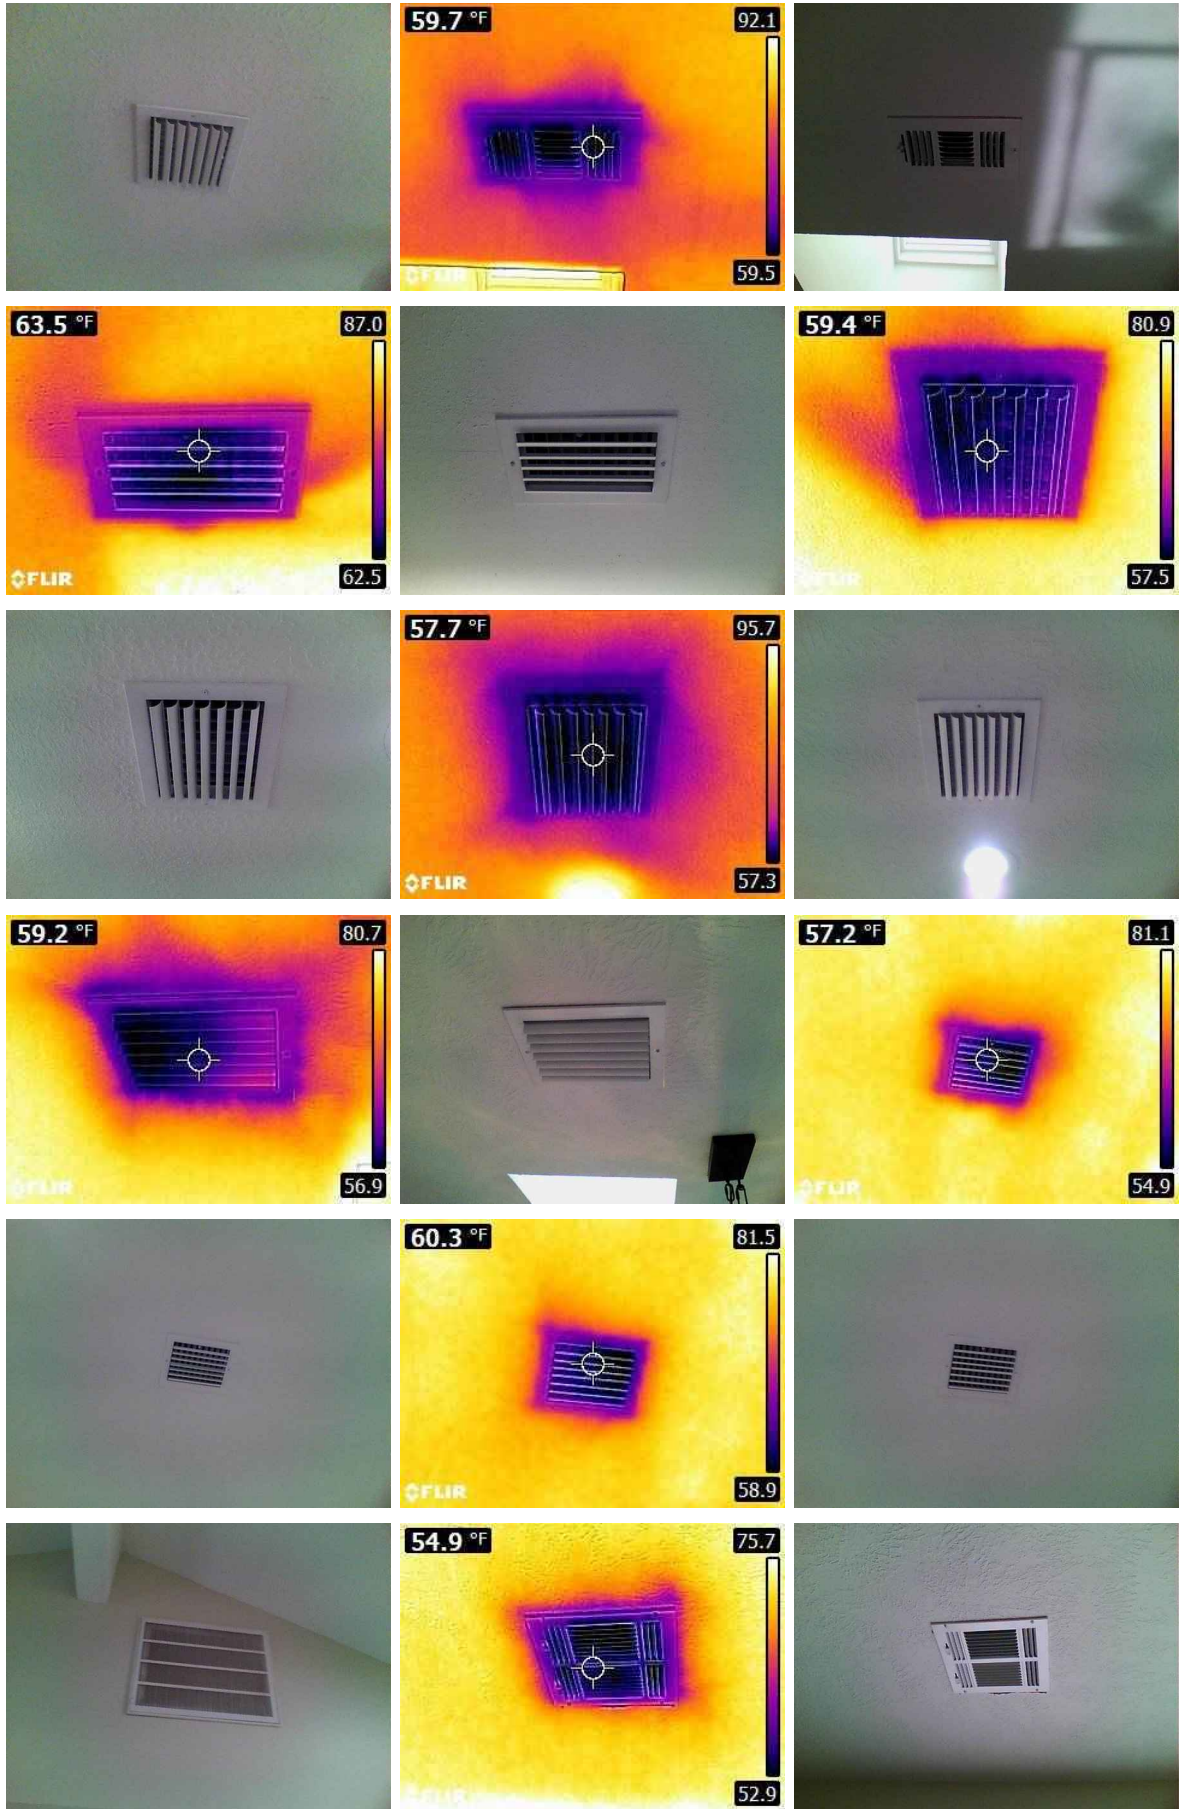
2: Due to the physical condition of the HVAC system you are recommended to have it evaluated

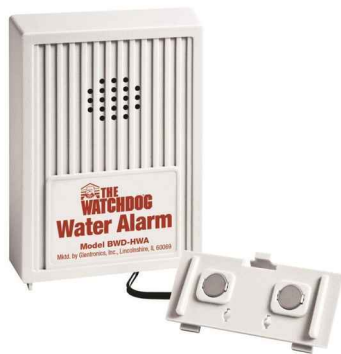
*Annual Maintenance Flush Needed:*

Water heaters should be flushed annually to prevent sediment buildup and maintain efficiency. Recommend a qualified plumber service and flush. [Here is a link.](#)

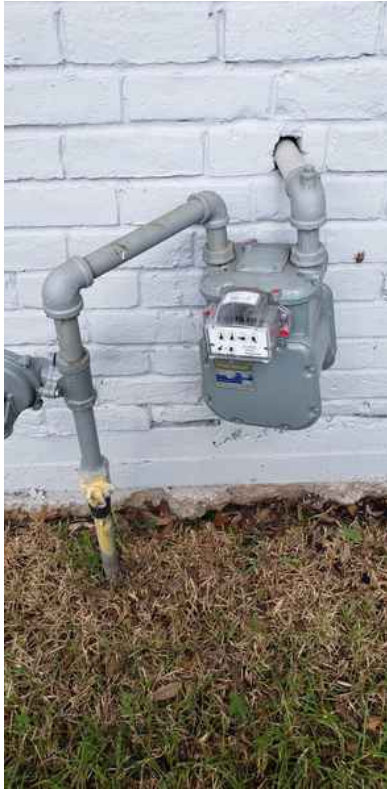
*Gas meter did not appear to be bonded correctly:*
