# Home Inspection Report

4414 West 43rd Street  
Houston, Texas 77092

# Semora Inspections LLC

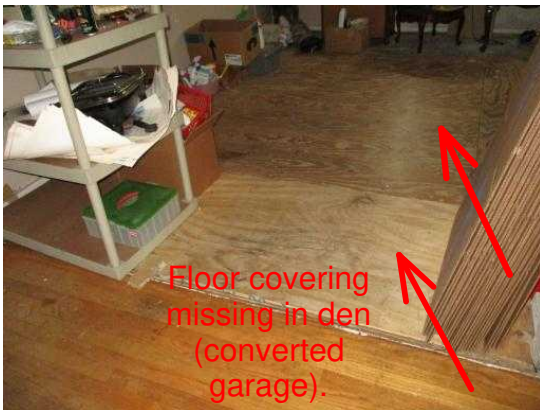
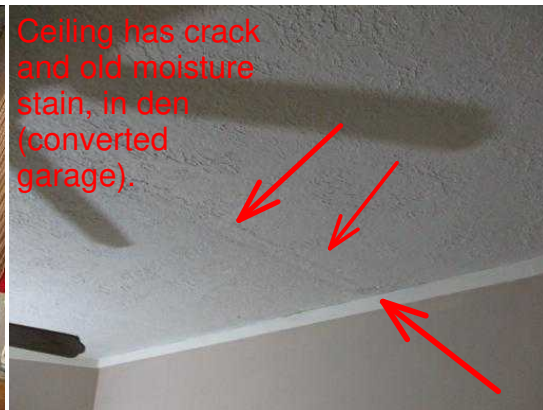
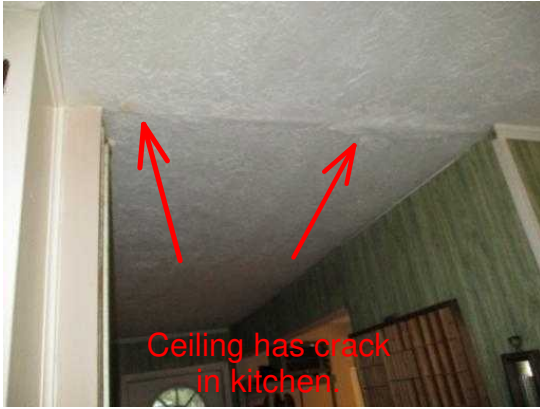
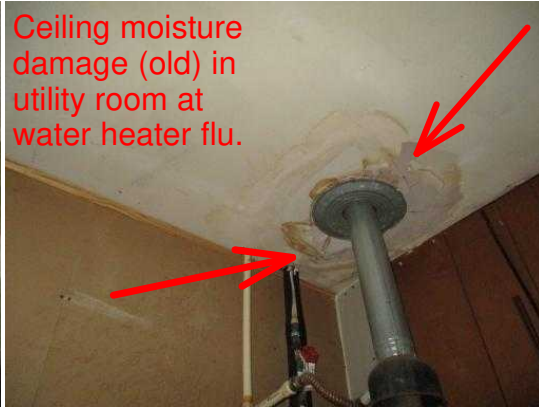
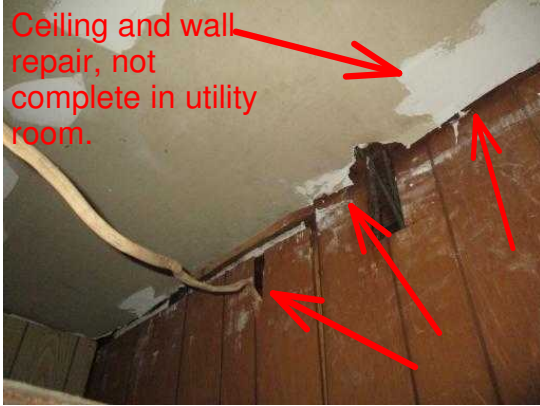
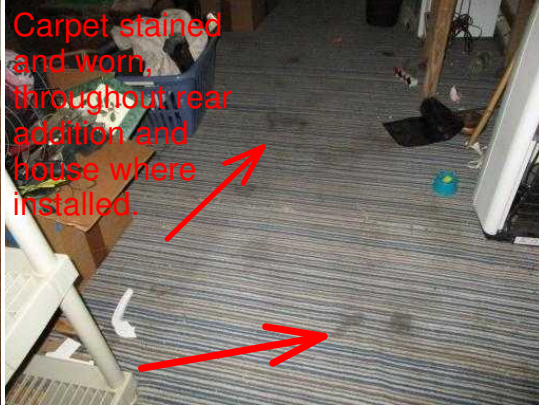
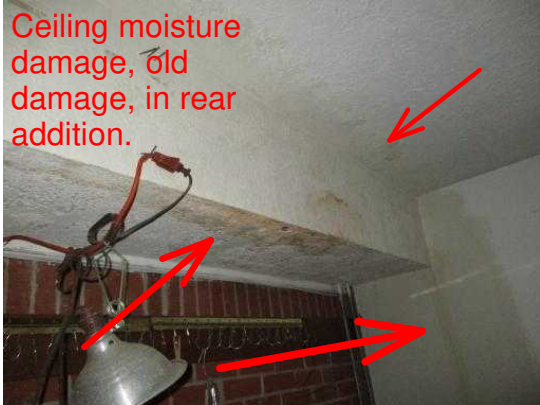
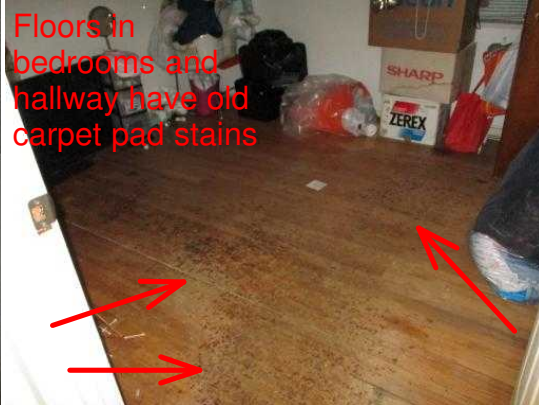
- Floor covering missing in den (converted garage).
- Ceiling has crack and old moisture stain, in den (converted garage).
- Ceiling has crack in kitchen.
- Ceiling moisture damage (old) in utility room at water heater flu.
- Ceiling and wall repair, not complete in utility room.
- Carpet stained and worn, throughout rear addition and house where installed.
- Ceiling moisture damage, old damage, in rear addition.
- Floors in bedrooms and hallway have old carpet pad stains.

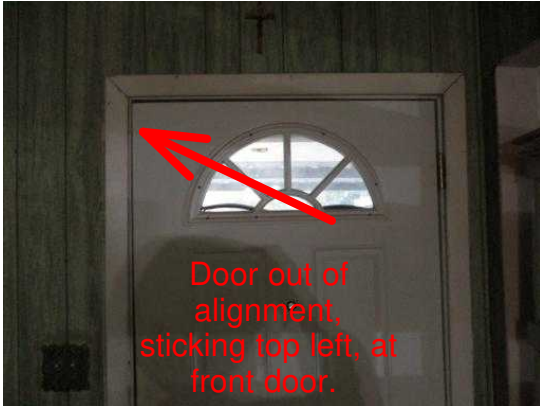
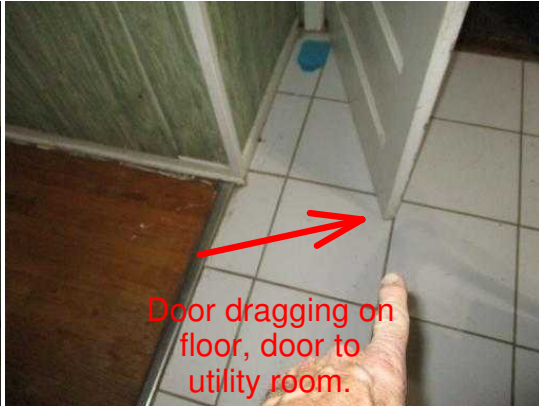
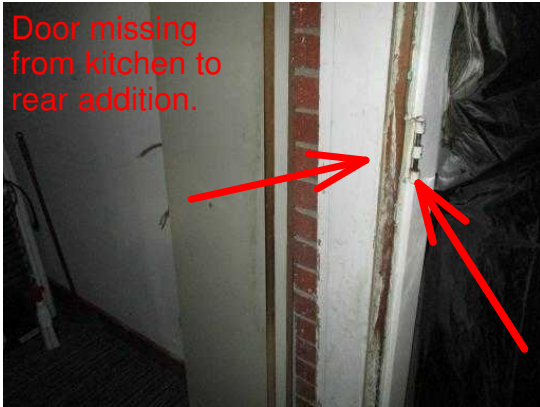
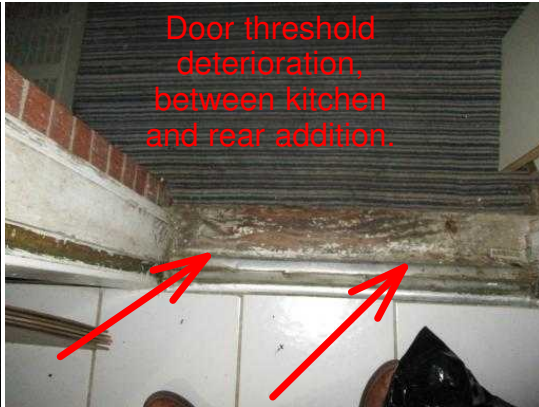
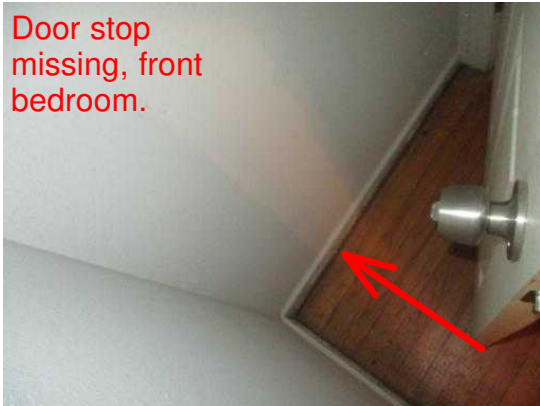
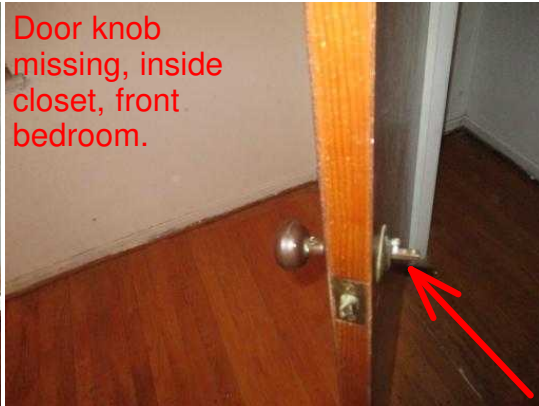
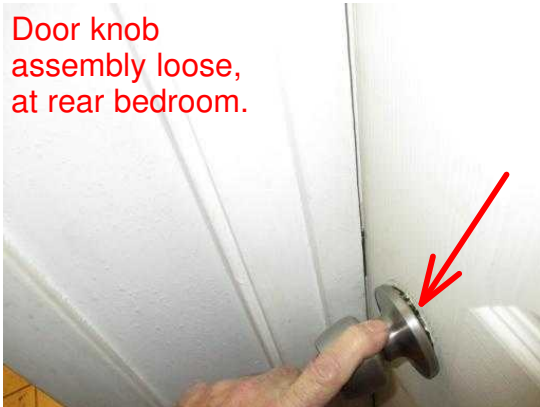
- Door out of alignment, sticking top left, at front door.
- Door dragging on floor, door to utility room.
- Door missing from kitchen to rear addition.
- Door threshold deterioration, between kitchen and rear addition.
- Door stop missing, front bedroom.
- Door knob missing, inside closet, front bedroom.
- Door knob assembly loose, at rear bedroom.

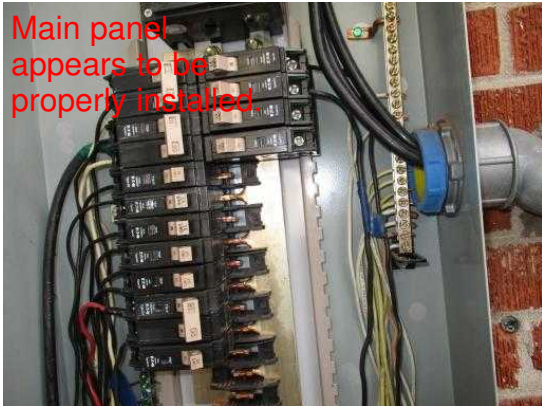
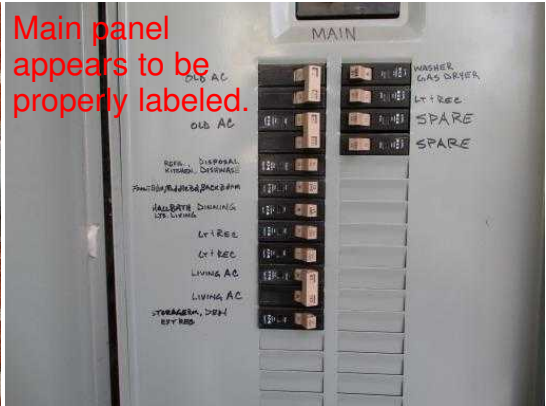
- The main electrical panel is an Eaton panel with overhead copper service wires to a 125 AMP service.
- Main panel appears to be properly installed.
- Main panel appears to be properly labeled.

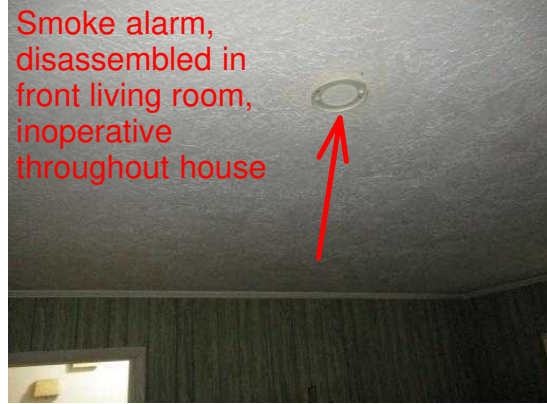
Smoke alarm, disassembled in front living room, inoperative throughout house

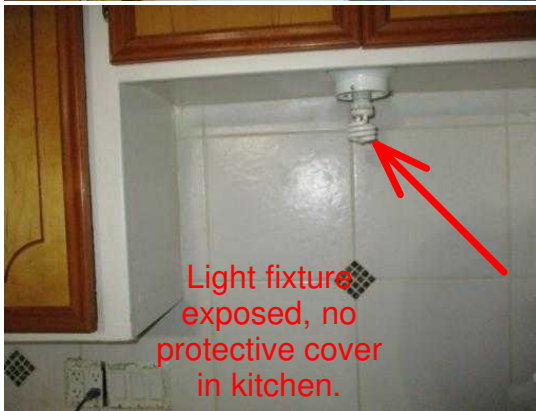
Light fixture exposed, no protective cover in kitchen.

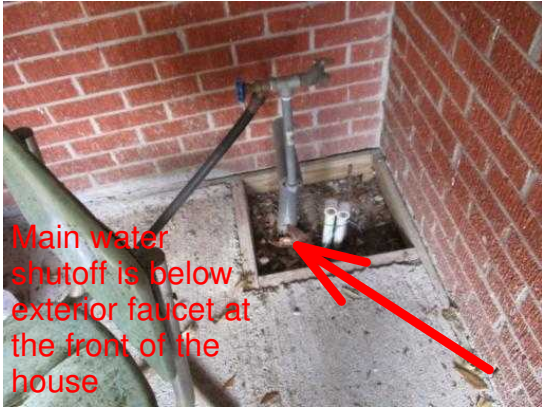
Main water shutoff is below exterior faucet at the front of the house

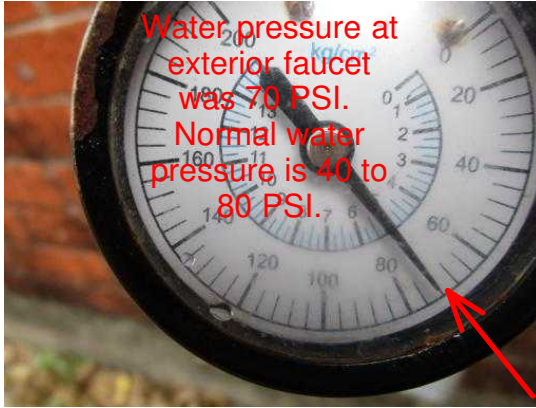
Water pressure at exterior faucet was 70 PSI. Normal water pressure is 40 to 80 PSI.

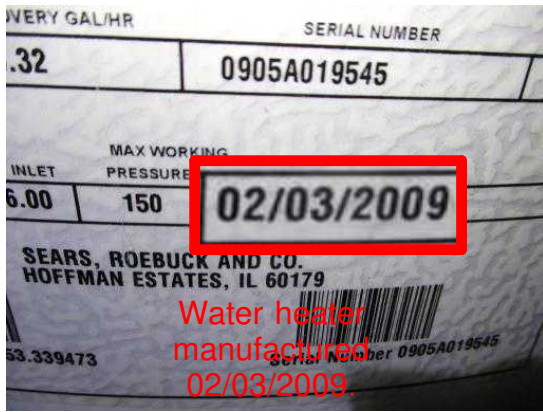
Water heater manufactured 02/03/2009.

TPR Valve (Temperature Pressure Relief) should be plumbed downward slope only, with unthreaded end on pipe

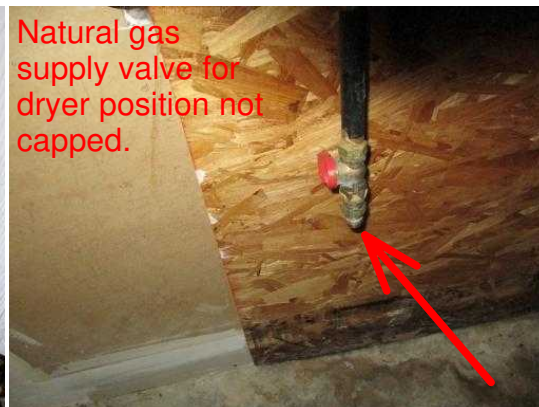
Natural gas supply valve for dryer position not capped.
