PROPERTY INSPECTION REPORT

Concerning: 10815 Lake Raven Ct. Cypress, TX. 77433

Inspected By: Rod Scarborough TREC License # 7189 May 28, 2021

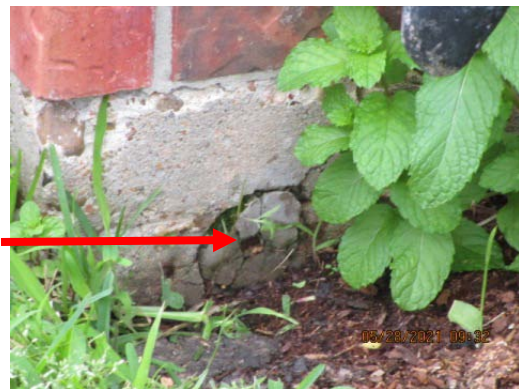
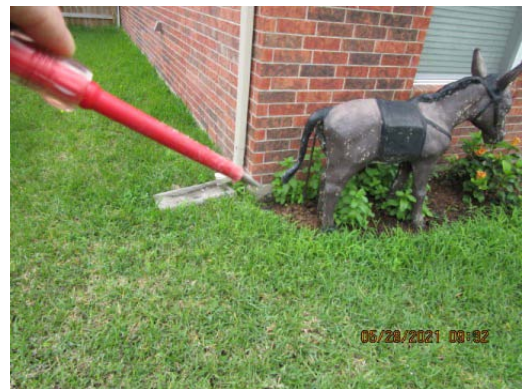
Exposed rebar/tendon port was observed but may not be limited to the back side of the structure. Recommend sealing.

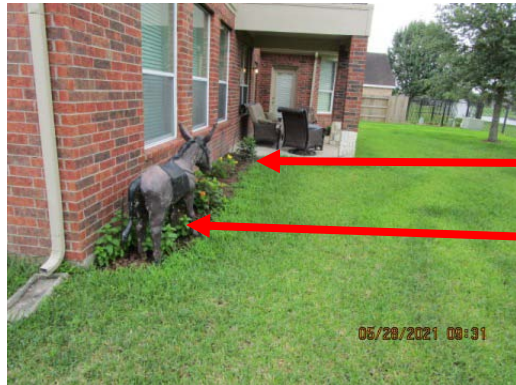
Grading and drainage around the structure does not appear to be functioning as intended in all areas. Flat/improperly sloped areas were observed on the back & front sides of the structure. These conditions may be conducive to ponding which may have an adverse effect on the foundation/structure. It is recommended that the drainage improvements be made in these areas or that sub-surface drainage be installed to allow the water to flow freely away from the structure & to the street as required. After the drainage improvements have been made it is recommended that the drainage around the structure should be monitored during/after heavy rains & if ponding water is observed then additional drainage improvements should be performed.

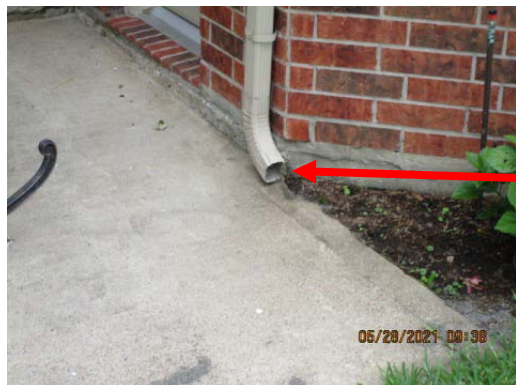
Some of the gutter down spouts do not divert water away from the foundation properly, down spouts should divert water away approximately 5' from foundation. Recommend adding splash blocks or diverters.

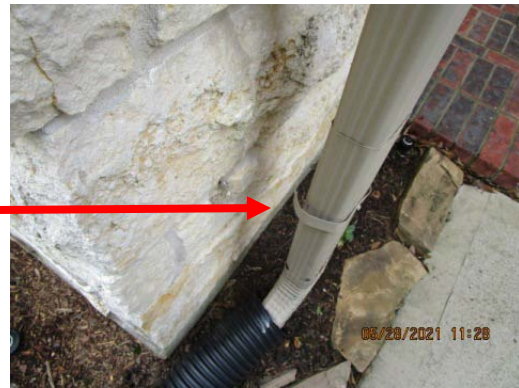
The gutter /down spout on the front side of the structure at the front porch area is not properly secured to the wall. Recommend securing.

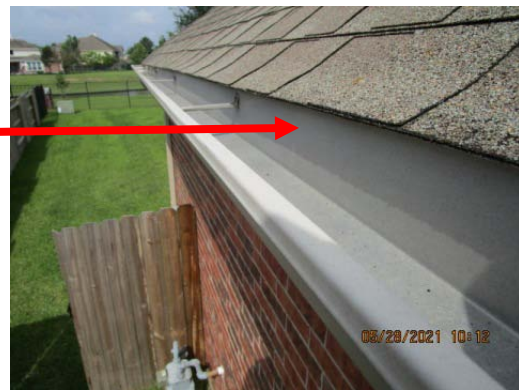
The gutters are not properly installed behind the drip edge as recommended to prevent leaking between the gutter & fascia board.

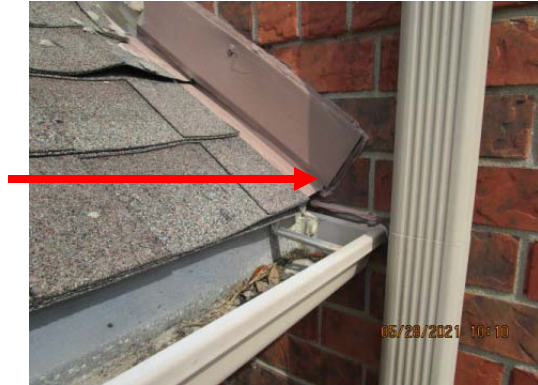
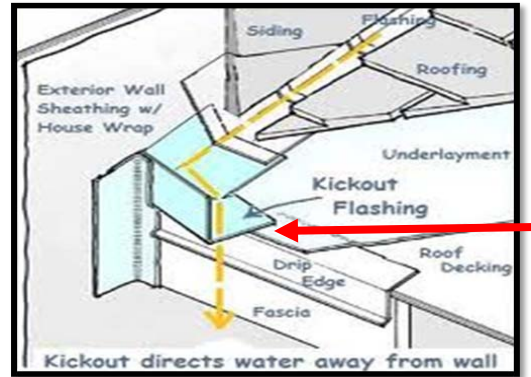
Kick out flashing is not installed at the roof/wall line in the recommended areas. Due to the volume of water that can pour down a sloped roof one of the most critical flashing details

occurs where a roof intersects a sidewall.

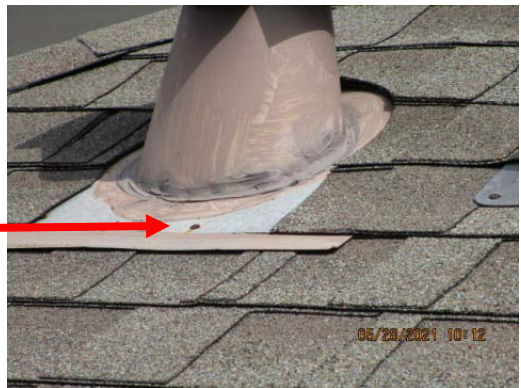
☒ Exposed nail heads were observed in some areas. Recommend sealing exposed nail heads.

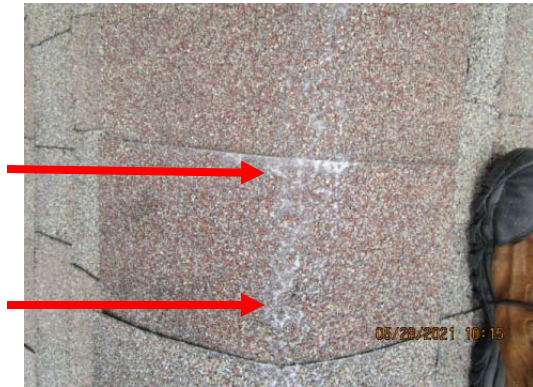
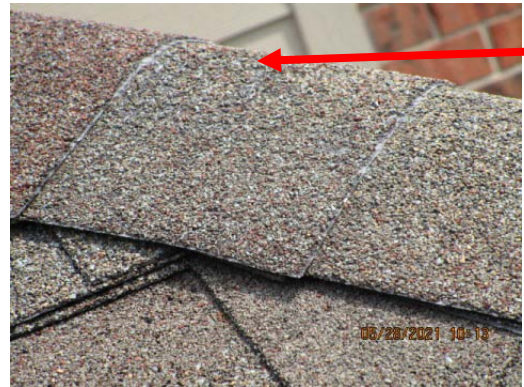
☒ Shingle granule loss exposing asphalt was observed in some areas.

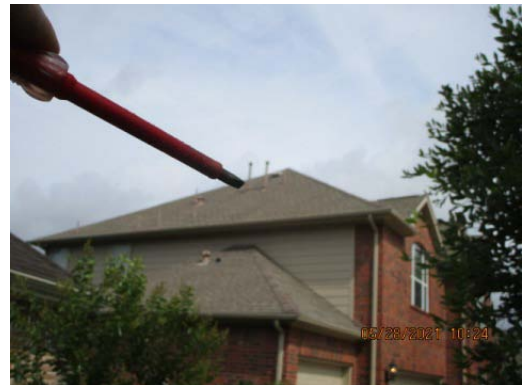
Roof shows evidence of sagging/deflection on the left side of roof by the water heater flue vent pipes. This may be due to improper structural support in the attic space.

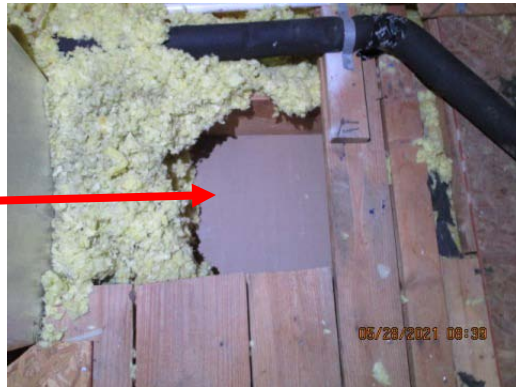
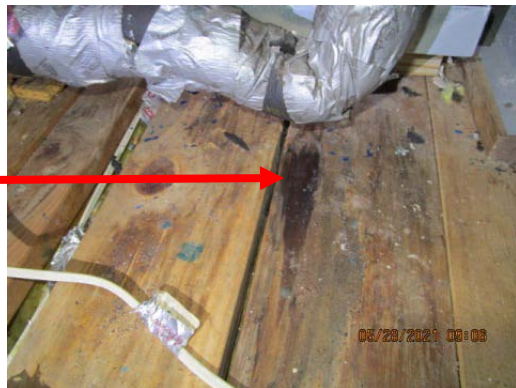
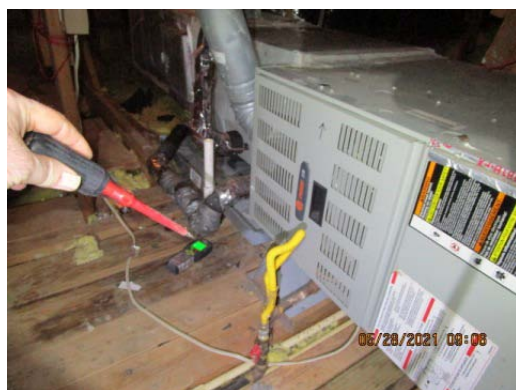
Existing moisture penetration staining was observed in the attic decking below the coil drain lines. A moisture reading was performed & moisture was detected at the time of the inspection. This is caused by condensation dripping from the primary drip pan drain lines.

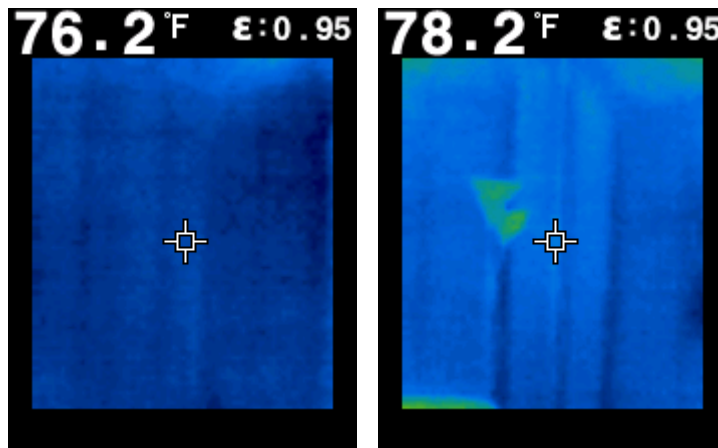
Existing/previous moisture penetration was observed but may not be limited to the base of the wall at the double doors in the game room on the interior of the structure. A moisture reading was performed & moisture was detected at the time of the inspection. Recommend to determine if any hidden structure damage has occurred.

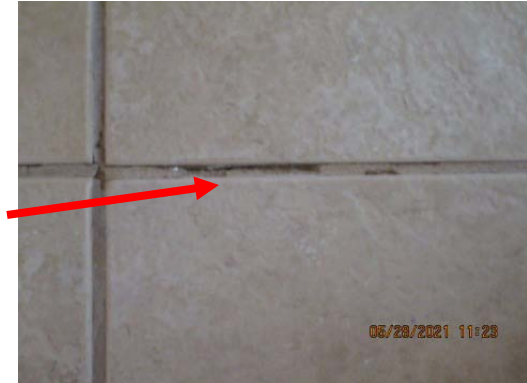
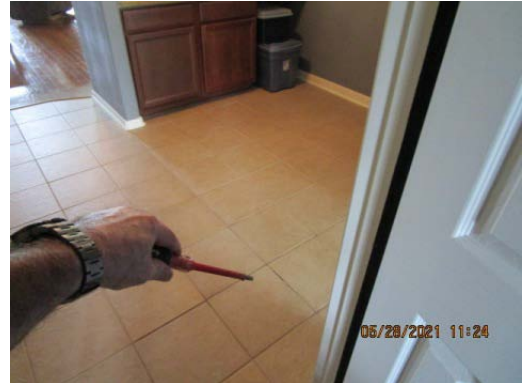
Floor grout is missing from the flooring in the wet bar area. Recommend repairing.

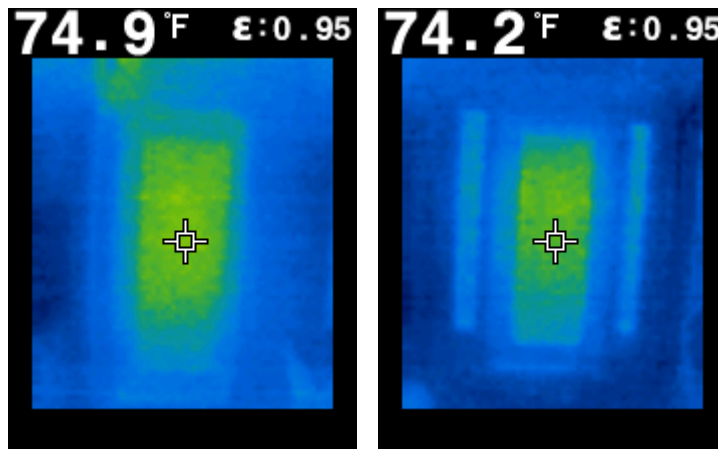
The door leading from the interior to the garage does not have self closing hinges installed to close the door when the door is released. Although not required in some areas it is recommended that self closing hinges be installed to help prevent unwanted fumes from entering the structure.

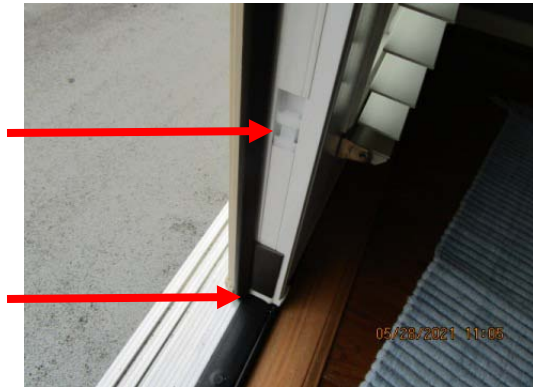
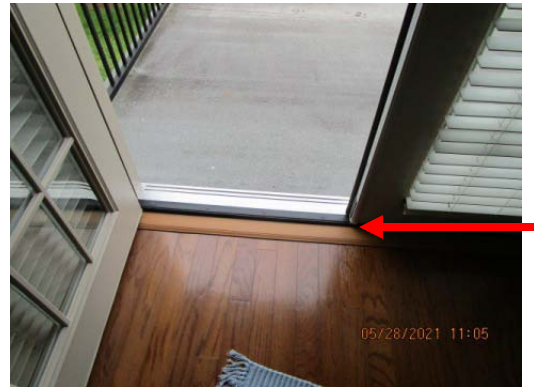
The double door leading from the game room to the balcony is missing the top mortised bolt strike.

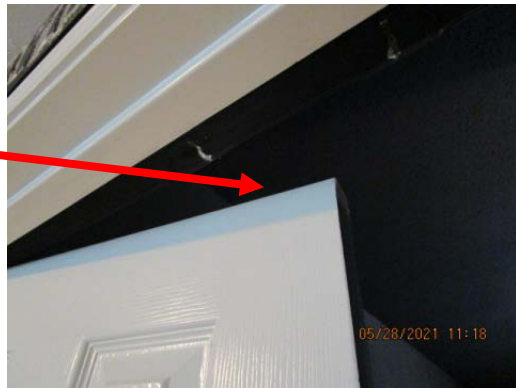
The doors leading into the media room & the master bathroom are extremely difficult to close under normal condition due to the top spring latches. Recommend adjusting/replacing.

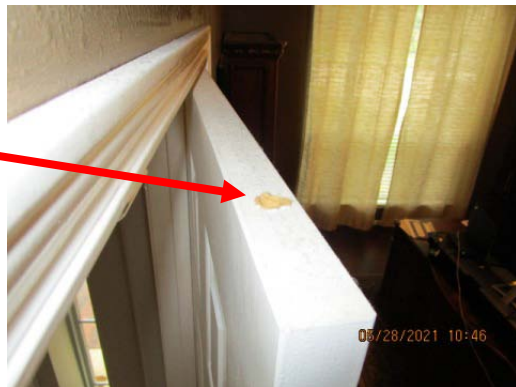
The doors leading into the cannot be latched due to the top spring latch is missing. Recommend replacing.

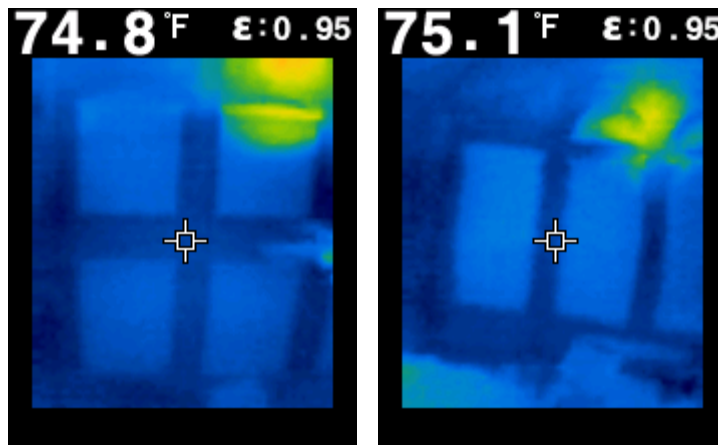
Unable to determine the presence of safety/tempered glass at the window to the right of the front door due to not being able to located the tempered/safety glass etching. Safety/tempered glass is required by today's standards.

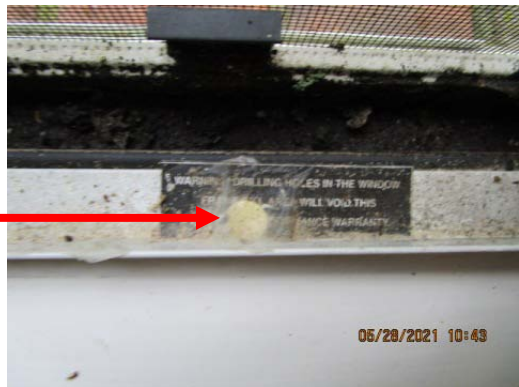
Holes were drilled & alarm sensors have been installed into some of the window frame sills. Buyer should ensure that all holes remain properly sealed to prevent possible moisture penetration into the wall cavity.

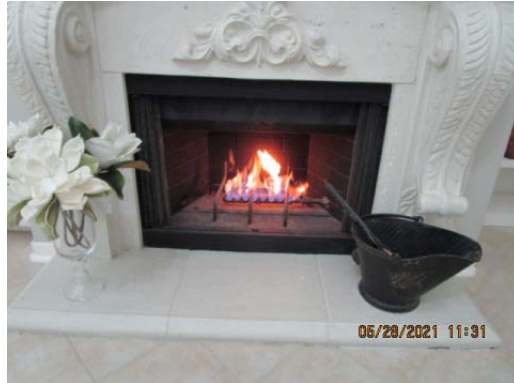
Damper does not have a damper block/stop installed. In the event that gas logs are installed in the fireplace at a future date the damper should have a damper block installed to prevent the damper from being closed.

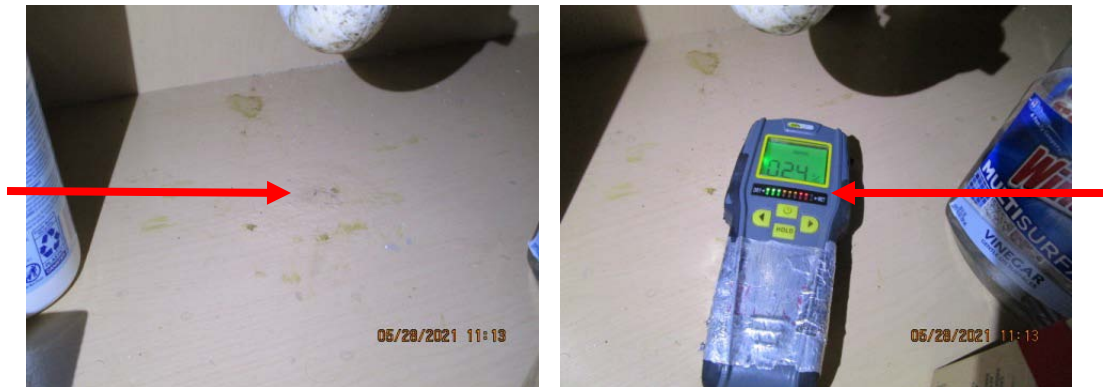
Signs of moisture penetration was observed under the jack & jill bathroom sinks. A moisture reading was performed & moisture was detected at the time of the inspection. The moisture appears to be the result of the p-traps condensating from the cold condensation from the AC coils in the attic.

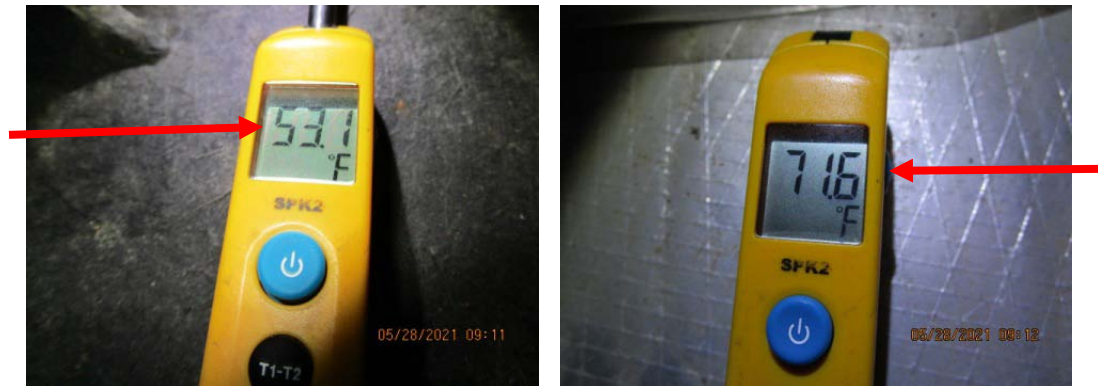
Downstairs supply air temp: 53.1 Degrees (as measured at the discharge side of the coil in the attic) Return air temp: 71.6 degrees (as measured at the return side in the attic)

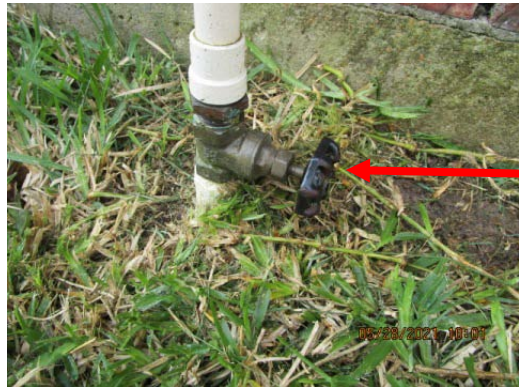
The main water supply valve on the right side of the structure could not be closed under normal conditions. Recommend repair/replacing.

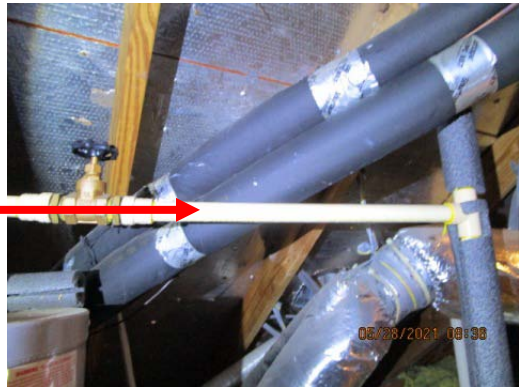
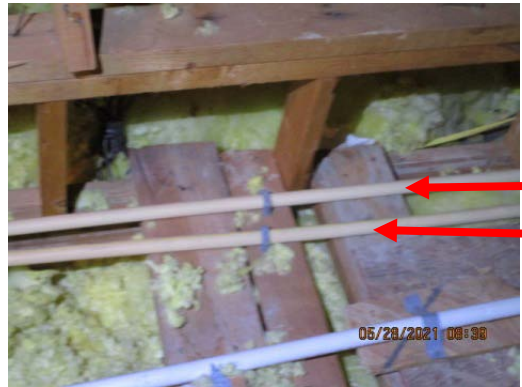
The water supply lines are not properly insulated in all areas of the attic space. Recommend adding insulation.

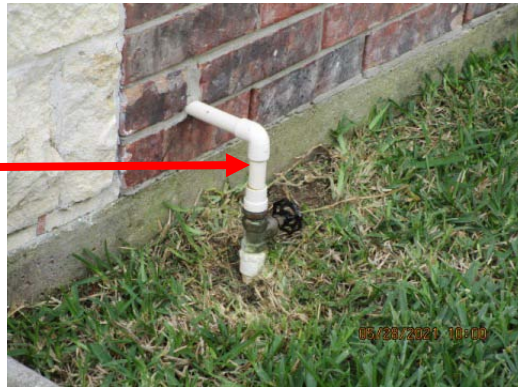
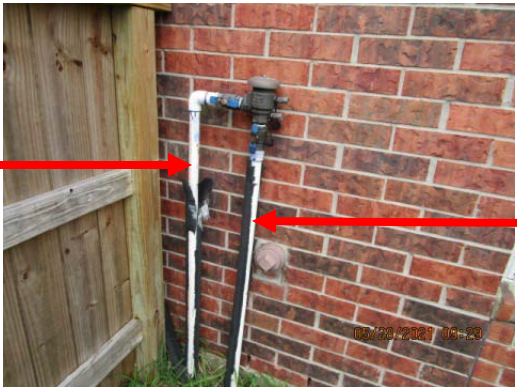
The main water supply line & the sprinkler system supply line on the right side of the structure has missing/damaged insulation. Recommend insulating.

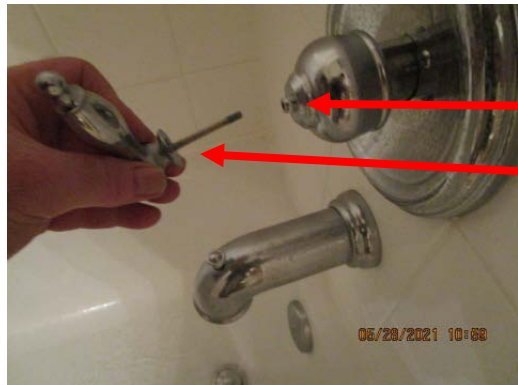
- The water supply valve handle at the bathtub in the upstairs ensuite bathroom is not properly secured & came off when attempting to open/closed the valve. Recommend repair.

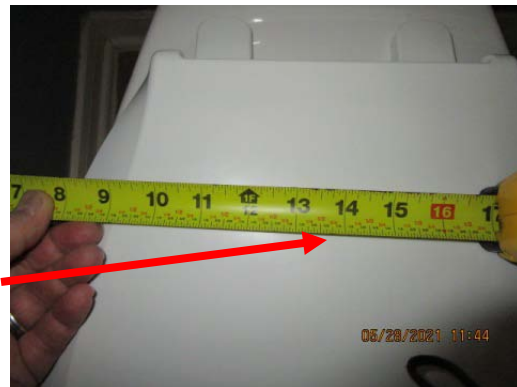
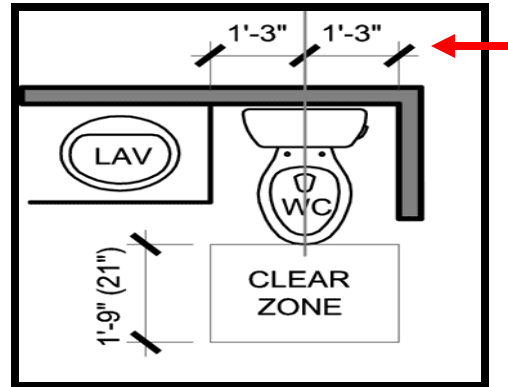
The commode in the master bath does not have the required 15" clearance to the center of the commode as required by today's standards.

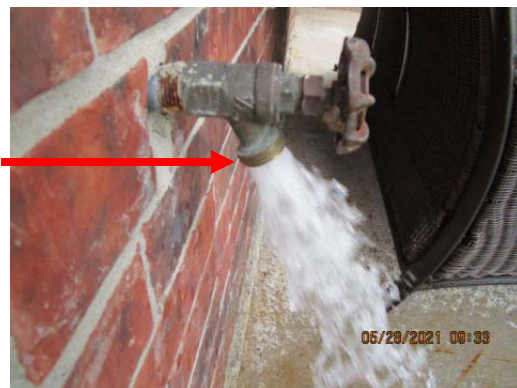
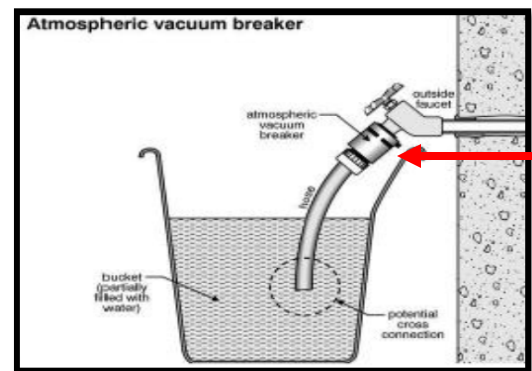
Back flow preventers are not installed on all hose bibs. Recommend installing to prevent water from backing up into the water system.

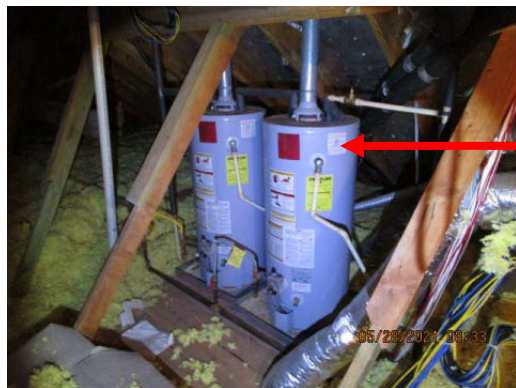
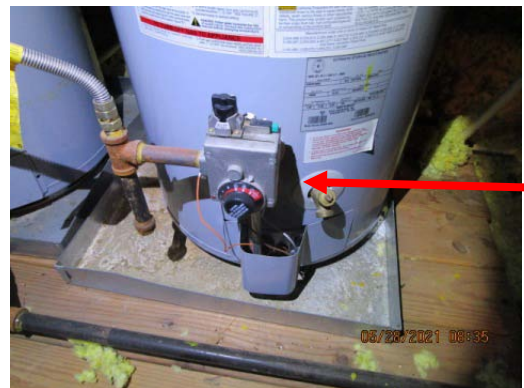
The right side water heating equipment was not in service at the time of the inspection. Multiple attempts were made to light the water heater however the water heater would not light under normal conditions. Recommend further evaluation/repair/replacement.

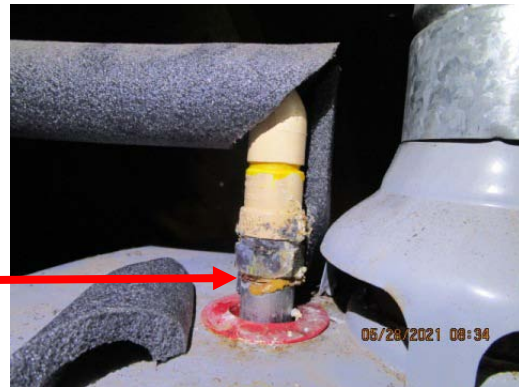
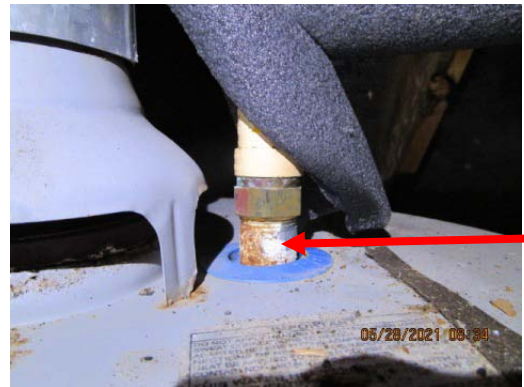
Water supply lines at the top of the left side water heater had oxidation/corrosion at the connections & a small active leak/water was observed at the left side connection. Recommend repair/replacing.

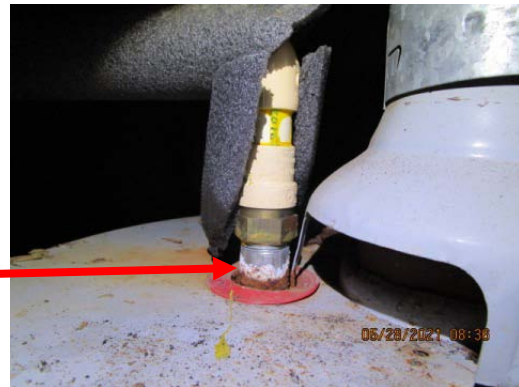
Water supply line at the top of the right side water heater had oxidation/corrosion at the connections. Recommend repair/replacing.

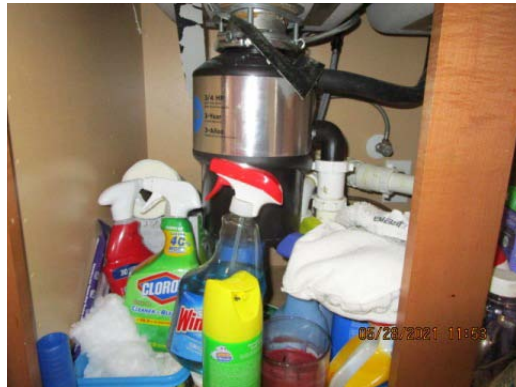
Surface rust was observed on the interior of the disposal.

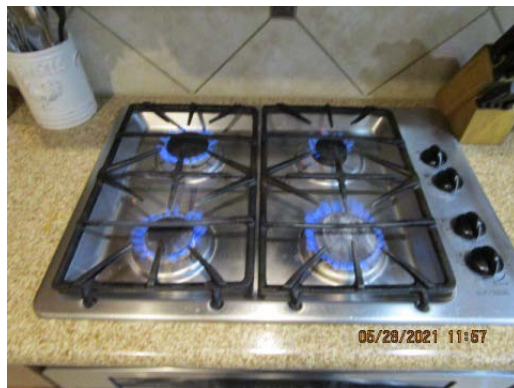
Random burners go out when turned to the low setting. Recommend that the burners be adjusted so the flames do not go out when set to the low setting.

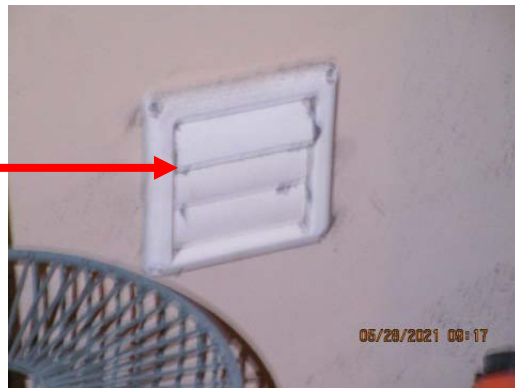
The dryer vent is terminated into the garage & not to the exterior as required. By today's standards

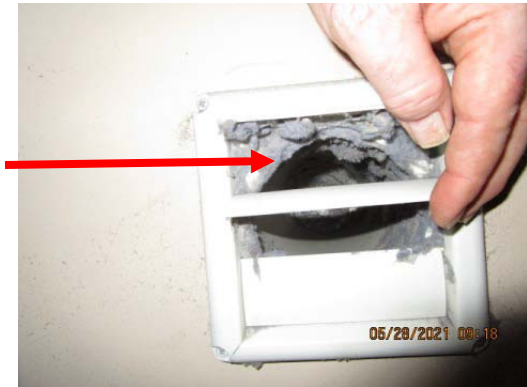
Dryer vent is dirty/filled with dryer lint. This is a potential fire hazard & should be properly cleaned.

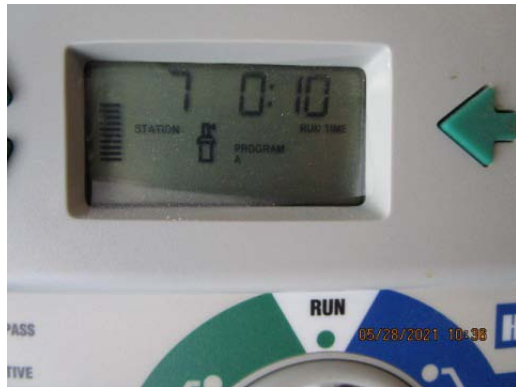
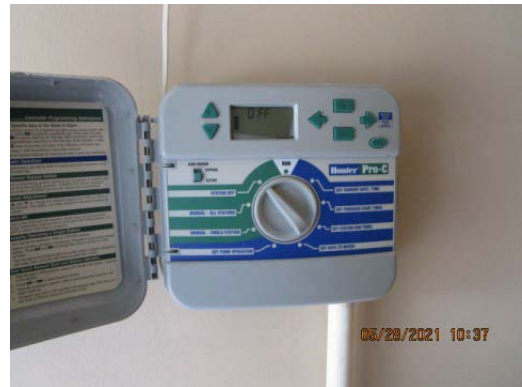
heads & there were deficiencies as described below. The system was not checked using the automatic timer. Sprinkler systems should be checked on a regular basis to ensure water is not being sprayed against the structure.

The system does not have a visible moisture sensor installed to shut the system down when excessive moisture is detected. Recommend further evaluation/repair.
