Inspection Report

Property Address:
14202 Grand Manor Ln
Humble TX 77396

Counter Home Inspections

PROPERTY INSPECTION REPORT

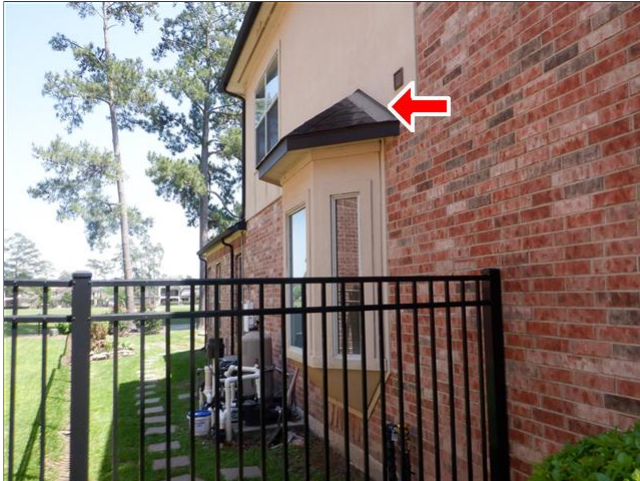
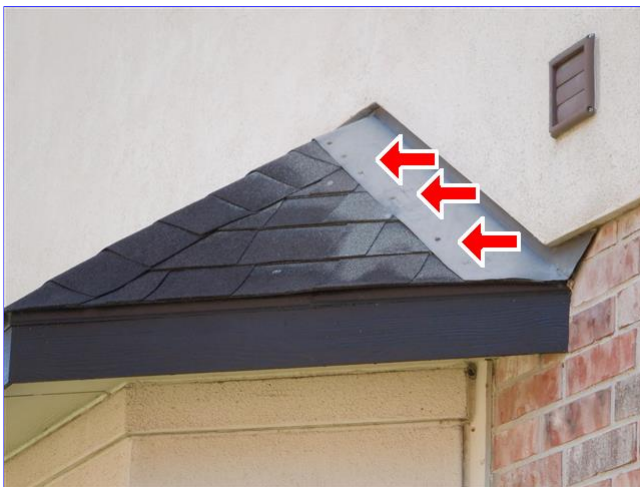
C. Exposed nail heads on flashing, left side of home

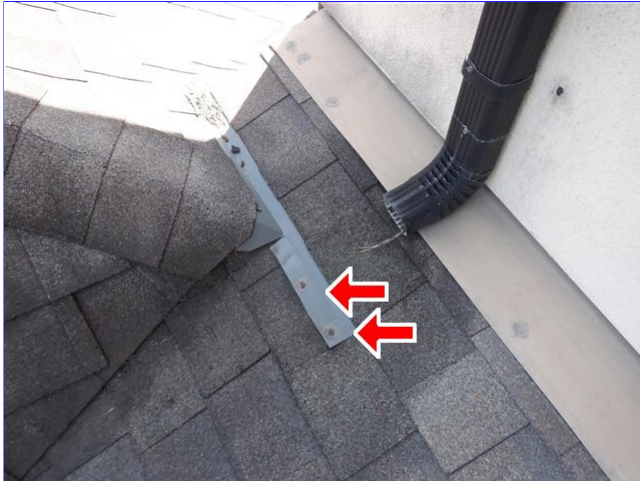
C. Exposed nail heads on flashing, back of home

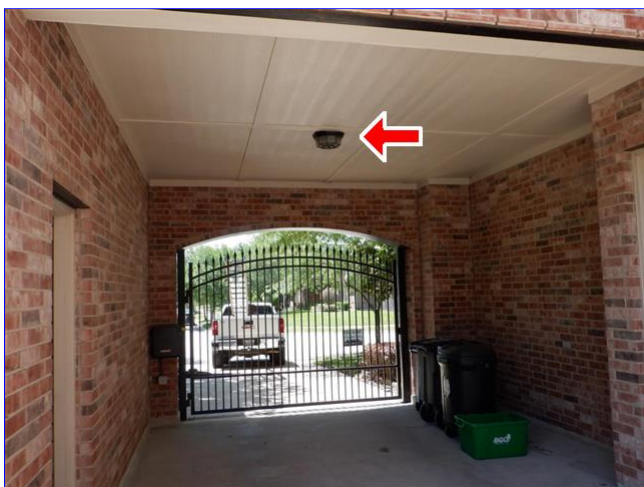
B. Driveway light not working

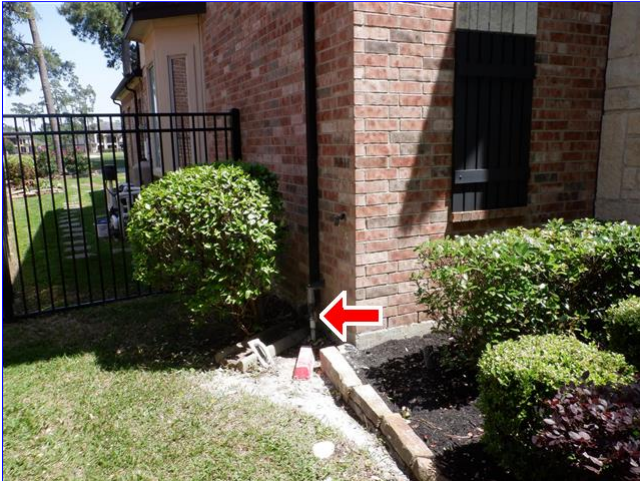
A. Front left corner of home, main water supply line, insulation needed
