Property Inspection Report

12618 Campsite Trail, Cypress, TX 77429
Inspection prepared for: Liesl Demaria
Real Estate Agent: Laura LoGiudice - Next Home Realty Center

Date of Inspection: 3/29/2018 Time: 8:30 AM
Age of Home: 1975 Size: 2780
Order ID: 8843

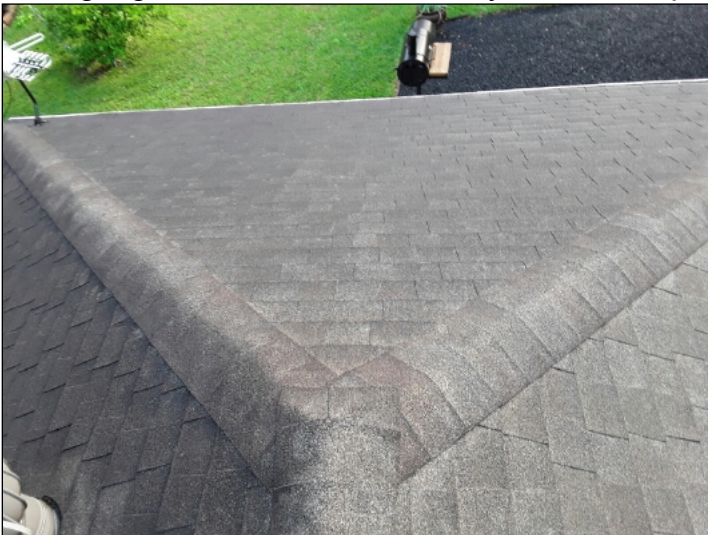
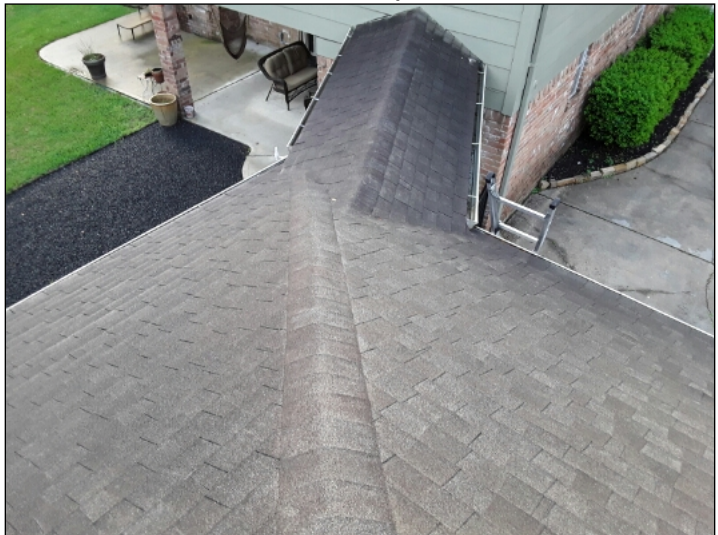
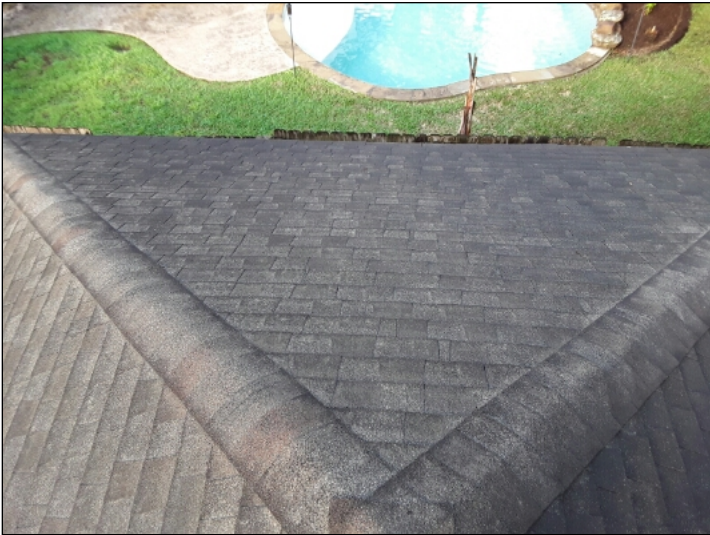
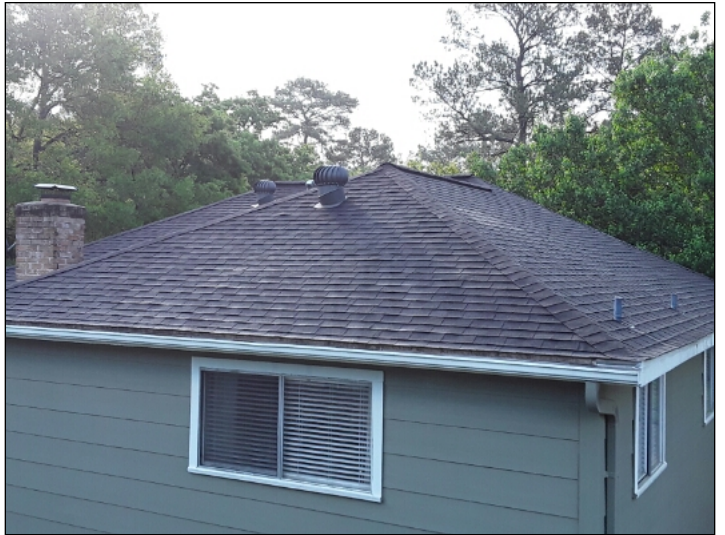
-Nails are noted backing out through the shingles, recommend repairs to help prevent shingles lifting during high wind conditions. Mainly at - Left slope

-Signs of previous repairs were noted on the roof. Indications are that they are working as intended at time of inspection.

Overview of roof

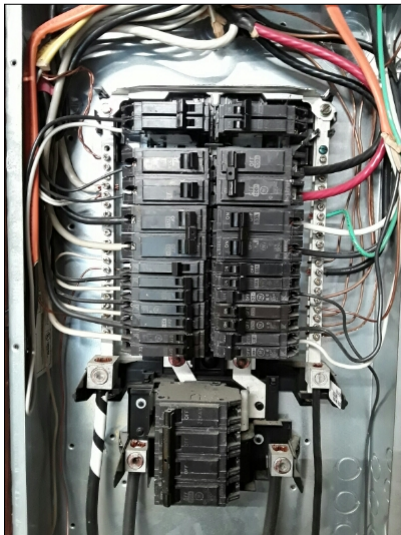
A.4. -Unable to verify bonding at the gas line, bonding is usually done at the gas meter or at the gas line to the water heater or furnace. Recommend having the bonding verified to help protect from damage to appliances or electrical shock.

A.5. Unable to verify grounding/ground rod clamp due to being buried.

Overview of main electrical panel

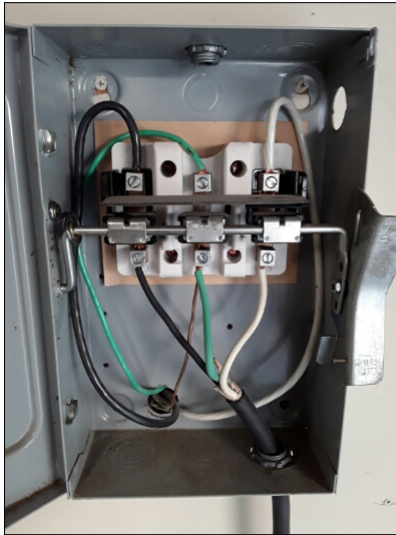
Overview of sub panel

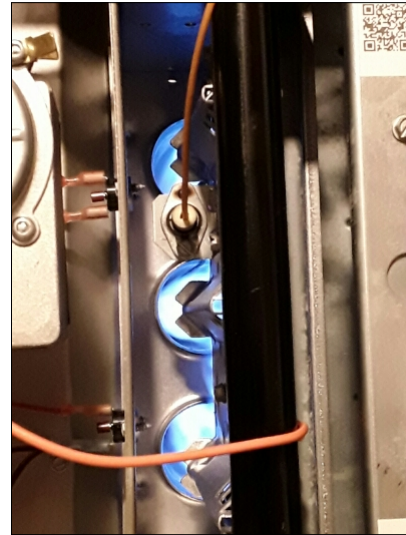
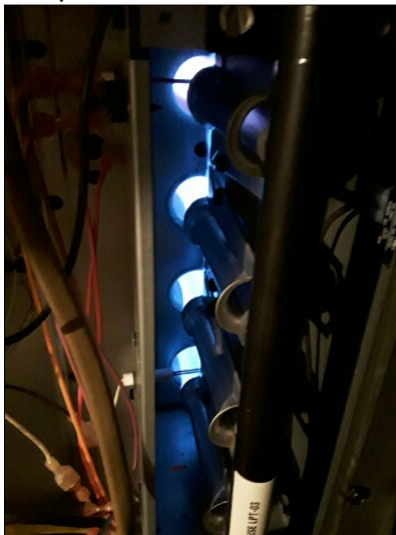
-Both of the gas furnaces are not properly vented, the furnace should be vented with double wall vent pipe through the roof with a rain collar installed above the roof jack sealed and terminated with a type B vent cap.

Overview of furnace burner compartment.

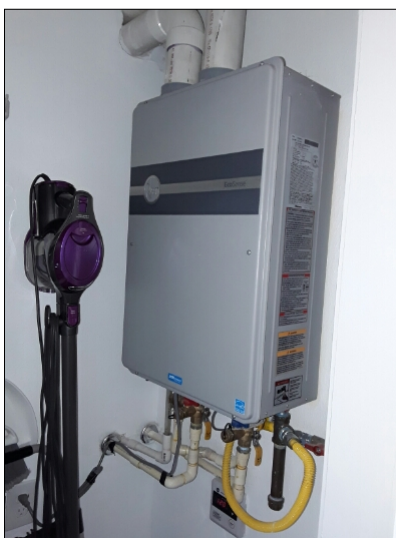
- -The water heater #1 is Tankless w/unlimited capacity.
- -Water heater(s) is/are located in the laundry room for the entire home.

Overview of water heater(s)

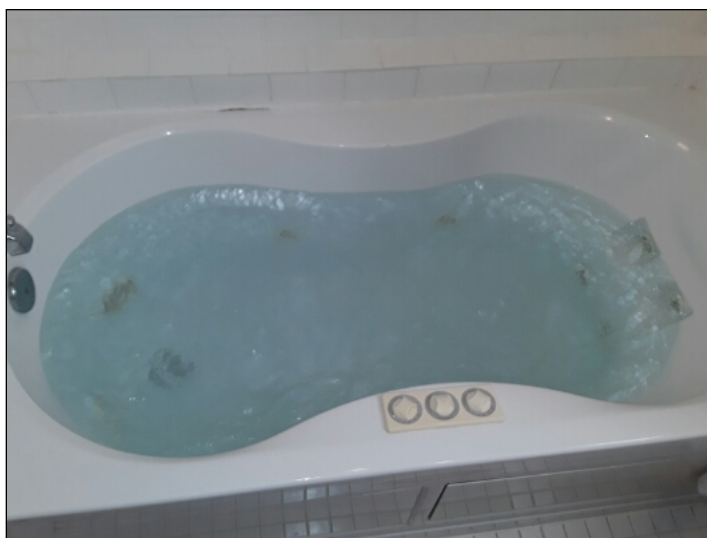
The hydro therapy tub is operating as intended.
