PROPERTY INSPECTION REPORT

Concerning: 604 Northwood Street, Houston, TX 77009
 (Address of Inspected Property)

By: Steven Gibson, RI #20994 08/09/2019
 (Name and License Number of Inspector) (Date)

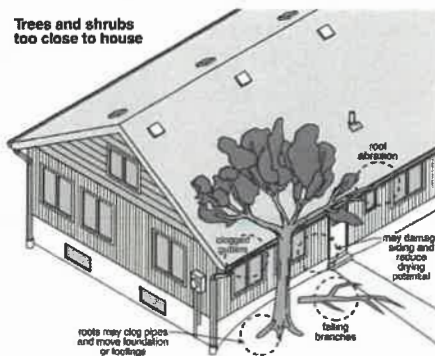
Large tree(s) near house foundation. This condition can have adverse effects on foundation performance. If this is a concern, recommend consideration of installing a root barrier or other preventative measure.

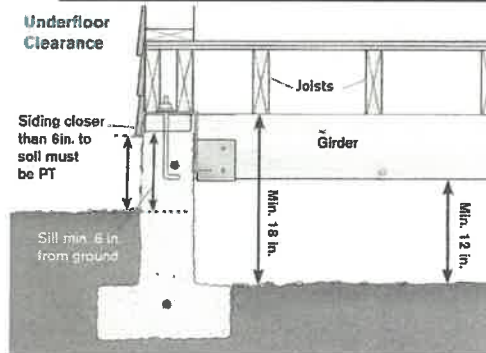
Observed wood framing under house has inadequate clearance from soil to prevent wood rot according to code. Minimum soil clearance to untreated wood joists is 18". Minimum soil clearance to untreated wood beams is 12". IRC R317.1

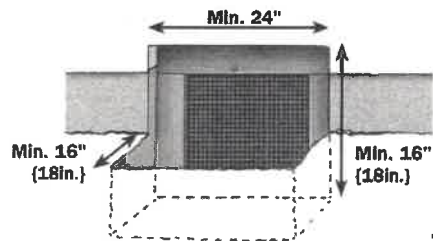
Could not access below most of home due to inadequate access and clearance of framing from ground. Code (IRC Section R408.4) requires that access be provided to all under floor spaces. Access openings through floors shall be a minimum of 18x24 inches, while openings through a perimeter wall shall be at least 16x24 inches. Recommend installation of proper access opening and subsequent inspection under house.

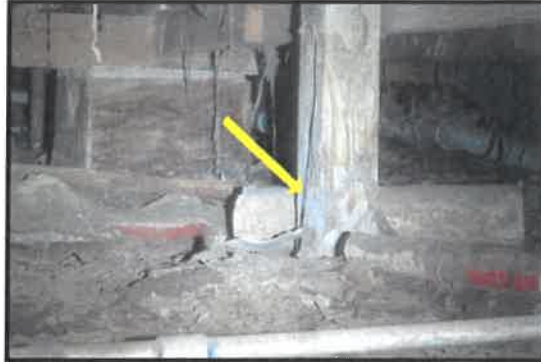
Earth wood contact in some areas, conducive condition to termite activity and wood rot.

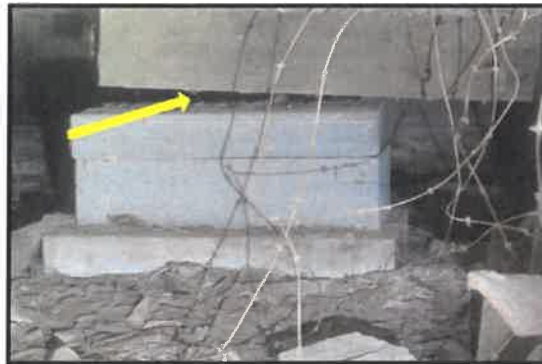
One or more piers need to be shimmed to support girder or beam.

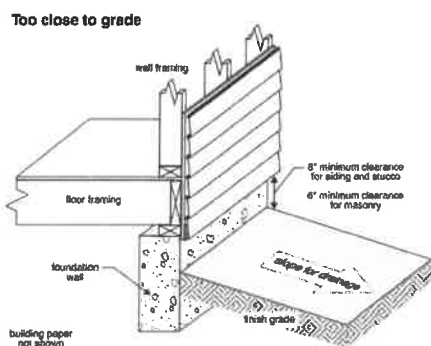
Soil level too high around areas with wood siding. Code and common industry practice requires a clearance of 6-8 inches from bottom of wood veneer to soil. High soil level near wood siding promotes water/termite penetration and wood rot.

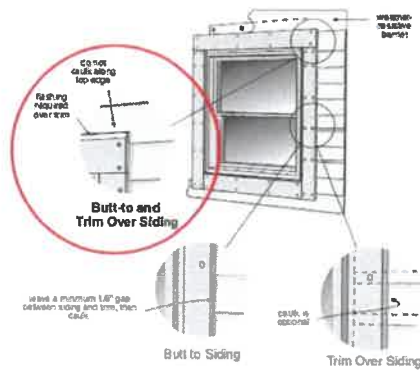
Head flashing missing over window/door trim pieces. Without head flashing over window trim, sealing must be maintained as a defense against water penetration.

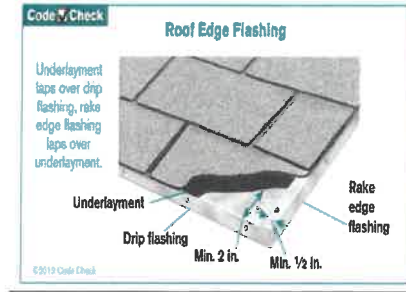
No metal drip edge visible at roof edge. When drip edge is not installed, water dripping off of the edge of the roofing can be drawn by capillary action into the exposed edges of the plywood which can cause the plywood sheathing and fascia begin to rot.(Car port)

Drip edge has been installed on garage

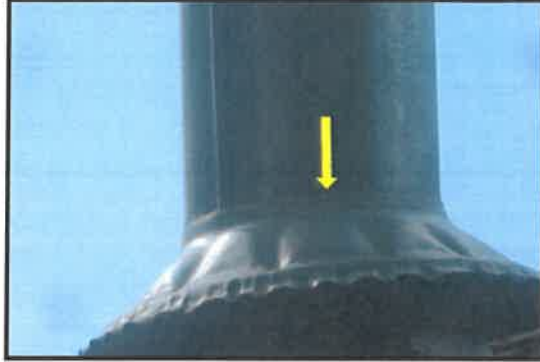
Storm collar not properly sealed on all house and water heater vent pipes.

**Storm
Collar has
been sealed**

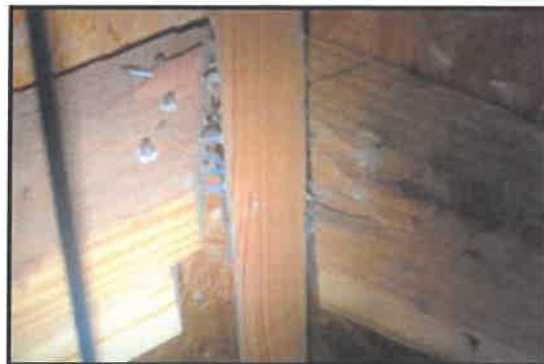
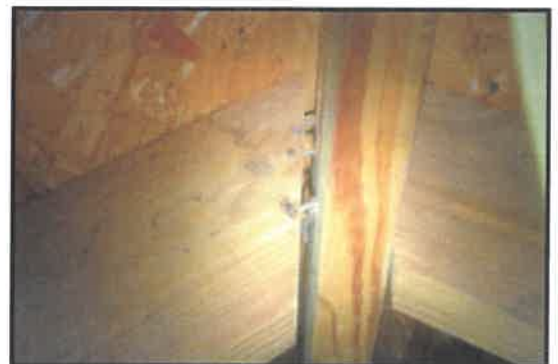
Rafters do not fit snugly against the ridge board.

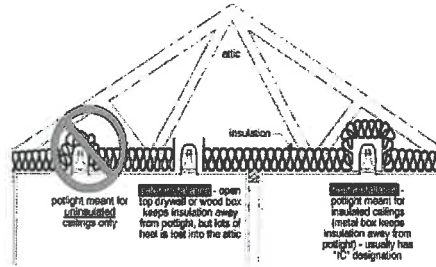
Potlights in insulated ceilings

Ensure insulation is maintained a minimum of 3 inches and wood a minimum of 1 inch from around all recessed lights to reduce possible fire hazard.

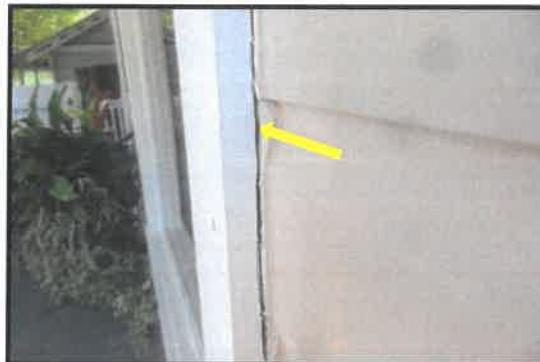
Caulking missing and/or deficient around vertical trim boards may allow wind driven rain entry.

Caulking complete

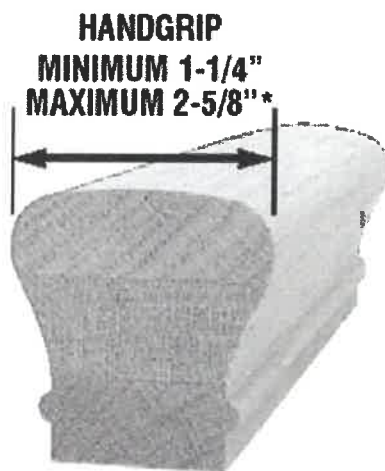
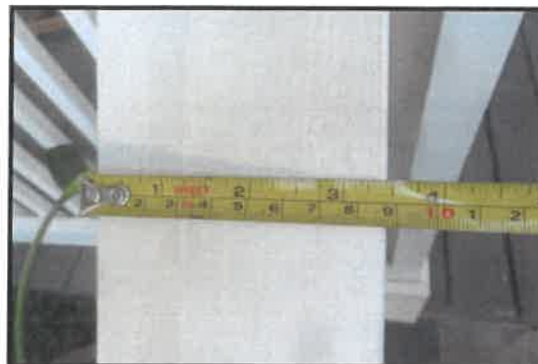
Section of gripable (proper size) handrail missing: Reference IRC R315.2 “the handgrip portion of handrails shall have a circular cross section of 1 ¼ inches minimum to 2 5/8 inches maximum.”

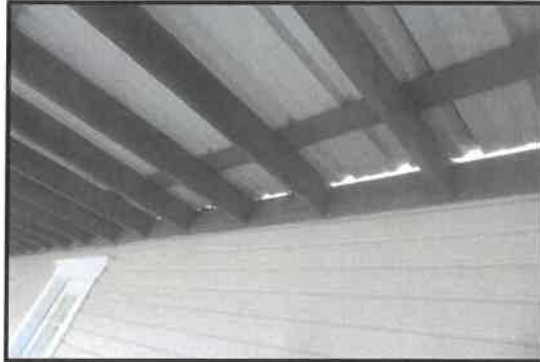
Car port cover does not appear to be properly secured; Missing lag bolts to secure ledger board to structure and or missing Joist Hangers to secure rafter to ledger board; possible hazard.

Additional support added

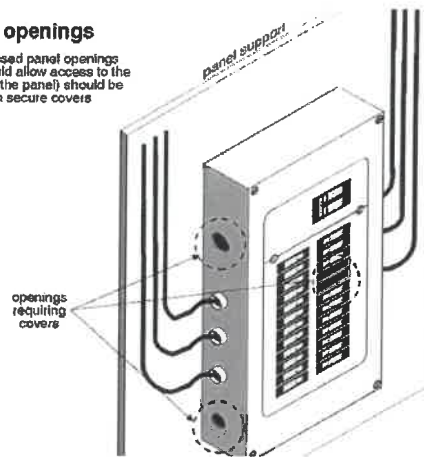
Panel openings

Missing one or more knock out cover(s).

any exposed panel openings (that would allow access to the inside of the panel) should be filled with secure covers

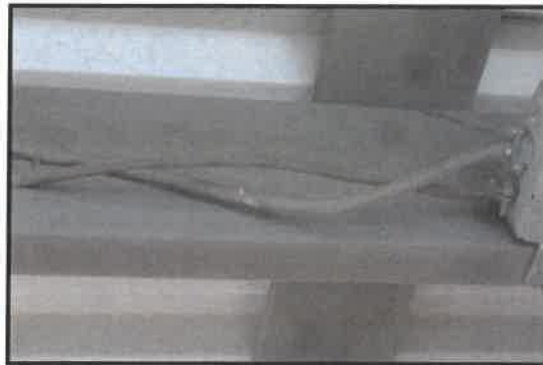
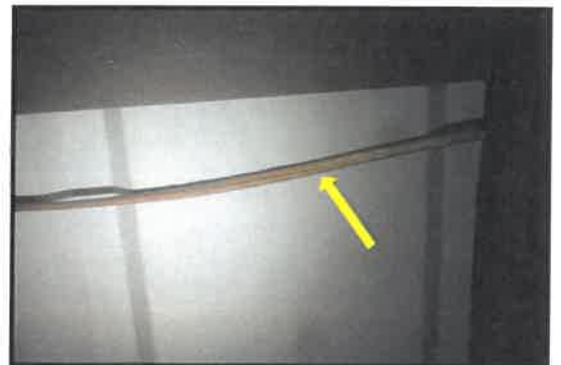
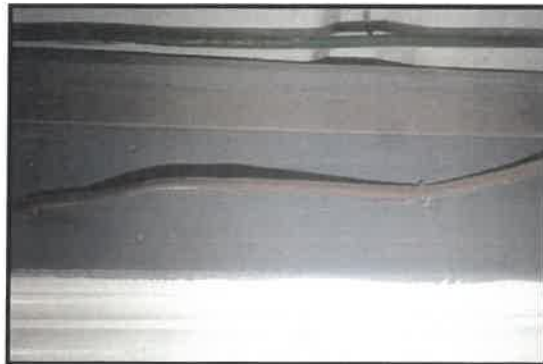
Electrical wiring not in protective conduit:(Car port, Back patio)

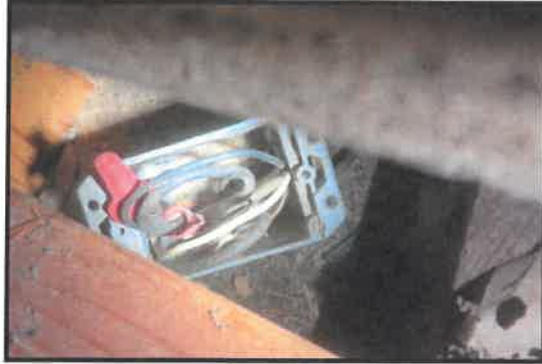
Wire connections are not enclosed in proper electrical junction box(s), or electrical junction box(s) do not have covers in place, including but not limited to the following location:(Attic)

Added covers

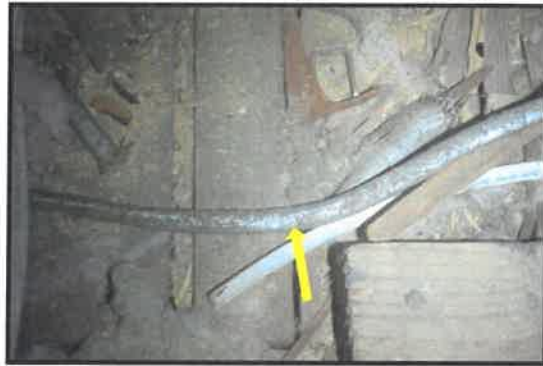
Antiquated electrical system, includes older type Romex wiring without or very limited grounding.

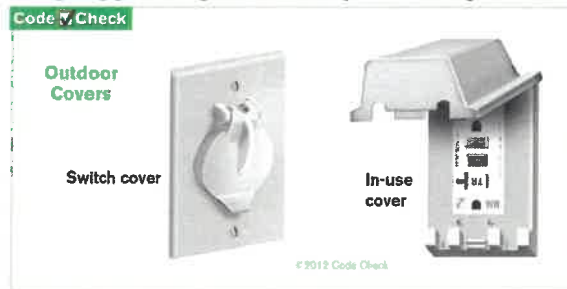
Exterior outlet missing proper rain tight cover where electrical device will remain plugged in permanently. (Back patio, Storage shed exterior)

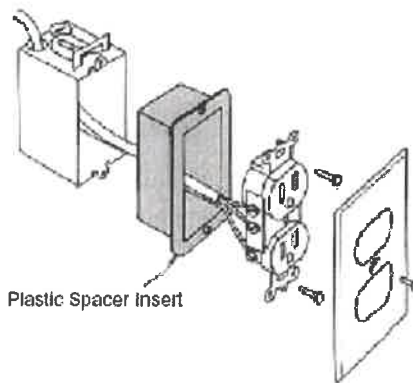
Outlets / switches / devices installed in / through combustable material were not flush mounted as required by code. space exists between face plate and edge of electrical junction box. Missing required spacer (spark ring) on following outlet(s): (Storage shed) Reference NEC 370-20 & IRC E3806.5. In walls constructed of wood or other combustable material, cabinets (outlet & switch boxes) shall be flush with the finished surface or shall project there-from.

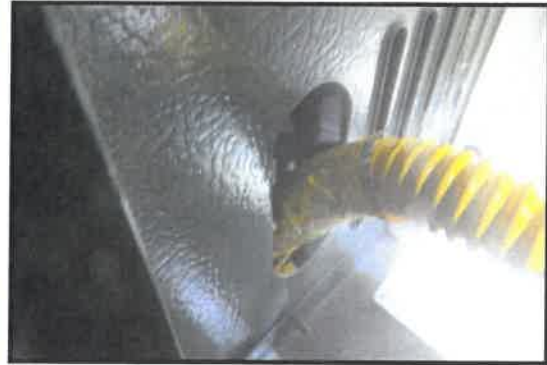
Flexible gas line is not allowed by current industry standards and most installation instructions to pass into metal cabinet of gas heating units due to vibration from unit can rub hole is gas line, rigid metal pipe should extend outside cabinet a minimum of 2 inches for flex line connection.

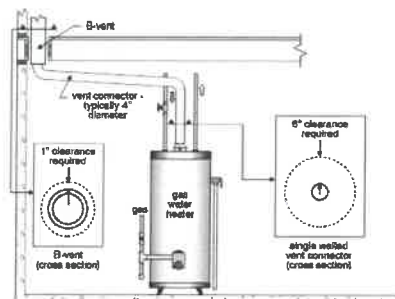
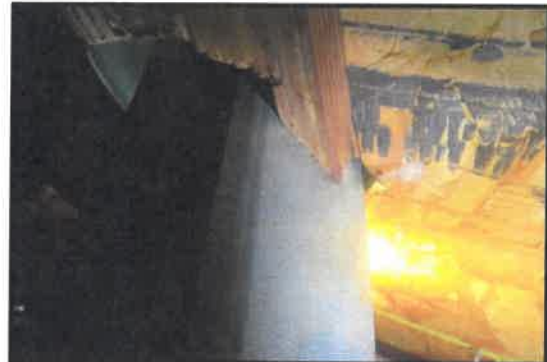
Vent clearances

Exhaust vent pipe is in contact with combustible material, [wood roof decking]. Current industry standards (code) require 1" clearance for double wall vent pipe.

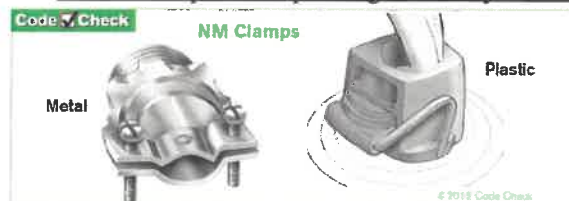
Thermostat wiring not secured to attic unit(s), missing small fitting that secures wiring to cabinet to prevent pulling loose by service personnel or homeowner.

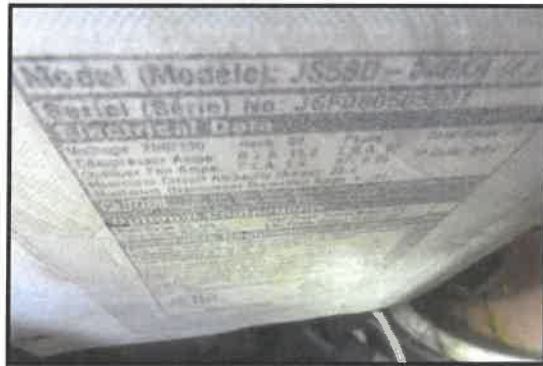
CONDENSING UNIT: (2008) 4 TON NORDYNE

Older unit, limited service life remaining.

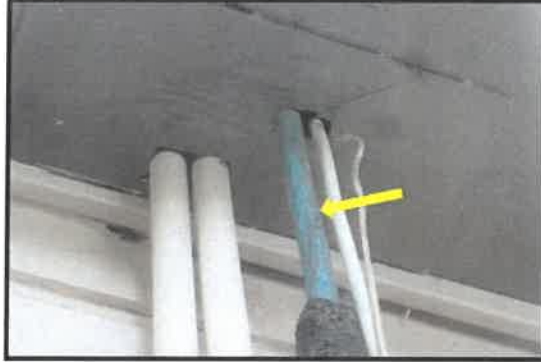
Section of suction line insulation missing or deteriorated near condenser.

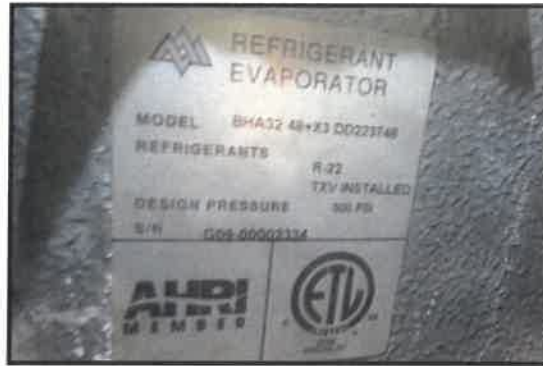
EVAPORATOR COIL:(2009) 4 TON ASPEN
Older unit, limited service life remaining.

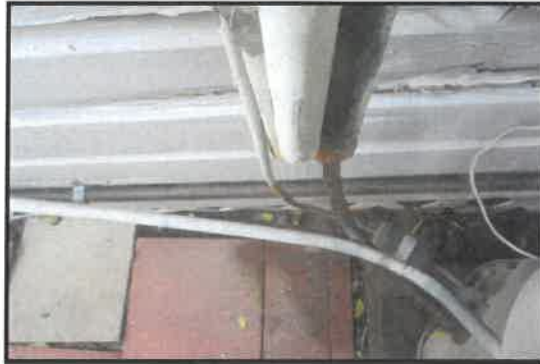
Primary drain line should not be allowed to discharge water right next to foundation.

Added additional pipe

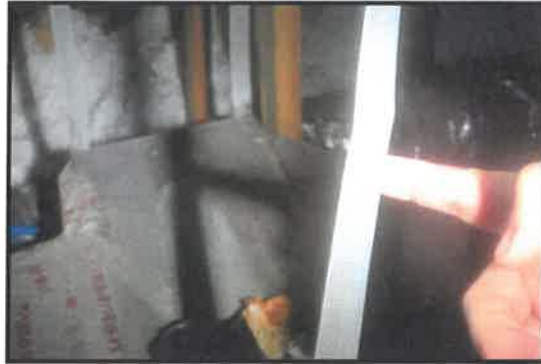
Metal straps that support the AC/Heating unit are required the be taped to help technicians from getting cut on the sharp sheet metal.

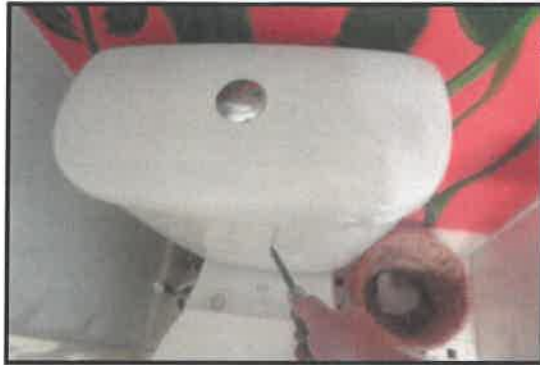
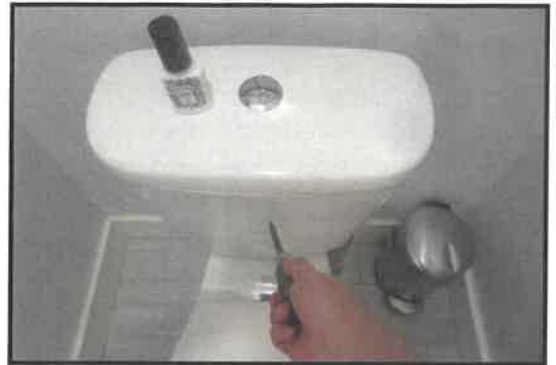
Tank not secured to bowl: (Master bath, Hall bath)

Secured

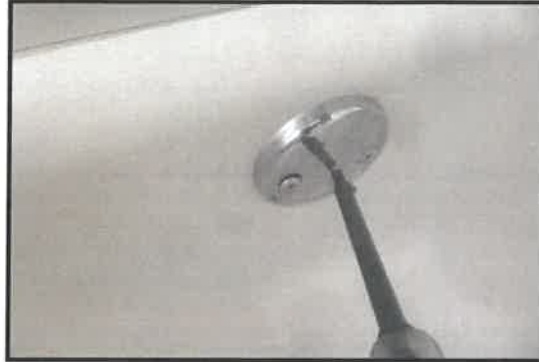
The overflow cover is loose. The overflow cover holds the overflow drain and gasket tight to the back of the tub. When it's loose, this joint can leak if the water level rises to the overflow. Check condition of gasket and tighten cover. (Hall bath)

Tightened

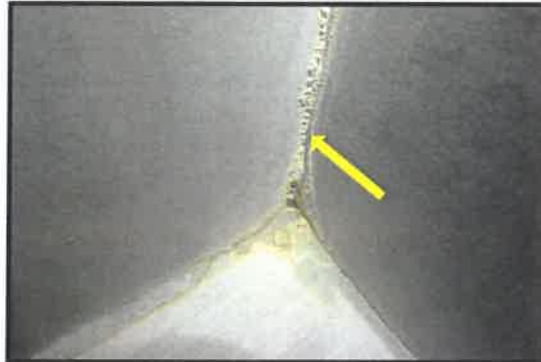
Grout / caulking needed at vertical tile corners, cracks in tile and/or mortar between tiles, to prevent water entry behind wall.

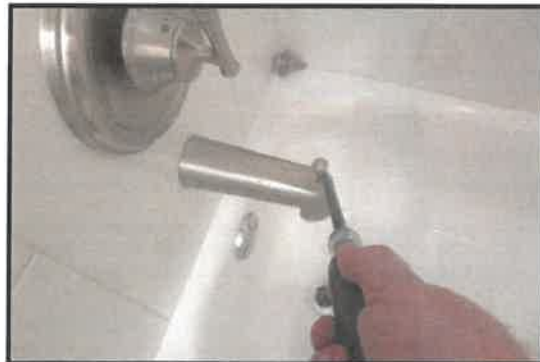
Shower diverter valve is not fully functional, does not direct all water to shower head during operation. (Hall bath)

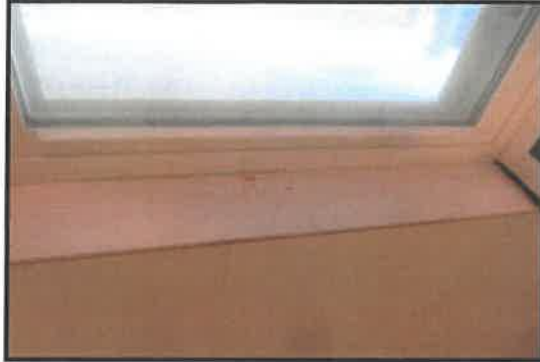
Observed level or improper sloping of shower window sill tile, sill should slope towards interior of shower not back towards window frame.(Hall bath)

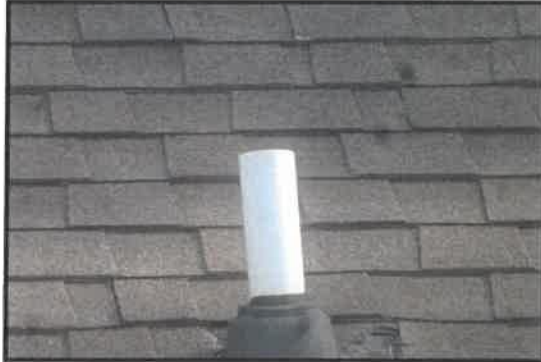
Painting of exterior plastic PVC vents above roof line required to prevent UV damage.

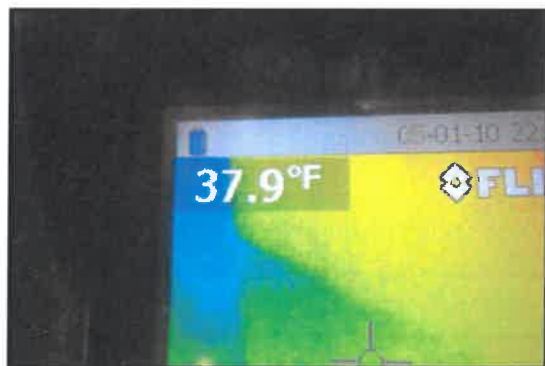
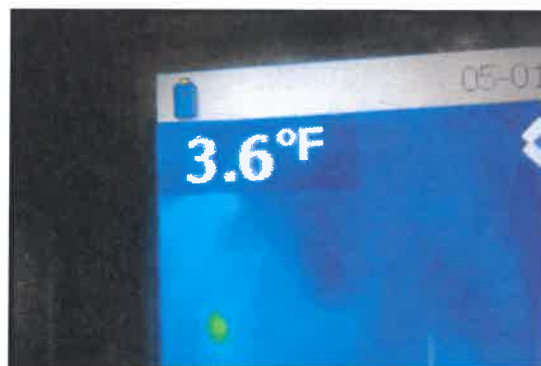
Temperature measures: Refrigerator
37.9°F Freezer_3.6°F
