MEP REPORT

604 Northwood St
Houston TX 77009

MARCH 2, 2020

PROPERTY INSPECTION REPORT

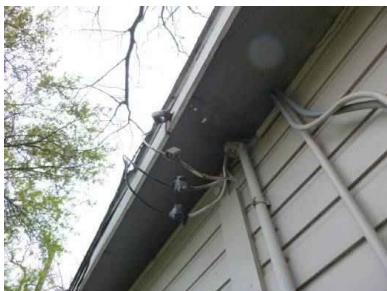
North Side

The service entrance conductors were observed to be too low and need to be raised so the lowest point is a minimum of 10 feet above grade.

Obtain Cost Estimate
E3504.2.2

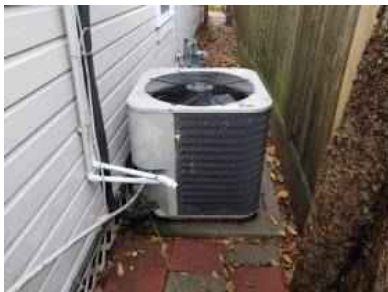
North Side

Condensing Unit - Limited Life:

Due to the age and/or condition of the equipment, it is our opinion that the equipment has only a limited amount of life remaining, and it would be a prudent thing to have the equipment thoroughly checked by a licensed air conditioning service company.

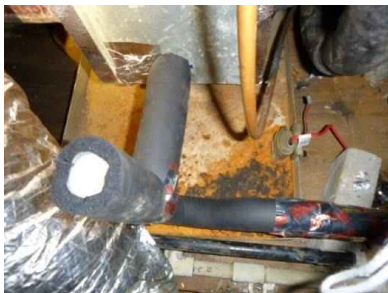
Rust was observed in the overflow pan under the coil, apparently due to water backing up at the primary drain line and overflowing into the pan. No water was observed in the overflow pan at the time of the inspection, however since the equipment was only operated for a short time during the inspection, It is recommended that the primary drain line and the coil be checked by an air conditioning service company.

Obtain Cost Estimate

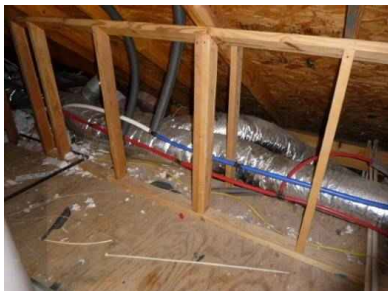
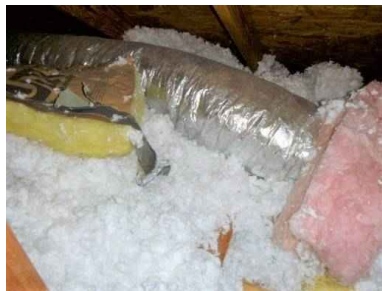
The ducts were laying on the insulation and ceiling joints and are not supported properly. The ducts should be supported in accordance with the manufacturer's installation instructions, which typically includes hanging the ducts from the rafters supported by 1 1/2 inch straps spaced approximately every four feet. Have a service company make the necessary repairs.

Obtain Cost Estimate

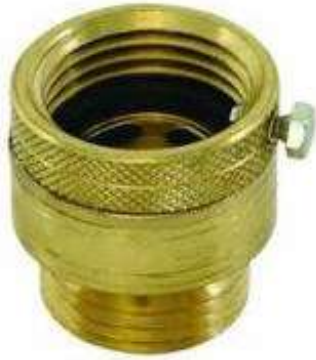
South Side

3: Hose Bibb - Handle missing

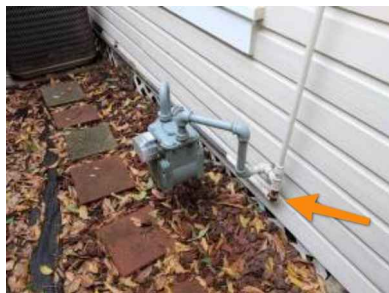
A section of the exterior gas piping was observed to be rusted. It is recommended that the rust be removed and the gas piping be painted to prevent further deterioration.

Obtain Cost Estimate

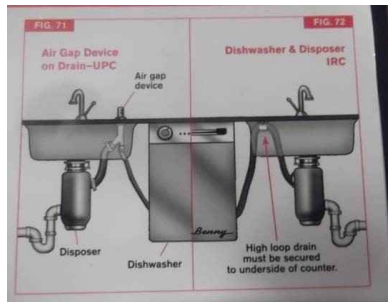
The drain line under the sink was not equipped with an anti-siphon device, nor was it looped up so that the top of the loop is at least six inches above the entrance of the drain line into the disposal. It is recommended at least that the drain line be looped to prevent the water from the garbage disposal from siphoning back into the dishwasher, or an anti-siphon device installed.

Obtain Cost Estimate

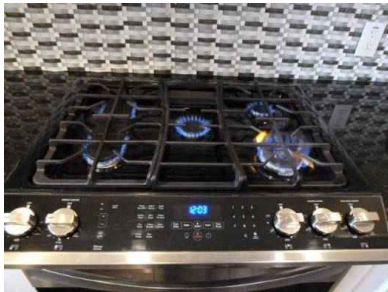
1: Oven - Not calibrated properly

The oven thermostat was checked and was not properly calibrated. The thermostat was set at 350 degrees, and the oven did not heat to within the allowable ± 25 degrees. The oven was checked with an oven thermometer and found to heat to 320 degrees. Have a service company make the necessary adjustments to the thermostat.

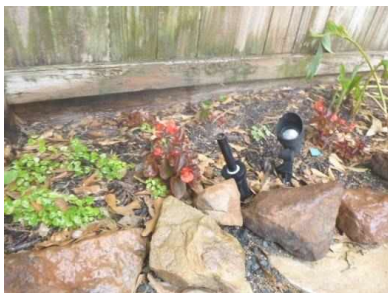
Sprinkler heads were leaning and need to be adjusted at zone 5.

Obtain Cost Estimate

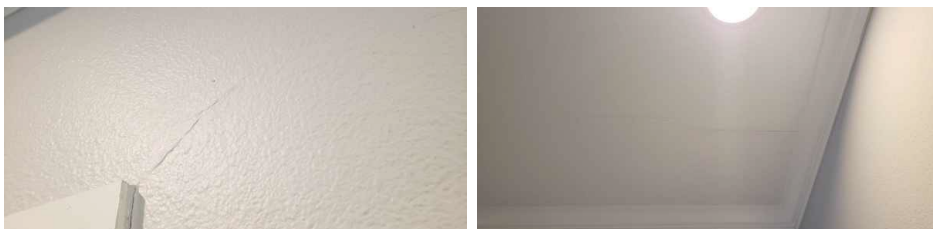
Sheetrock Cracks/Patches/Compression ridges

Sheetrock cracks, patches, and/or compression ridges were observed in the house during the inspection, including at the above locations.

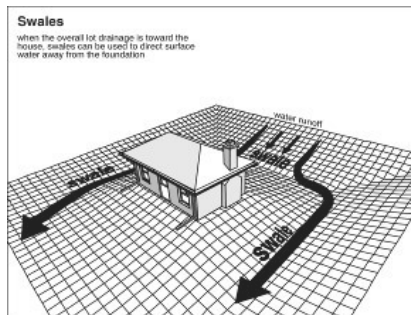
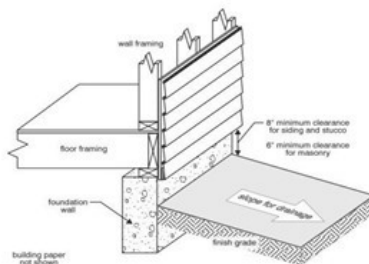
Perimeter Grading/Drainage: Wood Deck

We could not determine if any provision has been made at the rear of the house for drainage under the wood deck. It is recommended that you check with the owner to determine if there are any drainage problems at the deck area, and if any provision for drainage has been made.

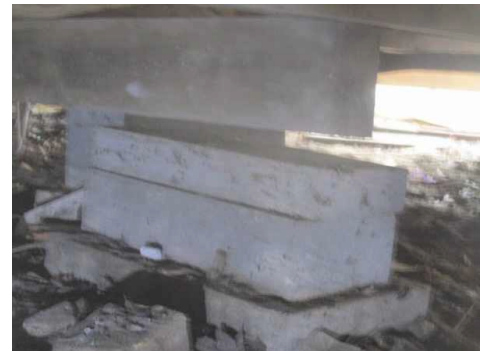
RECOMMENDED REPAIRS - PIERS SETTLED

We observed piers under the house at the crawlspace under the house that have settled, and are no longer supporting the house framing. It is recommended that a foundation repair contractor be contacted to make the needed repairs.

Contact a qualified professional.

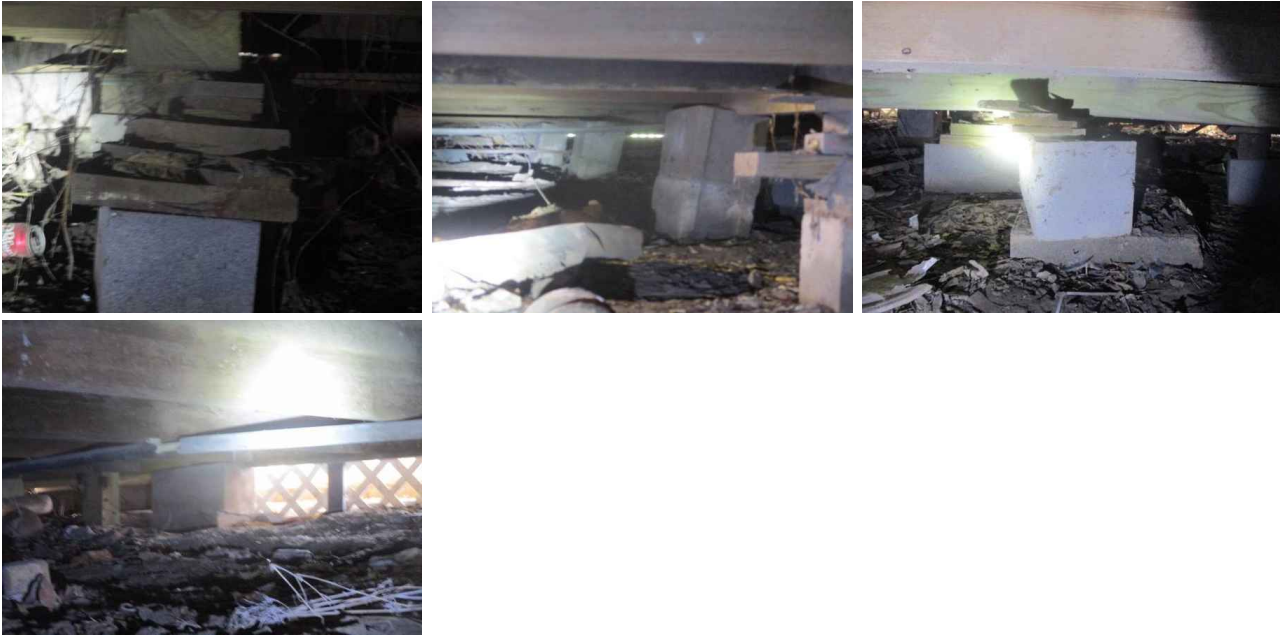
4.2.3 Crawlspace

RECOMMENDED REPAIRS - PIERS LEANING

We observed piers under the house that were leaning out of a vertical position. The degree of the leaning was more than normally observed in the inspectors opinion, and repairs are recommended to the leaning piers. Further investigation with a foundation repair contractor is recommended to obtain a cost estimate to make the needed repairs.

Contact a qualified professional.

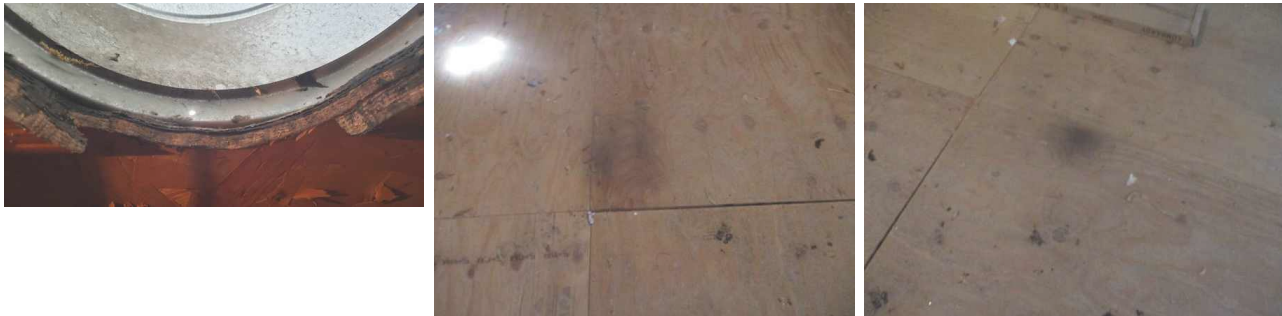
5.1.1 Roof Leaks

REPAIRS - OBSERVED AT ATTIC ROOF DECKING AND/OR FRAMING MEMBERS

After observing the interior of the structure, evidences of roof leaks were visible in the attic, where the roof decking and/or roof framing members were water stained. It is recommended that a roofing contractor be contacted to find the source of the leaks, and to make any needed repairs.

Contact a qualified professional.

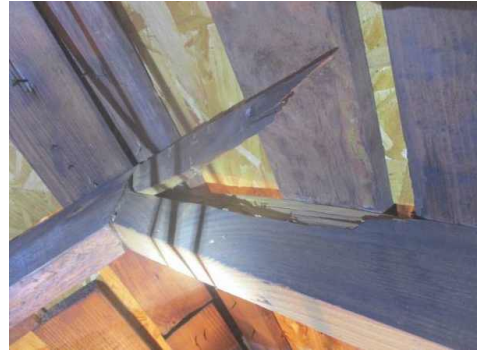
RECOMMENDED REPAIR - SPLIT RAFTER

One or more rafters in the attic were observed to be split, and need to be repaired.

Contact a qualified professional.

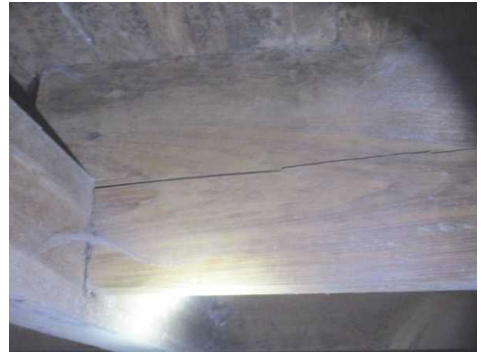
6.15.1 Crawlspace Framing

FLOOR JOIST DAMAGED

The floor joist was damaged, and needs to be repaired.

Contact a qualified professional.

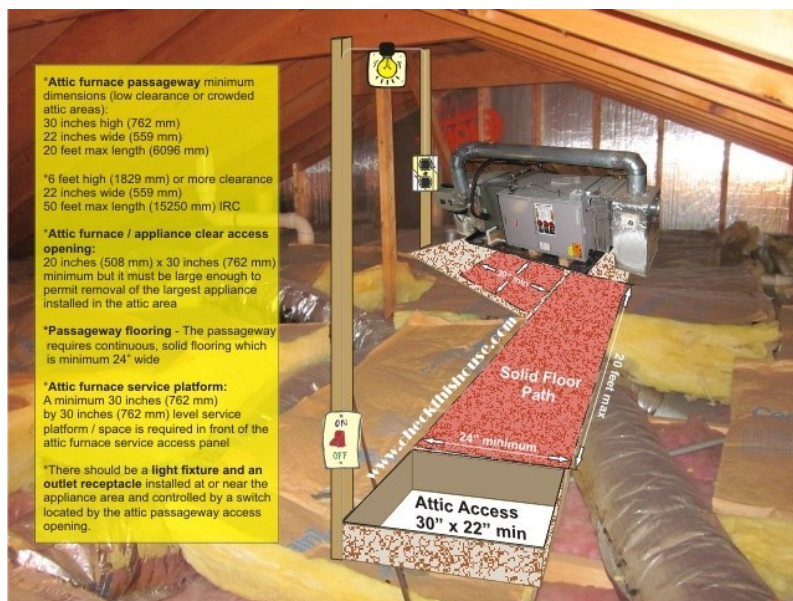
INADEQUATE WALKWAY DECKING

The attic did not have adequate service decking to all the equipment in the attic. The service decking should be a continuous deck that is a minimum of 24 inches wide, that extends from the attic access opening to all equipment in the attic. In addition, the decking should be free from any obstructions, such as gas lines, electrical wiring, ductwork, framing members, etc. The decking was thin in areas and presents a tripping hazard

Contact a qualified professional.

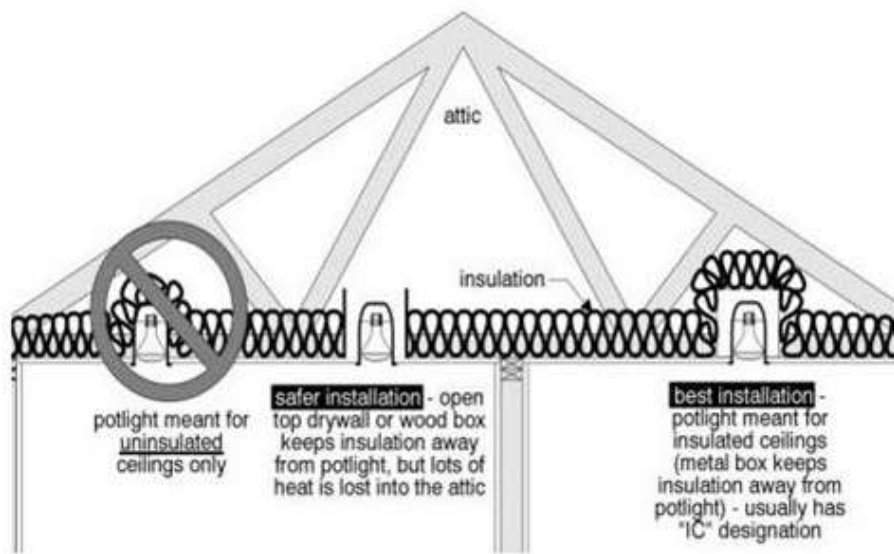
The insulation was in contact with the recessed lights, which can be a fire hazard and shorten the life of the light bulbs. It is recommended that the insulation be pulled back to provide a three inch air space.

Potlights in insulated ceilings

Contact a qualified professional.

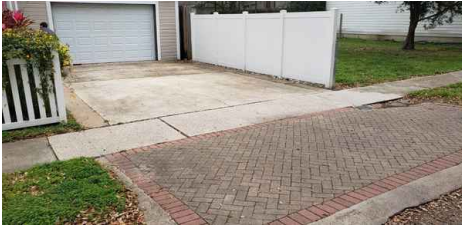
Flatwork Concrete/Patios/Walkways: Cracks Driveway

Cracks and some separations were observed in the driveway concrete. In our opinion, the driveway is still in serviceable condition at this time.

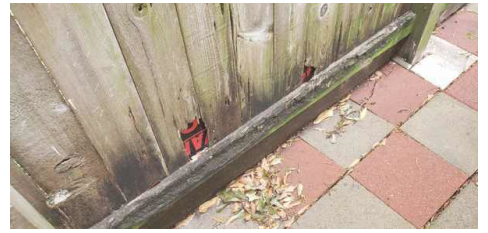
10.4.1 Gates and Fences

WOOD FENCE

Damaged

The wood fence was in need of some repairs.

Contact a qualified professional.

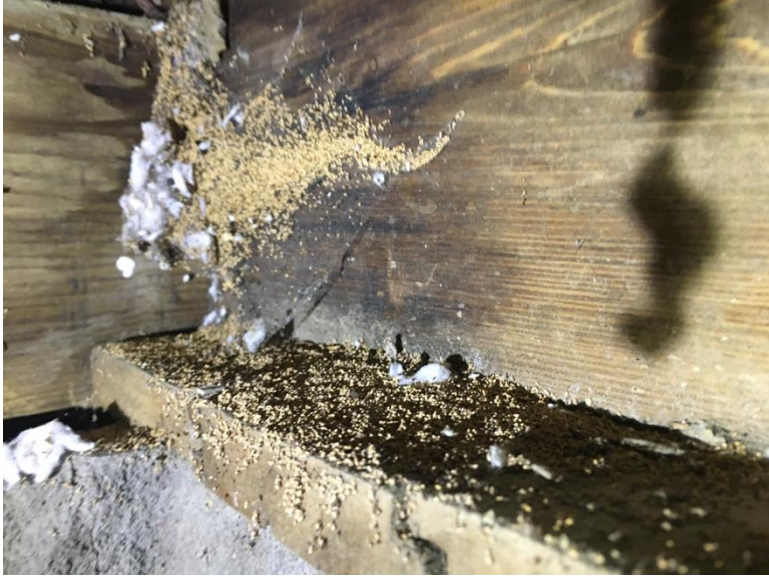
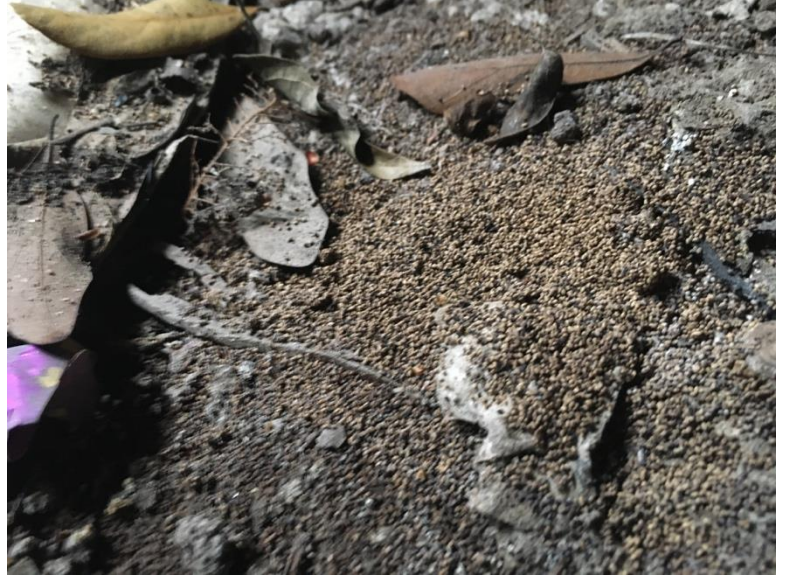
Evidence of Drywood termites

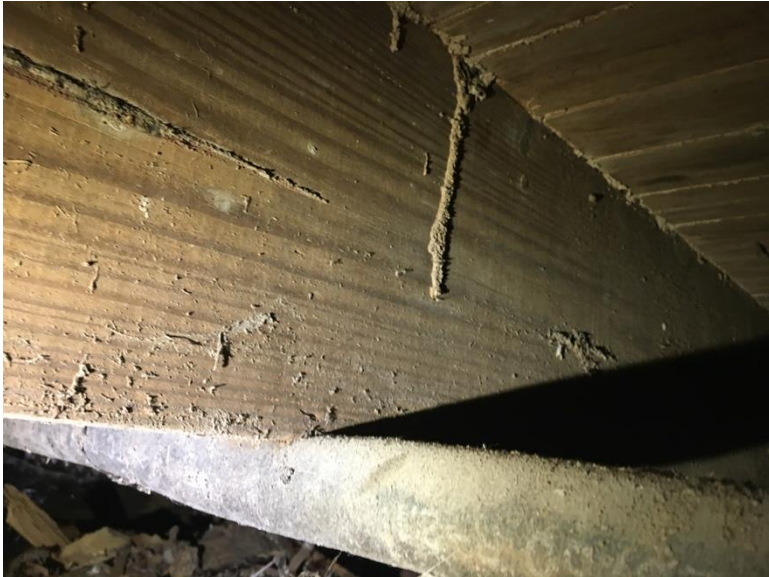
Previous Subterranean termites.

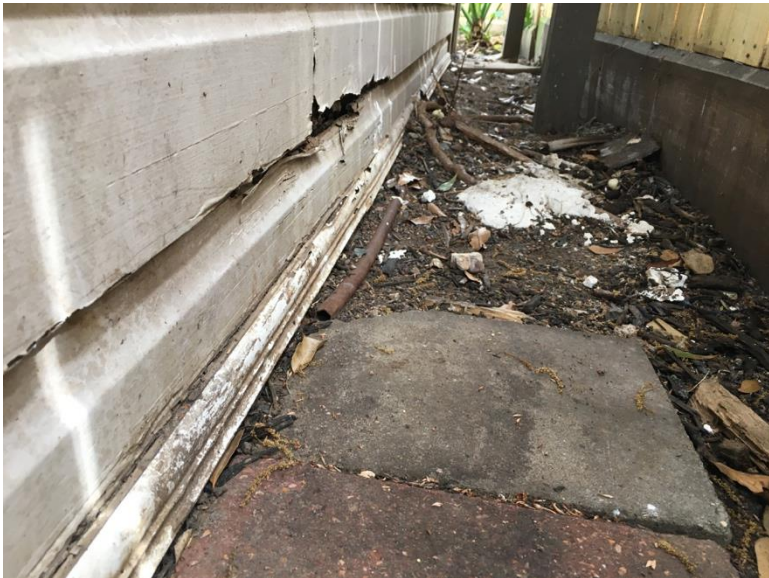
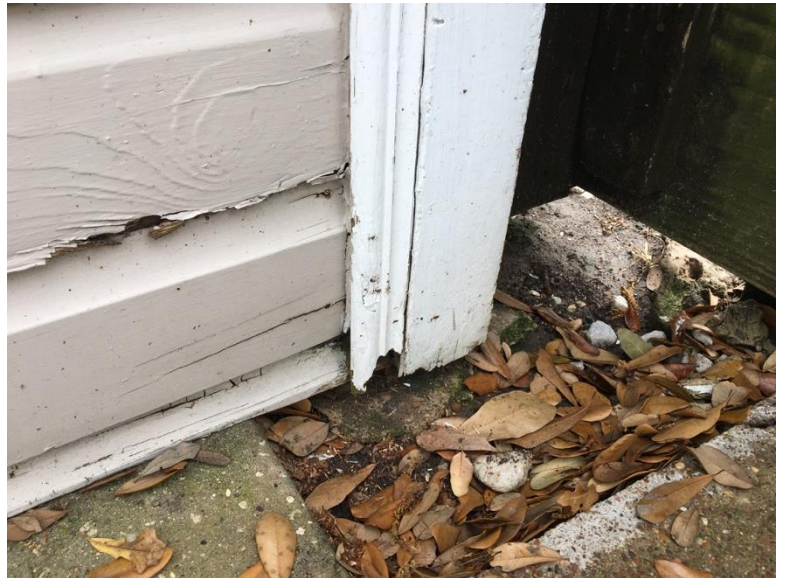
Wood Rot

Additional Comments: All damaged and rotten wood needs to be replaced.

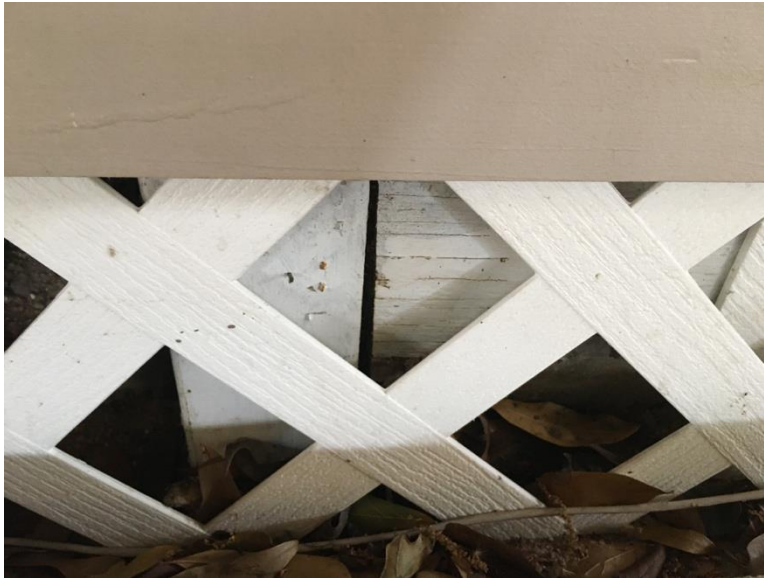
Wood to ground contact

Wood to ground contact needs to be corrected.

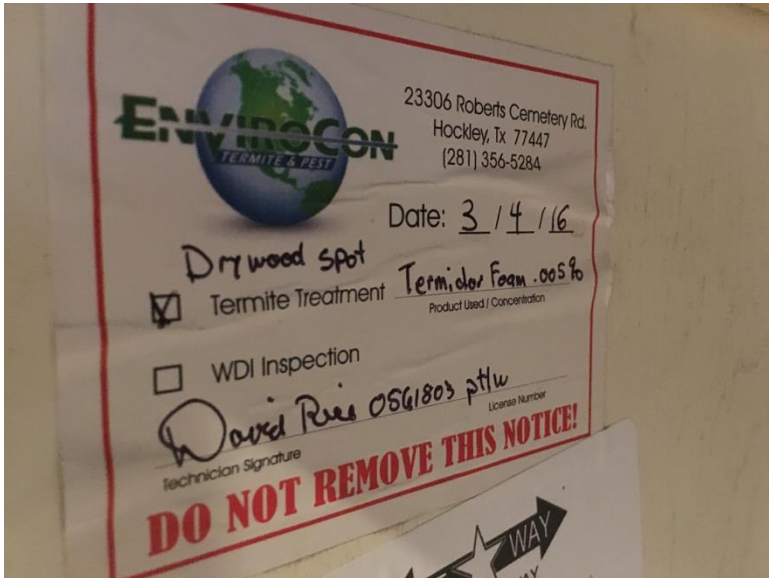
Evidence treatment of Drywood termites

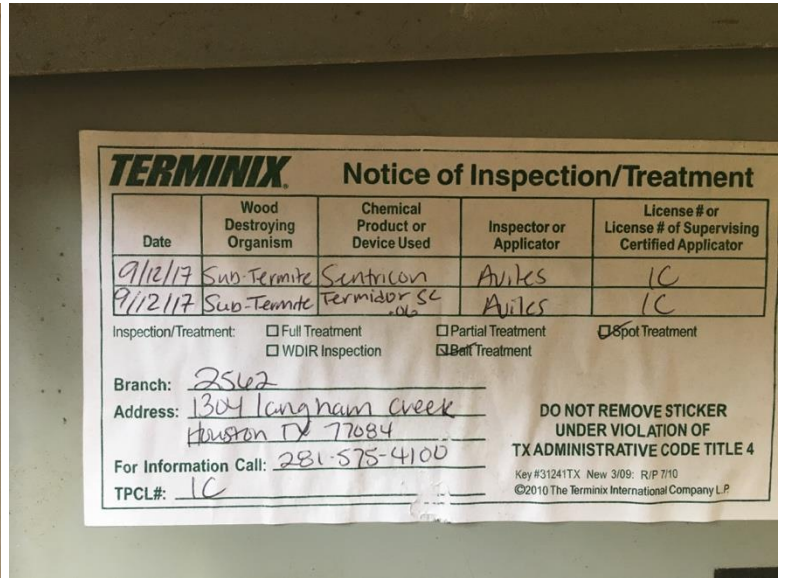
Evidence of Subterranean termites treatment

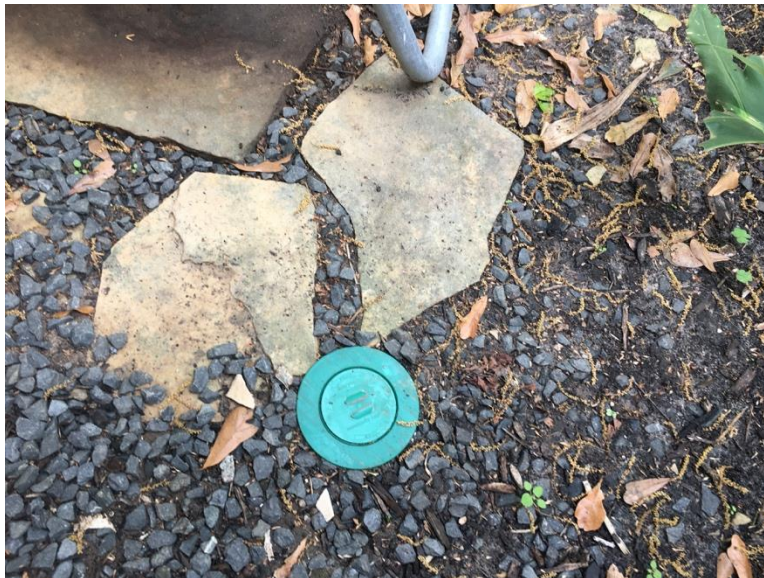
Bait stations

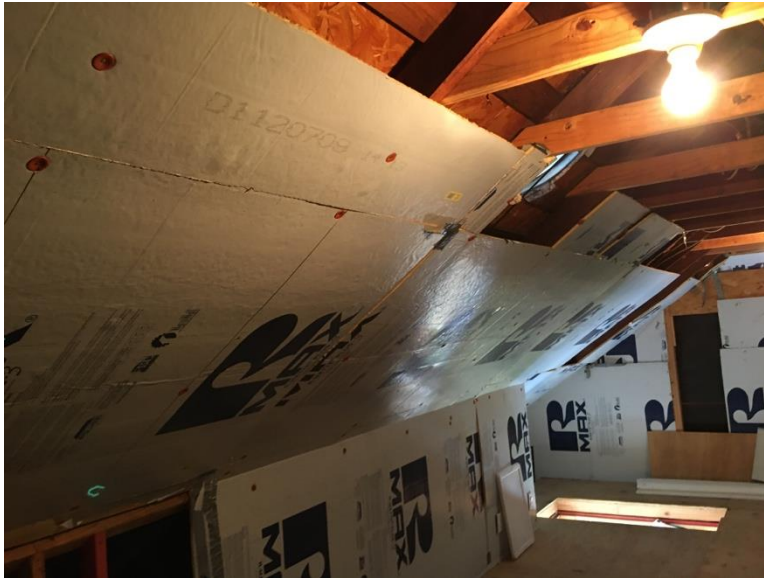
Obstructed view in attic
