**Comprehensive Evaluation Report
(Structural/Mechanical)
for
1401 Winnie Street (Avenue G)
Galveston, Texas 77550**

October 16, 2017

Re: 1401 Winnie St. (Ave. G), Galveston, TX 77550

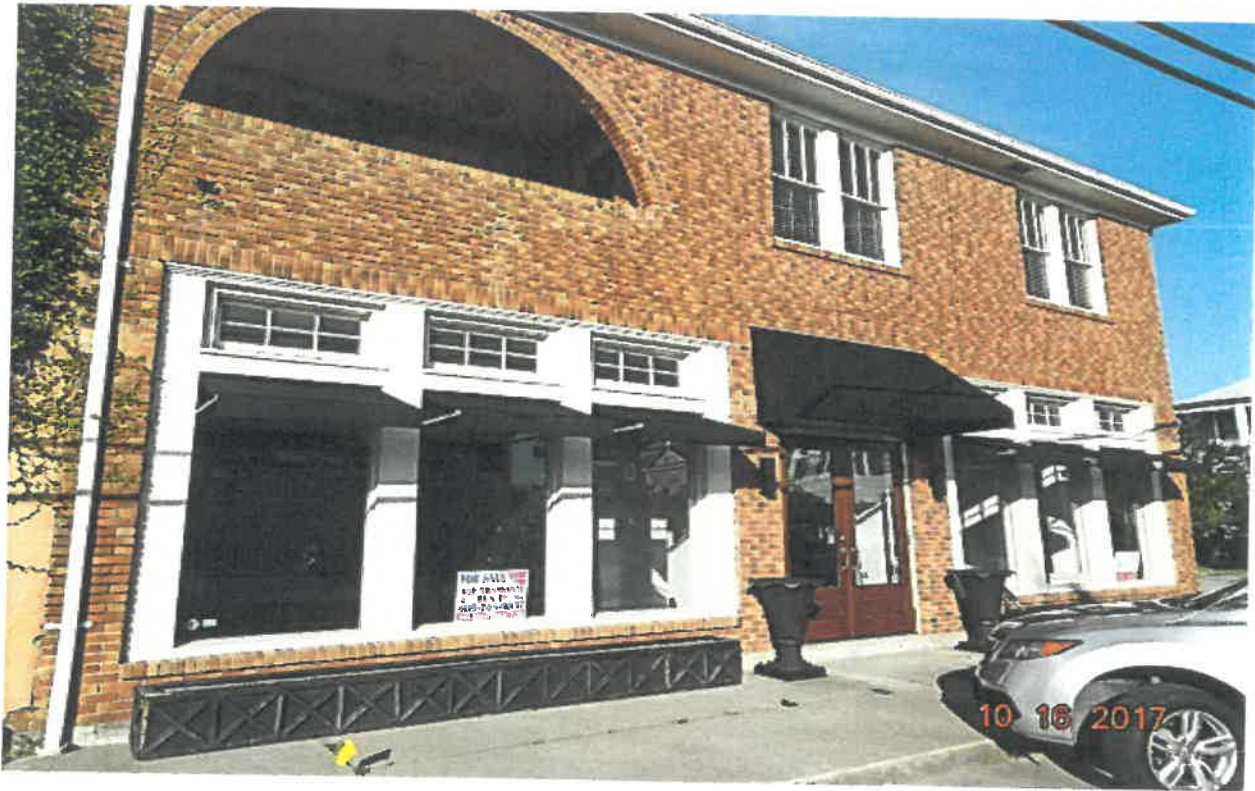
Photo # 1 Left side of building from 14th Street, front faces Winnie St.

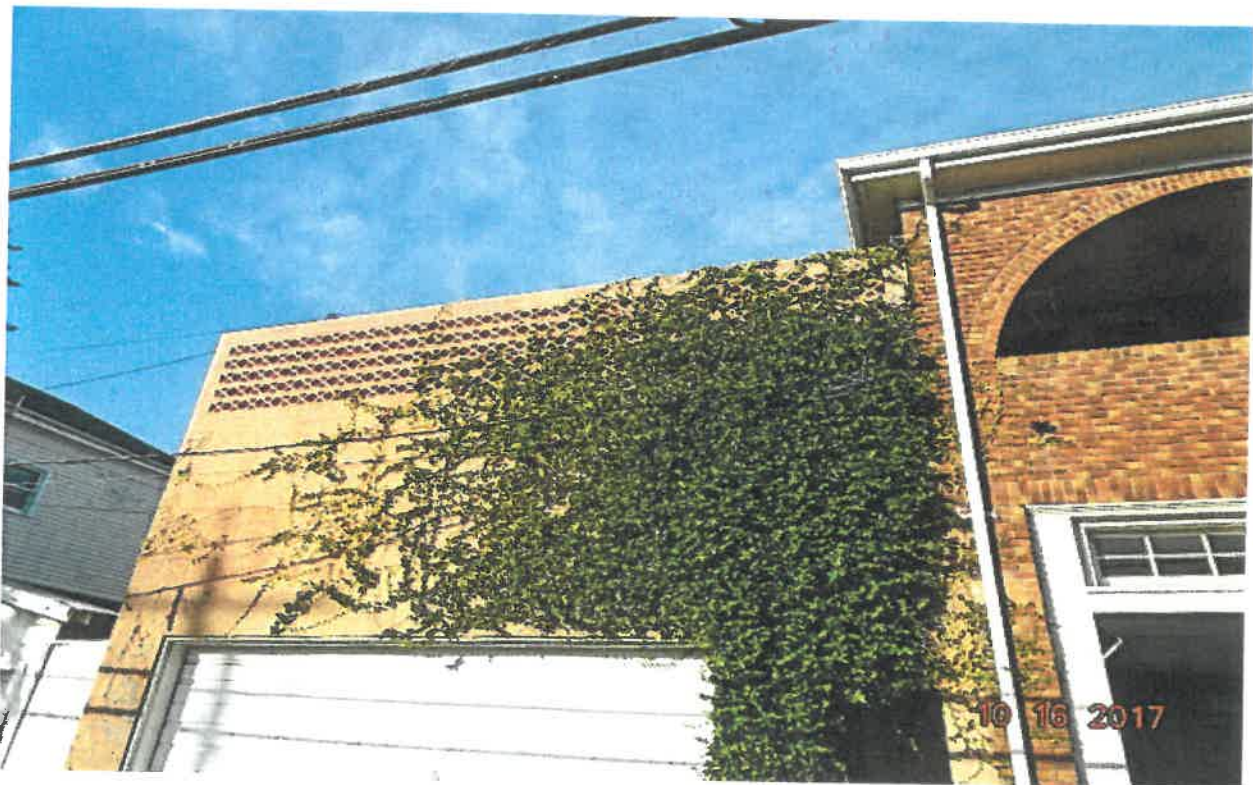
Photo # 2 Garage addition at rear of building

- Remove and replace the flat roof covering on the garage with an appropriate roofing material such as TPO or similar material.
- It is recommended that

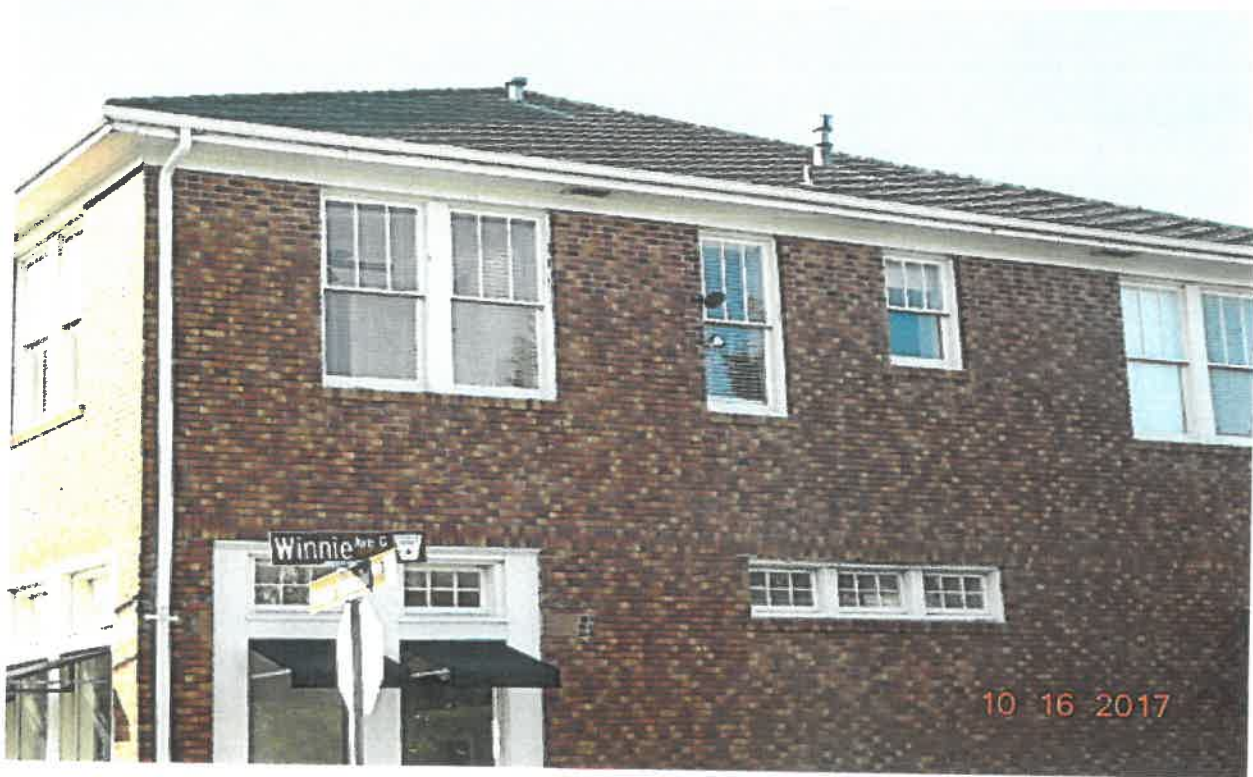
Photo # 5 Front of building from Winnie Street

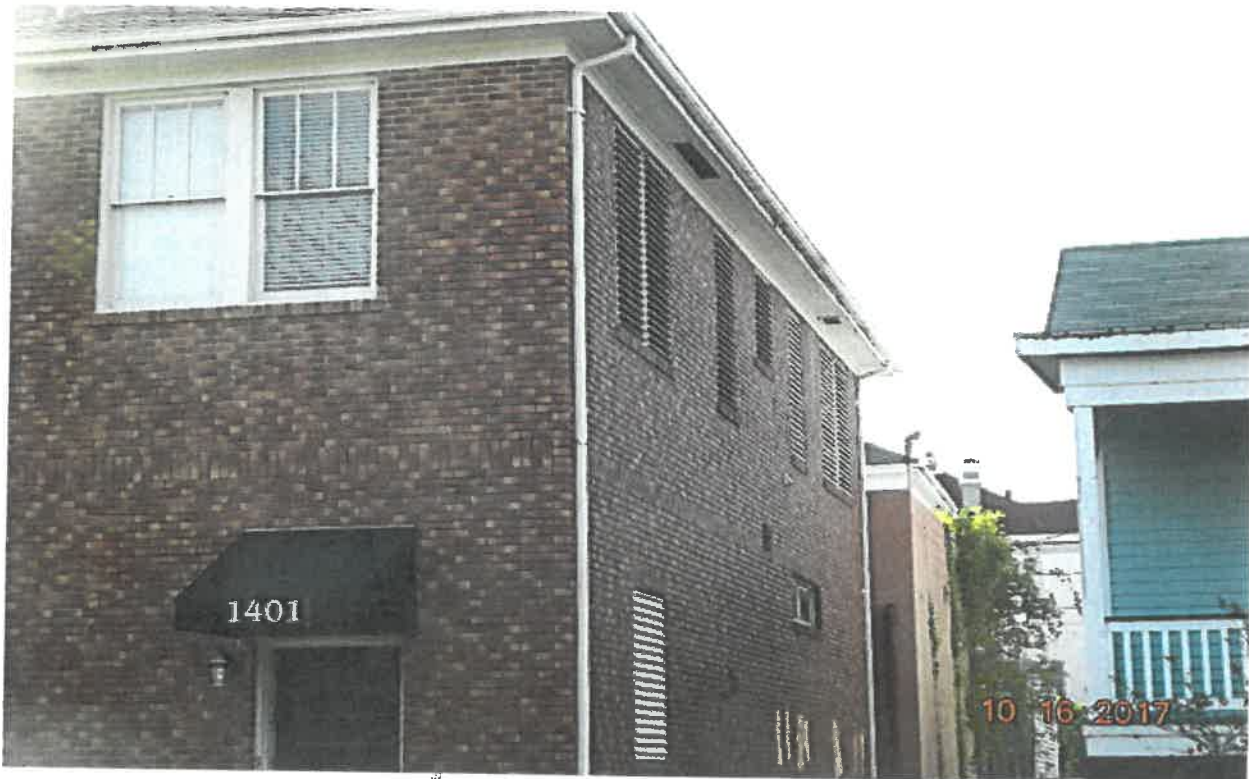
Photo # 6 Right front and right side of building from Winnie Street

- Consideration should be given to replacing exterior personnel doors with hurricane resistant doors.
 - The steel lintels over the transom windows on the front and right side of the building be repaired or replaced, as recommended by a qualified brick mason.

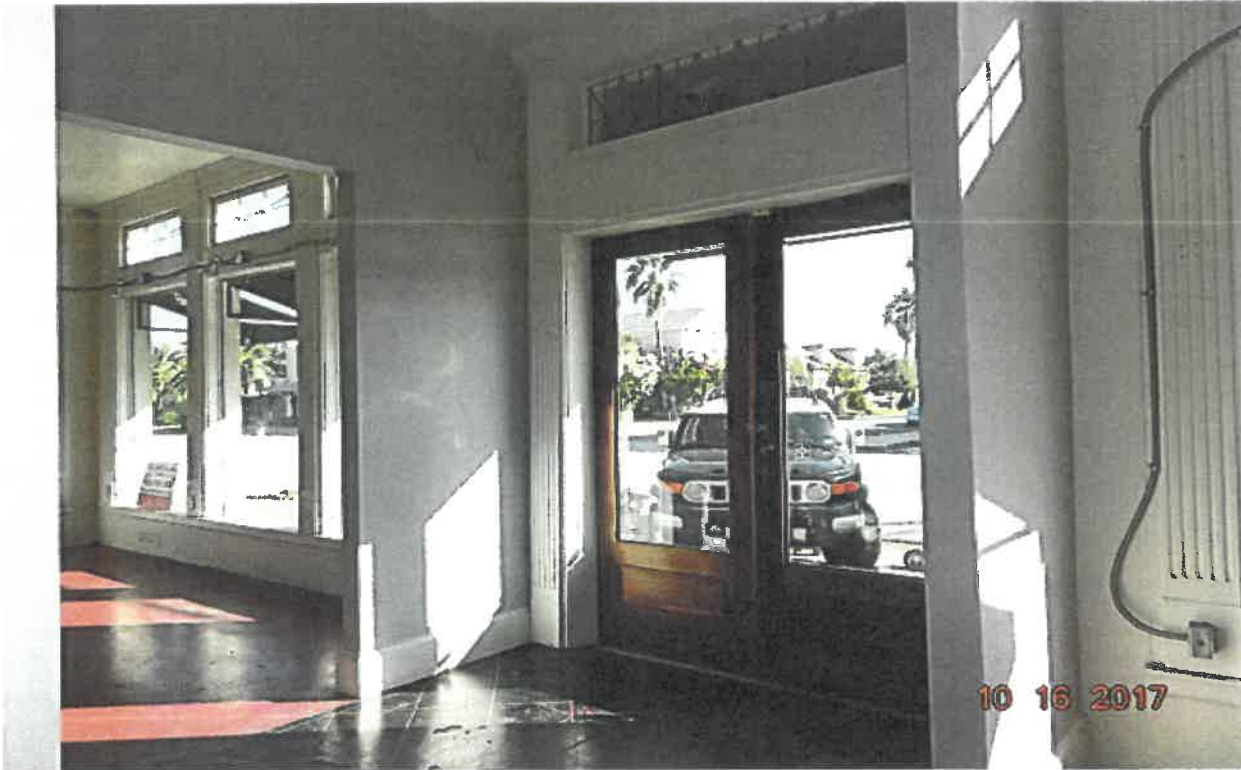
Photo # 11 Front entry to office space

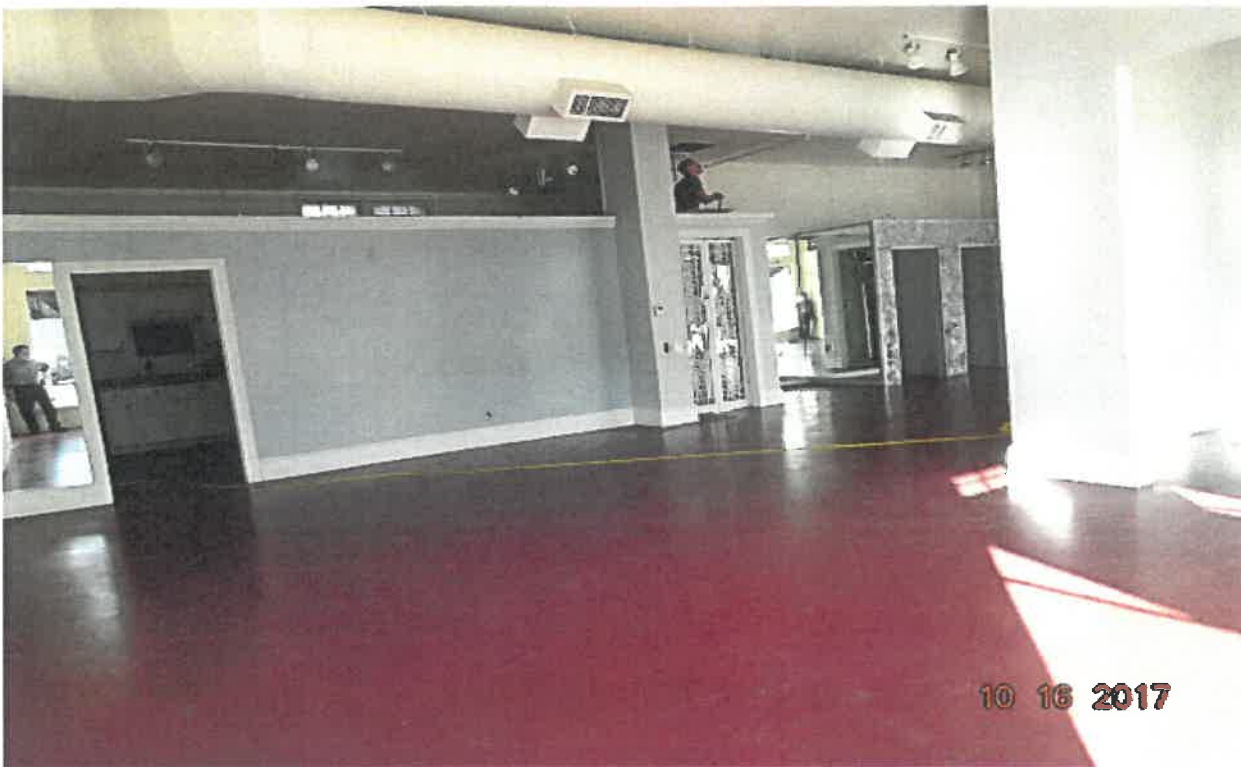
Photo # 12 Typical of office space

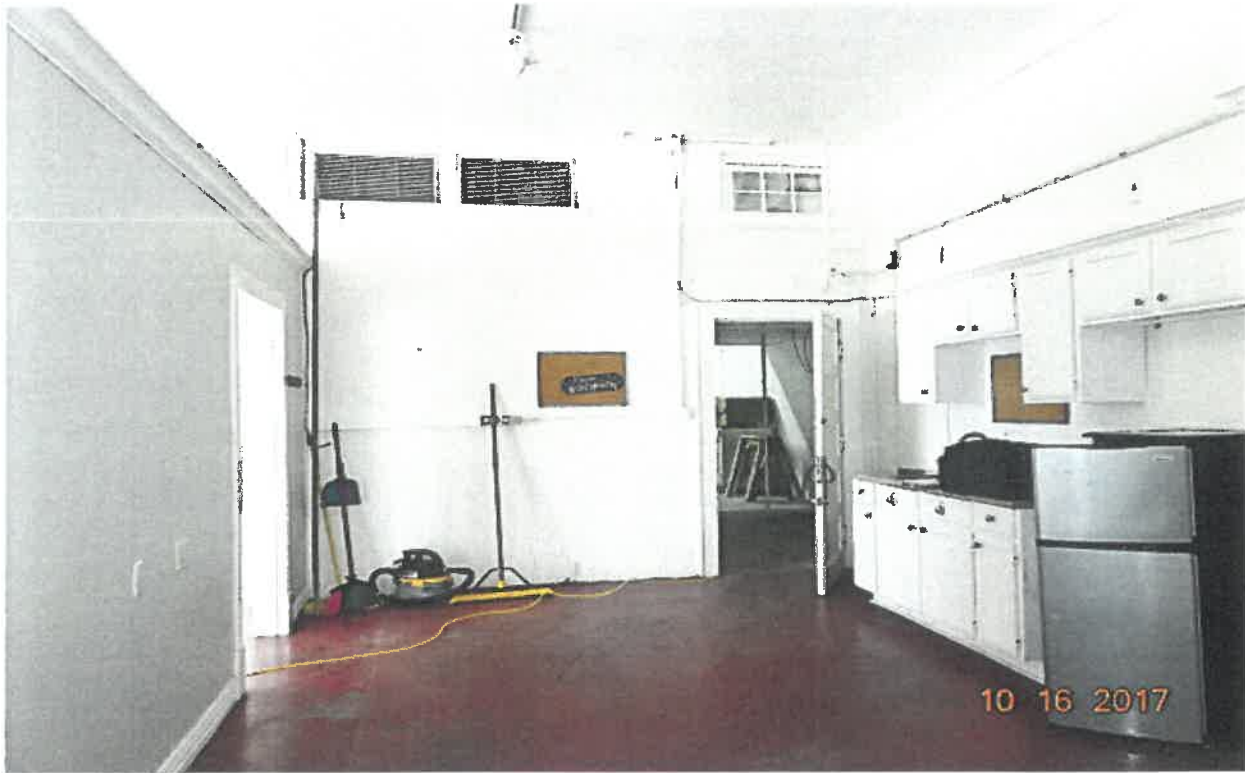
Photo # 13 Downstairs (office) kitchen

- It is recommended that appliances be cleaned or, as mentioned by client, replaced. It is recommended that the temperature/pressure relief valve drain line for the water heater in the garage be modified as discussed during the inspection.

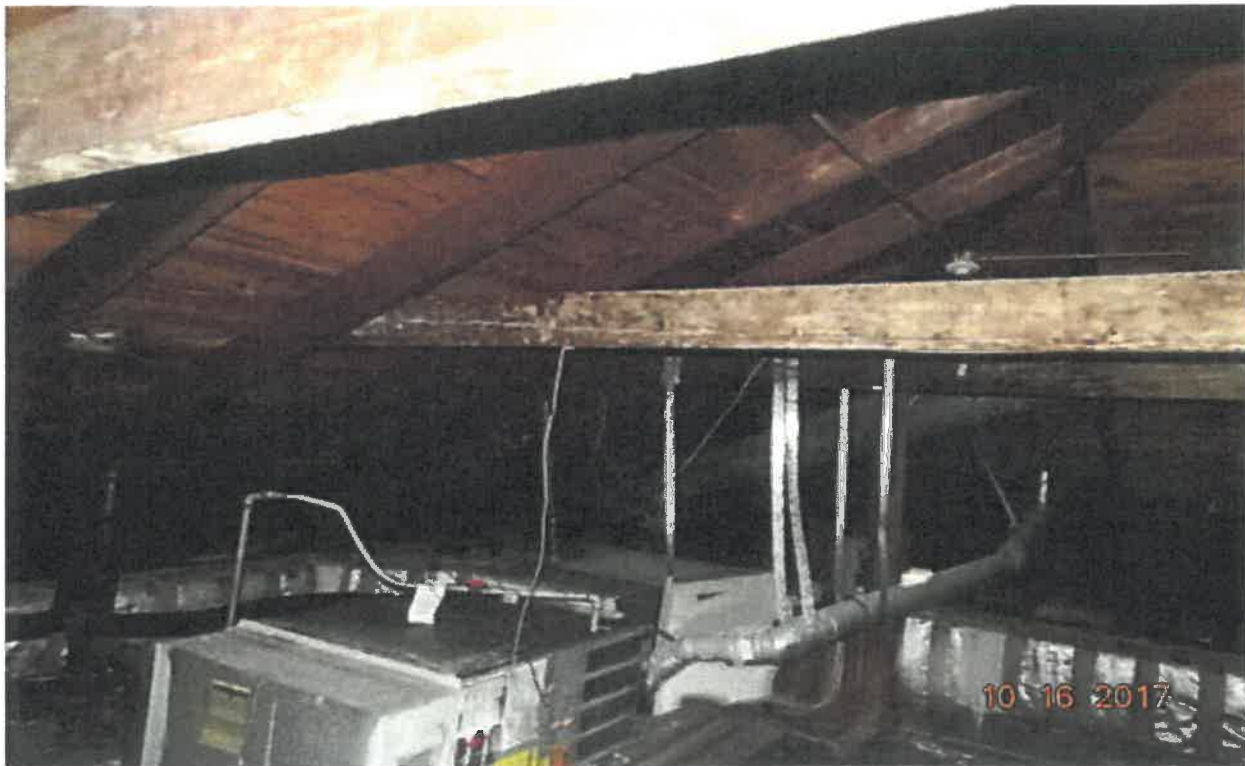
Photo # 14 Typical of attic

- It is recommended that the inoperative attic power vent system be repaired.
- It is recommended that a high water shut off switch be installed in the secondary condensate drain pan for the unit in the garage.

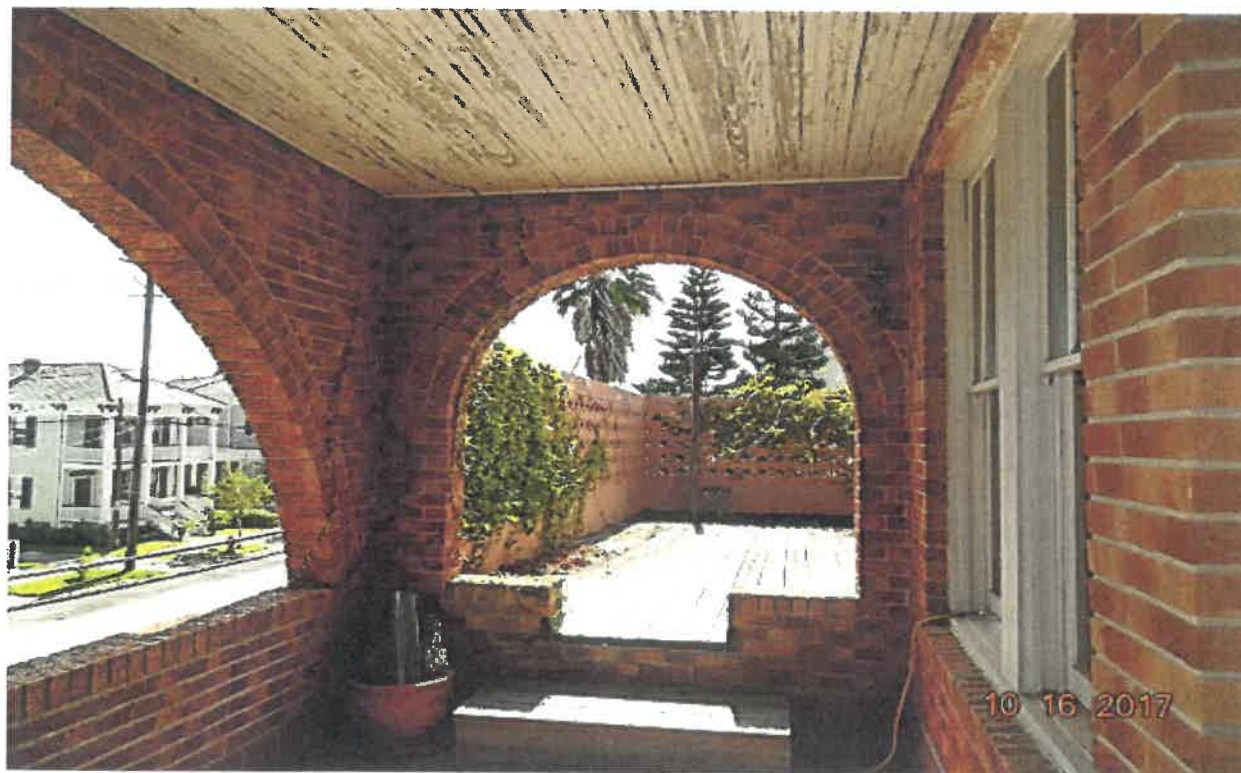
Photo # 18 Second level patio

- It is recommended that the deck over the garage be removed and replaced, to include the roofing under the deck.
