## Inspection Report

**Property Address:**  
2219 Rambling Brook Dr  
Spring Texas 77373

# PROPERTY INSPECTION REPORT

**By:** Stephen Weston TREC #21249 / Weston Inspection 6/2/2021

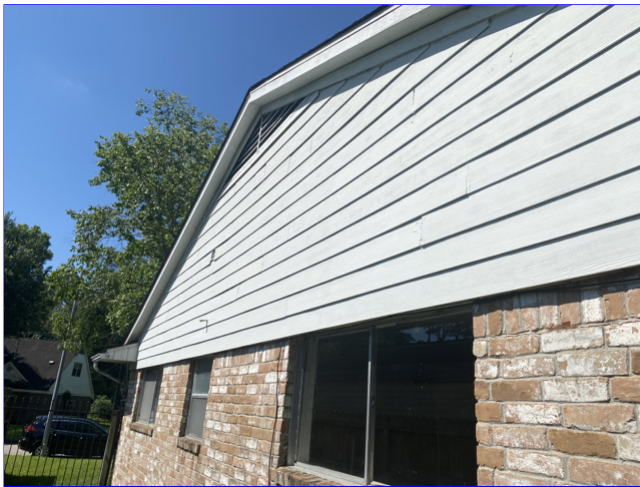
E. Item 4(Picture)

(4) The damage observed at some wood siding and framing members was consistent with damage from wood destroying insects. Inspector recommends further evaluation by a licensed termite technician to advise on any necessary treatments.

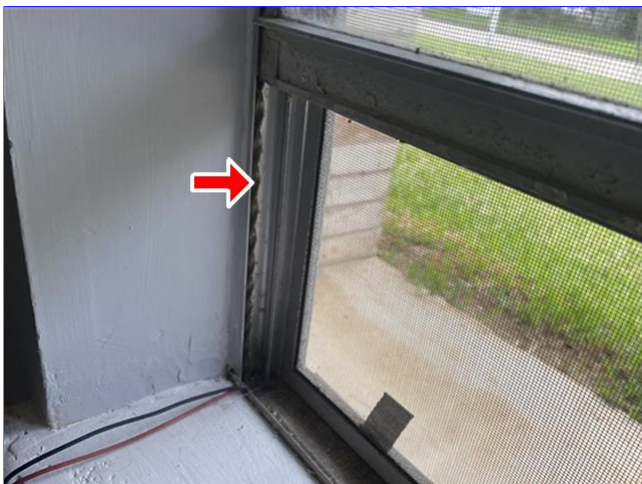
H. Item 3(Picture)

(5) Inspector was unable to open a rear dining area window while applying excessive force.

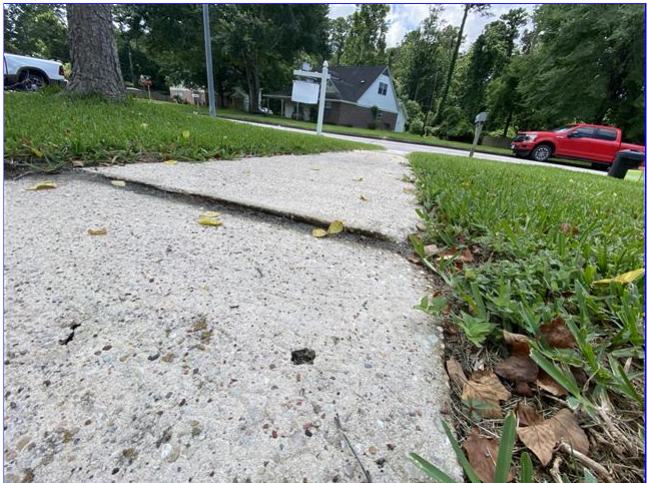
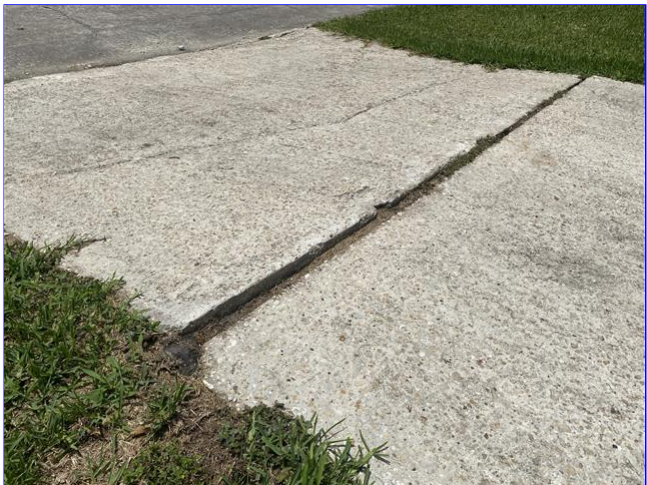
(2) The driveway had severe cracking visible at the time of the inspection. The source of cracking appeared to be soil movement.

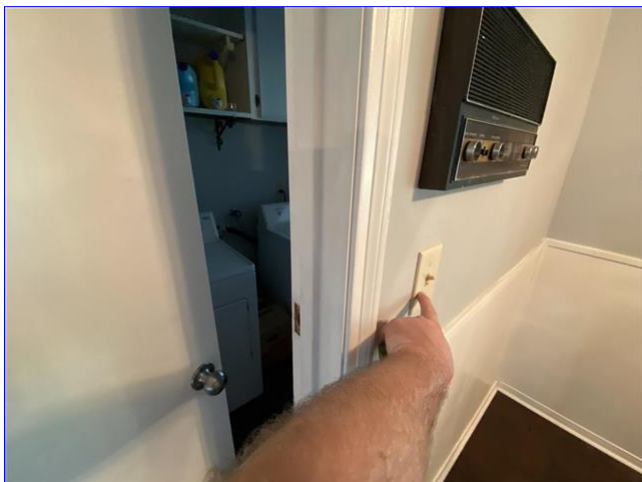
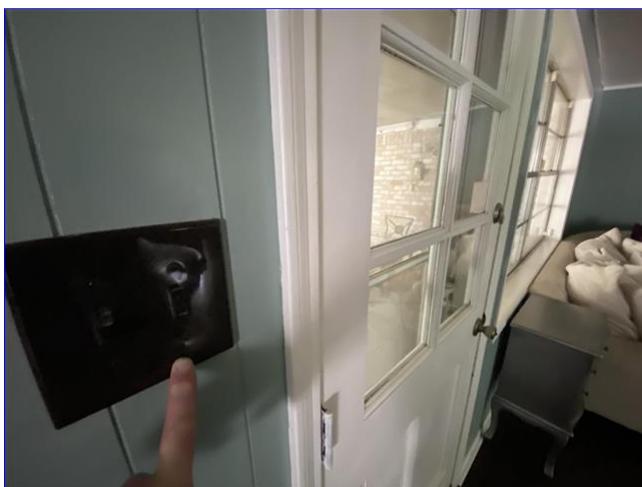
(9) Multiple fans would not operate on all speed settings, at the time of inspection. (Master bedroom and living room ceiling fan)
