Inspection Report

Property Address:
6411 Waldron Dr. Unit A and B
Houston TX 77084

GOLDEN SCOPE INSPECTION SERVICES

PROPERTY INSPECTION REPORT

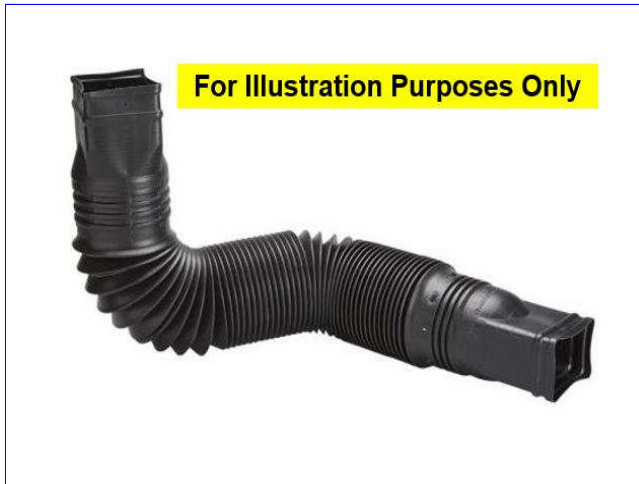
B. Item 2(Picture) Extension

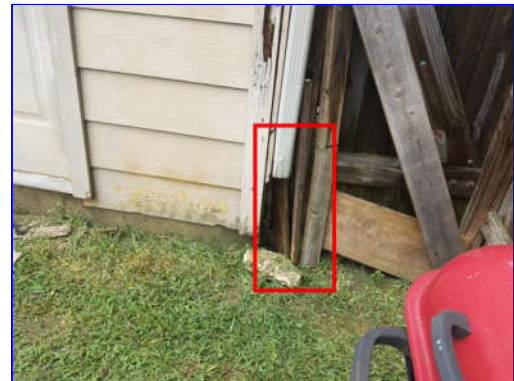
B. Item 3(Picture) Unit A

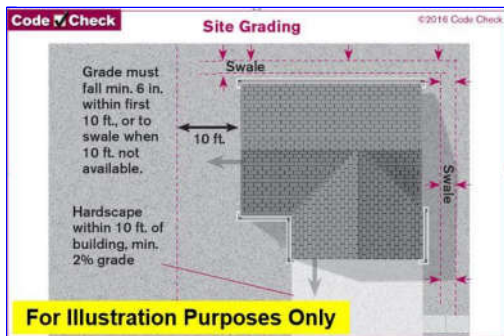
B. Item 4(Picture) Drainage

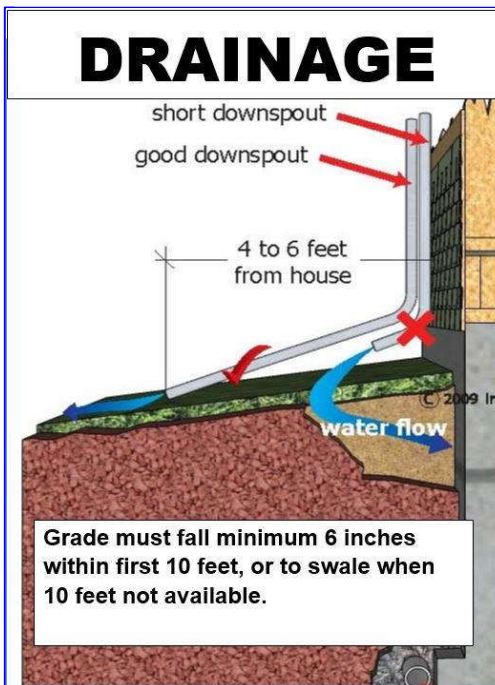
B. Item 5(Picture) Drainage

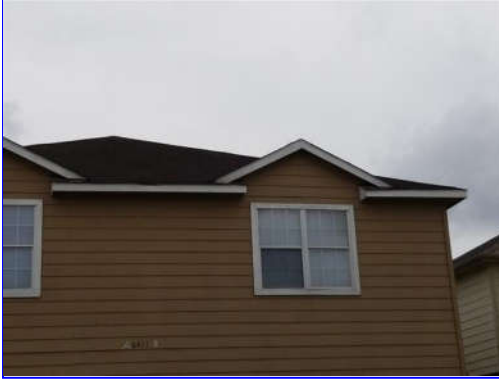
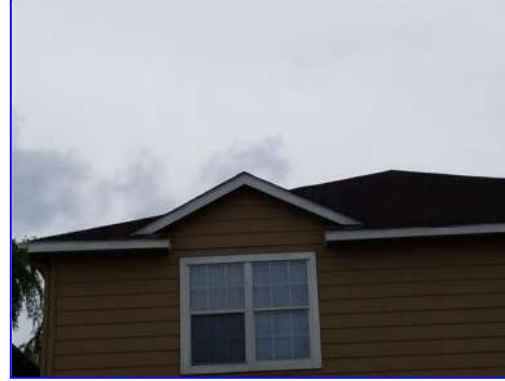
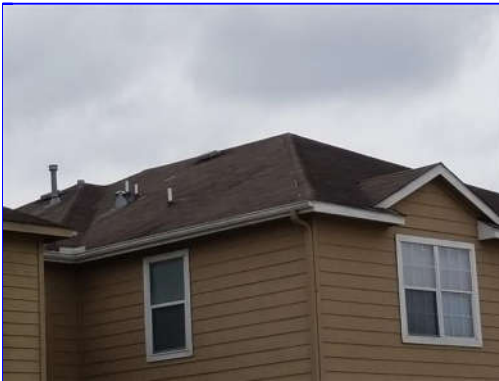
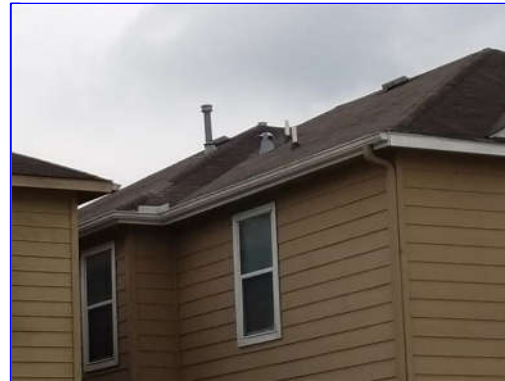
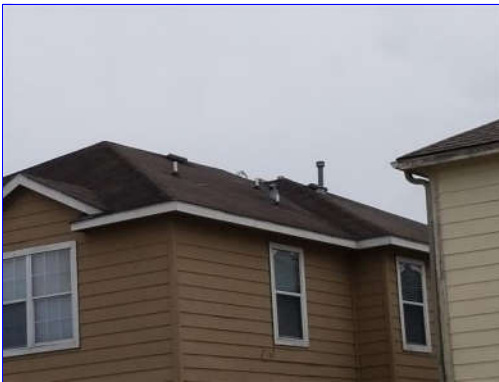
- The roof covering was observed to be older but serviceable. Repairs are needed. A qualified roofer should be consulted to further evaluate these conditions and provide an estimated cost of repairs.

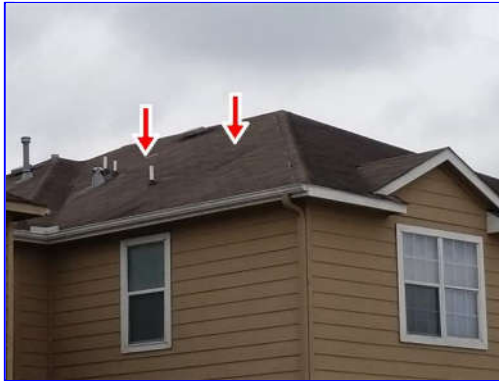
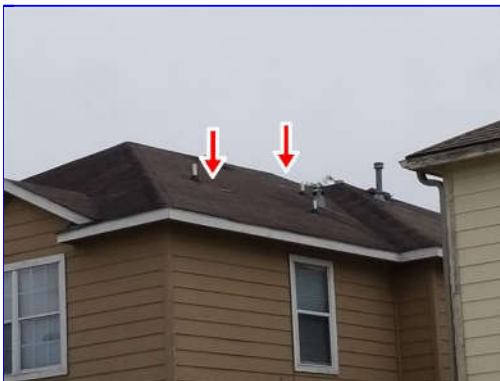
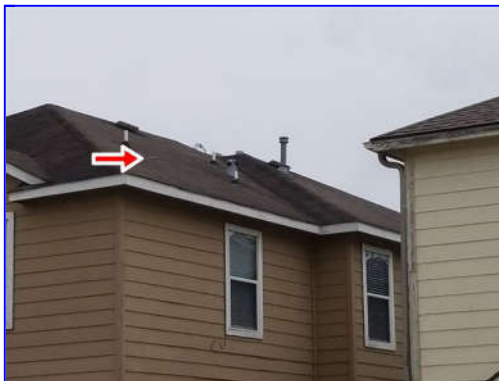
C. Item 6(Picture) Examples of damaged shingles

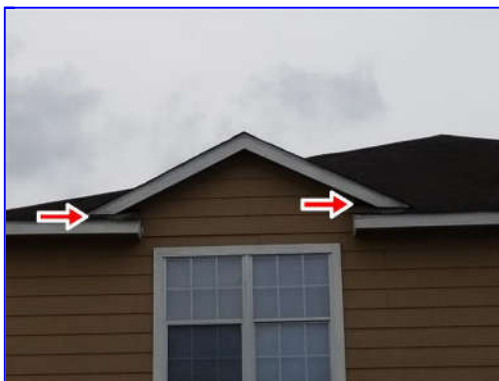
C. Item 11(Picture)

- The clearance of the siding and/or trim at the flashing was observed to be insufficient. This condition leaves the siding and/or trim vulnerable to rot. This detail is usually repaired when siding and/or trim needs repair or replacement or when re-roofing work is performed.

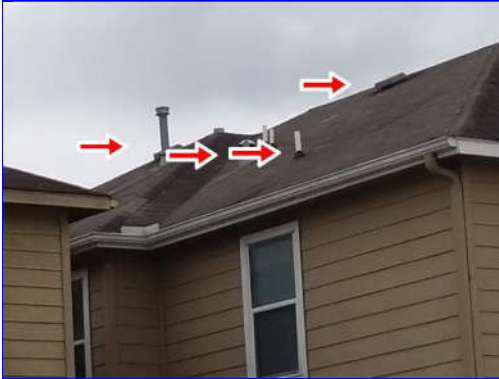
C. Item 12(Picture)

- Most plumbing vent jacks and roof jacks at various locations were observed to be raise, and damaged. They should be replaced to prevent water intrusions.

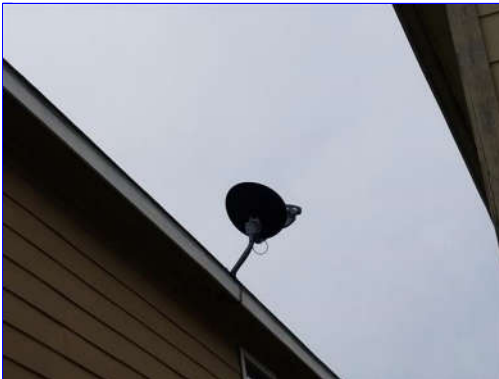
C. Item 14(Picture)

- **BUYERS ADVISORY NOTICE:** This home was observed to have a roof mounted satellite dish and/or unused brackets from removed satellite dishes. The type mounting bracket observed has been known to create roof leaks. Installation of a mounting bracket that will not damage shingles may be advisable. In addition, when removing the brackets, the roof covering beneath the bracket should be replaced to avoid water intrusion.

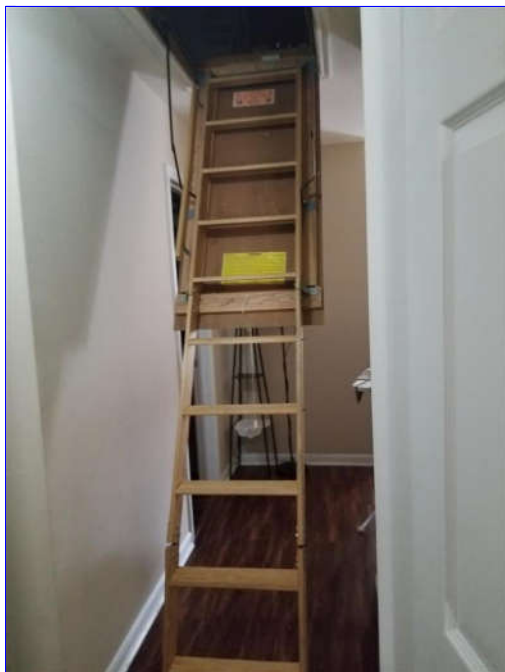
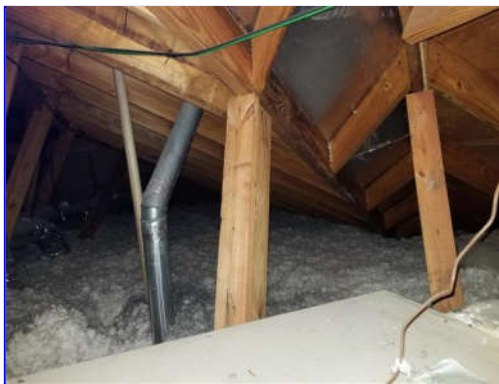
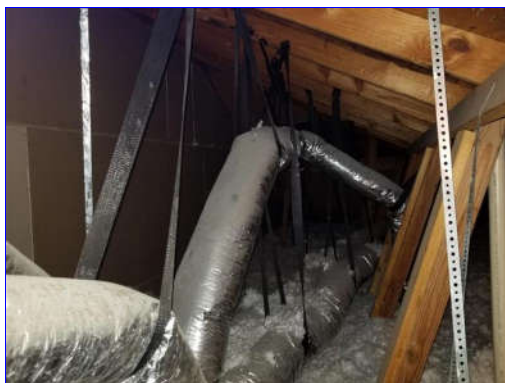
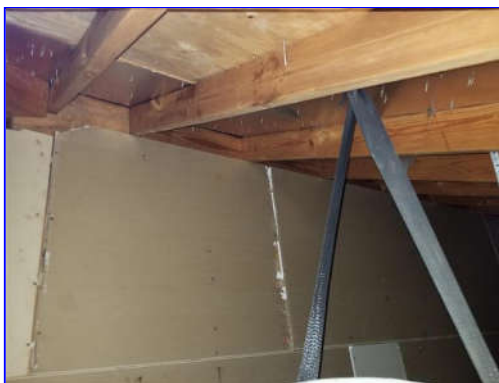
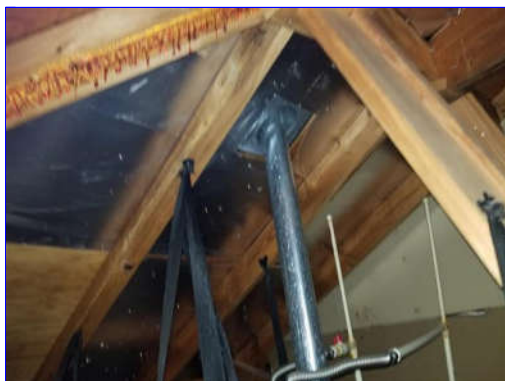
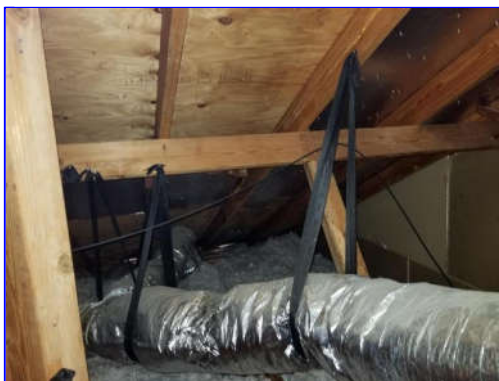
- Attic framing was observed to be installed and functioning as intended with no major defects observed.

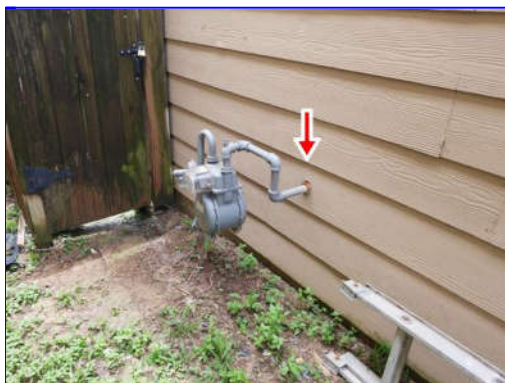
E. Item 1(Picture)

- Caulking brick, siding, doors, expansion joints, exterior light(s), exterior penetrations into home, fascia, garage door, trim, hose bib penetrations, vent terminations and windows in various locations, was/were observed to be cracked. Caulking improvements should be undertaken as needed.

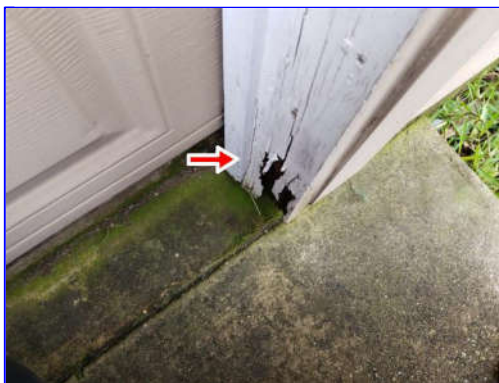
E. Item 7(Picture)

- The siding and/or trim was/were observed to have the following defect(s): are damaged. I recommend repair as needed.

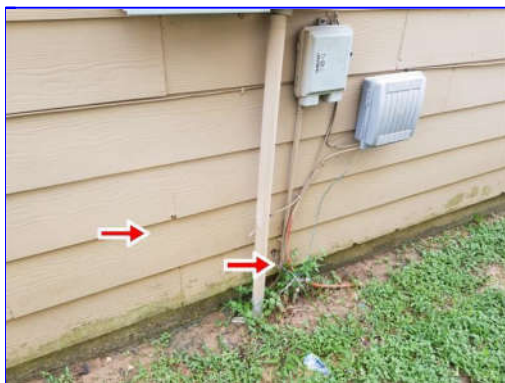
E. Item 32(Picture)

- Caulking brick, siding, doors, expansion joints, exterior light(s), exterior penetrations into home, fascia, garage door, trim, hose bib penetrations, vent terminations and windows in various locations, was/were observed to be is missing. Caulking improvements should be undertaken as needed.

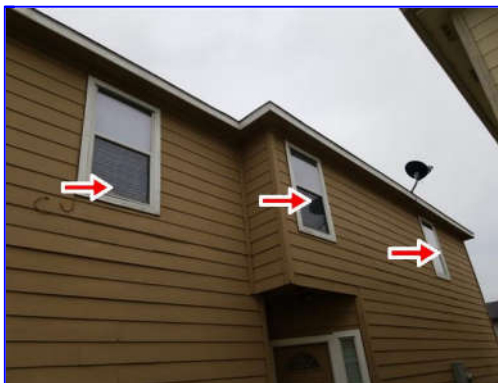
E. Item 37(Picture)

- The siding and/or trim was/were observed to have the following defect(s): damaged loose. I recommend repair as needed.

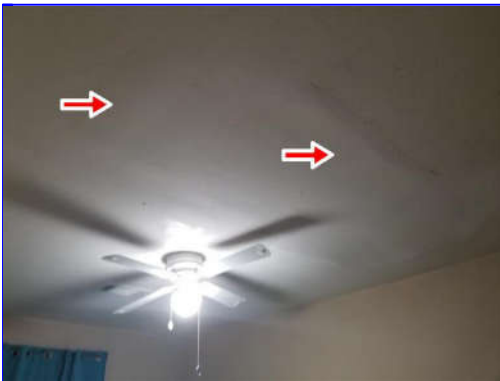
F. Item 1(Picture)

- The ceiling and floor system in this unit is in fair condition with no major damage.
- Evidence of repairs/previous damage were observed. The area could not be reached to test with a moisture meter. The area appears to be dry at the time of inspection
- Evidence of moisture intrusion was observed at the ceiling. The area was tested with a moisture meter. Excessive moisture levels were not observed. The source of water intrusion appears to originate at the exterior of the home

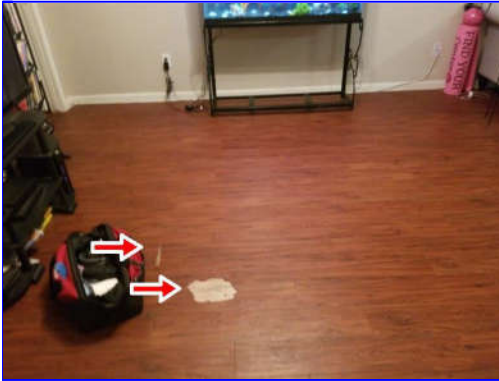
F. Item 3(Picture)

- The floor in the living room is damaged. It should be repaired

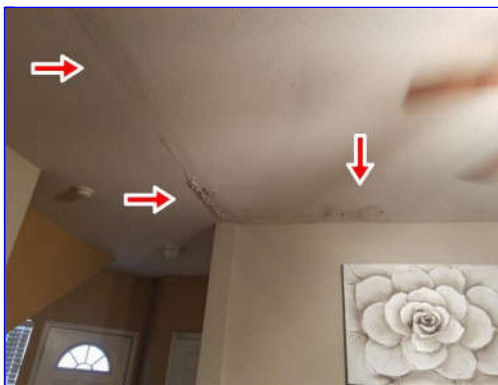
F. Item 5(Picture) living room

- Evidence of moisture intrusion was observed at the ceiling in various locations. The area could not be reached to test with a moisture meter. The source of water intrusion appears to originate at the exterior of the home Sheetrock and insulation affected by moisture should be removed and replaced. Preventive measures for microbial hazards should be undertaken by a qualified, verified professional
- An organic biological substance was/were observed to be present on walls, ceiling or other surfaces. We did not inspect, test or determine if this growth is or is not a health hazard. The underlying cause is moisture or dampness. I recommend you contact a licensed mold inspector for investigation or correction if needed. This is a potential safety hazard and should be investigated further.

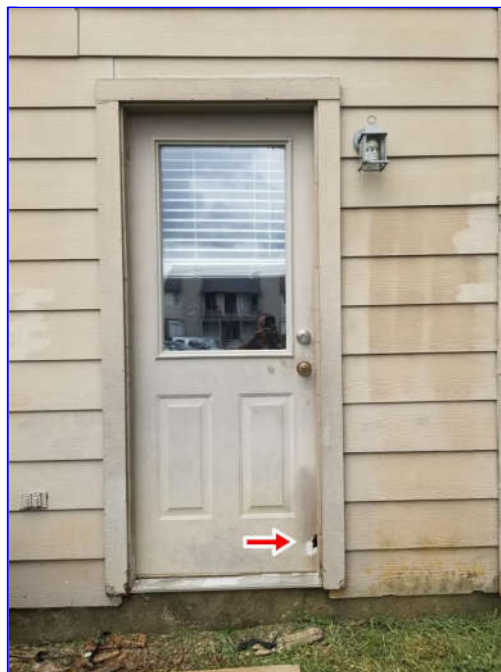
G. Item 2(Picture)

- The rear door was observed to have excess air gap, damaged weather stripping, door and frame are deteriorated at the bottom
- The door to the garage has damaged weather stripping

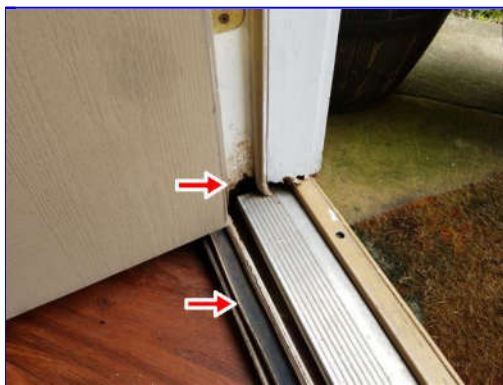
G. Item 4(Picture)

- The rear door was observed to have excess air gap, damaged weather stripping, door and frame are deteriorated at the bottom
- The front door has a loose threshold, door frame is damaged at the bottom, excessive air gap.
- The garage door binds on frame.
- The kitchen pantry door binds on frame.
- The garage door panels are damaged.

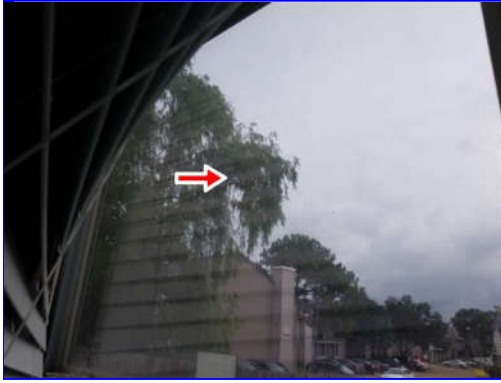
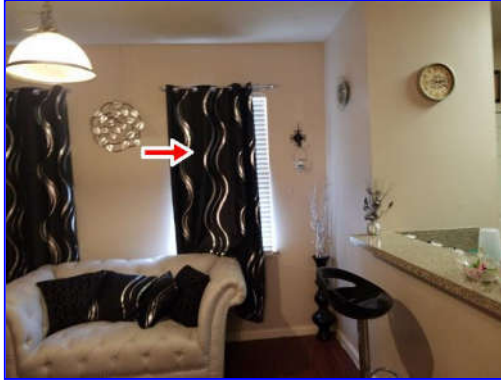
- The window(s) in the living room is/are fogged suggesting the seals have failed. A qualified, verified window specialist should be consulted regarding this condition.

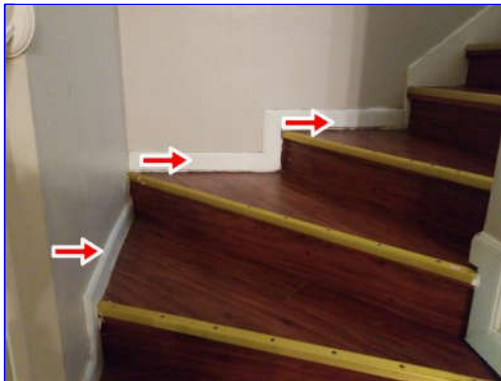
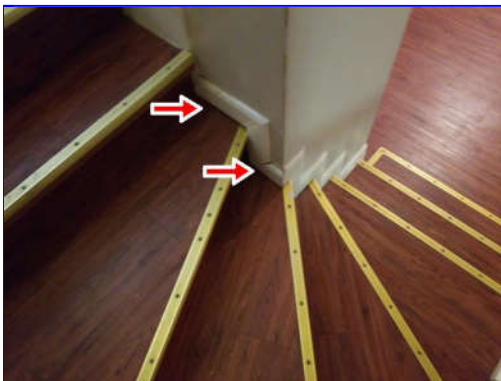
- Several steps are not properly cover along the risers and steps. They should be repaired or sealed.

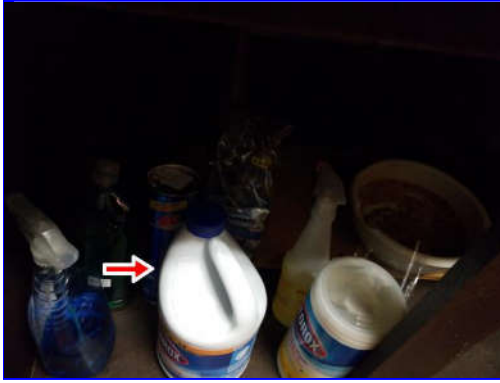
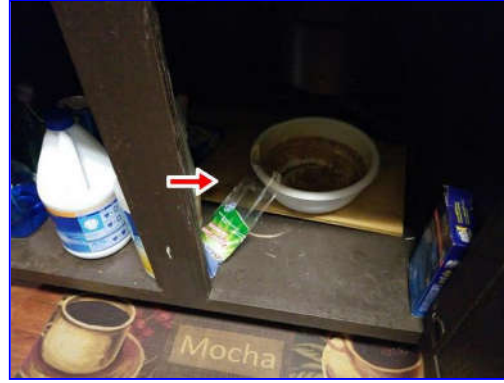
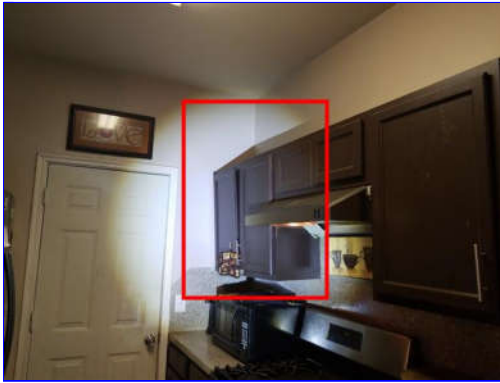
- The kitchen sink cabinet is damaged. It should be repaired.
- The kitchen top cabinet is loose and not properly secured on the wall. This is a safety hazard, it should be repaired.

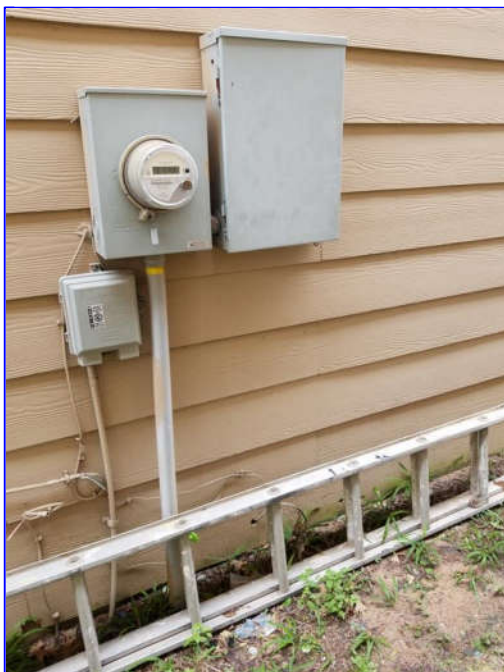
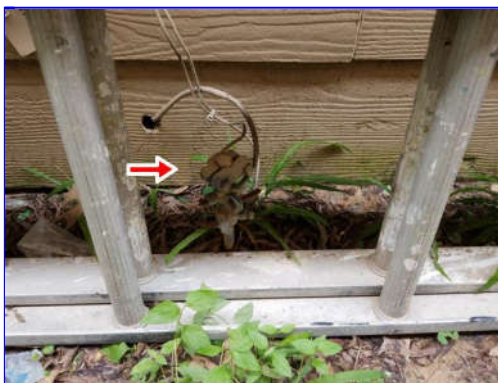
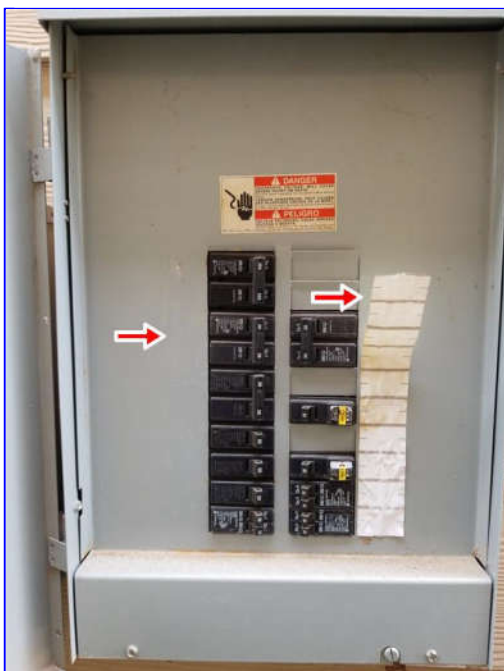
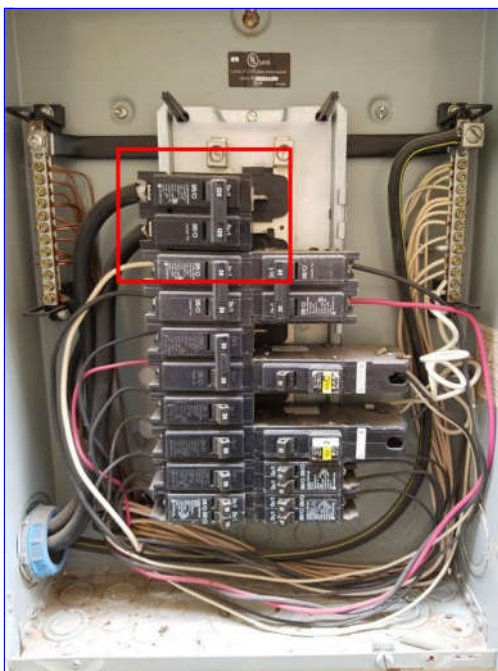
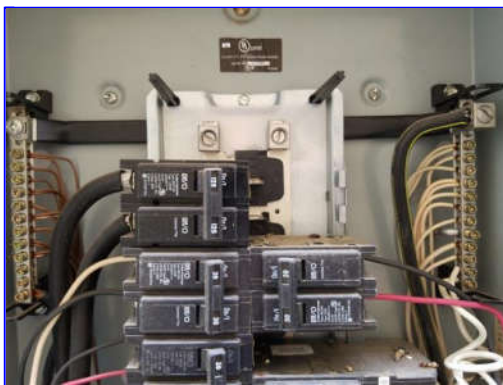
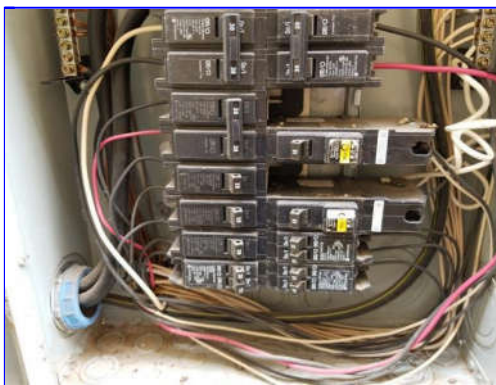
- The aluminum feeder wires are not coated with anti-oxidant paste to prevent corrosion.
- Breakers are missing labels. This is considered to be a potential safety hazard. Breakers should be identified and labelled accordingly. Without proper labelling the inspector cannot determine the proper amperage for appliances such as the HVAC condensing unit(s).

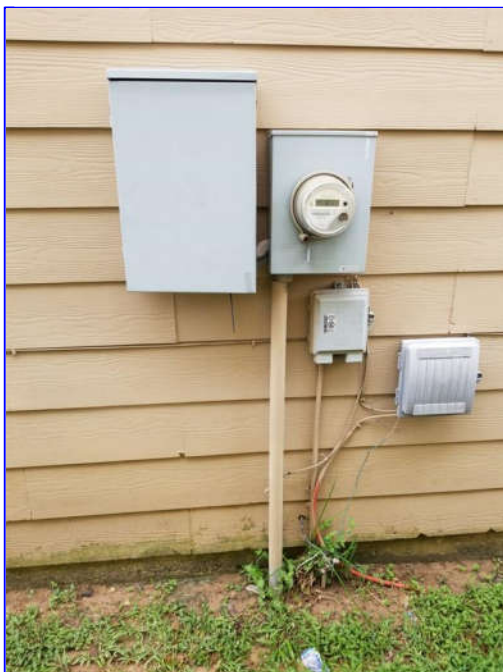
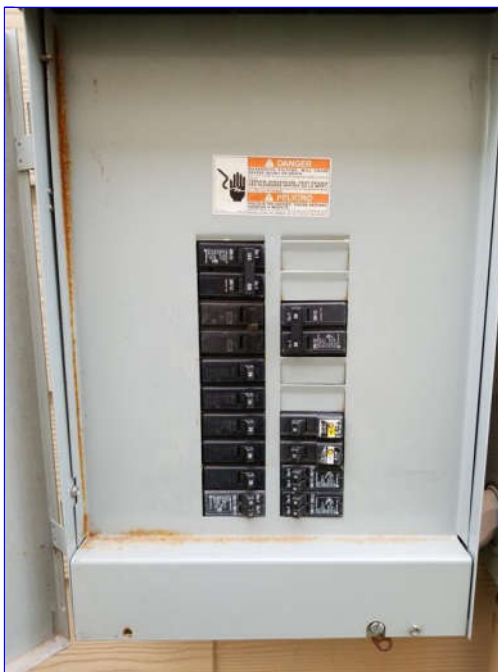
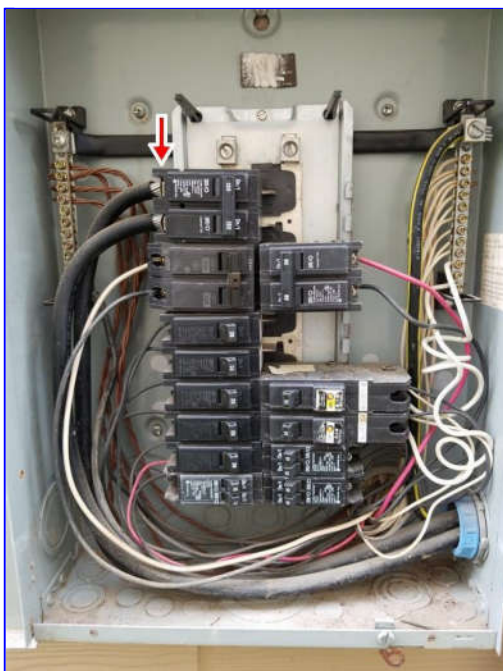
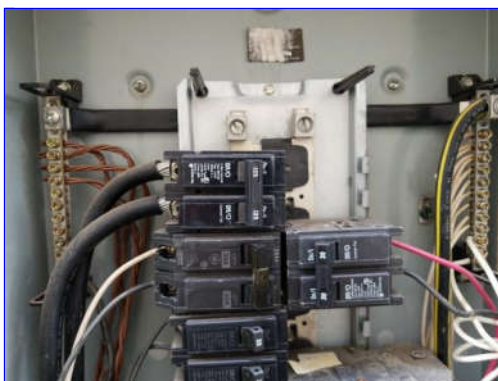
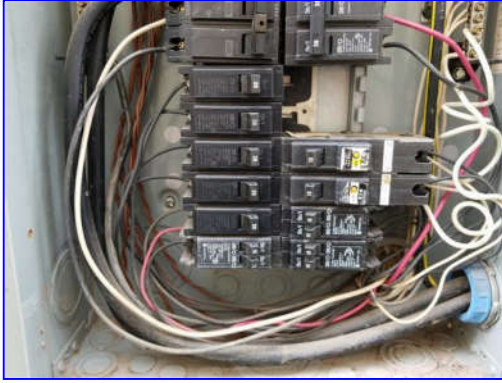
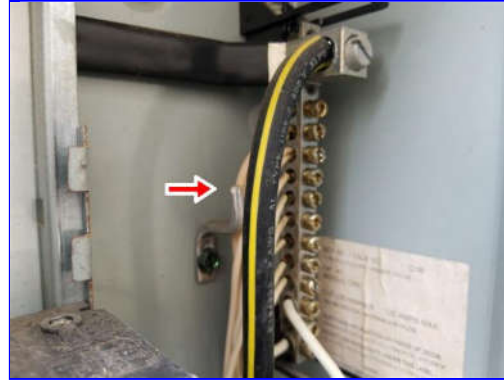
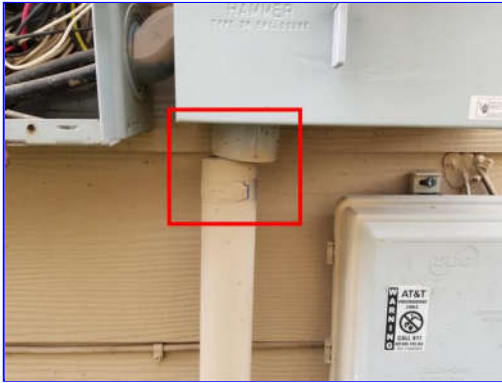
Unit B - Cutlet Hammer - 125 Amps Main Disconnected Breaker with Aluminum Feeder and Copper Branch Circuits

- The aluminum feeder wires are not coated with anti-oxidant paste to prevent corrosion.
- The main panel enclosure is not properly bonded to the grounding system. This condition is a safety hazard.
- The service entrance conduit is disconnected at the electrical meter. It should be repaired.

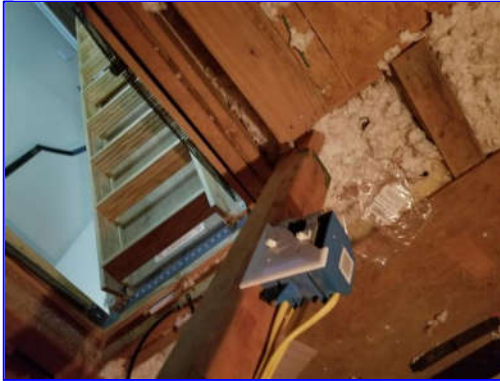
B. Item 1(Picture)

- One outlet cover plate in the attic is damaged and it should be replaced.
- Exterior receptacle(s) was/were observed to have a damaged weather-proof covering. Repair is needed.

- Several light fixture(s) in various locations throughout the home is/are inoperative. If the fixture does not work after replacing the bulbs, a licensed electrician should be consulted. .

- Smoke detector(s) was/were observed to have the following defect(s): is/are not installed in all required locations in the home in various locations throughout the home. Smoke detectors are critical to occupant safety and should be repaired as needed. By current standards smoke detectors are required in each sleeping area, in the vicinity outside the sleeping area, and one each inhabitable level of the home. Smoke detectors in newer homes are required to be hard wired to the electrical system, have battery backup, and be interlinked to activate all smoke detectors in the home if one is activated. All smoke detectors should have batteries replaced upon moving into the home. This ensures all batteries are new and in working order.

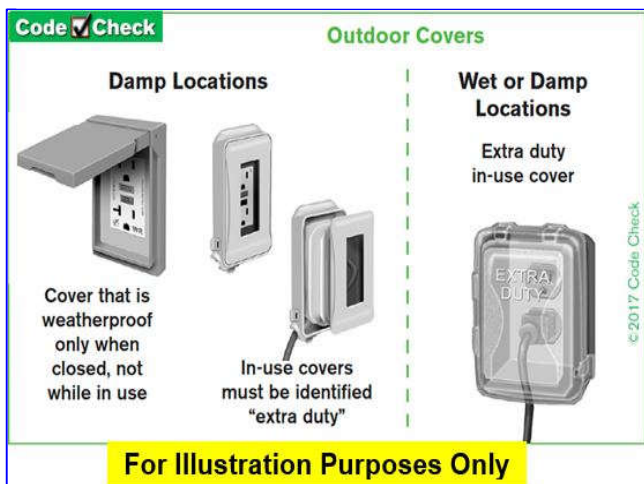
B. Item 2(Picture) Exterior Receptacle

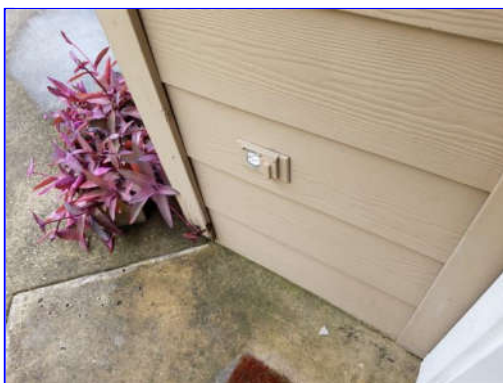
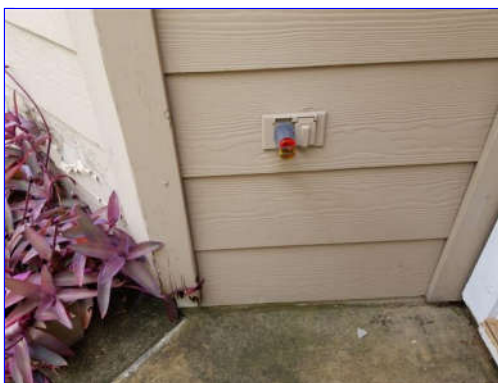
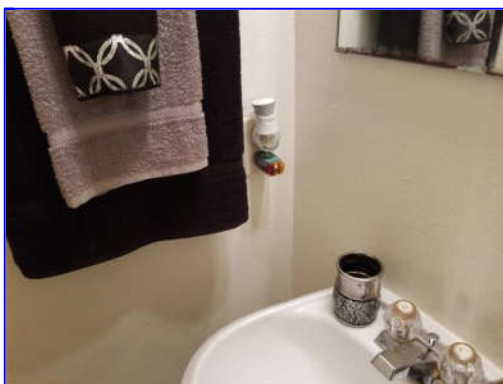
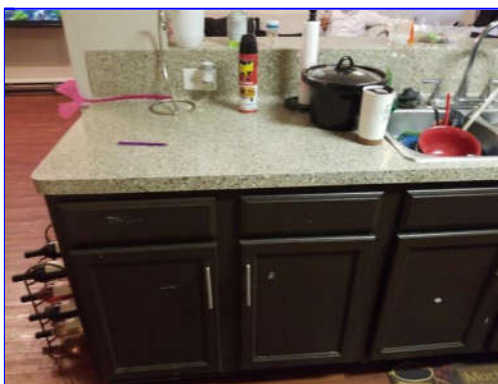
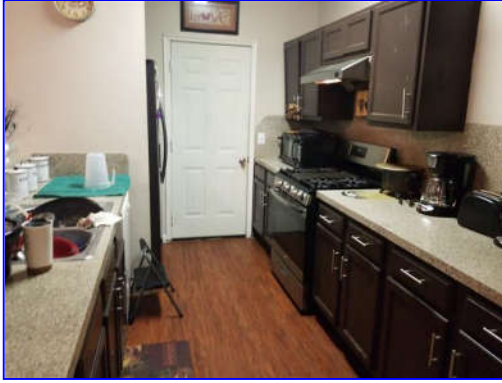
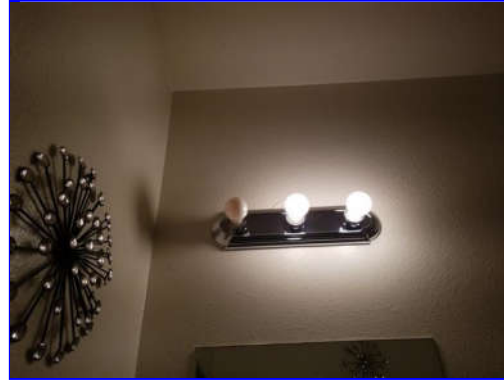
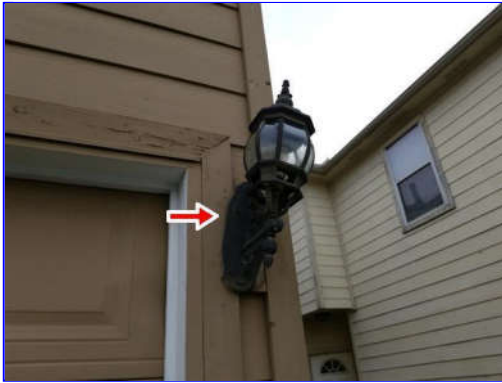
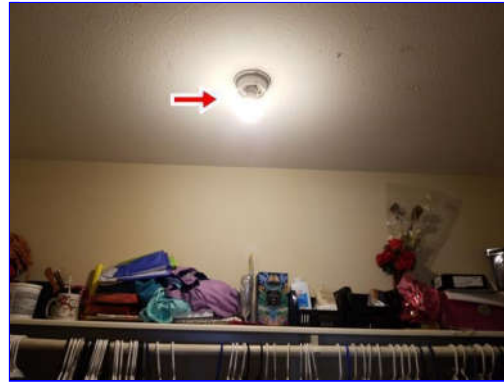
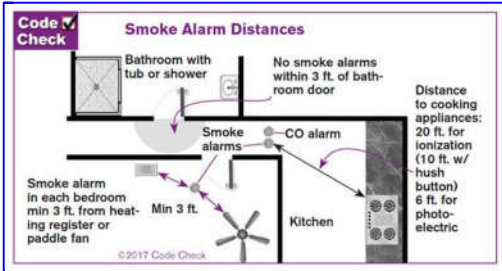
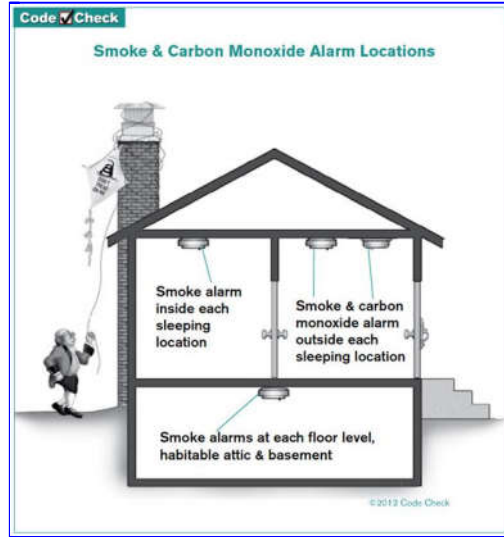
- Exterior receptacle(s) was/were observed to have a damaged weather-proof covering. Repair is needed.
- Several light fixture(s) in various locations throughout the home is/are inoperative. If the fixture does not work after replacing the bulbs, a licensed electrician should be consulted.

- All ground fault interrupt receptacle(s) in required locations, kitchen countertops, kitchen island, bathrooms, exterior, garage and/or within six feet of a sink was/were observed to have the following defect(s): did not trip when tested. A defective GFCI receptacle will affect other receptacles on this circuit, possibly in other rooms or in other locations requiring GFCI protection Repairs should be undertaken by a qualified, verified, licensed electrician.

- The exterior light fixture is loose and not properly mounted. It should be repaired
- Light fixture(s) at closet(s) in various locations throughout the home should have shade or globe installed. This condition is a potential fire hazard.

- Smoke detector(s) was/were observed to have the following defect(s): is/are not installed in all required locations in the home in various locations throughout the home. Smoke detectors are critical to occupant safety and should be repaired as needed. By current standards smoke detectors are required in each sleeping area, in the vicinity outside the sleeping area, and one each inhabitable level of the home. Smoke detectors in newer homes are required to be hard wired to the electrical system, have battery backup, and be interlinked to activate all smoke detectors in the home if one is activated. All smoke detectors should have batteries replaced upon moving into the home. This ensures all batteries are new and in working order.

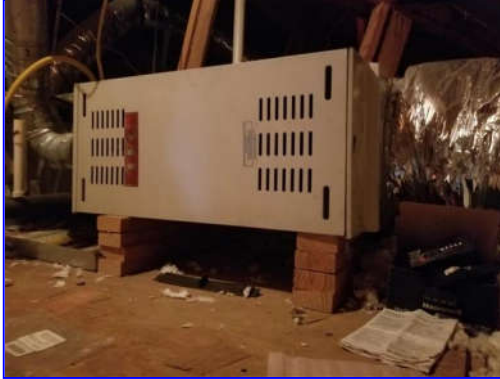
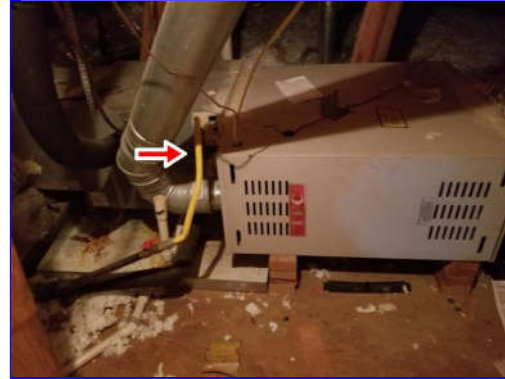
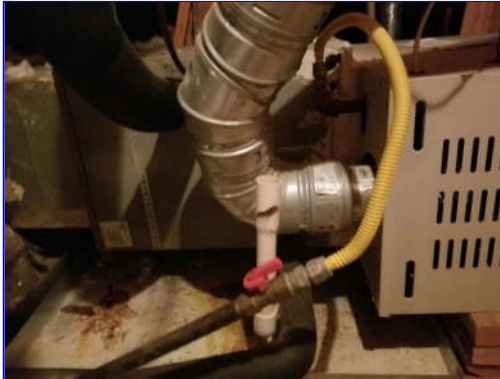
Unit A - Gas Furnace: TFC

- The heater/furnace gas supply line is not equipped with a sediment trap just before the appliance connector. This condition does not meet current installation requirements and should be corrected. Sediment traps prevent debris from entering the gas controls and causing hazardous malfunctions. A licensed, qualified plumber should be consulted regarding this condition.
- The furnace is supporting by wood blocks. Wood blocks is not a stable structure. A more stable and solid structure to be replaced.

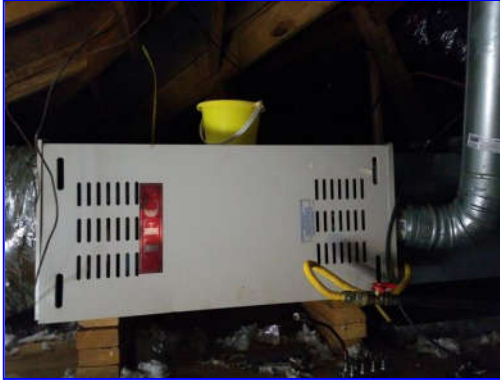
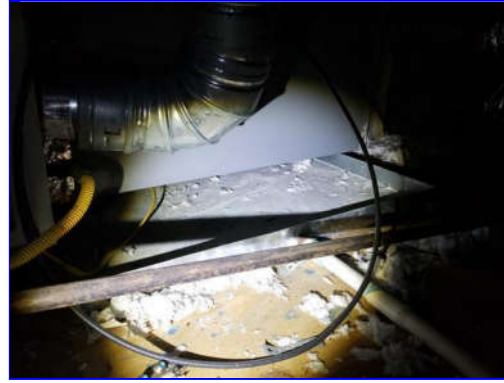
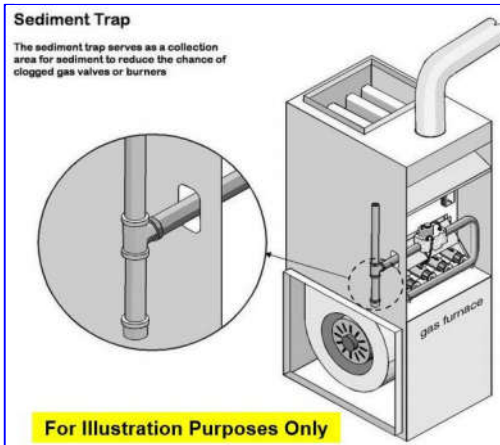
Unit B - Gas Furnace: TFC

- The heater/furnace gas supply line is not equipped with a sediment trap just before the appliance connector. This condition does not meet current installation requirements and should be corrected. Sediment traps prevent debris from entering the gas controls and causing hazardous malfunctions. A licensed, qualified plumber should be consulted regarding this condition.
- The furnace is supporting by wood blocks. Wood blocks is not a stable structure. A more stable and solid structure to be replaced.

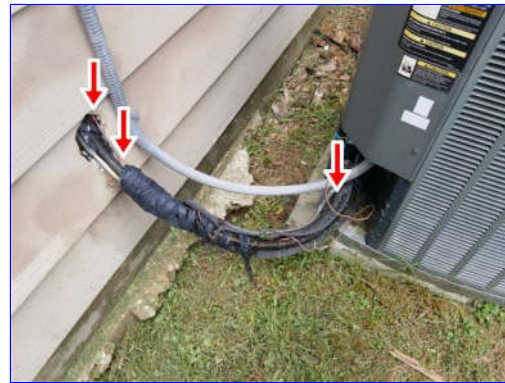
B. Item 2(Picture)

- Severe damage to the condensing unit fins was observed. This lessens the efficiency and may result in other conditions developing with the HVAC system. A qualified, verified, licensed HVAC technician should be consulted regarding repair or replacement.

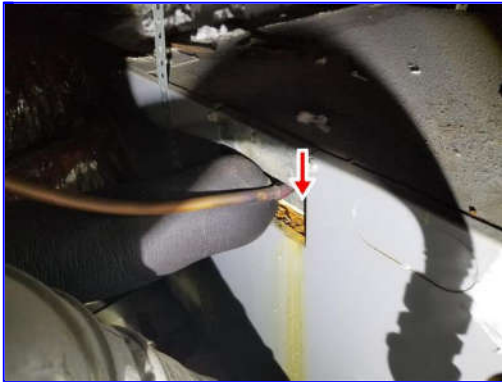
B. Item 9(Picture)

Unit B - Delta T 14 degrees

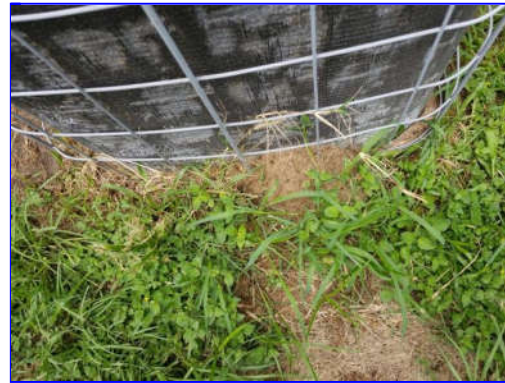
B. Item 11(Picture)

- The condensing unit is very loud while running. It should be repaired by a licensed HVAC technician.
- Locking caps for HVAC freon ports are missing. As of 2009, any HVAC system is required to have a locking cap on all units in residential or commercial dwellings. Residential, multifamily, may be subject to significant fines stemming from the lack of locking caps. Only a licensed HVAC company/technician may install or remove the locking cap.
- The insulation at the condensing unit(s) refrigerant line(s) are damaged or missing and should be replaced.
- Coils at the condensing unit are in need of cleaning. A qualified, verified, licensed HVAC technician should be consulted regarding this condition.
- The concrete pad the HVAC condensing unit(s) are sitting on is sinking. Pads should have 3" visible clearance from grade level and be horizontally level.

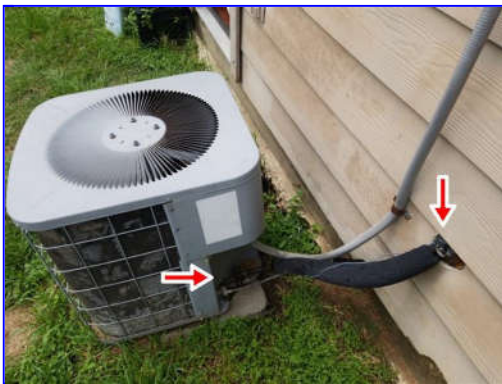
B. Item 12(Picture)

- A refrigerant hood is needed at the HVAC condensing unit lines. Refrigerant hoods should be installed and caulked on the top and sides only. Refrigerant hoods help protect the lines from damage and help prevent moisture, insects and vermin from entering the home if properly installed. A qualified, verified contractor should be consulted regarding this installation.

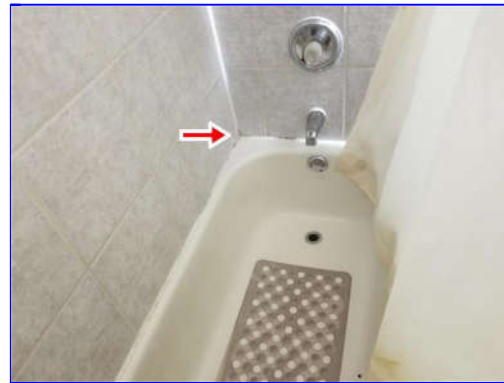
A. Item 2(Picture)

- Caulk/grout improvements are needed at the tub in the hall bathroom and the master bathroom

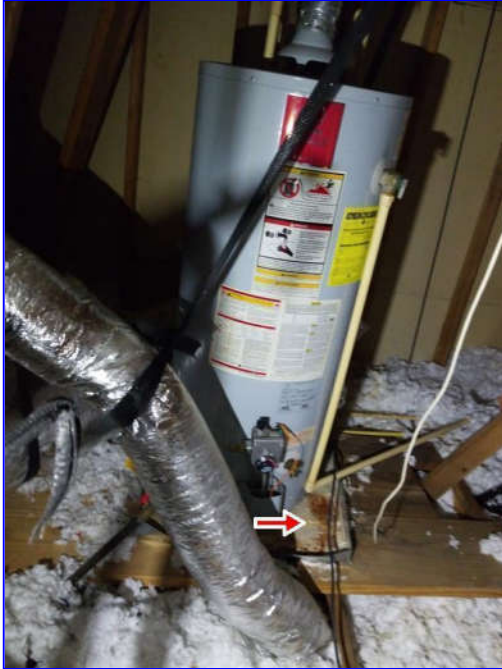
C. Item 5(Picture)

Unit B - State brand, 40 gallons, gas water heater, located in the attic

- Water heater safety pan was observed to be corroded. Replacement is necessary to prevent potential damage surrounding surfaces if the water heater fails in any way.

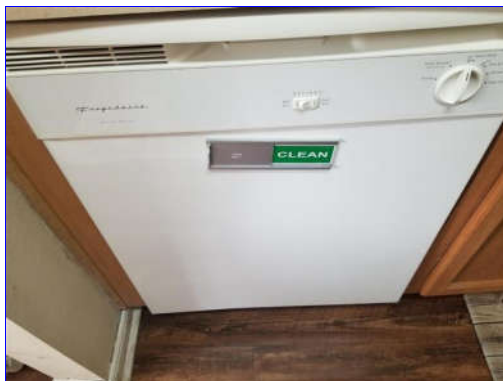
A. Item 1(Picture)

- The dishwasher was operated through a normal cycle and appeared to be in serviceable condition at the time of the inspection.

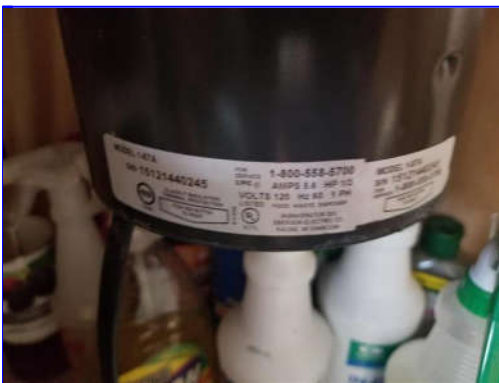
B. Item 1(Picture)

- The food waste disposal was observed to be functioning as intended.

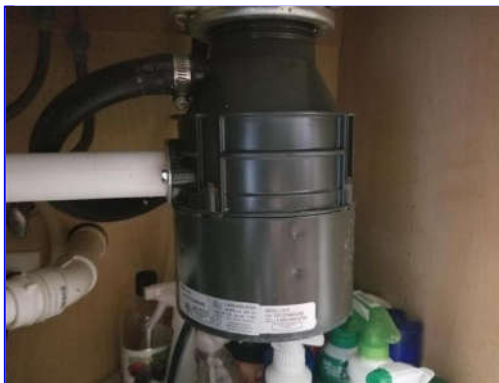
B. Item 2(Picture)

Unit B

- The food disposal was observed to have the following defect(s): inoperable. I recommend repair as needed.

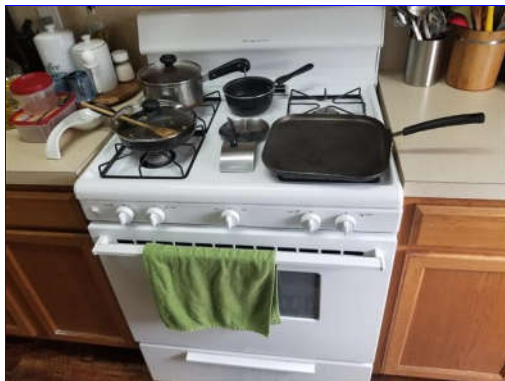
D. Item 1(Picture)

Unit A

- The range was observed to be functioning as intended.

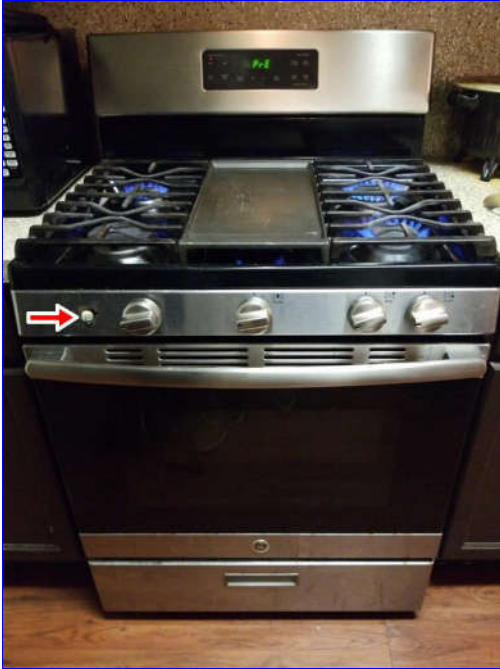
D. Item 2(Picture)

Unit B

- One left handle is missing. It should be repaired.
