Date of Inspection: 7/30/2017 Time: 10:00 AM

PROPERTY INSPECTION REPORT

Concerning: 415 22nd St, 3C
Galveston TX, 77550
(Address or Other Identification of Inspected Property)

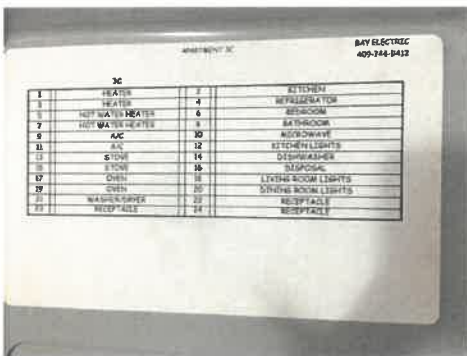
- White wire which is associated with the "neutral" wire was found to be installed on a hot breaker. This is considered unsafe due to no labeling or correct color coding. This wire is intended to be a hot wire with incorrect color coding. I recommend installing black electrical tape at both ends of this circuit to change the color for proper and safe identification.

Circuit labeling

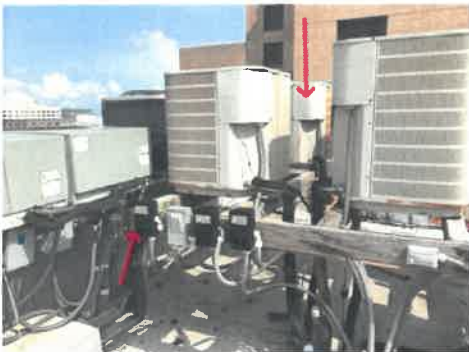
- The condensing unit(s) installed at the exterior appear to have dirty/damaged/corroded coils and may need to be cleaned and serviced. I recommend repair/service by a licensed HVAC contractor.
- The condensing unit and disconnect were not labeled very well. I recommend better labeling so servicing will be easier to locate equipment.
- The HVAC system was not operational at the time of the inspection. I recommend further evaluation and repair by a licensed HVAC contractor.

AC disconnect and condensing unit location
