PROPERTY INSPECTION REPORT

243 Capriccio Lane
Montgomery, TX 77316

Report Number: 042519-Yazbak

By: John Nobles, Lic #6907 04/25/2019
(Name and License Number of Inspector) (Date)

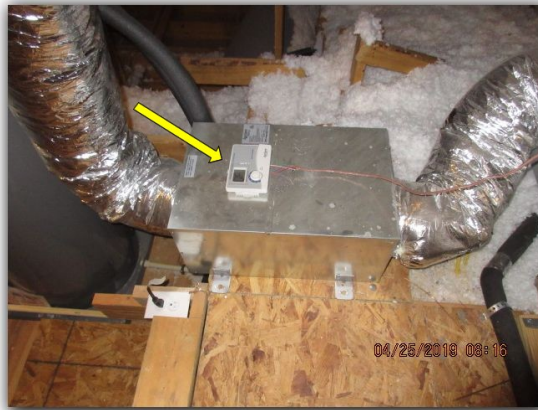
The HEPA filtration/Electronic Air Cleaner/Fresh Air Intake/Dehumidifier systems are not a part of this inspection as stated in the Inspection Agreement. It is recommended that a qualified licensed HVAC company be consulted to ensure that these systems are functioning properly.
