PROPERTY INSPECTION REPORT

Concerning: **614 Asbury Unit B, Houston, Texas 77007**

By: **Scott Gillis # 22819**

October 31, 2018

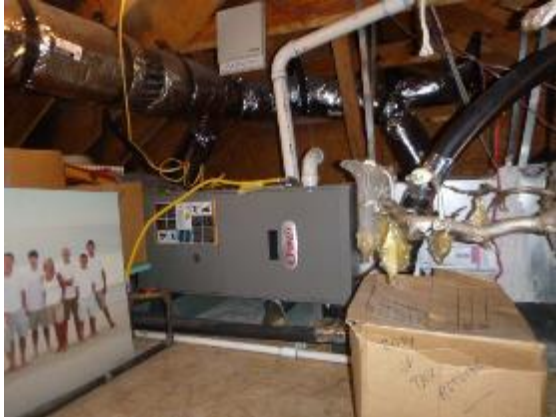
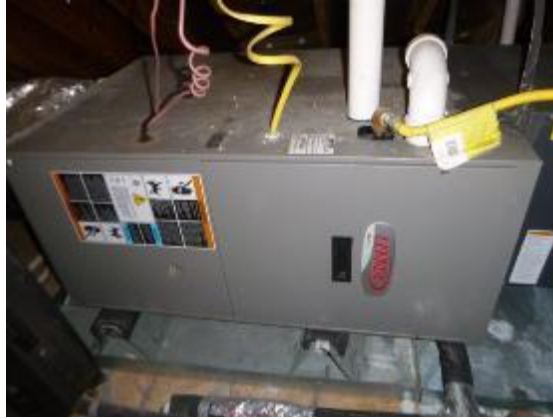
The heating for the house was provided by two gas-fired horizontal furnaces located in the attic. The equipment for the individual zones was as follows:

<u>Zone</u>	<u>Size</u>	<u>Manufact.</u>	<u>Date</u>
First/Second floor	66,000-BTU	Lennox	2010
Third floor	66,000-BTU	Lennox	2010

The furnaces were operationally checked at the time of the inspection, and no repairs were indicated to the operation of the furnaces. The furnaces responded to the thermostats, and the burners came on, and were heating.

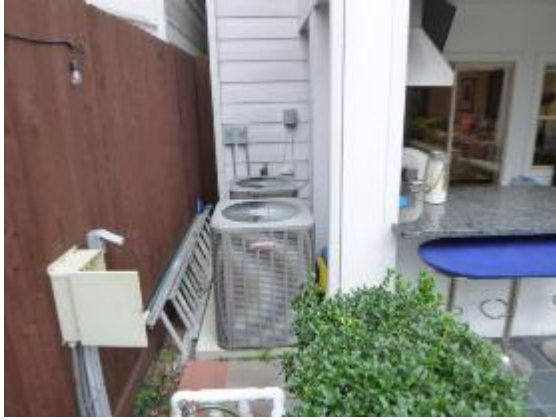
Condensing Unit

No items requiring repair were observed at the time of the inspection for the operation of the condensing units.

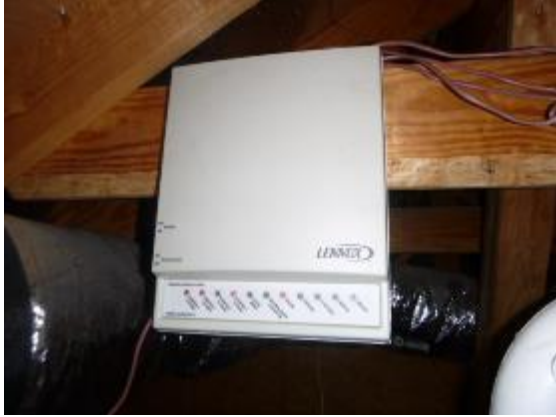
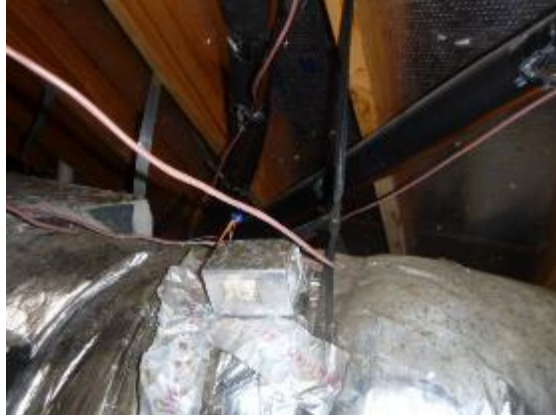
Ducts/Registers

A thermostatically controlled damper system was installed in the duct work for the first and second floor system creating two zones. The damper system was controlled by the thermostats located at the first floor and second floor halls. No items requiring repair were observed for the operation of the dampers or thermostats at the time of the inspection.

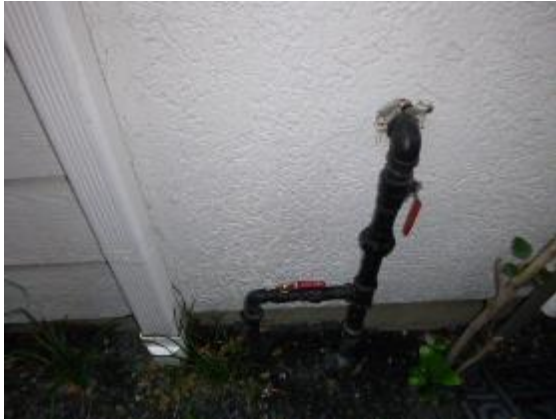
Supply Piping

The shut-off valve for the main inlet water line was located at the exterior at the north side of the house. The water meter was located at the front curb. (Information)

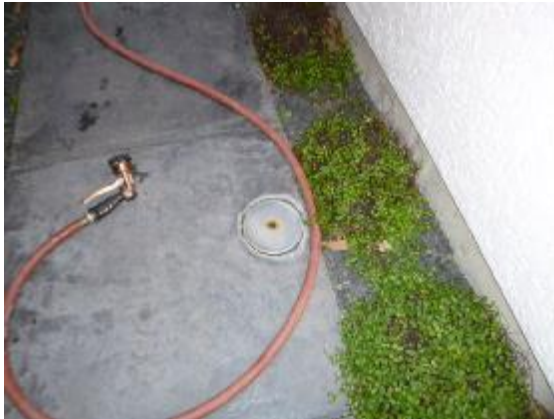
The main sewer PVC clean out was located at the north side of the house. The clean out is needed in the event of a stoppage in the main sewer drain line, and the clean out is where a sewer snake would be installed to remove the clog in the drain line.

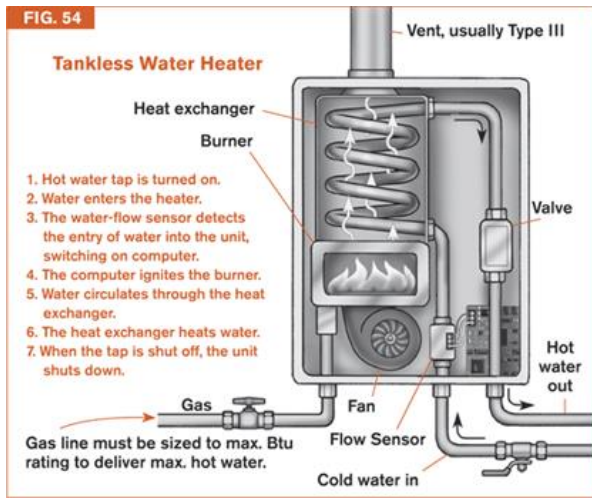
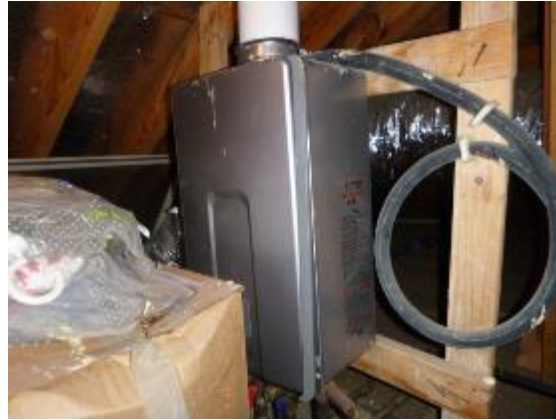
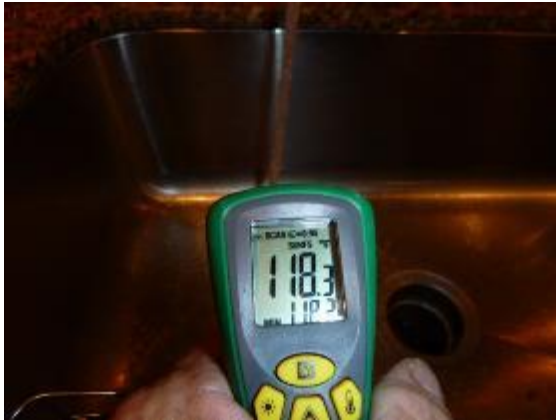
The hot water for the house was provided by a 160-gallon per hour natural gas fired tankless water heater manufactured by Rinnai in 2010 and located in the attic. The water piping from the water heater was observed to be PEX. (Information)

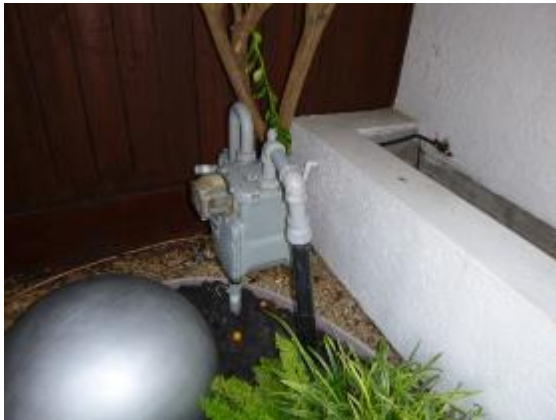
The gas meter that was connected to the gas valve was located at the north front garden of the house. (Information)

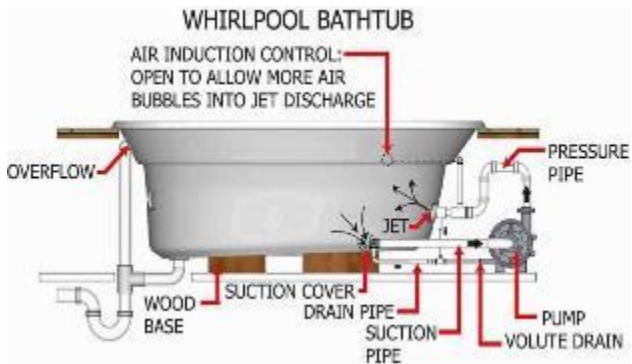
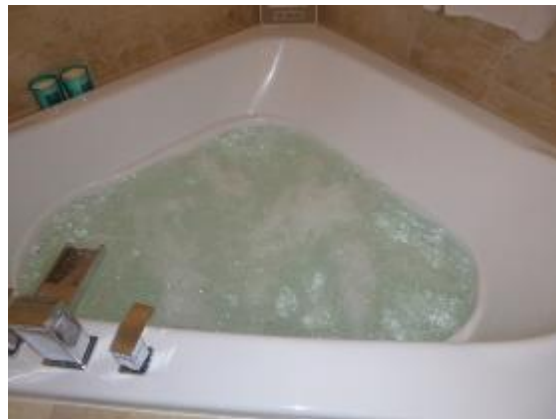
No items requiring repair were observed in the operation of the whirlpool tub. The recirculation pump, aerators, and Ground Fault Circuit Interrupt device were functioning properly. Locations included: The master bathroom

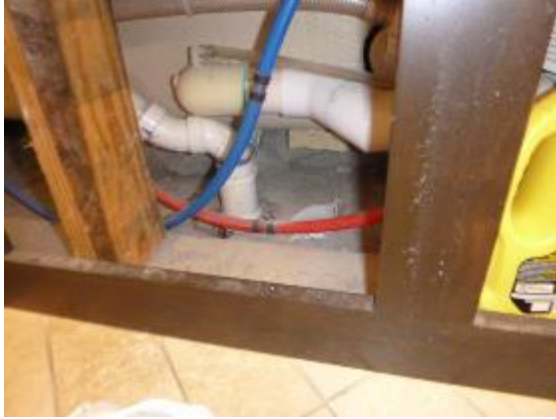
Access panels were provided at the hydro-therapy tub. (Information)

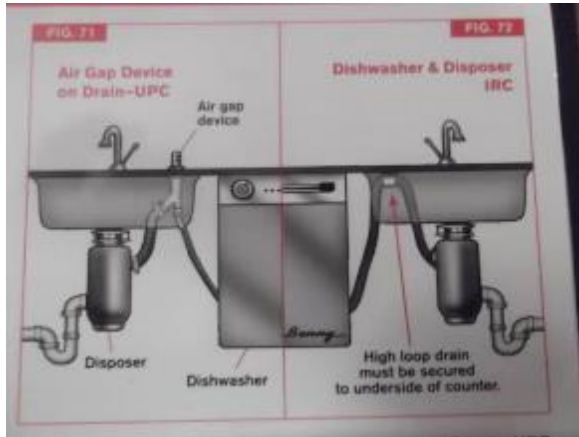
The drain line under the sink was looped up so that the top of the loop was higher than the point where the drain line connected to the disposal. This will help to prevent garbage from running down the drain line into the dishwasher.

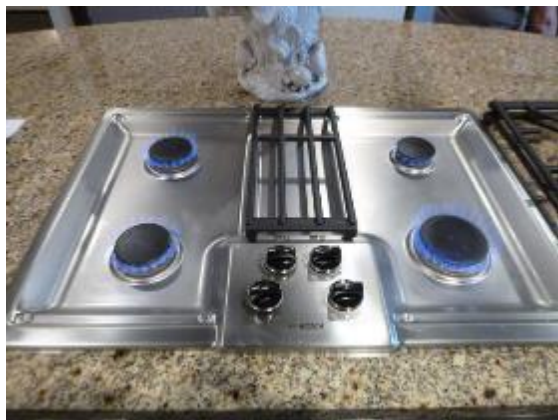
No items requiring repair were visible at the time of the inspection for the gas cooktop. All of the burners and controls were operating properly at the time of the inspection.

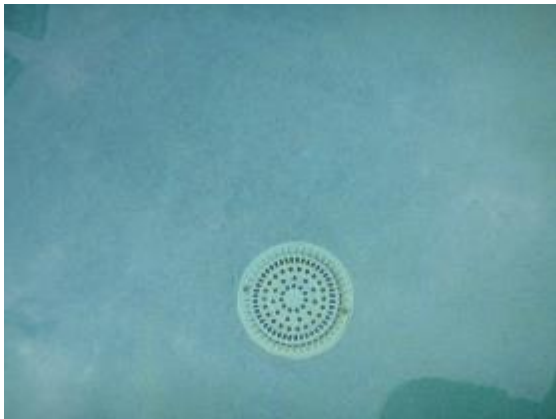
Bottom Cover

The bottom drains for the pool contained two inlets, which were observed to be the approved raised covers that will reduce the potential hazard for entrapment.

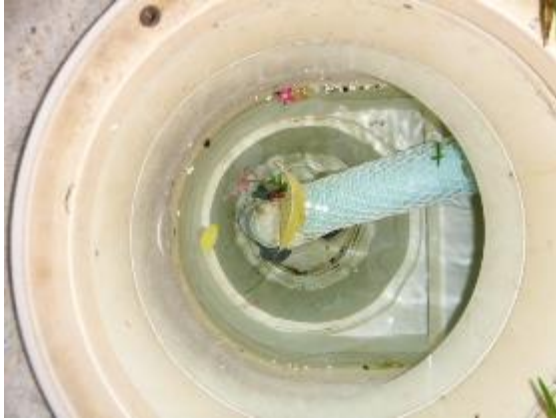
Skimmers

No items requiring repair were observed at the time of the inspection for the pool skimmers.
(Information)

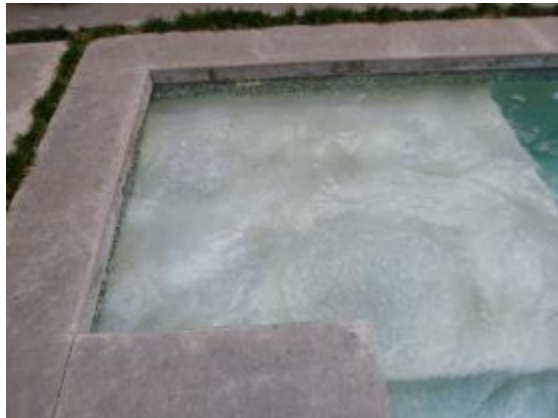
Water Feature

No items requiring repair were visible at the time of the inspection of the water feature. The timer was turned on the jets were pumping water. (Information)

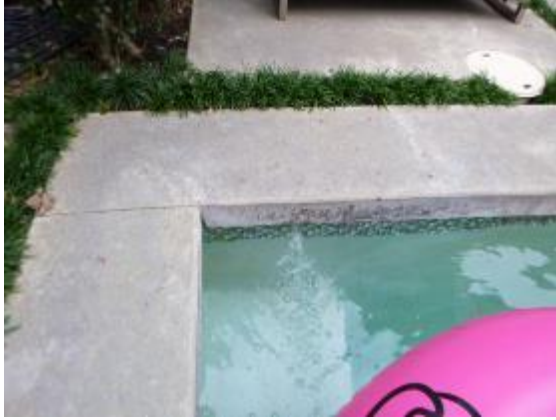
Pool Fill Line

The pool fill line was functional at the time of the inspection, and was equipped with a backflow preventer device. No leaks were present at the time of the inspection.

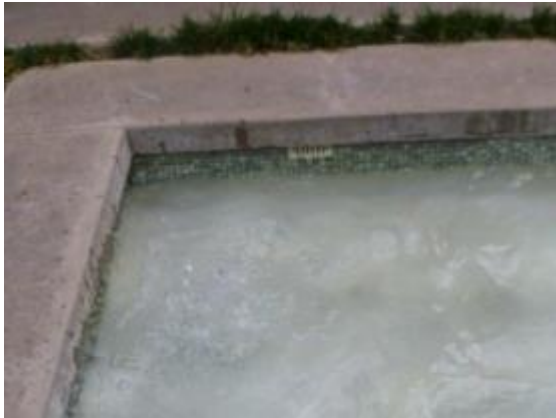
Overflow Drain Line

Newer swimming pool are required to be equipped with an overflow drain line, so that the pool will not overflow. The overflow drain line was visible at the time of the inspection. (Information)
