HEDDERMAN ENGINEERING, INC.

REF: CONDITION OF PROPERTY SURVEY

At your request, a visual survey of the house located at 614 Asbury, Unit B, Houston, Texas, was made by Mr. Dennis Polk and Mr. Scott Gillis.

614 Asbury, Unit B

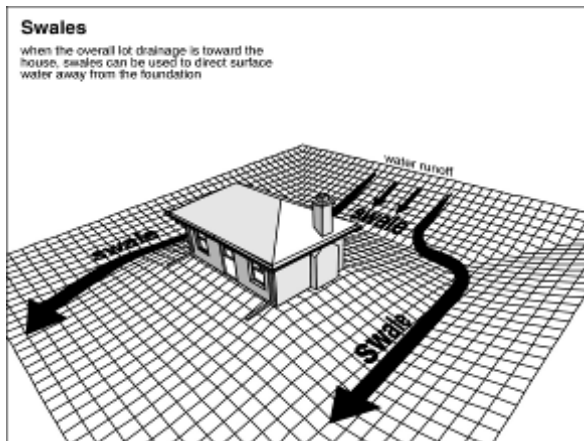
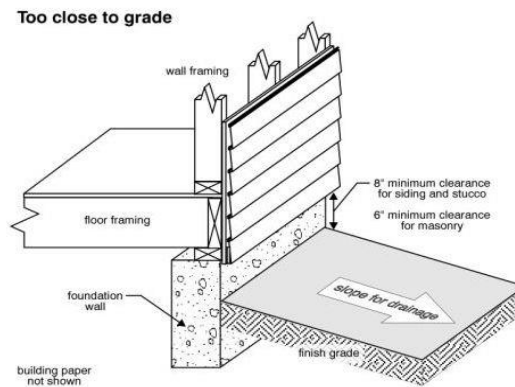
The perimeter drainage around the property appeared to generally be adequate. It was not raining at the time of the inspection and, therefore, it could not be determined with certainty if water would pool at any localized low areas around the property. Further investigation with the homeowner is recommended to determine if there are any drainage problems or standing water after a rain.

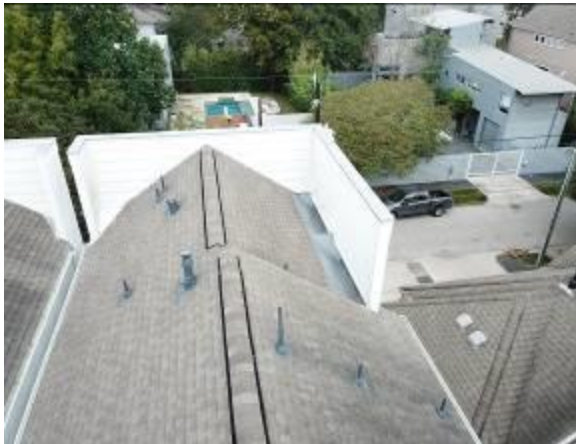
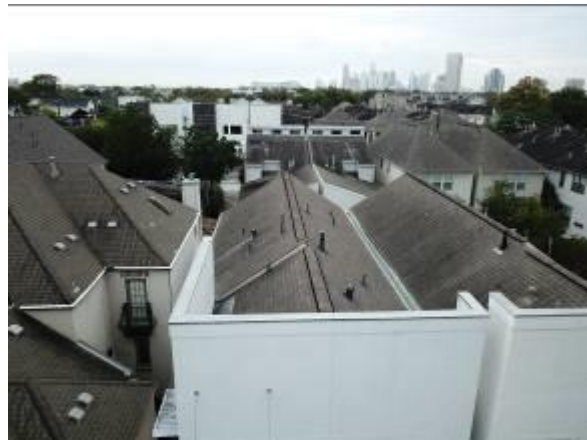
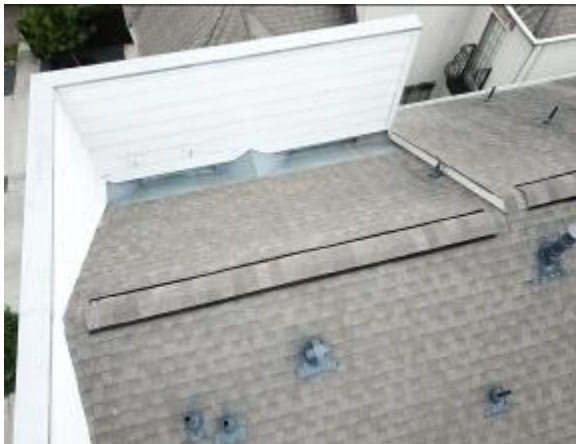
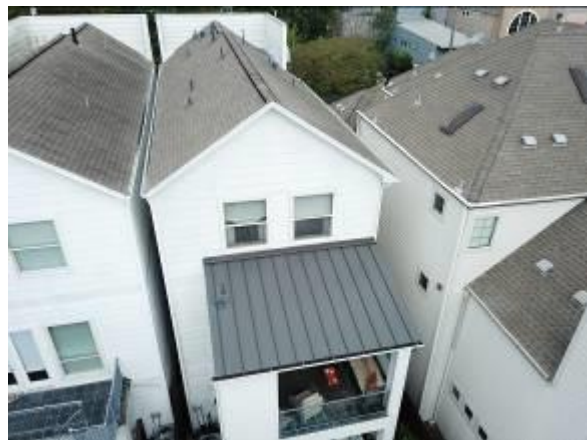
The roof surface was constructed of composition shingles. The life expectancy of a composition shingle roof has been observed to vary from 15 to 20 years, with most requiring replacement at about 17-20 years. We estimate that the age of the roof is approximately eight years, which coincides with the age of the house.

The roof surface above the living room and rear balcony was constructed of a standing seam metal roof. The life expectancy of the roof is considered to be the life of the structure. We estimate that the age of the roof is approximately eight years.

Due to the height of the roof, the roof was not viewed from its surface due to safety concerns but was viewed from the ground and by drone.

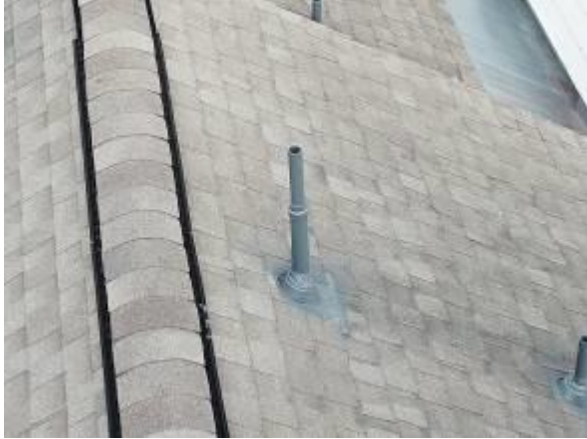
Active dripping at the roof jack/Standing water in the water heater pan

A repair attempt was made at the water heater vent pipe previously. However, the vent pipe was actively leaking at the time of inspection.

The roof is in generally serviceable condition at this time with some repairs needed for the above item(s). Have a roofing contractor provide a cost estimate to make all necessary repairs to bring the roof into a completely serviceable condition.

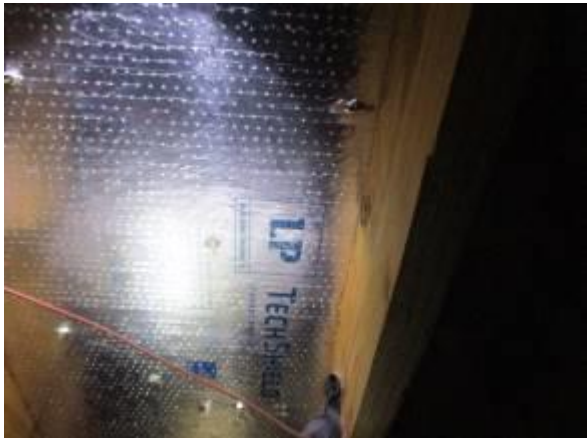
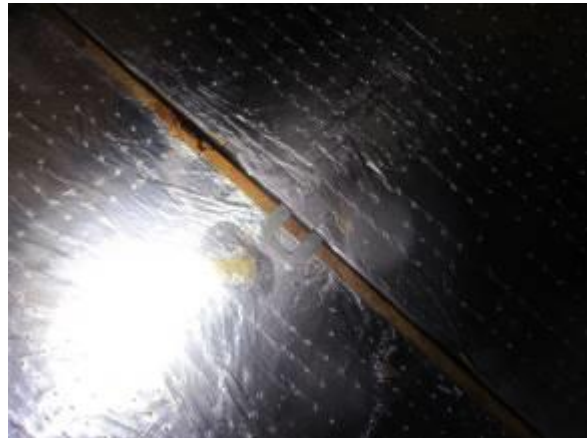
The roof decking was observed to be a radiant barrier decking that has aluminum foil on the underside, which helps to prevent radiated heat from entering the attic. This will, in turn, keep the attic cooler.

It was observed that spacer clips were installed at the joints between the roof decking to allow for expansion of the roof deck.

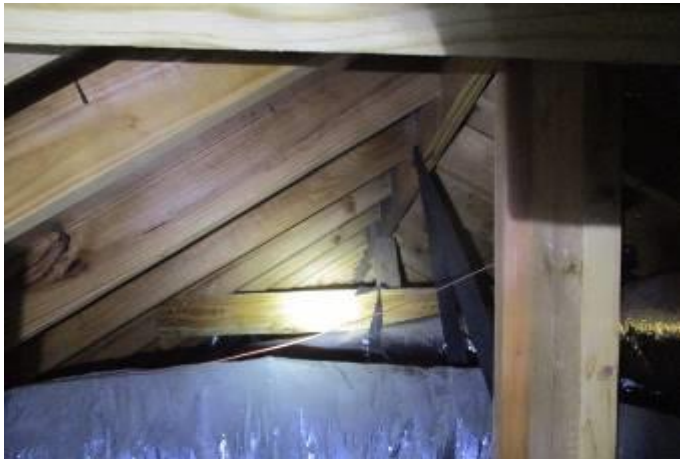
No deficiencies were observed in the primary load carrying members of the structural framing that were accessible and viewed at the time of the inspection, including the roof framing, load bearing walls, ceilings, and floors.

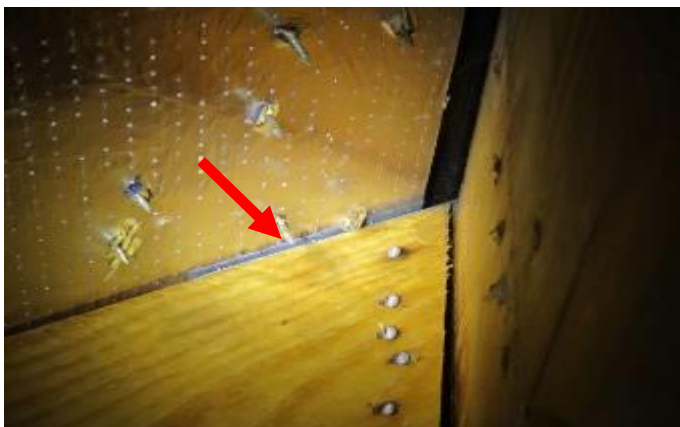
Wind uplift or hurricane clips and/or straps were observed to be installed over the ridge beam to rafters on both sides of the ridge beam. This provides a stronger structure and will be more resistant to wind uplift from hurricane and tornadoes. Due to the insulation installed at the eaves of the attic, we were not able to view the metal clips attaching the rafters to the top of the wall framing.

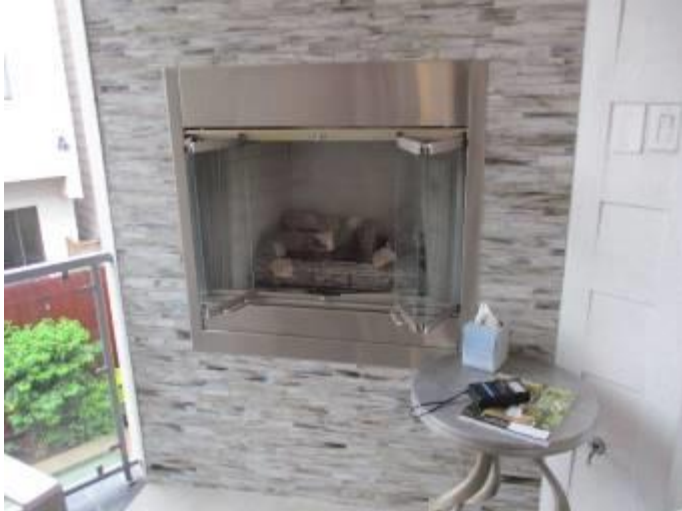
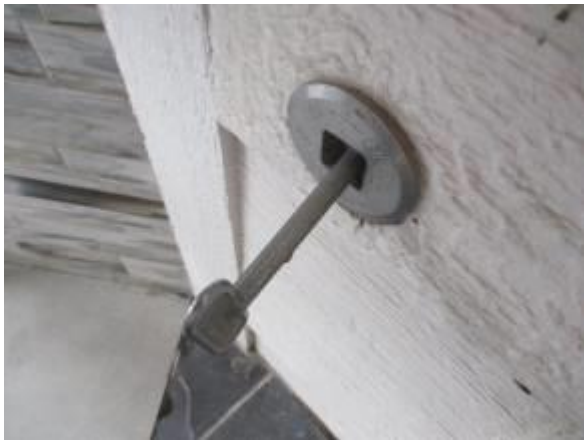
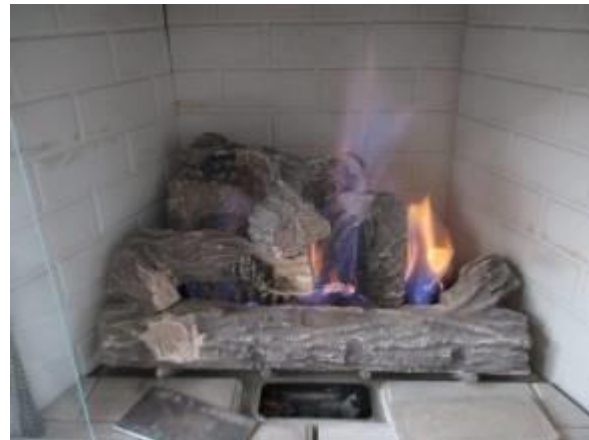
The fireplace was a prefabricated metal fireplace with a ceramic gas log that vented by a direct vent to the exterior balcony area. The burner was controlled by a switch on the wall near the fireplace and was functional at the time of the inspection.

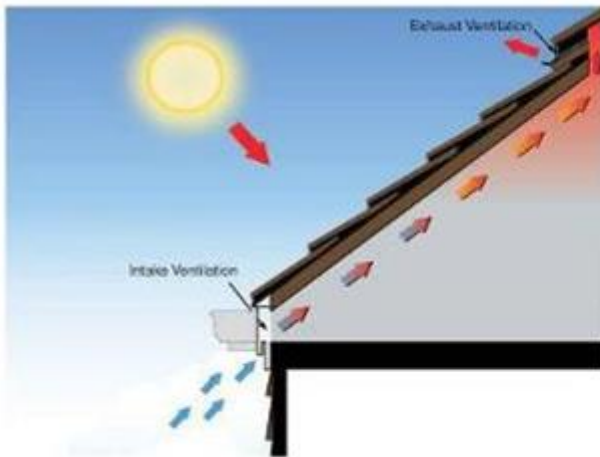
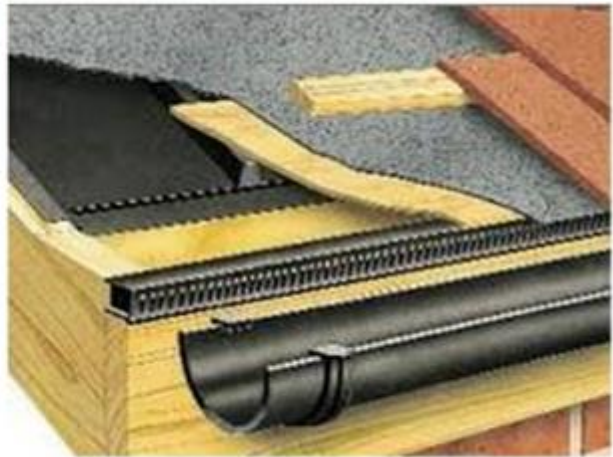
The ventilation for the attic included continuous ridge vents and continuous soffit vents.

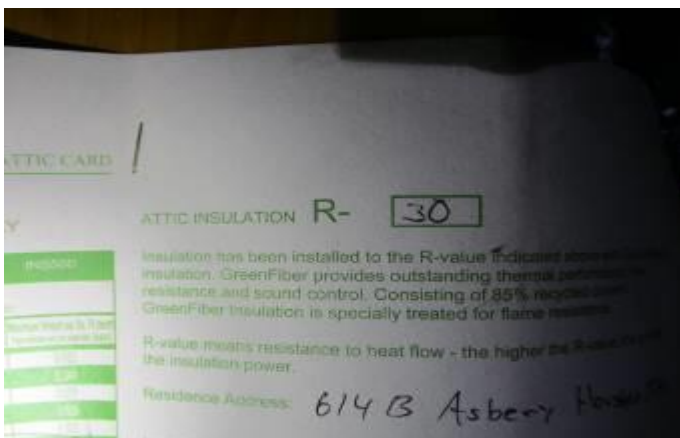
The insulation in the attic was average by today's standards. The normal amount of insulation for attics in this area is an R30 energy rating. The company who installed the insulation left a tag in the attic stating that the insulation was an R30 rating.

The insulation was covering the recessed lights. We saw no evidence on the outside of the recessed cans to indicate that the cans were rated as “IC”, which is the manufacturer designation for “Insulation Contact”. However, **NEWER** recessed cans are typically rated as IC by the manufacturer and further investigation is recommended to verify this detail, including dismantling the trim kit in the ceiling below if necessary. If the recessed cans are NOT “IC” rated, then the insulation needs to be pulled back, and a three inch air space provided around the lights to prevent overheating and a possible fire hazard.
