Lone Star Stucco, LLC

Moisture Assessment Report

614 Asbury St # B

3/3/2021

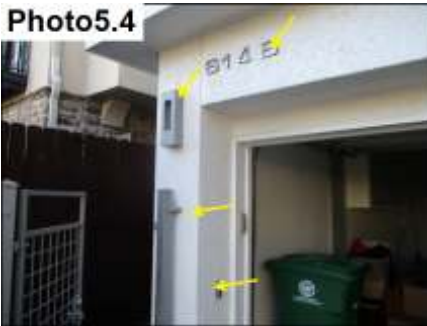
Photo5.4

- The penetration sealants are aged. The inspector suggests having a qualified stucco waterproofing contractor seal this area with NP1 or low modulus sealant in an effort to prevent moisture intrusion. These types of sealants are of high quality and compatible with stucco and other termination points. Please refer to photos #5.2, #5.3, #5.4, #5.5, #5.6, #6.1, #6.2, #6.3, #6.4, #6.5 and #6.6 for more detail.

Penetration Sealants/ Seal

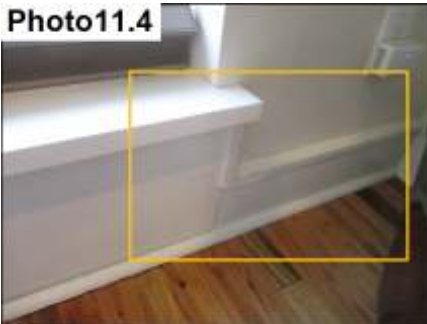
Photo11.4

- Elevated moisture and semi-firm substrate is noted below the bank of windows where the cement fiber panel has been sealed over. The inspector suggests having a qualified stucco waterproofing contractor further assess, core sample and rework or modify this area as needed in an effort to allow proper moisture evacuation. Please note that this area was previously repaired, but inspector believes the window is failing allowing additional moisture intrusion. Please refer to photos #11.2, #11.3, #11.4, #11.5 and #11.6 for more detail.

Semi-Soft Substrate Below Bank Of Windows

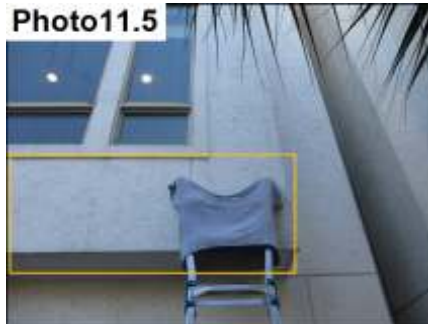
Photo11.5

Semi-Soft Substrate Below Bank Of Windows

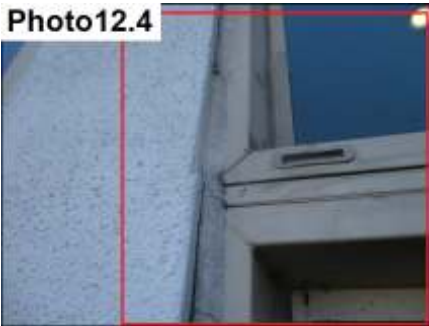
Photo12.4

- The window and window miter sealants are aged and separated. The inspector suggests having a qualified stucco waterproofing contractor to assess and wet glaze then seal this area with NP1 or low modulus sealant in an effort to prevent moisture intrusion. Additionally, it is recommended to have a representative of the window manufacture assess the left window for defects or improper flashing during initial construction. Please refer to photos # 12.2, #12.3, #12.4, #12.5 and #12.6 for more detail.

Windows / Wet Glaze & Seal

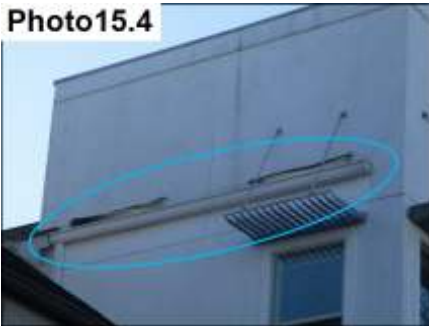
Photo15.4

Roof Diverter Flashing Sealants/s Seal
