Property Inspection Report

PROPERTY INSPECTION REPORT

Concerning: 9010 St. Laurent Ln., Houston, TX 77044
(Address or Other Identification of Inspected Property)

By: Larry Fleming, Lic #4860 08/16/2019
(Name and License Number of Inspector) (Date)

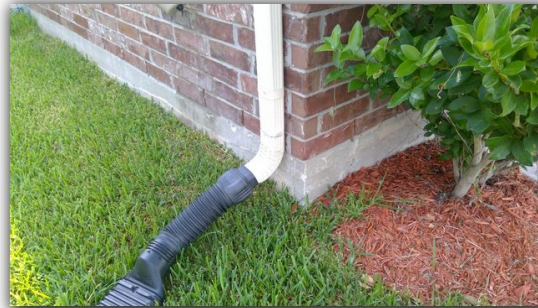
- Shovel Cracks observed at slab brick ledge corners at multiple locations

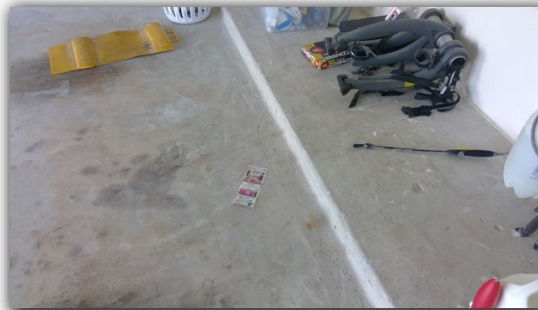
- Cracks observed in exposed garage concrete floors at one or more locations.

Would recommend that a licensed and / or qualified contractor be consulted to make any further recommendations and / or repairs

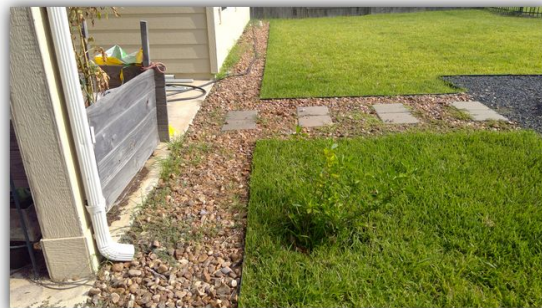
Grade does not conform to current code requiring a 6" fall 10' from the structure. Due to the age of the house, the current code specifications may not have been in effect at the time of the structure's construction.

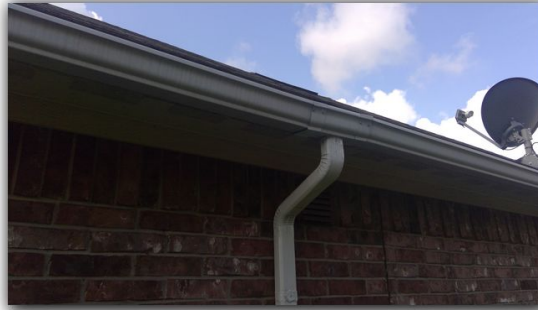
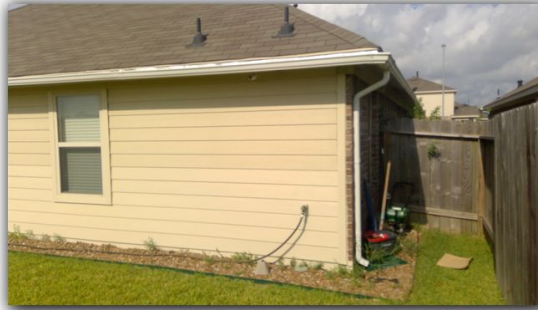
Gutters / downspouts observed to be damaged / dented at one or more locations.

Would recommend that a licensed and / or qualified contractor be consulted to make any further recommendations and / or repairs

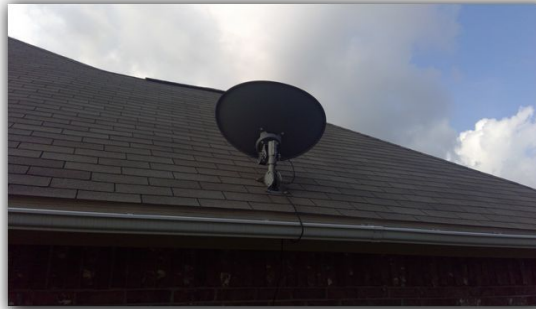
- Satellite dish screwed into the roof covering

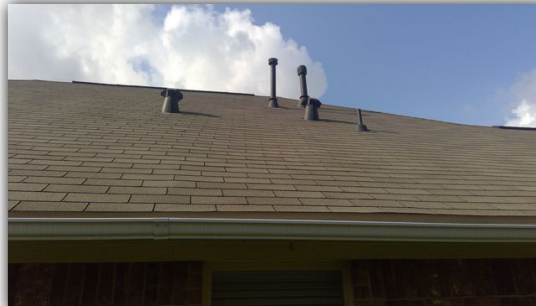
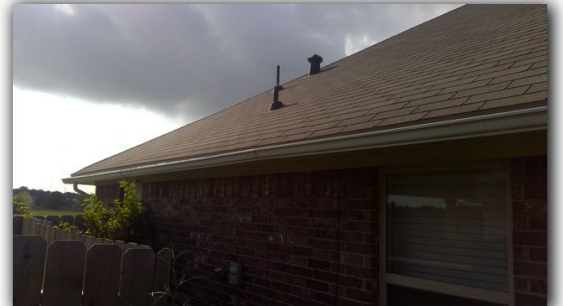
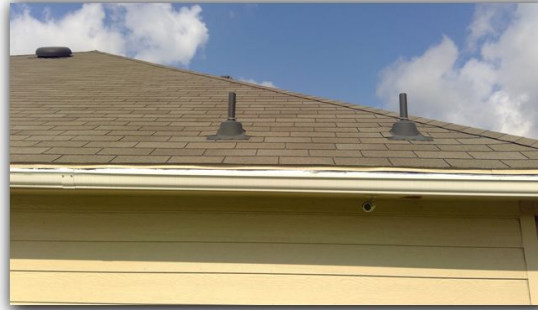
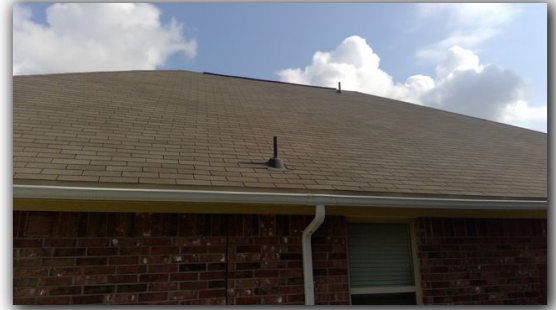
- Vent roof jacks appear to need maintenance / caulking / painting.

Would recommend that a licensed and / or qualified contractor be consulted to make any further recommendations and / or repairs

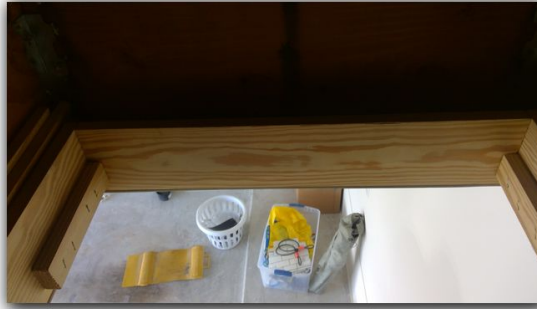
- Attic access fold down ladder not installed per manufacturer's specifications / proper fasteners

Would recommend that a licensed and / or qualified contractor be consulted to make any further recommendations and / or repairs

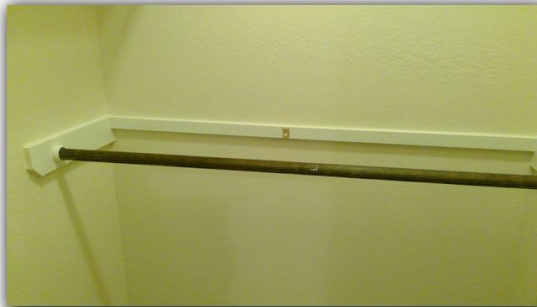
- Braces for closet shelving / rods appeared to be removed and not replaced at the time of the inspection.

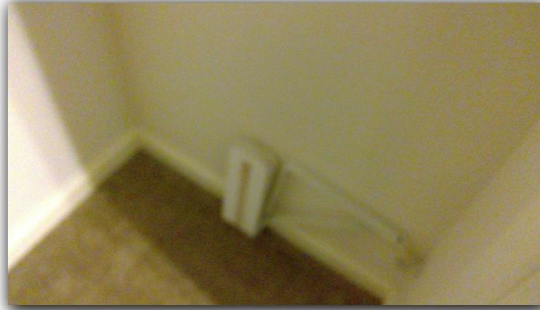
Sheetrock damage observed behind doorknobs at one or more locations where it appears the sheetrock has been damaged by the doorknob.

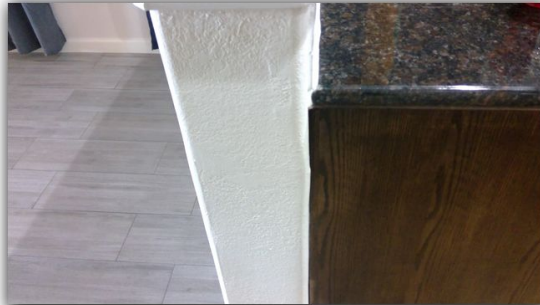
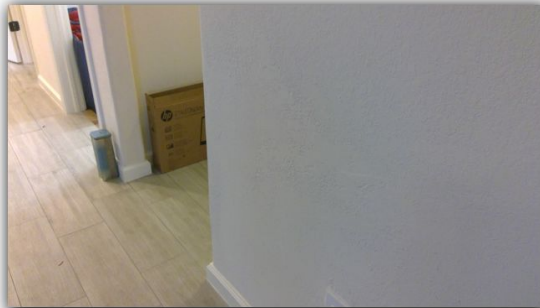
Evidence of previous repairs observed in interior walls at one or more locations. It appeared to the inspector that the sheetrock repair was due to previous flooding of the house. The sheetrock repairs did not appear to be performed in a usual and customary building practice manner. Seams were very noticeable.

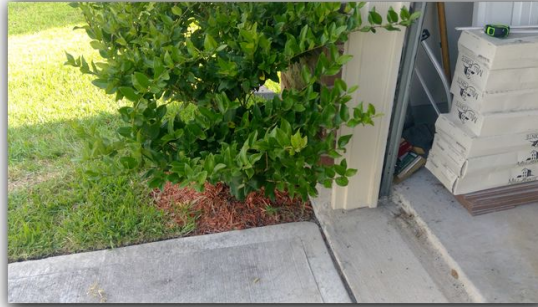
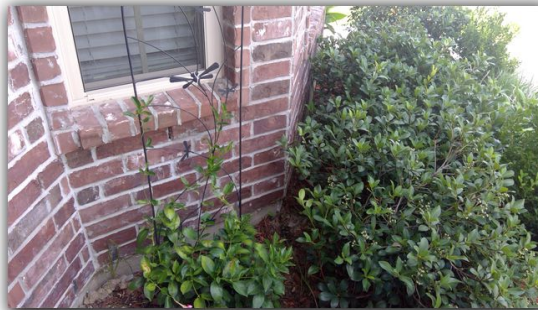
Heavy vegetation needs to be trimmed from touching exterior walls

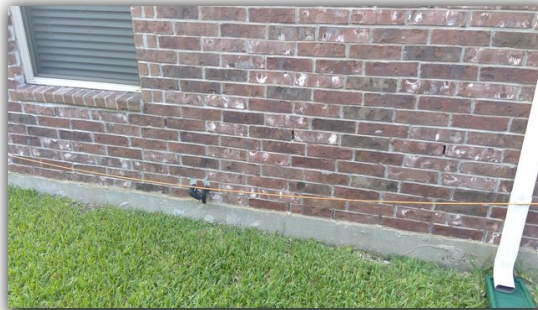
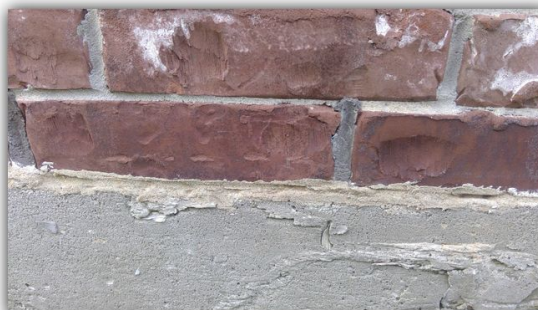
Weep holes had been closed at some locations and other mortar was removed higher up with what appeared to be an attempt at weepholes or drying out of the walls due to previous flooding of the house. The removed mortar should be patched and the lower weepholes need to be opened to properly maintain the moisture barrier drainage system in the exterior wall system.

Would recommend that a licensed and / or qualified contractor be consulted to make any further recommendations and / or repairs.

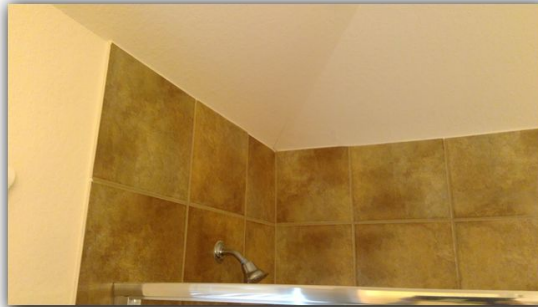
- Small cracks observed in the gambrel ceiling corners in one or more locations

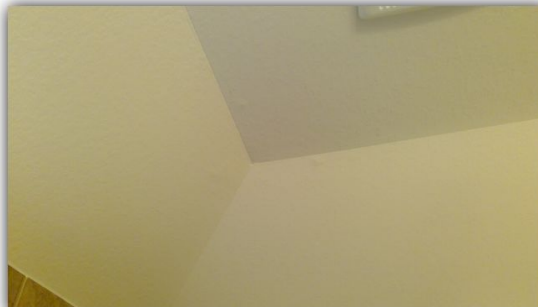
- Nail "pop outs" observed at one or more locations in the sheetrock ceiling.

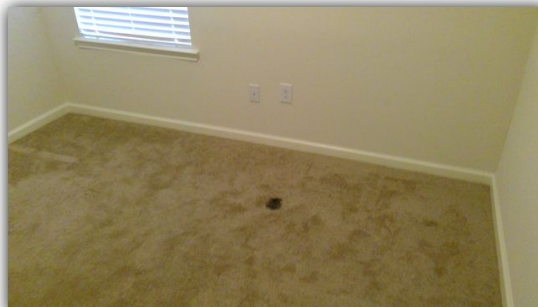
- Carpet floor covering is stained at one or more locations.

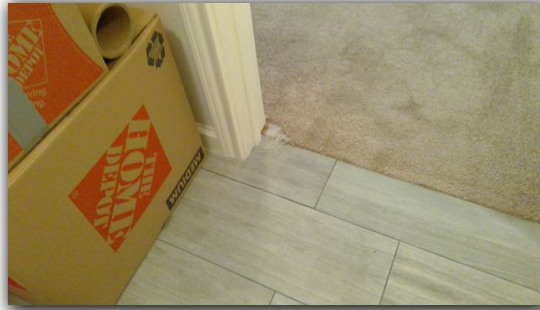
- Carpet floor covering appears damaged at one or more locations

Would recommend that a licensed and / or qualified contractor be consulted to make any further recommendations and / or repairs

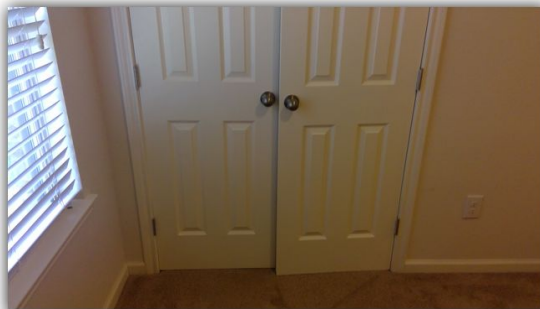
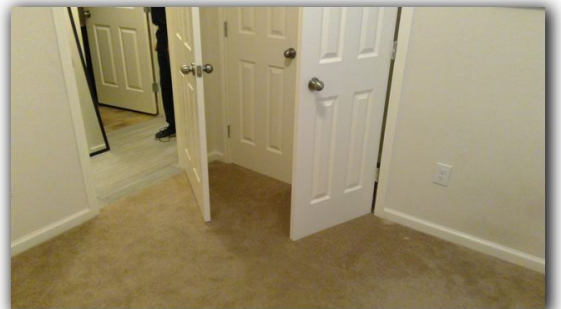
Interior doors dragging carpet at multiple locations. _____

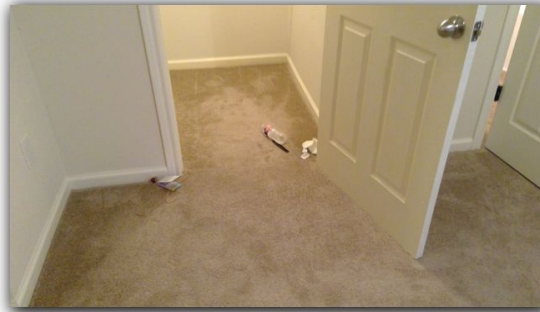
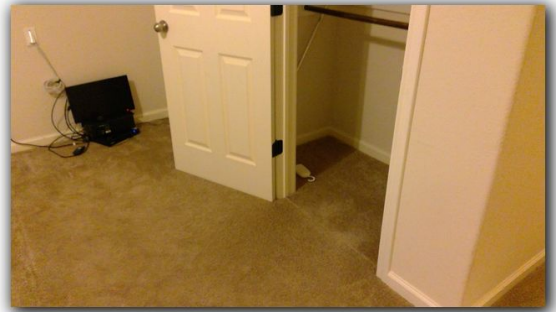
Interior doors rub, stick or hit frames at multiple locations.

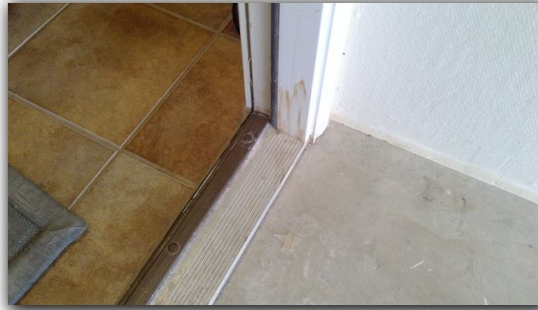
Trim at rear garage door appears to be pulling loose.

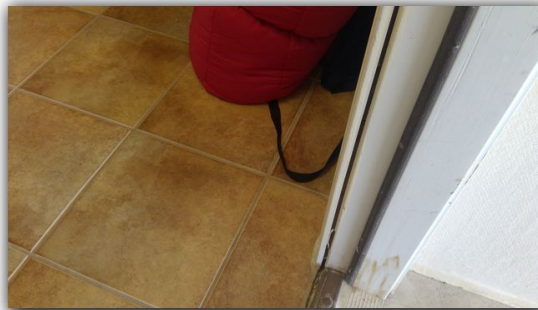
Damaged weather stripping observed at one or more exterior door locations

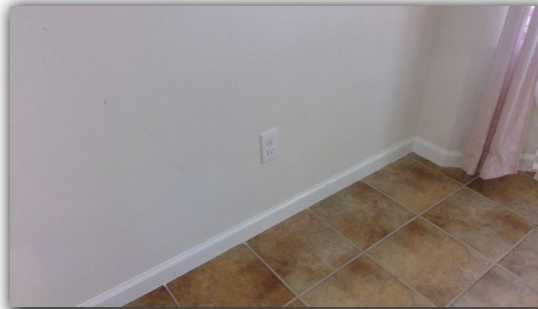
Outlet/Switches loose at multiple locations.

Would recommend that a licensed and / or qualified contractor (Electrician) be consulted to make any further recommendations and / or repair

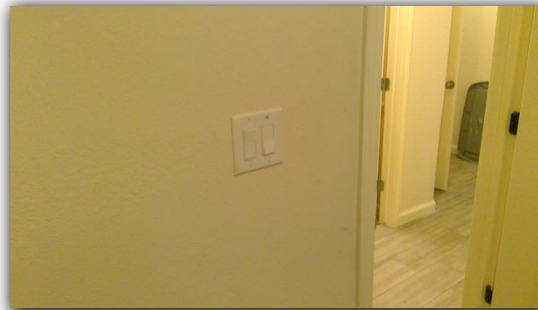
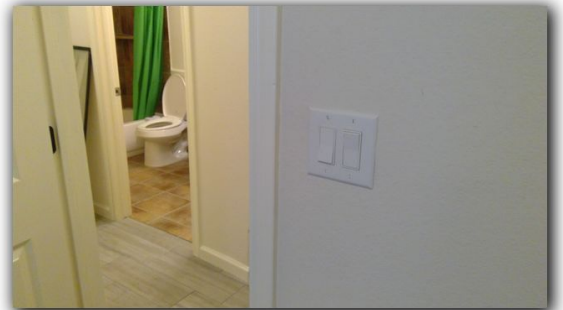
Switch(s) could not be determined for proper operation at one or more locations. It is possible that some switches were pre-wired for ceiling fans which were not present at the time of the inspection

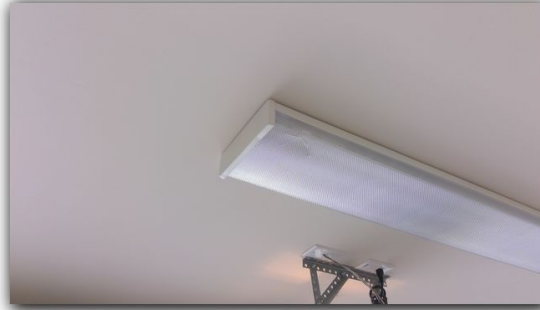
Light fixtures cover damaged at one or more locations. See garage.

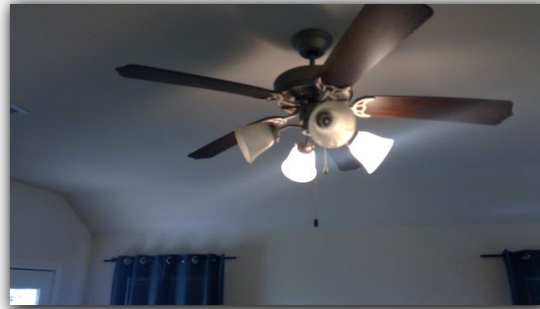
Bulbs appeared to be burned out and / or not operating in one or more fixtures

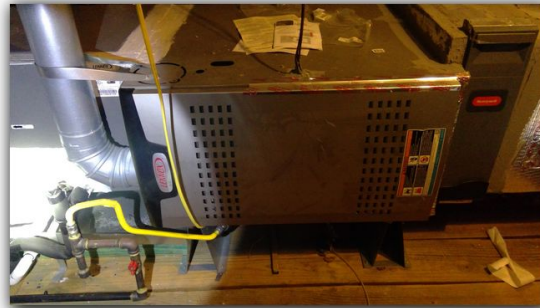
- HVAC furnace does not appear to be operating properly. Gas shut off to house.

Would recommend that a licensed and / or qualified contractor be consulted to make any further recommendations and / or repair

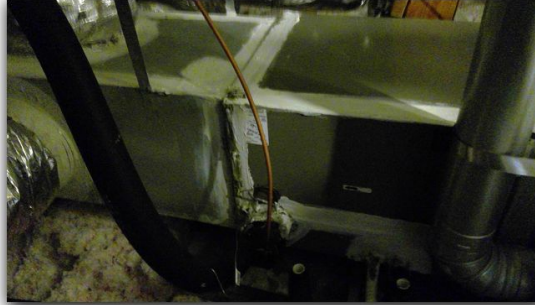
HVAC duct system does not conform to current code regarding proper sealing / mastic

Would recommend that a licensed and / or qualified contractor be consulted to make any further recommendations and / or repair

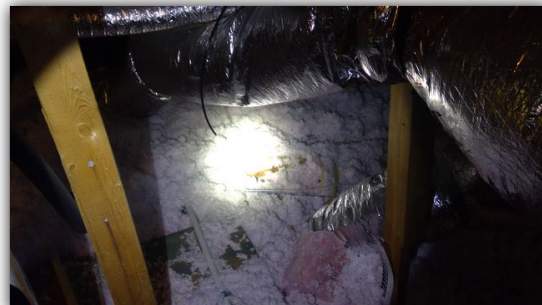
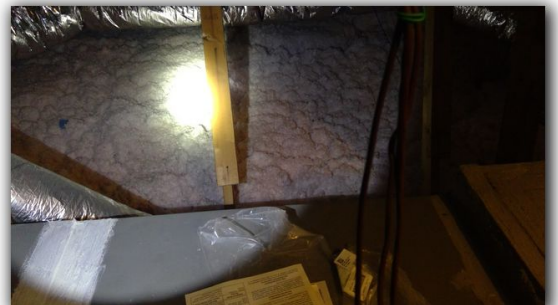
- Exposed plumbing supply lines in attic need to be protected from freezing (insulated)

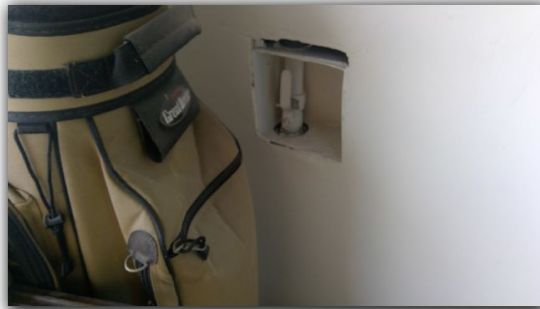
- Plastic trim ring missing from water shutoff at left side garage.

Would recommend that a licensed and / or qualified contractor be consulted to make any further recommendations and / or repair

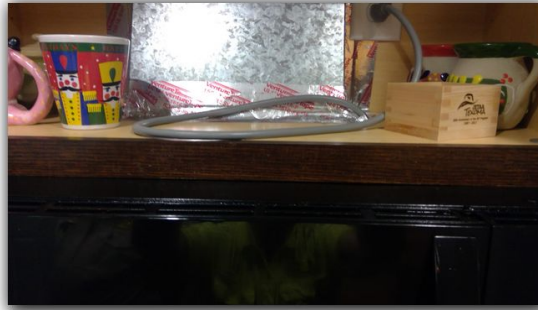
Exhaust vent duct for the range hood / exhaust vent is not properly connected at unit / Leaking air

Would recommend that a licensed and / or qualified contractor be consulted to make any further recommendations and / or repair

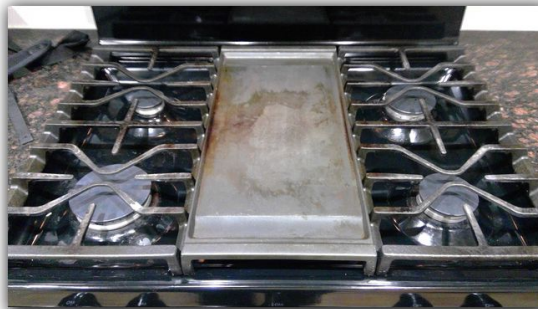
Stove / oven / range unable to be properly inspected. Gas turned off to house.

Would recommend that a licensed and / or qualified contractor be consulted to make any further recommendations and / or repair

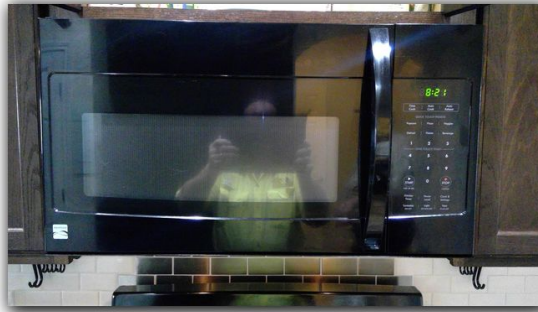
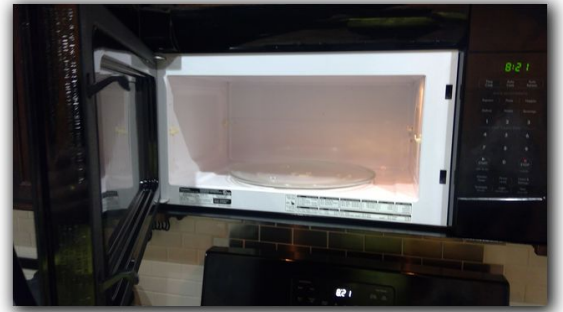
E. Microwave Ovens

Comments: It is the opinion of this inspector that the microwave oven appeared to be performing its intended function at the time of the inspection with the exception of any observed / noted / checked (deficient) items below.

Metal rack(s) missing from interior of microwave.

Would recommend that a licensed and / or qualified contractor be consulted to make any further recommendations and / or repair

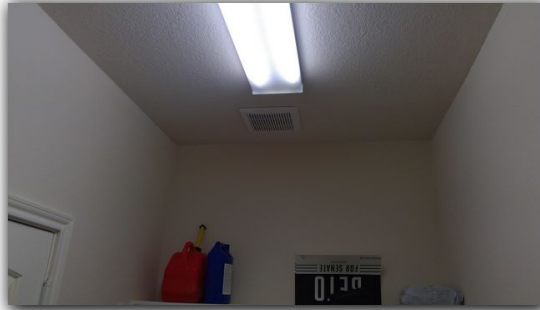
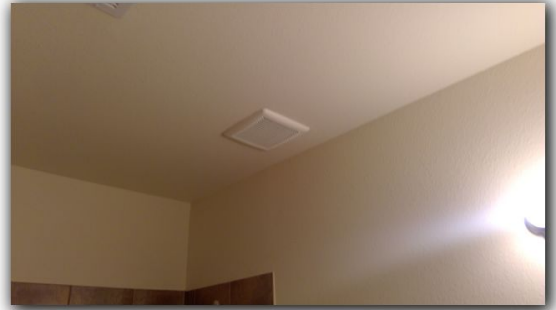
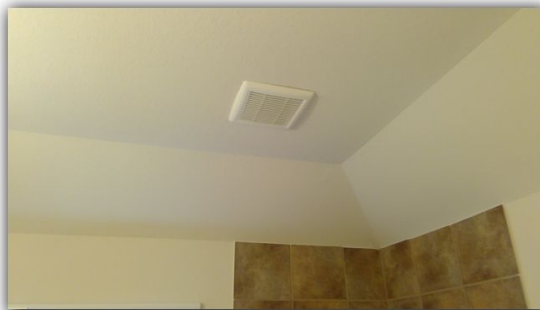
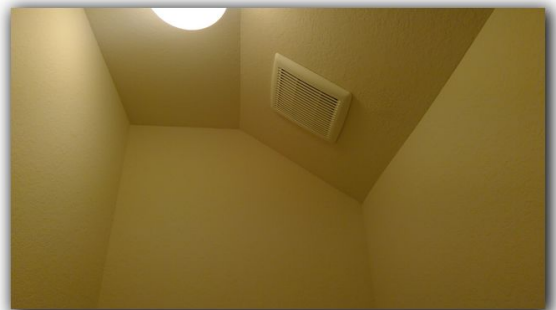
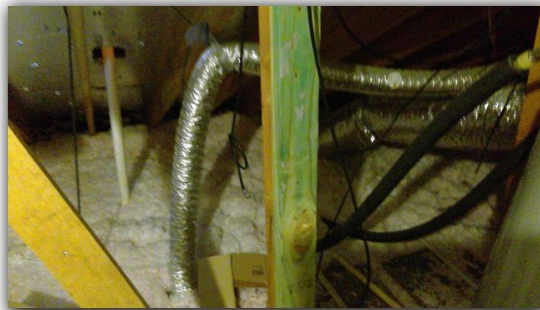
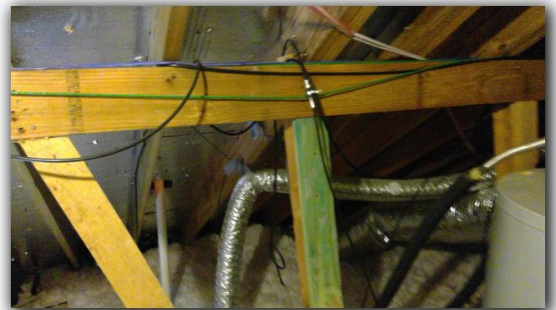
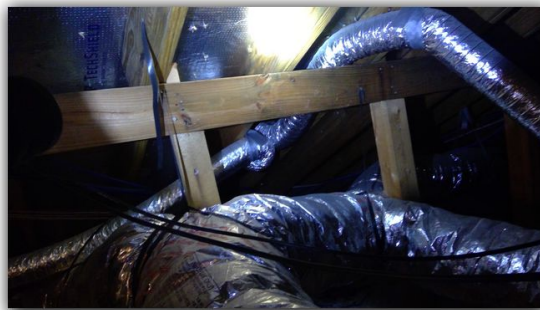
F. Mechanical Exhaust Vents and Bathroom Heaters

Comments: It is the opinion of this inspector that the mechanical exhaust vents and bathroom heaters appeared to be performing their intended function at the time of the inspection with the exception of observed / noted / checked (deficient) items below.

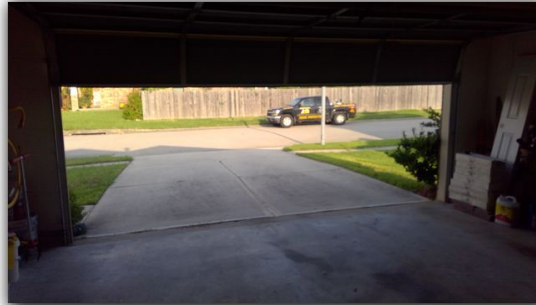
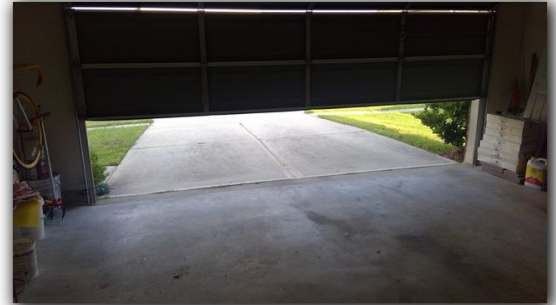
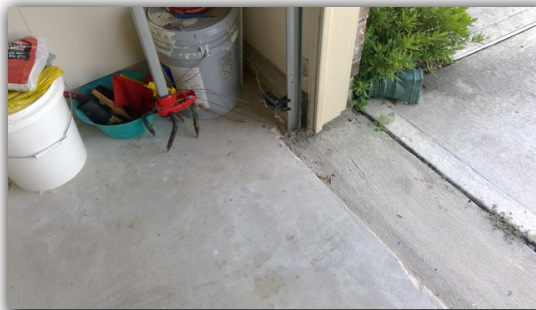
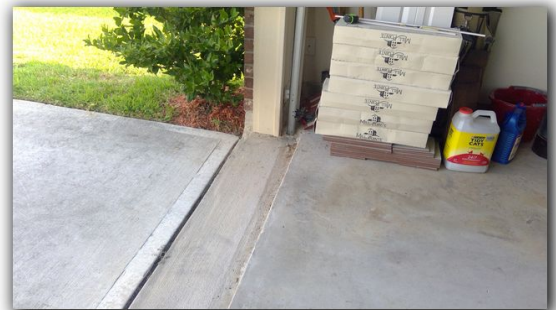
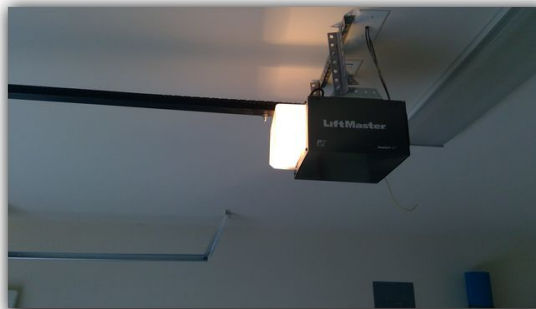
G. Garage Door Operators

Comments: It is the opinion of this inspector that the garage door operator equipment appeared to be performing its intended function at the time of the inspection with the exception of observed / noted / checked (deficient) items below.

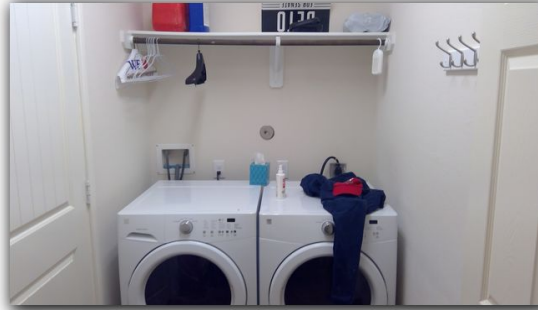
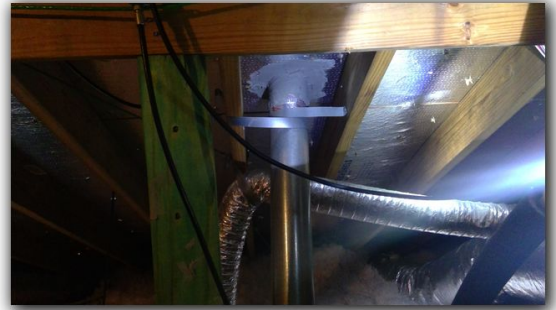
Comments: It is the opinion of this inspector that the dryer exhaust system appeared to be performing its intended function at the time of the inspection with the exception of observed / noted / checked (deficient) items below.

It is recommended that the dryer vent be properly cleaned by a professional prior to using vent. There are components of the dryer exhaust vent system that are not accessible and cannot be inspected.

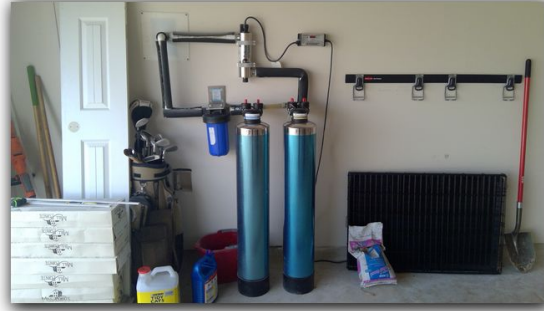
F. Other

Water softener system present but not a part of the inspection
Water filtration system present but not a part of the inspection
