RESIDENTIAL INSPECTION REPORT

10335 Dyer Glen
Houston TX 77070

PROPERTY INSPECTION REPORT

Concerning: 10335 Dyer Glen, Houston TX 77070

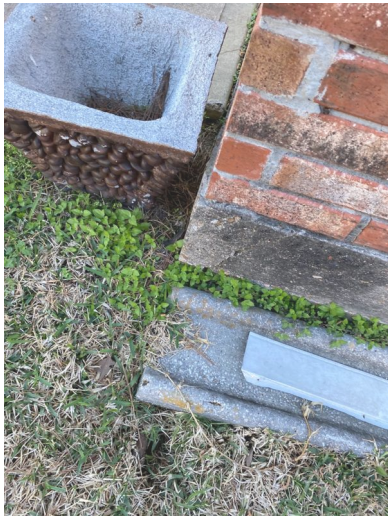
1: Slab: Shear Cracks

Note: Shear cracking ("corner pops") observed at foundation corners is not normally associated with structural movement or deficiencies.

Recommendation: Contact a handyman or DIY project

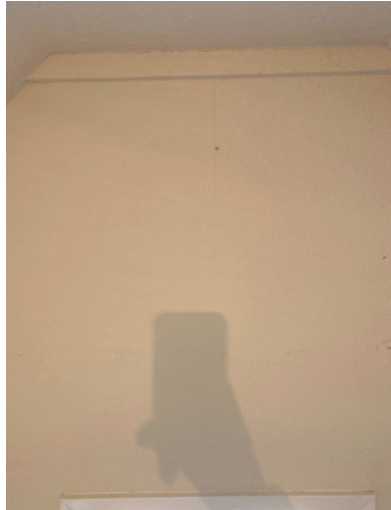
2nd Floor

8: Wood Destroying Insect Activity

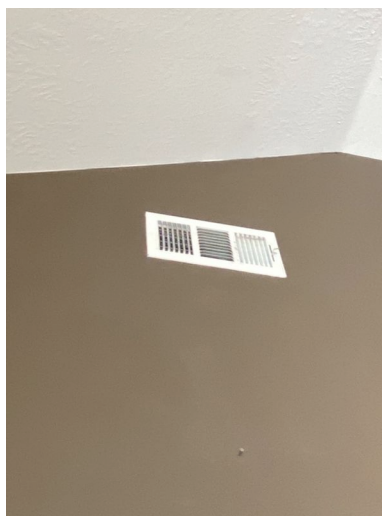
Primary Bedroom

A dark substance was observed on an air supply register in the home. Servicing and cleaning of the system by a qualified HVAC contractor is recommended, as this can be a result of excessive water vapor/humidity in the conditioned air.

Recommendation: Contact a qualified HVAC professional.

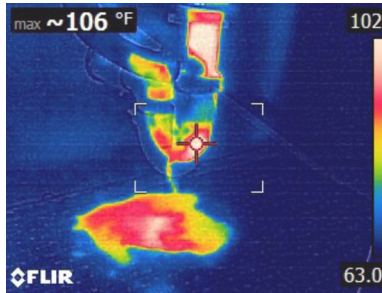
2nd Floor Hall Bathroom

Leaking was observed at time of inspection. Evaluation and/or remediation by a licensed plumber is recommended.

Recommendation: Contact a qualified plumbing contractor.
