# Home Inspection Report

4111 Avenue T, Galveston , TX 77551

Wednesday July 14, 2021

# PROPERTY INSPECTION REPORT

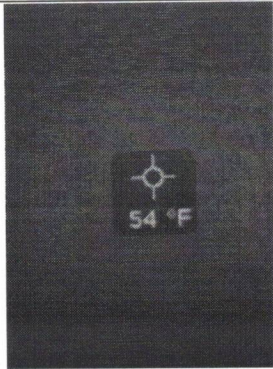
Dining room supply air temperature was 54°

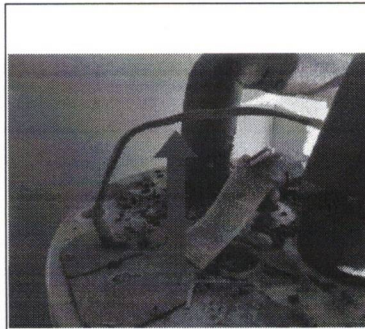
Wiring needs to be in conduit and there needs to be a safety disconnect to kill the power
