PROPERTY INSPECTION REPORT

Concerning: 14827 Fall Creek Preserve Dr. Humble, Texas 77396

Inspection Date: 02/15/2018

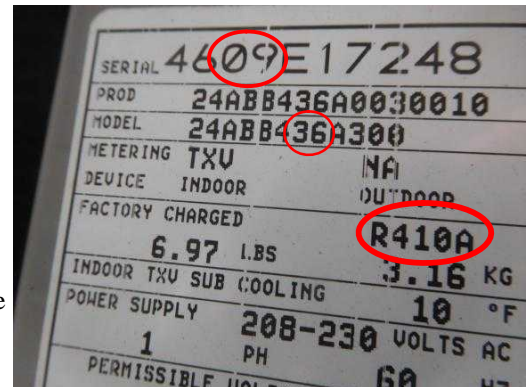
The system appears to have proper temperature drops across the coil to cool sufficiently at this time.

Average temperature differential readings (taken at the ducts on either side of the evaporator coil) were from 68 down to 49 degrees Fahrenheit (19 degrees). Ideal temperature differential drops between the air return and registers should range from 16 to 22 degrees.
