Inspection Report

PROPERTY INSPECTION REPORT

1113 East Washington Avenue, Navasota, TX 77868

William Baldwin TREC 21825 10/22/2018

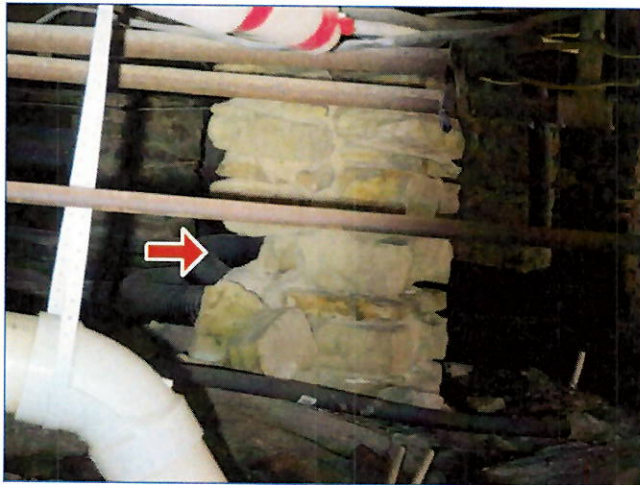
A. Item 4(Picture)

- The piers are the original stacked stones and also stacked concrete masonry blocks placed under the porches. The mortar between the stacked stones has deteriorated at all of the piers, which then allows the house to settle and become out of level. The upstairs floors are out of level, and the downstairs floors slope towards the center of the home.
- There are wide spans between the piers under the center of the home, which may be contributing to the sagging. An engineer is recommended to determine the best layout of piers and repairs that need to be made.
- Loose stones and step cracks throughout perimeter stone walls under bay window at North wall.
- Loose and missing stone at piers on NE corner.
- There are a couple of screw jacks that are rusted and appear to have been added as floors sagged.

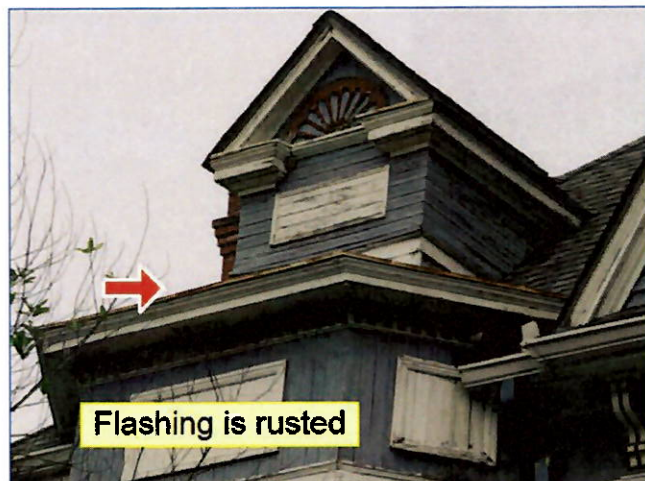
C. Item 1(Picture)

- Roll roofing over porch has areas where water stands, roofing is buckled. I recommend to have a roofer inspect and give estimate for repairs during the option period. This roof covering appears to older than the shingle roof, but I cannot be certain.
- Drip flashing at edge of second story roof is very rusted. This flashing may have been re-used when the new roof was installed.
- Siding is in contact with the shingles at the dormers. There should be a 1/8" gap between the siding and the shingle, per current code.
- Raised flashing at dormers.

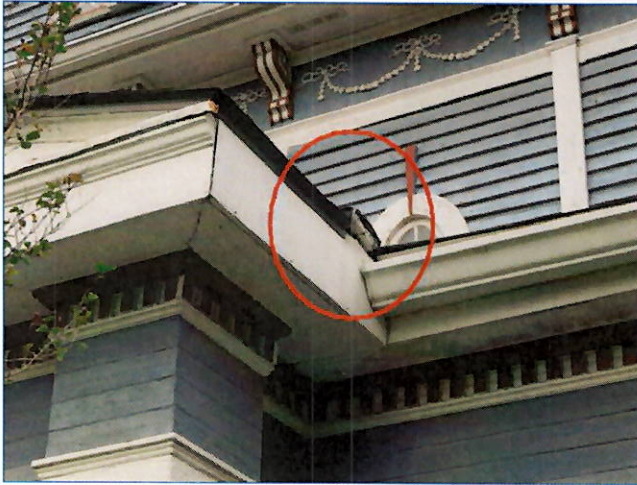
D. Item 1(Picture)

- Water stains visible from inside the attic at the dormers where there is wood rot and missing panes of glass. Water intrusion from these areas can cause damage to the second floor ceilings and walls.
- Daylight is visible through the siding at the dormers, from the attic area. Water intrusion can easily occur in these areas.

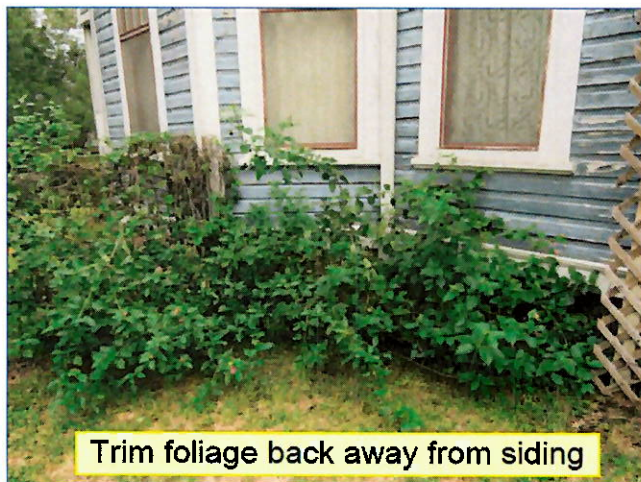
E. Item 24(Picture)

- Foliage, such as shrubs and tree limbs, are in contact with the siding in several locations around the home. This condition contributes to moisture problems, such as wood rot, and can cause pest issues. I recommend to trim all foliage away from the walls.

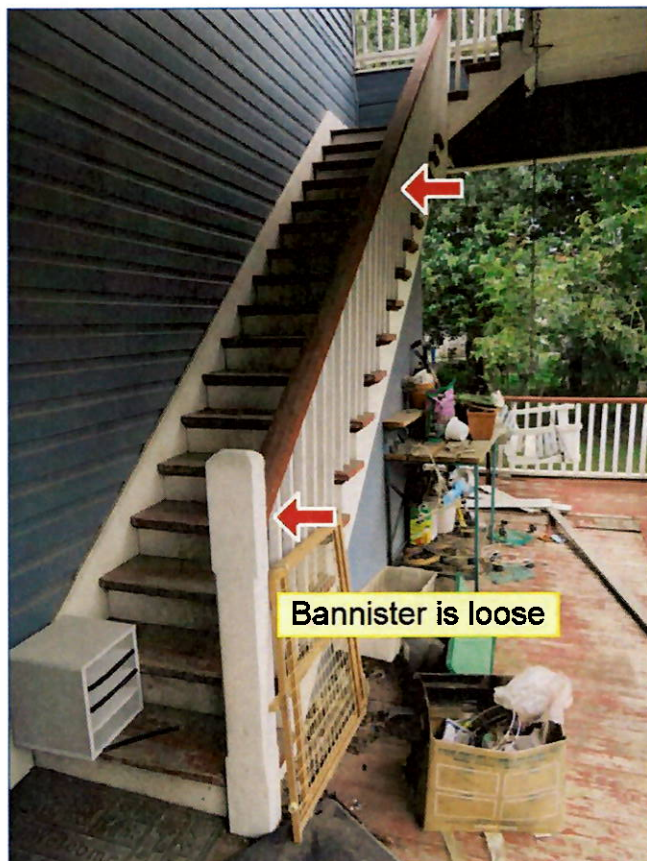
I. Item 1(Picture)

- Loose bannister at outside staircase to second floor balcony.
- Steps to attic are too steep per current codes, handrail does not meet safety standards of current code, there are no spindles. Use caution when going up and down these stairs until repaired.

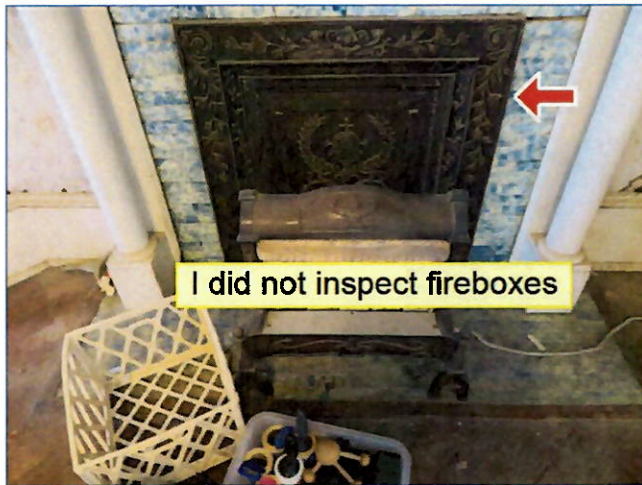
J. Item 2(Picture)

- The liner was not inspected by our company. I recommend a qualified chimney sweep inspect for safety.

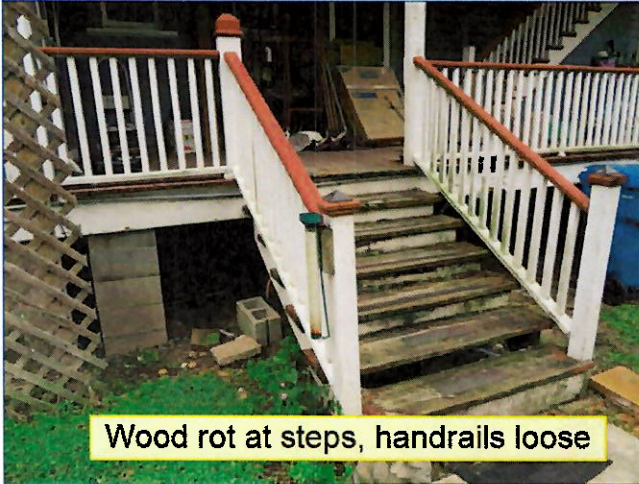
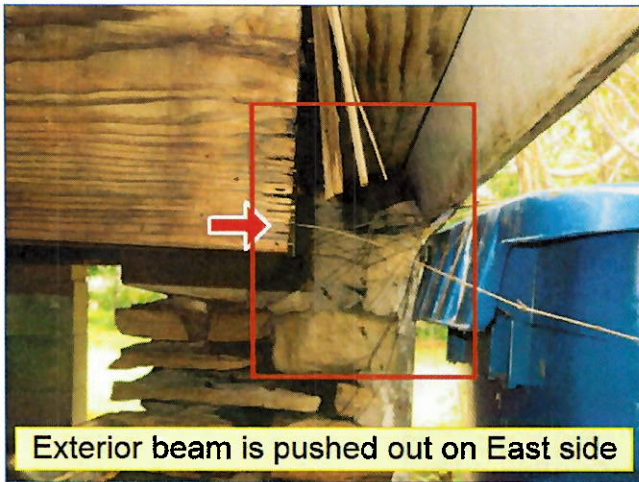
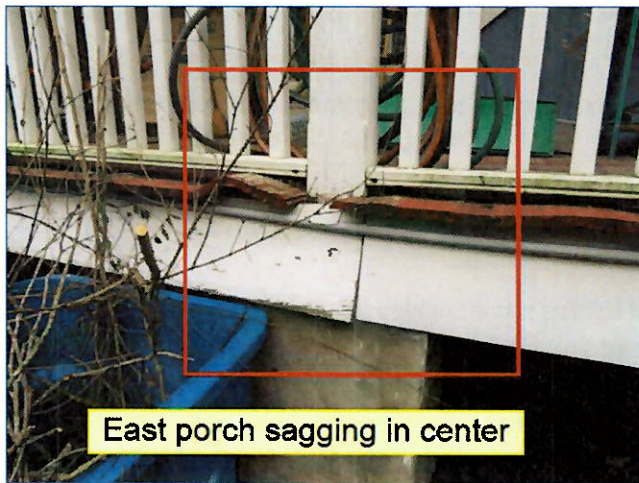
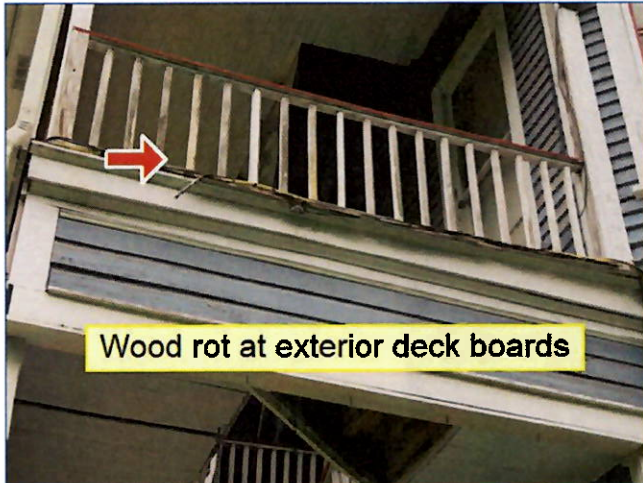
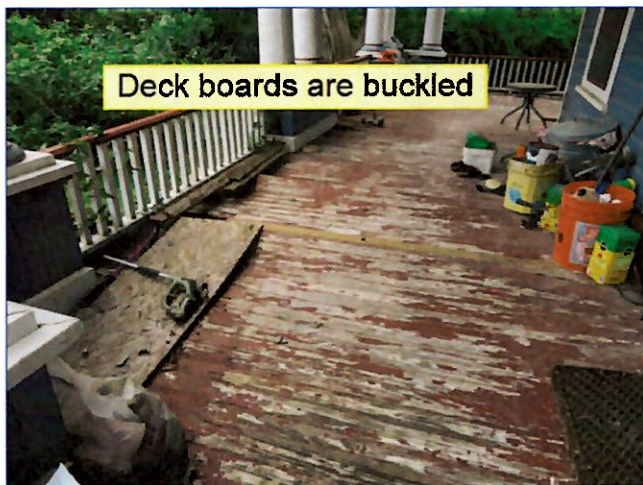
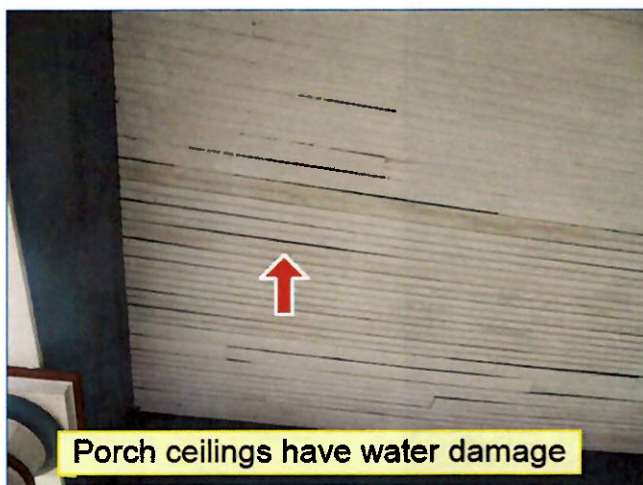
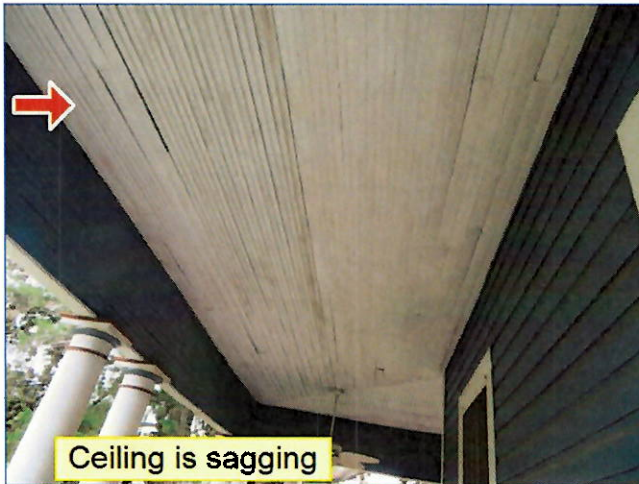
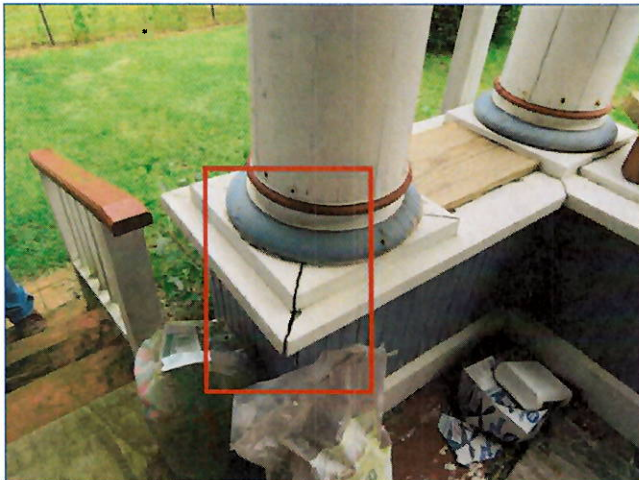
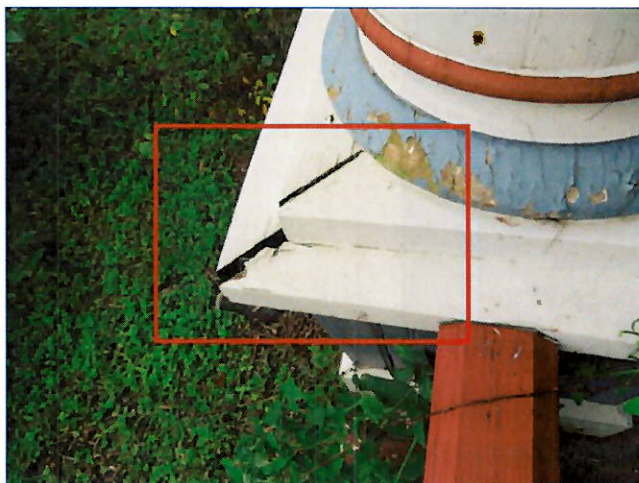
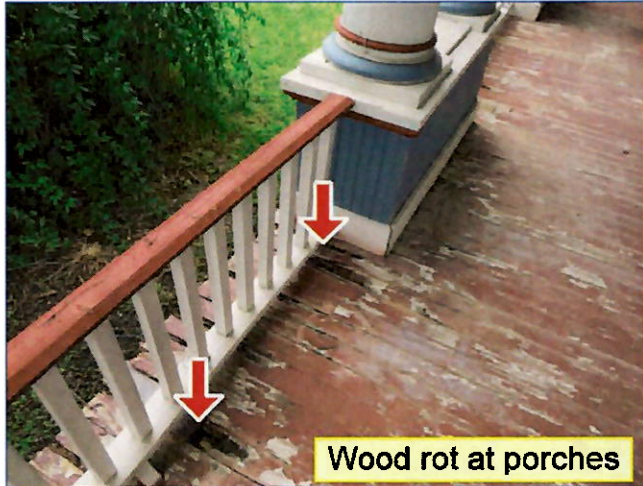
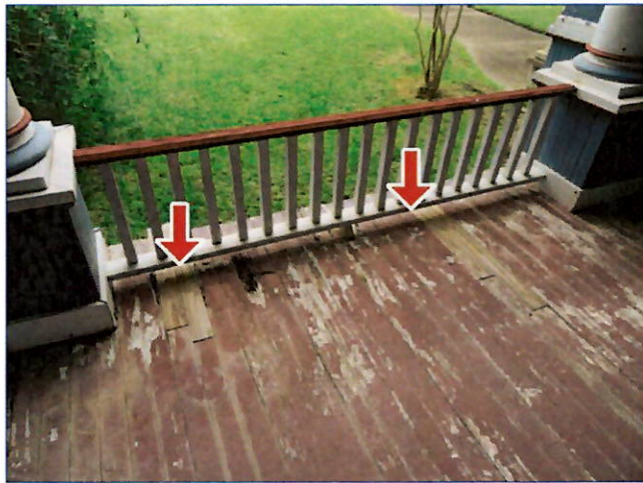
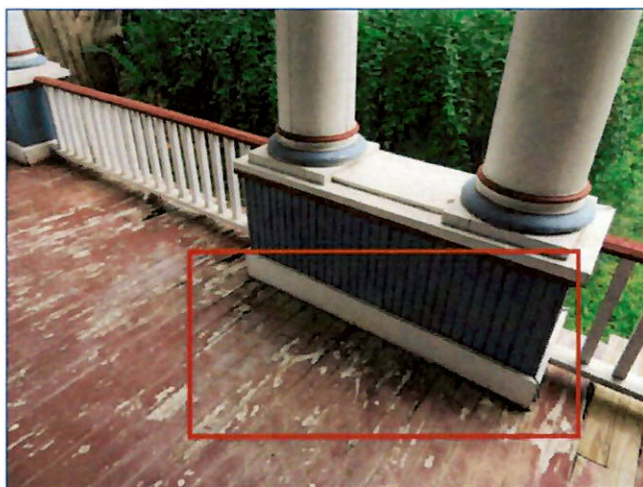
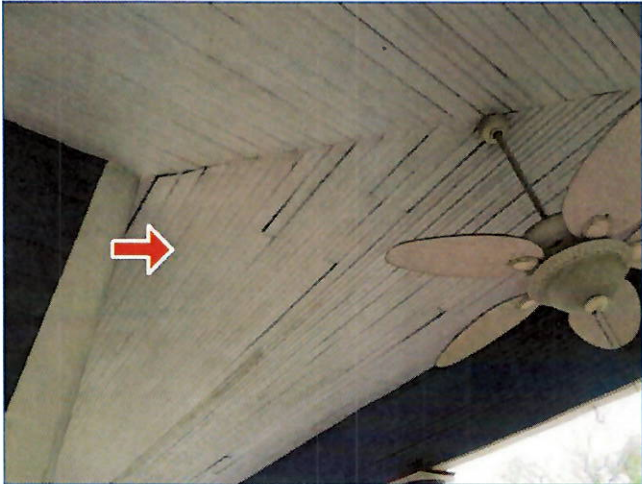
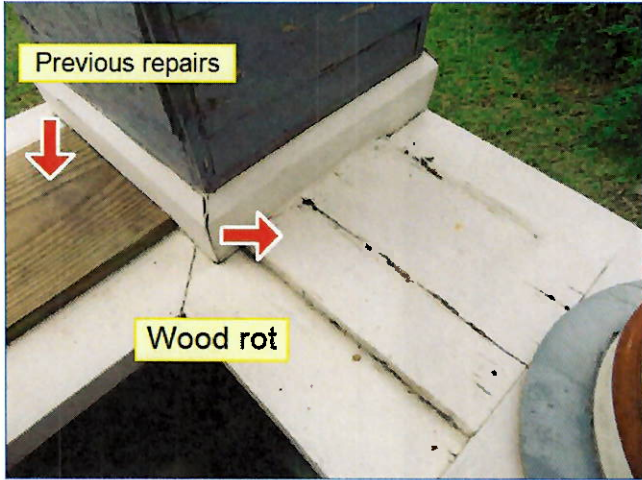
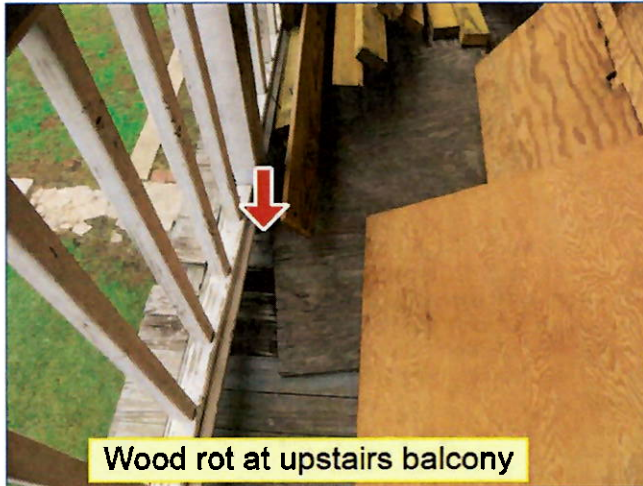
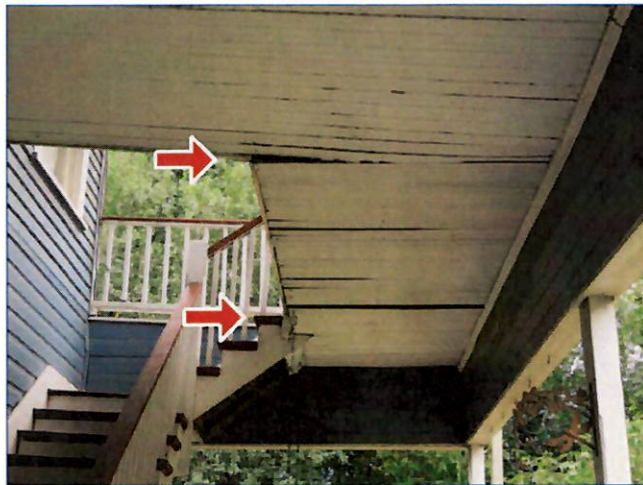
- Front and back porch deck boards have buckled in several locations and there is extensive wood rot. The porches have settled and are shifting, which is contributing to the buckling. This is a safety item and repairs are necessary.
- Wood rot at front and back porch stairs, the steps should be replaced as necessary for safety. .
- Support columns for porches are leaning, specifically on the East side.
- Porches are out of level and may be unsafe.
- Outside porch beam on East side has shifted and pulled outwards, specifically where the stacked stone piers have shifted. The porch is sagging at this center column.
- Loose, sagging, and separated bead board porch ceilings are due to water leaks and age. You may find more water damage once the ceilings are removed during renovation.

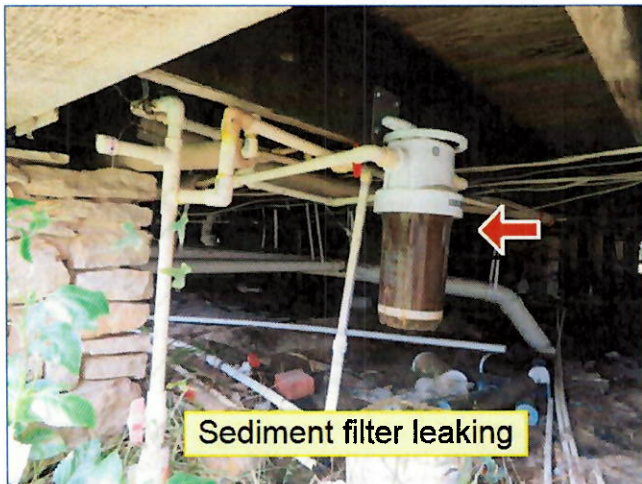
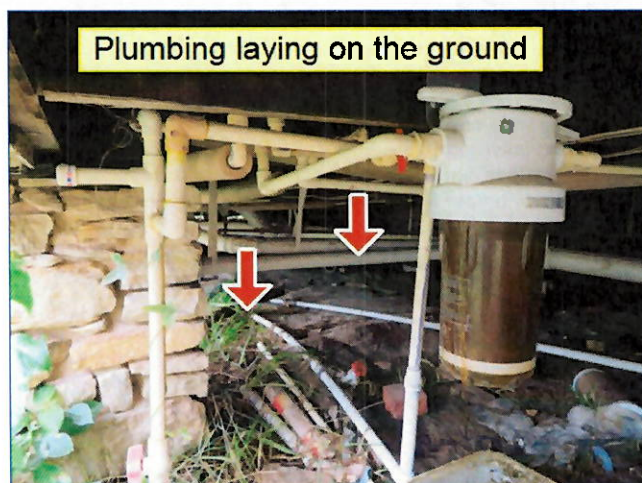
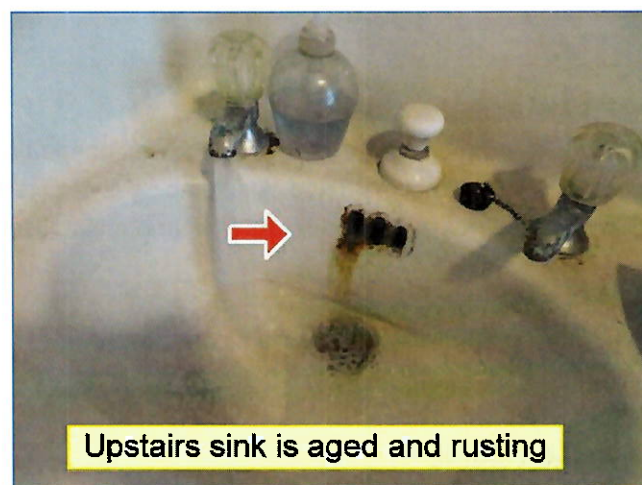
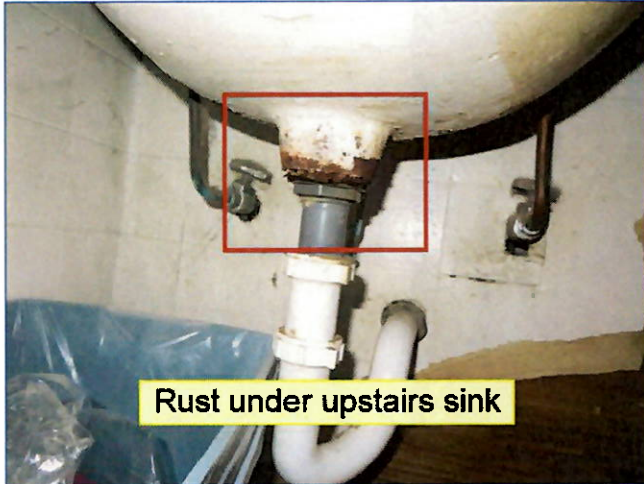
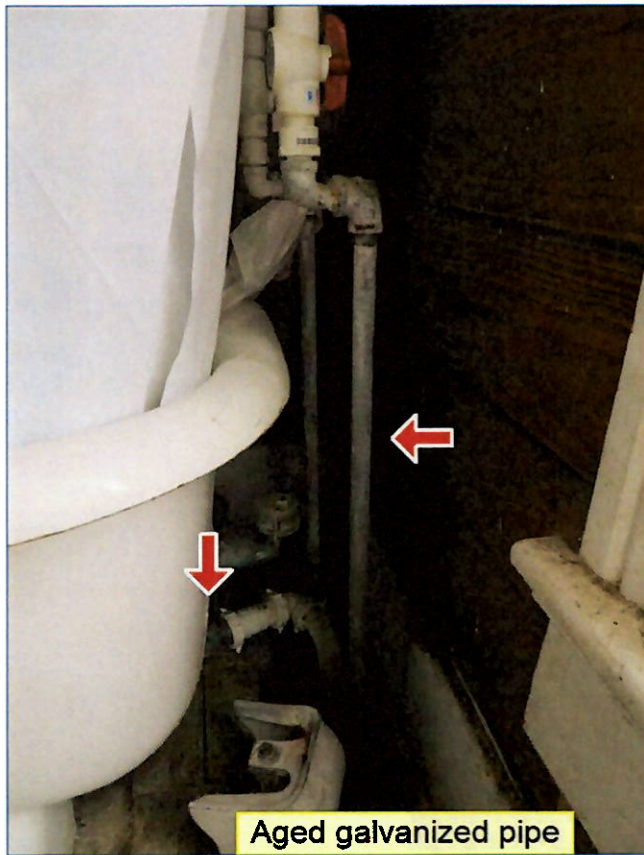
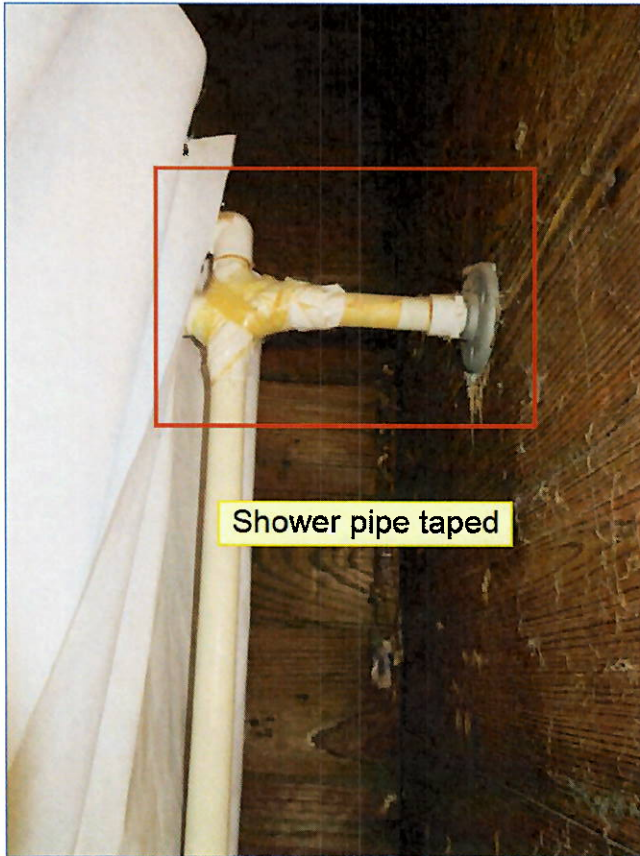
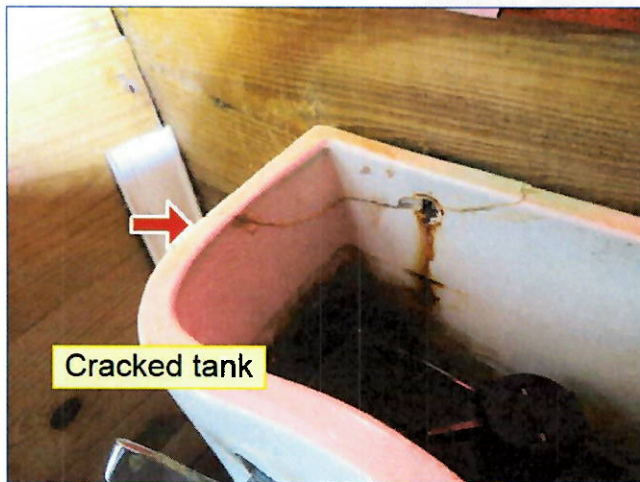
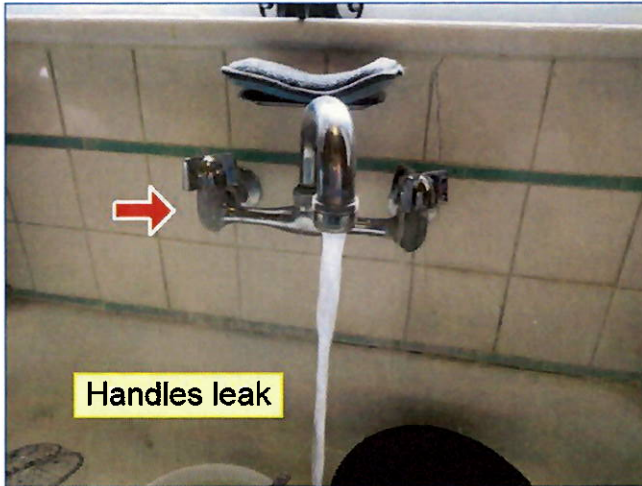
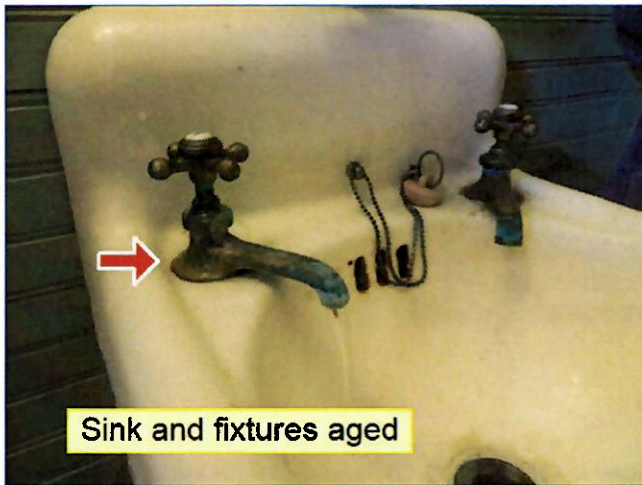
- All hose bibbs around the home are disconnected.
- The sediment whole house filter is leaking constantly and is due to be changed and for repairs.
- Supply plumbing is laying on ground and is not insulated. All plumbing is required to be suspended and properly supported. I do not feel that a licensed plumber installed the CPVC piping to plumbing code.
- Washer water lines are dripping constantly.
- Upstairs bathroom sink is in poor condition, rust around drain connection.
- Upstairs toilet has a crack in tank.
- Kitchen sink leaks at handles.
- No cold water at downstairs powder room sink.
- The upstairs shower piping is galvanized connected to CPVC. The galvanized pipe is aged and the shower pipe is not supported properly and is taped together. Repair are necessary to this plumbing.

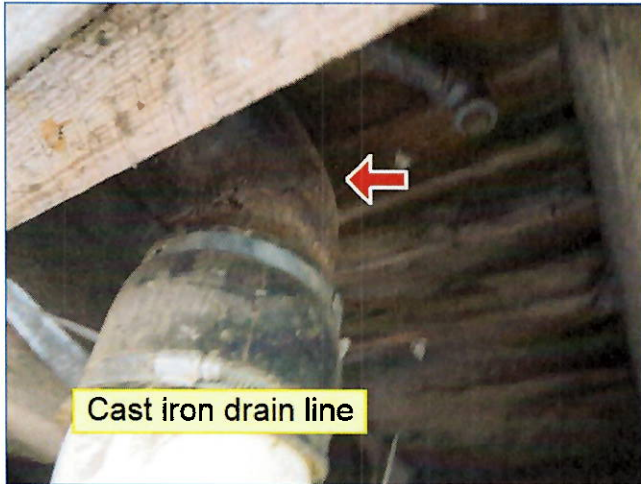
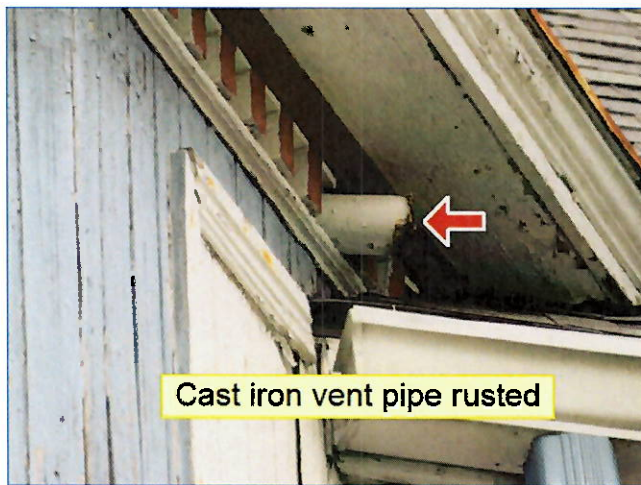
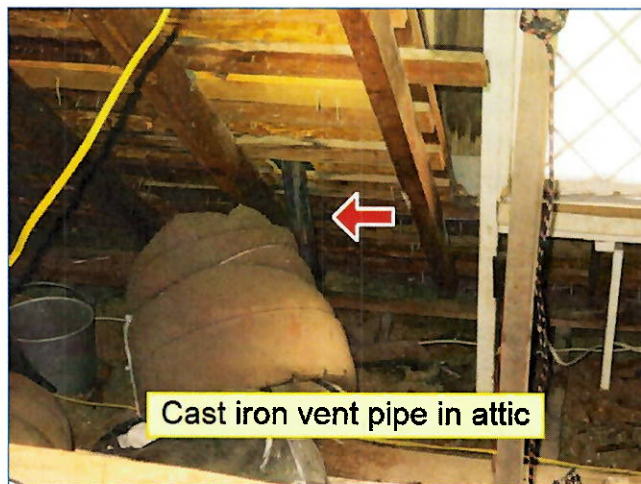
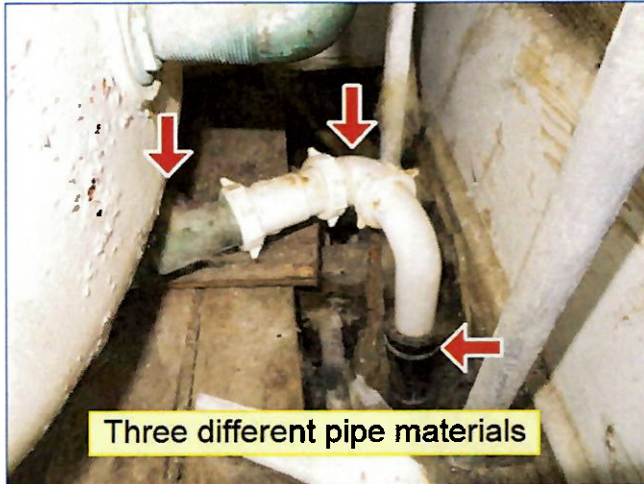
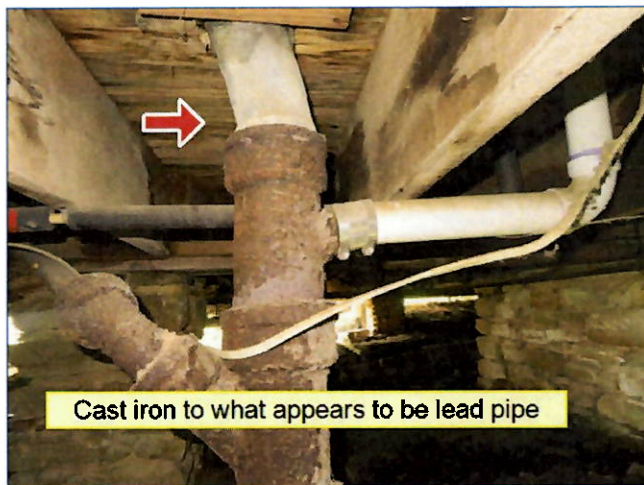
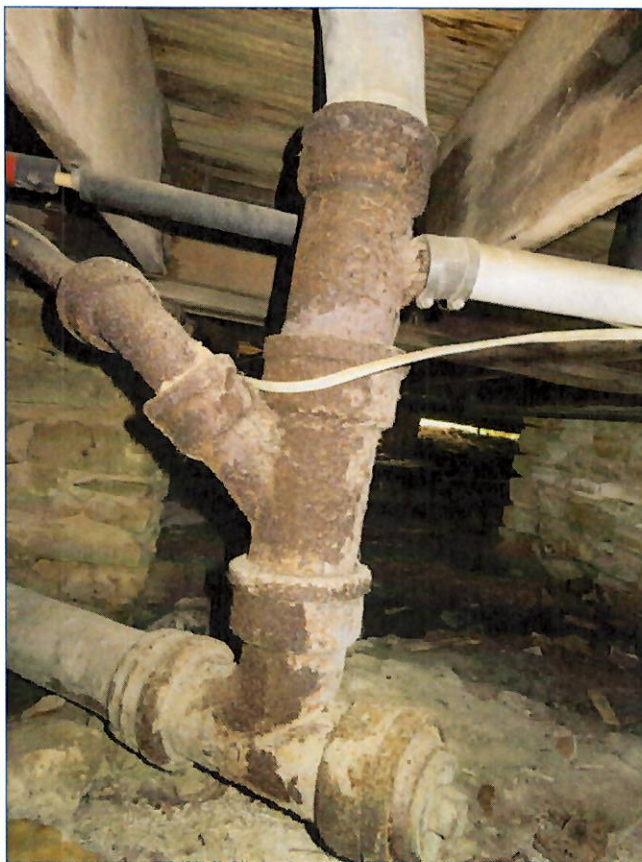
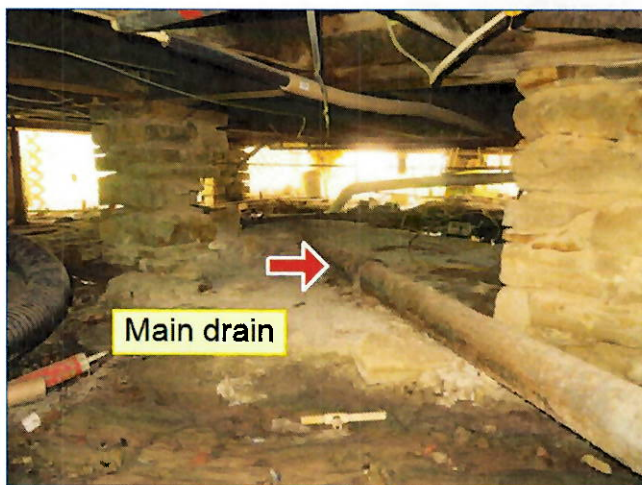
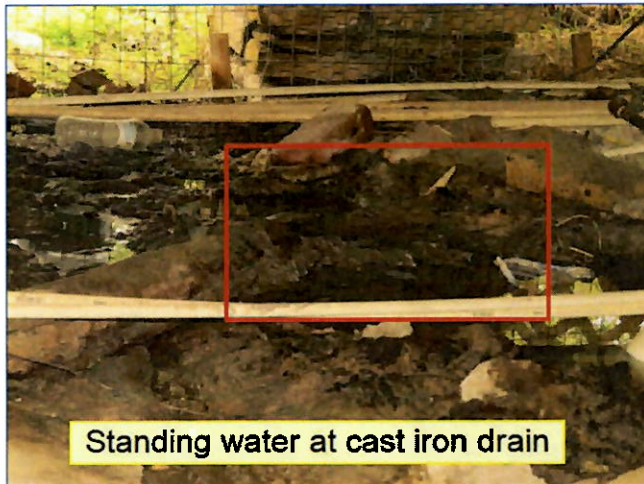
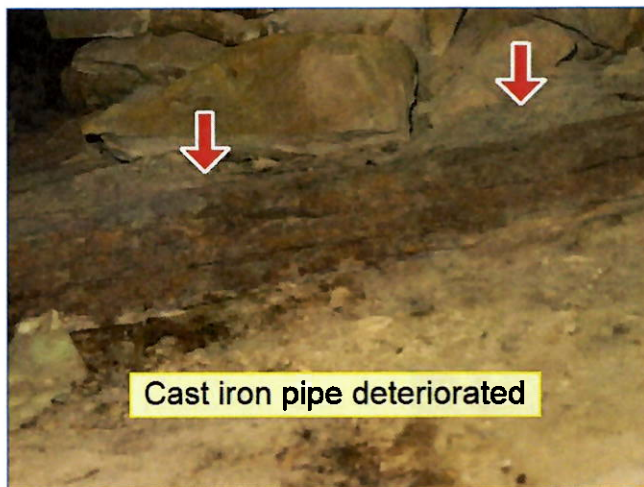
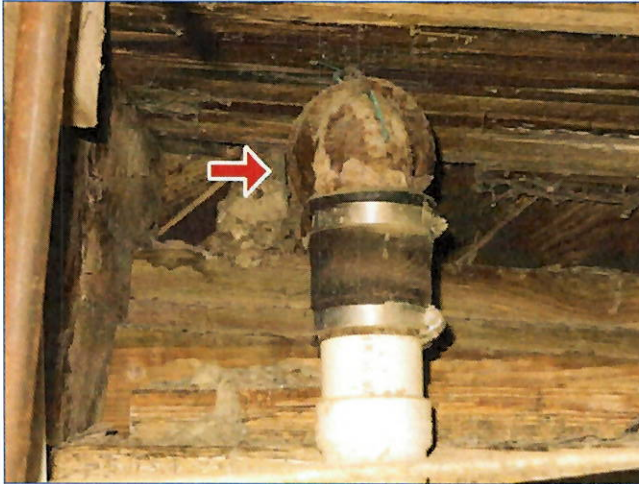
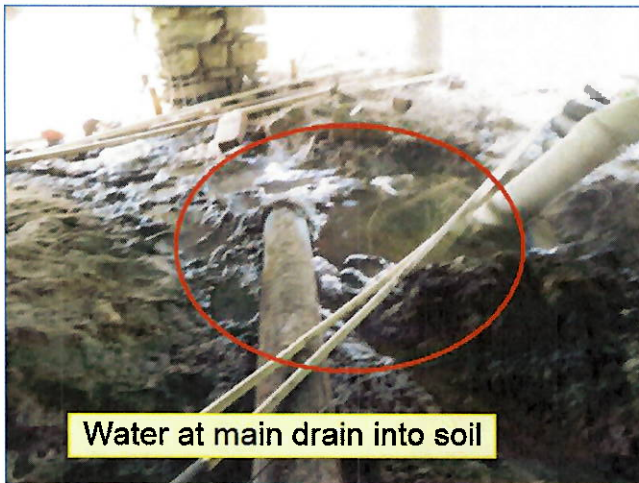
- There is standing water around the cast iron and PVC drain lines in the SE area of the foundation. There are two water leaks under the home that are contributing to water under the home, but I cannot rule out that the cast iron is not leaking also. The cast iron pipe is in poor condition and is overdue for replacement. Cast iron may also be the main drain to the city sewer. I recommend to have a plumber inspect the drain pipes during your option period.
- Appears to be leak at main sewage pipe under foundation.
- The cast iron vent pipe, visible from the front of the home at the dormer, is rusted.
- Drain pipe from the upstairs bathtub is connected to cast iron and there are three different pipe materials at this drain. I recommend to have a plumber inspect the connections.

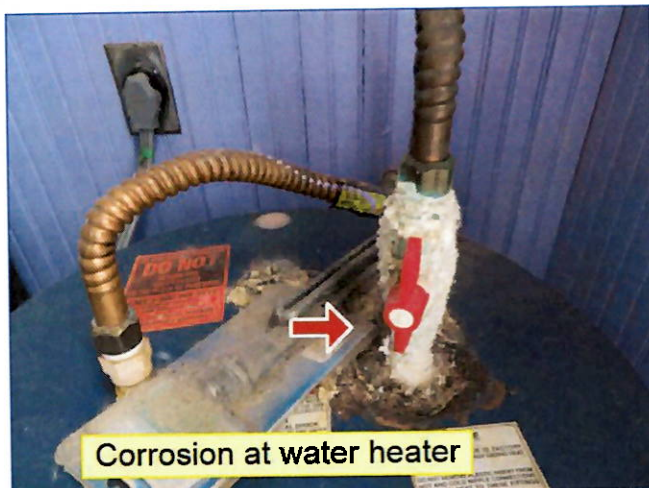
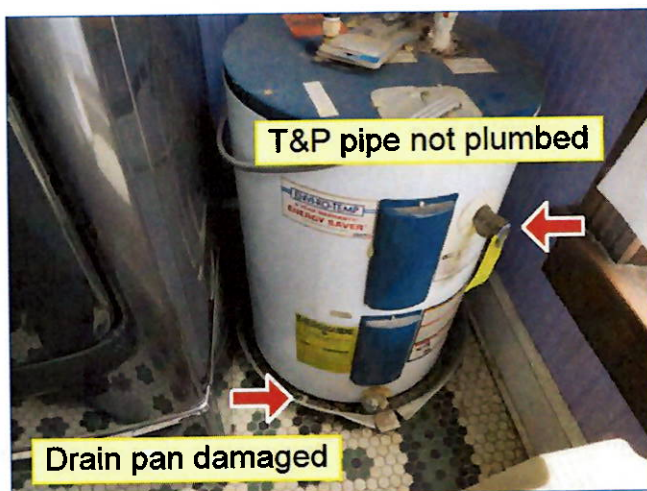
- Corrosion at pipe to water heater. The water heater is aged and due for replacement.
- Drain pan damaged.
- The T&P, temperature and pressure valve is not plumbed. This is a safety item and repair is necessary.

- The water heater is aged and is due for replacement. Water heaters typically have a 10-12 year life span, depending on maintenance, such as draining yearly. This unit is 18 years old.

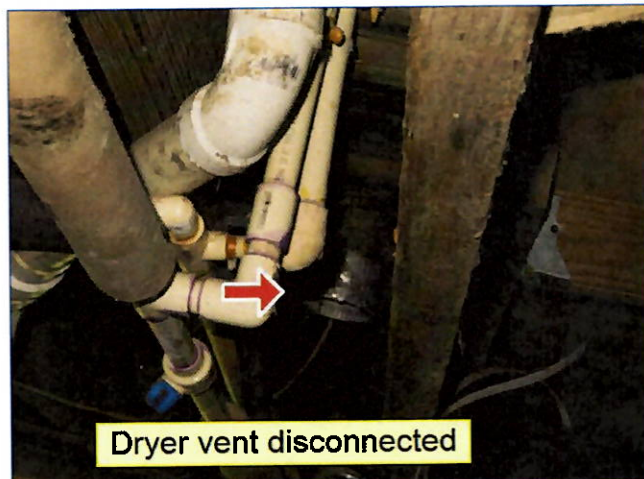
H. Item 1(Picture)

- The dryer vent is disconnected under house. The vent pipe should be reconnected so that it vents outside the crawlspace.
