PROPERTY INSPECTION REPORT

Concerning: 9114 Kirkstone Spring, TX. 77379

Inspected By: Rod Scarborough TREC License # 7189 September 28, 2020

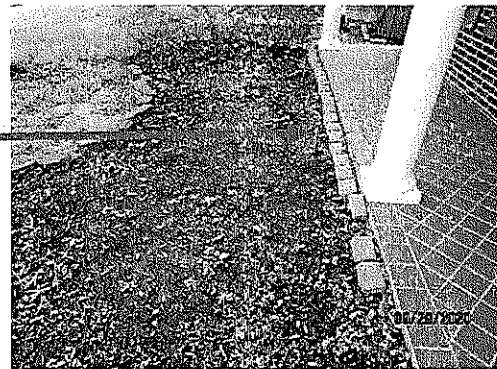
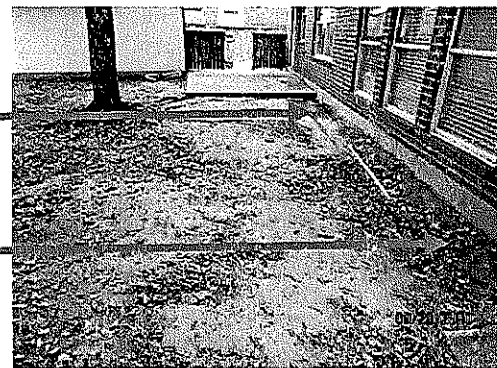
☒ Grading and drainage around the structure does not appear to be functioning as intended in all areas. Signs of erosion/damage & flat/improperly sloped areas were observed on the front, back & left sides of the structure. These conditions may be conducive to ponding which may have an adverse effect on the foundation/structure. It is recommended that the drainage improvements be made in these areas or that sub-surface drainage be installed to allow the water to flow freely away from the structure & to the street as required. After the drainage improvements have been made it is recommended that the drainage around the structure should be monitored during/after heavy rains & if ponding water is observed then additional drainage improvements should be performed.

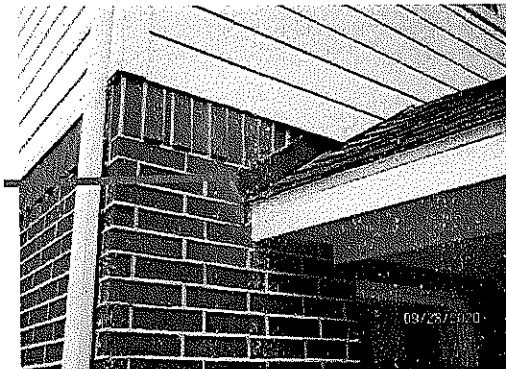
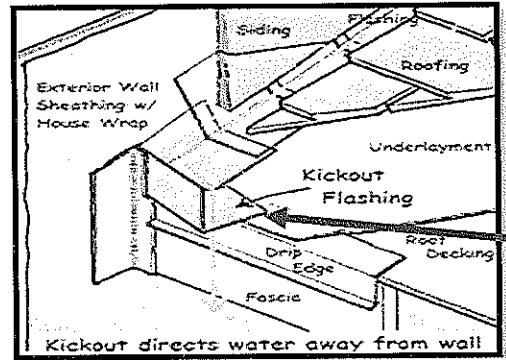
Kick out flashing is not installed at the roof/wall line in the recommended areas. Due to the volume of water that can pour down a sloped roof one of the most critical flashing details occurs where a roof intersects a sidewall.

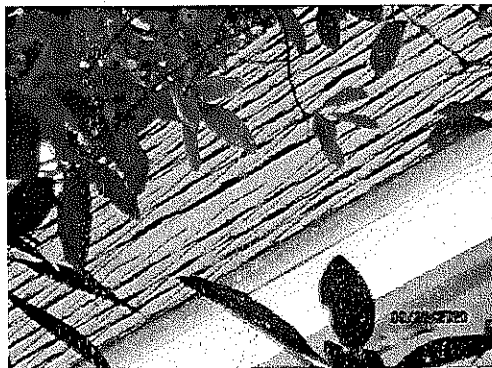
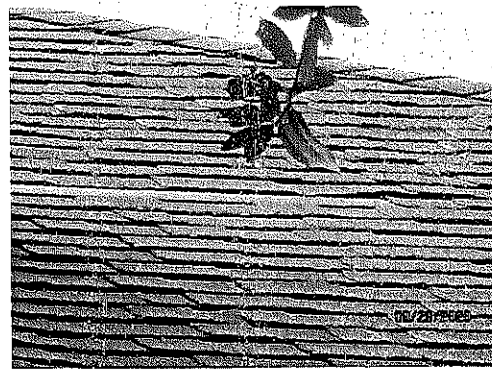
What appeared to be damaged/missing shingles were observed on the front, left & back sides of the roof. Recommend repair/replacement.

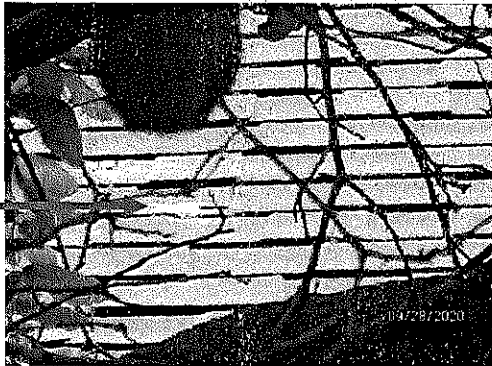
Shingle granule loss exposing asphalt was observed in some areas. Recommend replacement.

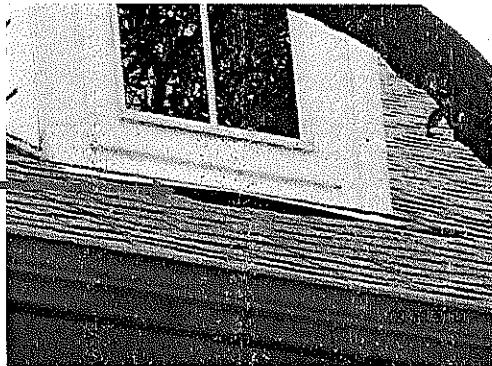
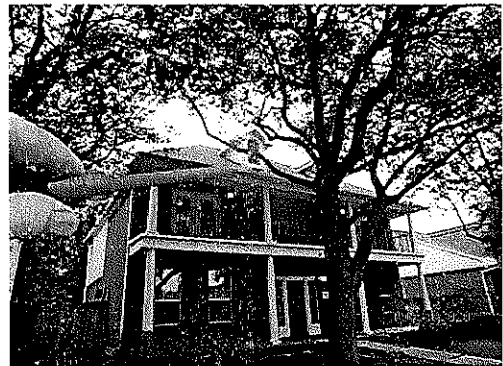
Nail backing out of roof decking pushing the flashing upward was observed on the front side of the roof. Recommend driving back in & sealing.

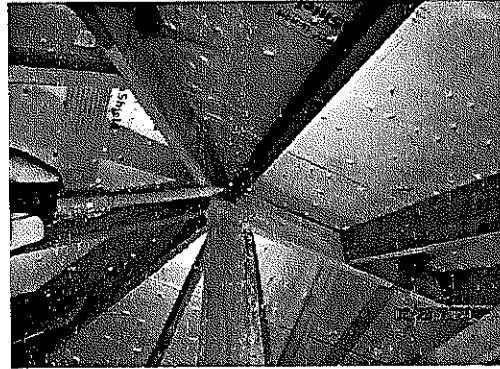
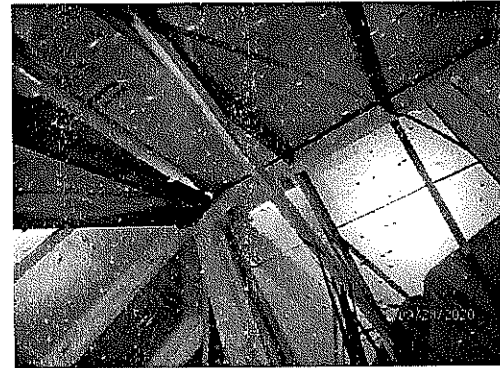
Small holes in the roof decking & shingles were observed from the interior of the attic space at both ends of the main ridge beam. Recommend further evaluation/repair.

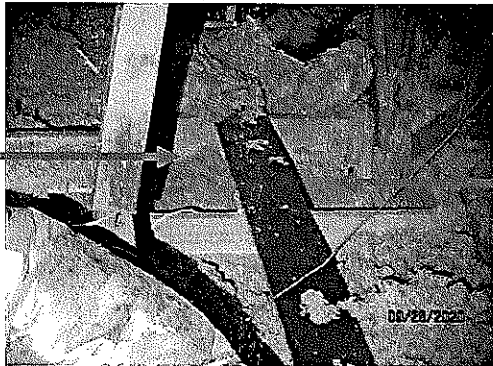
Existing/previous moisture penetration/staining was observed in the attic decking by the upstairs HVAC equipment. A moisture reading was performed in & moisture was detected at the time of the inspection.

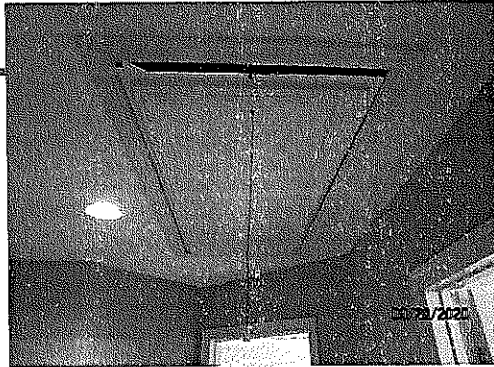
The attic access is missing weather stripping & insulation. Recommend sealing to help reduce energy cost.

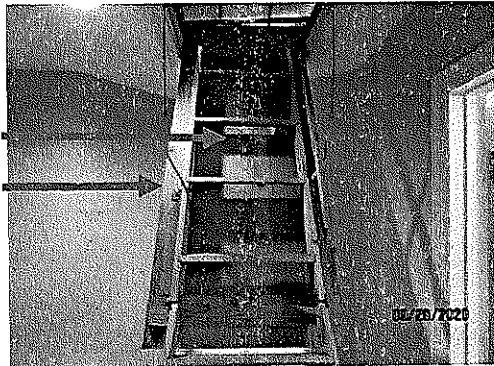
Evidence of rodent penetration was observed in some areas of the attic as noted by the fecal matter.

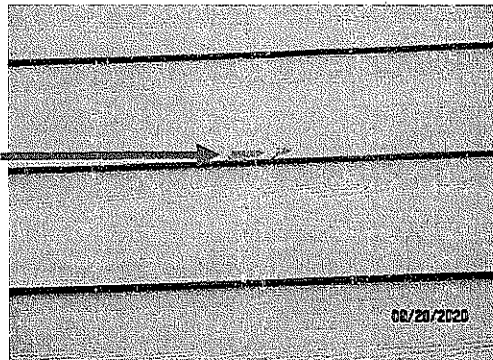
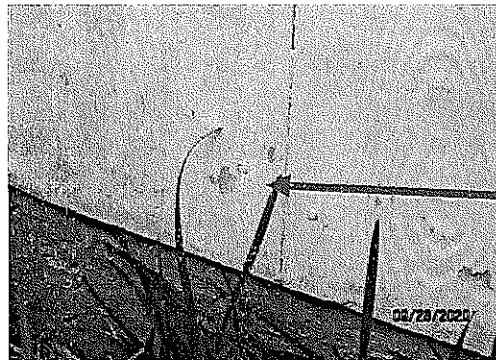
Minor peeling/missing paint was observed at various areas around the perimeter of the structure. Recommend repainting as required.

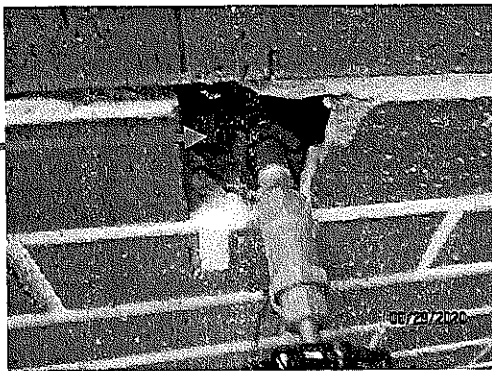
Missing/damaged brick was observed around the hose bib on the back side of the structure. Recommend repair/sealing.

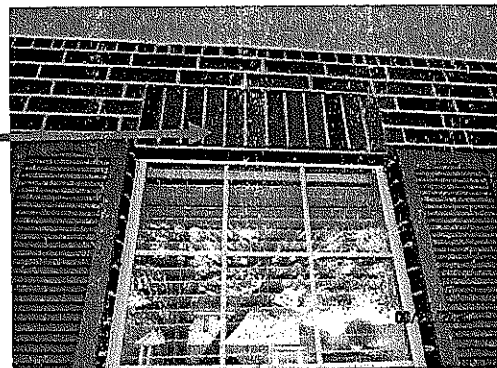
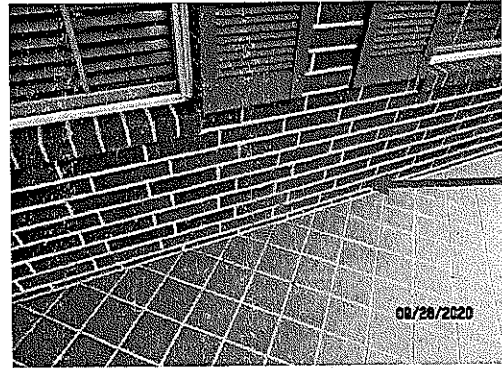
Weep holes are not installed over the windows/doors & at the front porch area. Weep holes should be kept free of debris and spaced at a max of 33" on center.

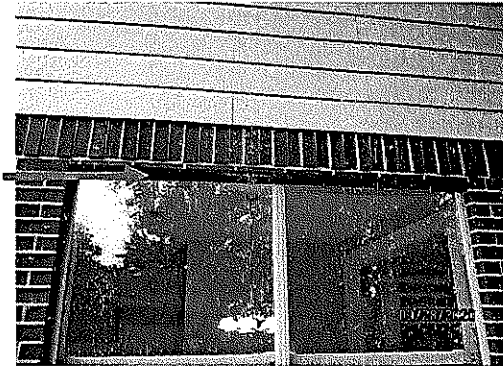
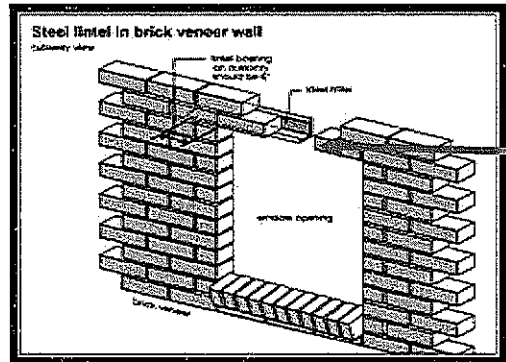
Minor rust was observed on some of the lintels at openings above the doors/windows etc. Recommend removing rust & priming/painting the lintels.

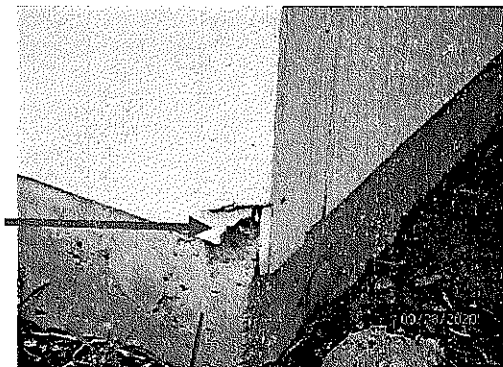
Minor damage to the siding/trim was observed in some areas around structure.

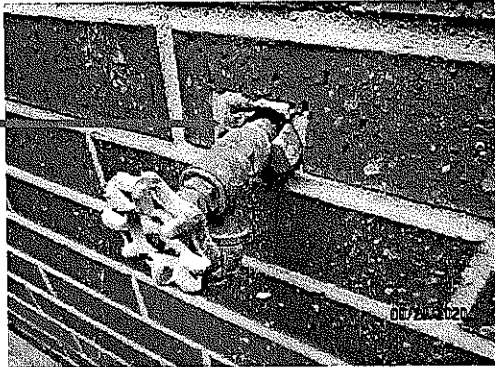
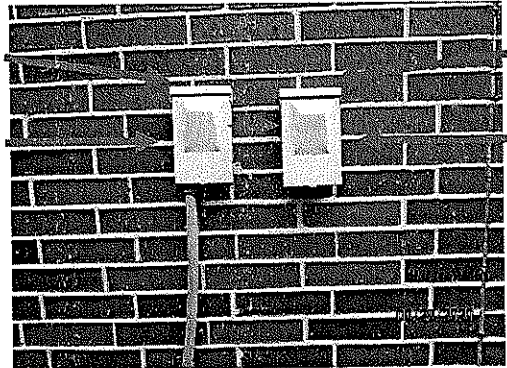
Recommend sealing all exterior penetrations to prevent possible moisture penetration including but may not be limited to: Electrical penetration, exhaust vents, door bell, electrical panel/disconnect/conduit penetrations.

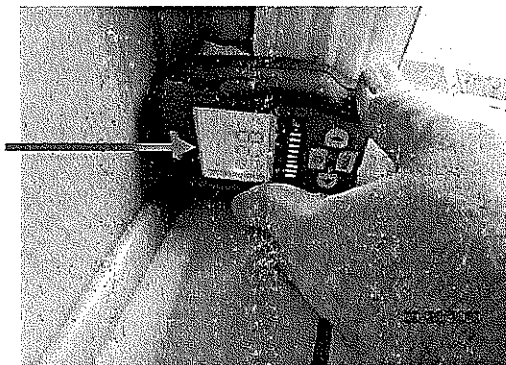
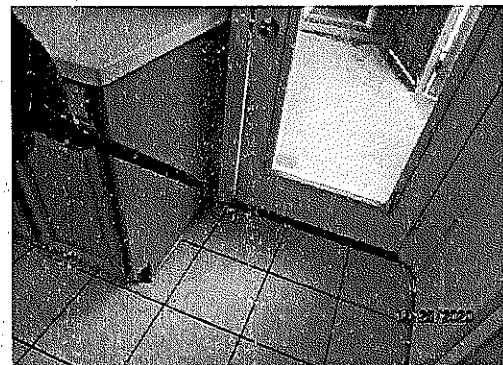
Existing/previous moisture penetration was observed but may not be limited to the base of the wall by the back door & at the base of the wall outside the upstairs hall bathtub on the interior of the structure. A moisture reading was performed & moisture was detected at the time of the inspection. Recommend further evaluation to determine the source of the moisture & to determine if any hidden structure damage has occurred.

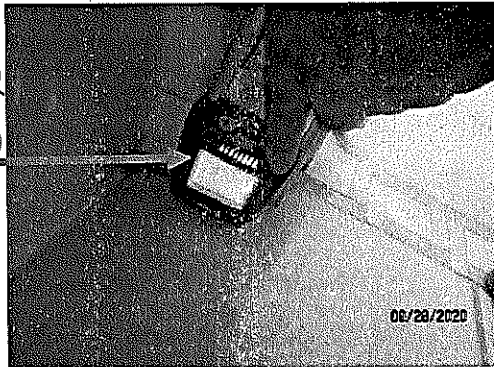
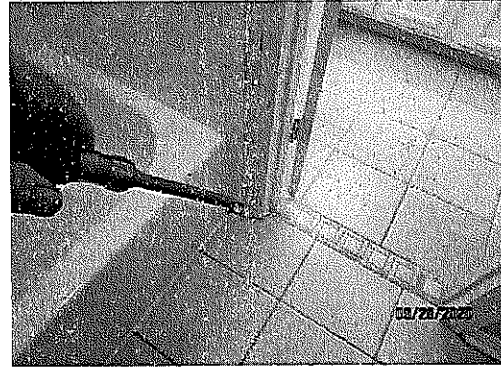
Existing/previous moisture penetration was observed but may not be limited to the base of the wall in the half bath on the interior of the structure. A moisture reading was performed & no moisture was detected at the time of the inspection.

The half bath was fully repaired all moisture affected trim and sheetrock was removed and replaced

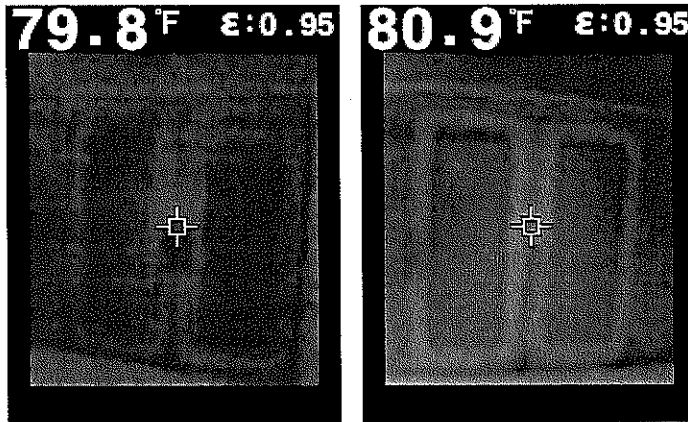
The weather stripping at the door leading to the balcony from the master bedroom is damaged.

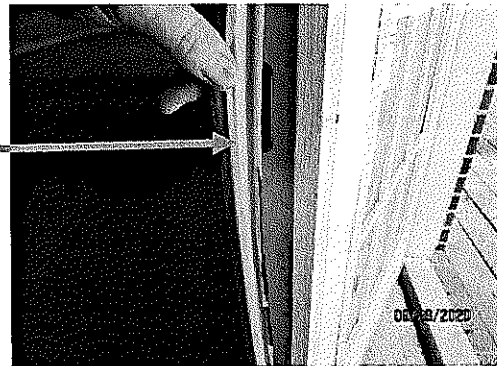
Keyed dead bolts on all egress doors need to be replaced with a dead bolt that can be unlocked without the use of a key or special knowledge or effort.

The back door is missing weather stripping & does not seal when closed. Recommend repair.

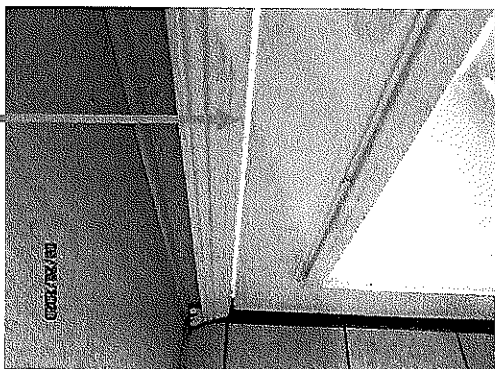
The glazing at the front door is broken. Recommend replacing.

Door was repaired →

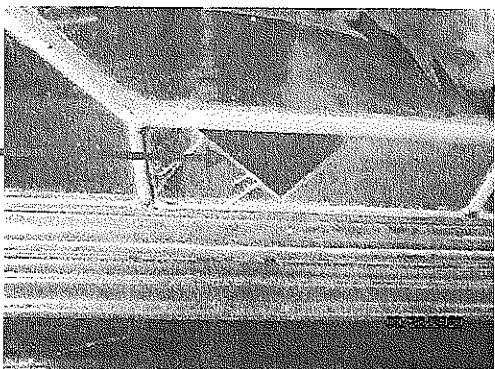
The door leading to the balcony is missing a faster at the hinge. Recommend replacing.

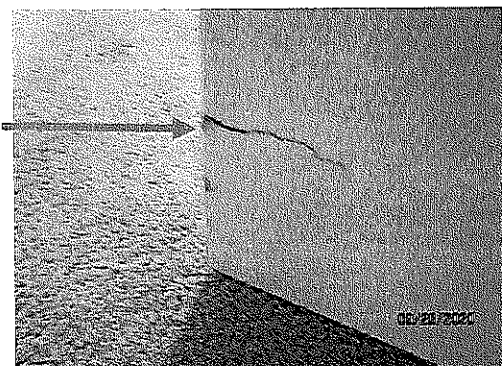
The door leading to the back middle bedroom rubs the frame when closing & is cracked at the base of the door. Recommend repair/replacing.

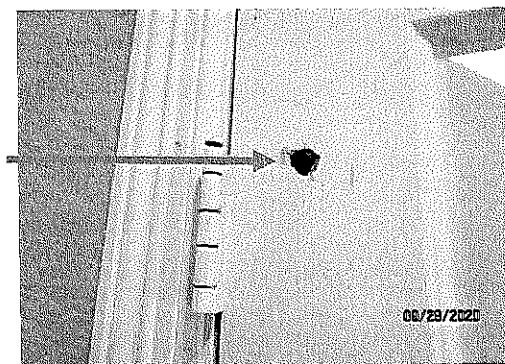
The door leading to the pantry has a hole in the door. Recommend repair/replacing.

hole in door was repaired

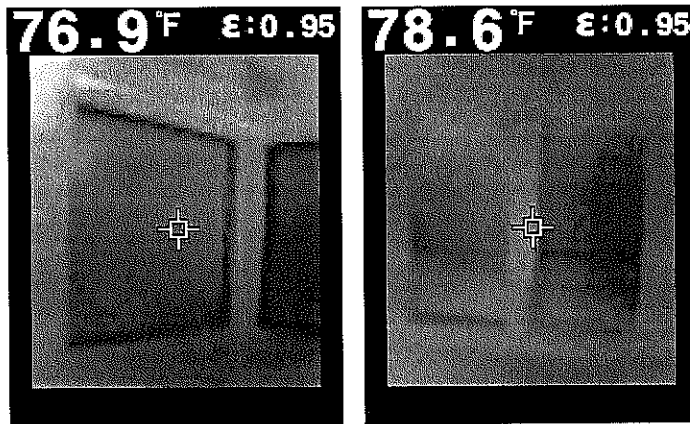
Unable to determine the presence of safety/tempered glass at the windows in the main living area due to not being able to located the tempered/safety glass etching. Safety/tempered glass is required by today's standards.

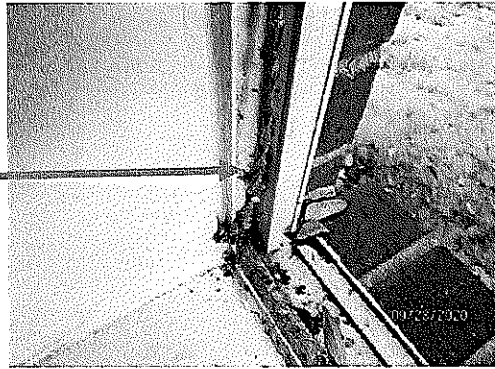
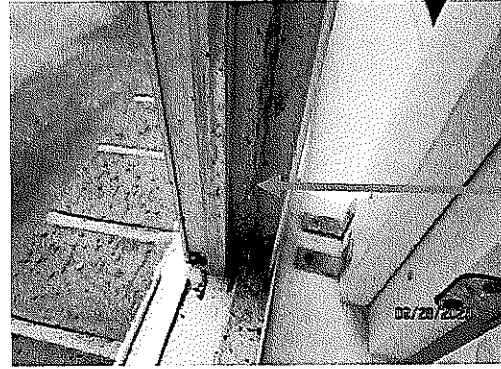
A total of 6 broken window sash balances were observed at various windows. Recommend repair/replacing.

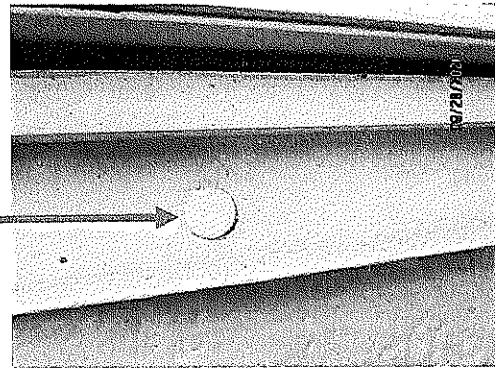
Holes were drilled & alarm sensors have been installed into some of the window frame sills. Buyer should ensure that all holes remain properly sealed to prevent possible moisture penetration into the wall cavity.

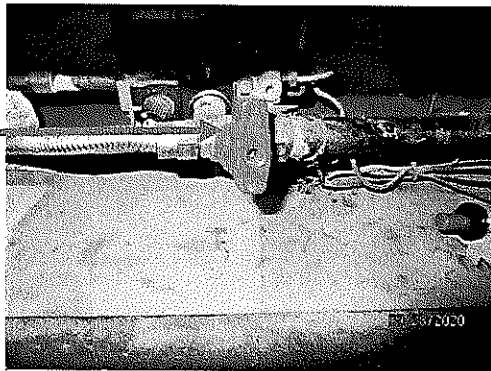
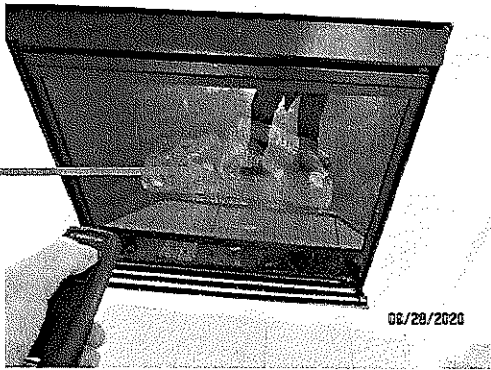
The fireplace could not be lit under normal conditions. The gas valve was closed & the pilot was out upon arrival to the inspection. The pilot was lit & multiple attempts were made to light the fireplace however the fireplace would not light under normal conditions. Recommend further evaluation/repair.

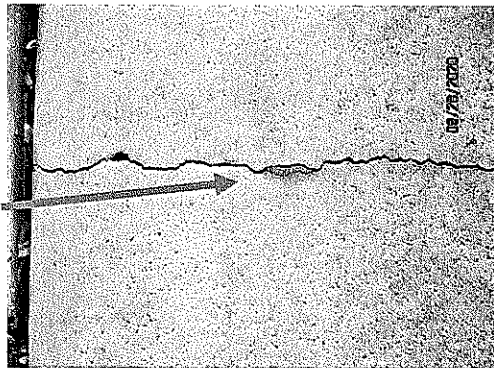
Cracking was observed in the driveway. Recommend repair.

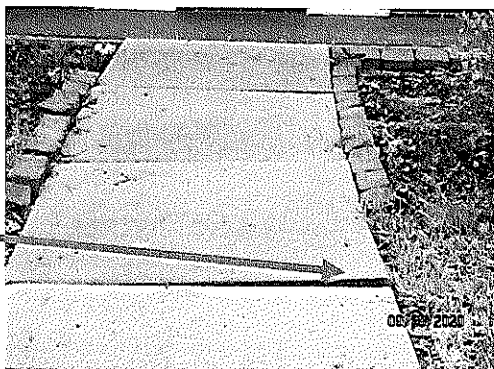
Upheaval/sinking of the walkway was observed creating a potential trip hazard.

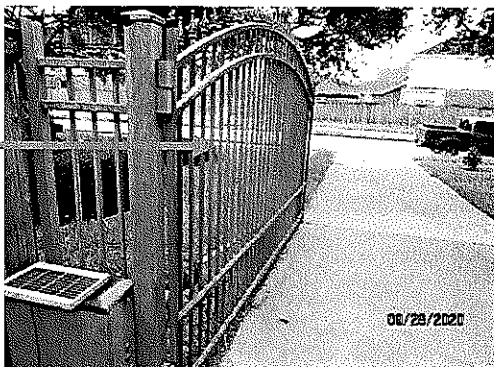
The driveway gate did not appear to function as intended. Recommend further evaluation/repair.

→ repaired, gate is functioning

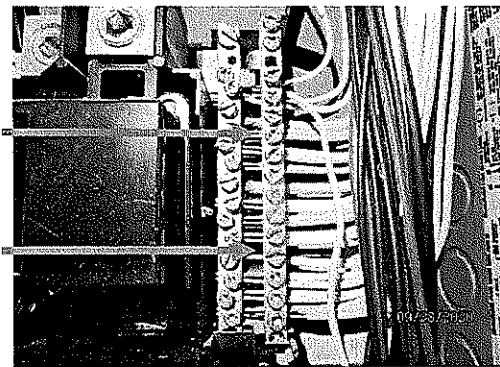
Double tapping of neutral conductors was observed at the bus bar. Each neutral conductor should be single tapped at the bus bar. Recommend repair.

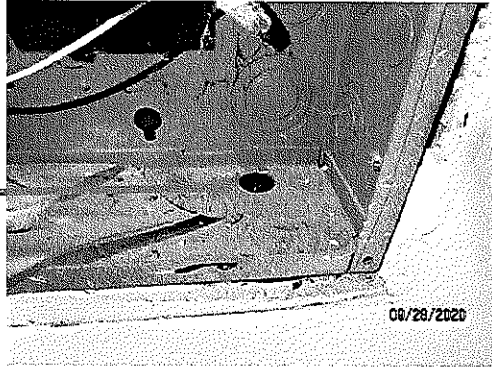
Conductors are not properly protected at penetration at the top of the panel.

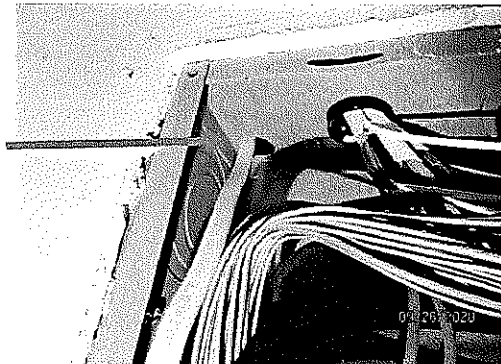
No anti-oxidizing compound was observed on aluminum feeder wires. Recommend installing anti-oxidizing compound.

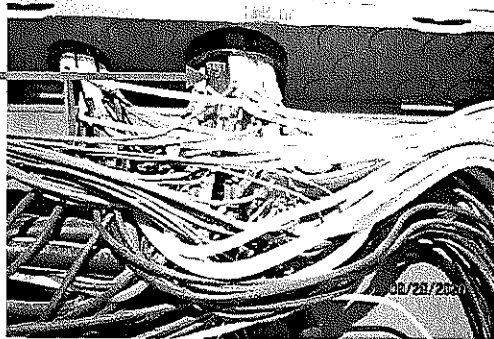
Improper conductor bundling through one clamp/opening was observed. Conductors must be secured to the panel & should not be bundled/clamped through one clamp/punch out due to the possibility of overheating of the conductors.

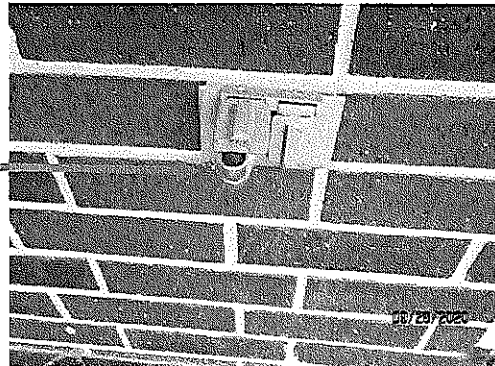
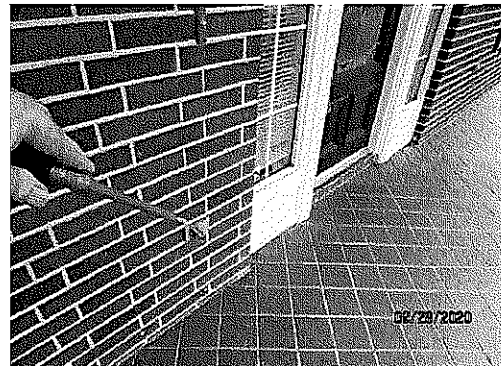
The outlet to the left of the front door is not GFCI protected as required. This is a safety issue, it is recommended that GFCI protection be added.

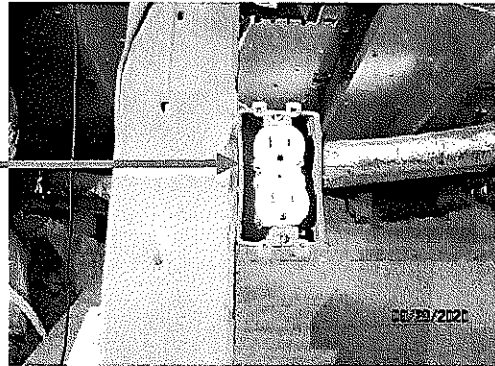
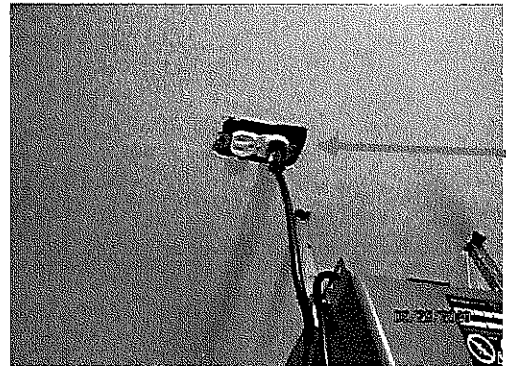
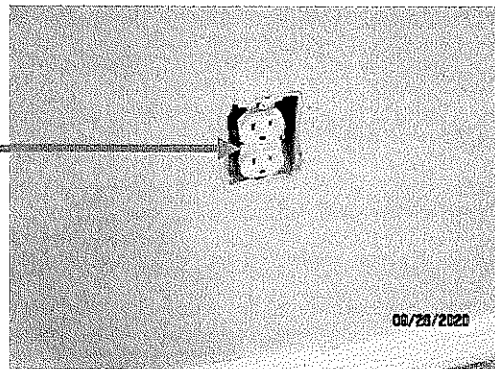
Some of the light fixtures did not function possibly due to burnt bulbs. It is recommended that all burnt bulbs be replaced & the light fixtures are turned on to determine if the fixtures function as intended.

All exterior light fixtures exposed to weather conditions should be properly sealed & the light fixtures/wall boxes at the front porch & balcony are not properly secured to the wall.

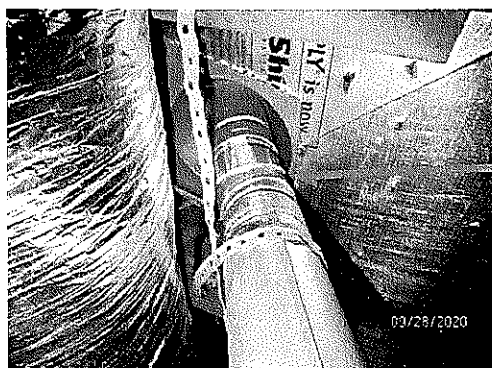
The heaters showed signs of aging & are potentially nearing the end of their life cycle. Recommend budgeting for replacement in the future.

Due to the overall age of the heaters it is recommended that the heaters be further evaluated by a licensed HVAC Technician prior to closing.

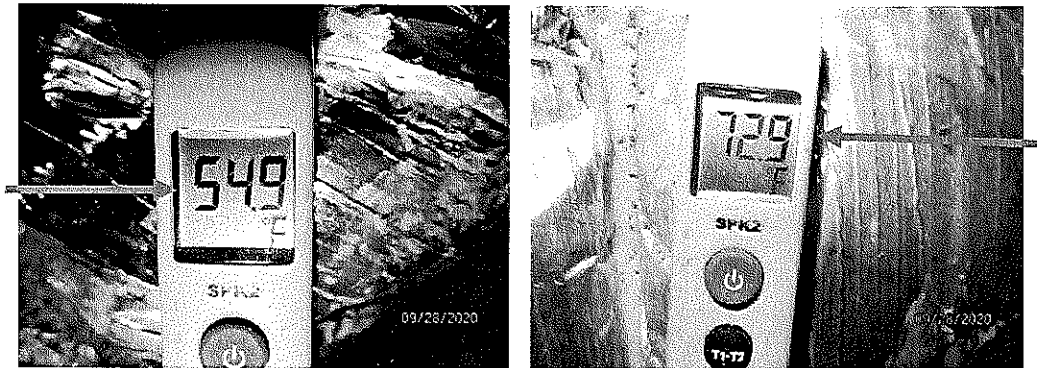
Upstairs supply air temp: 54.9 Degrees (as measured at the discharge side of the coil in the attic) Return air temp: 72.9 degrees (as measured at the return side in the attic)

A variance of 15 - 21 degrees between the supply and return air is considered to be functioning as intended.

The upstairs cooling equipment was operated and is functioning as intended however there were deficiencies as described below.

The downstairs cooling equipment did not function as intended under normal operating conditions. Recommended further evaluation/repair by a licensed HVAC Technician prior to closing.

Has been repaired, both cooling units are in working condition

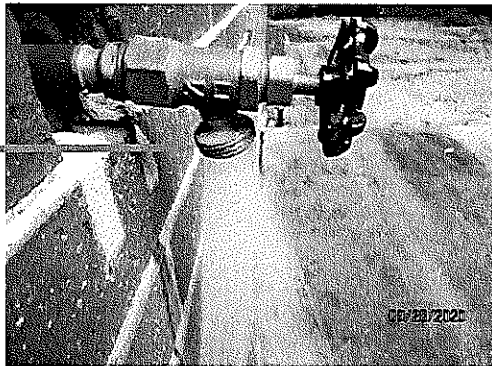
Hose bibs on the left & right sides of the structure leaks when turned on.

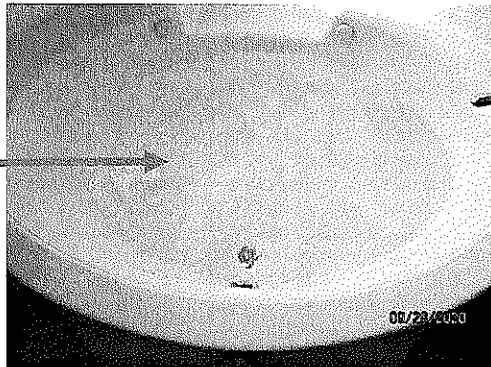
Access panel is not installed to inspect equipment/plumbing under bath tub.

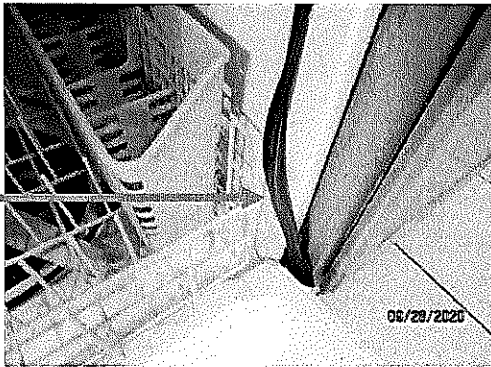
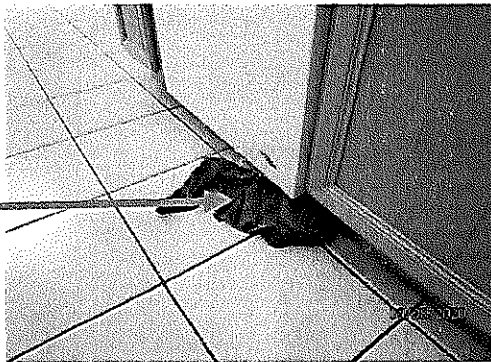
An attempt to run the dishwasher through a complete normal cycle was made however the dishwasher had to be shut off without completing the cycle due to the dishwasher door seal is damaged & is leaking water all over the floor. The dishwasher was shut off & the cycle was not completed. Recommend repair as required.

Dishwasher replaced with new in March

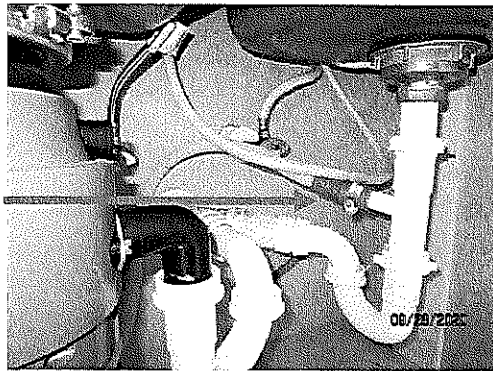
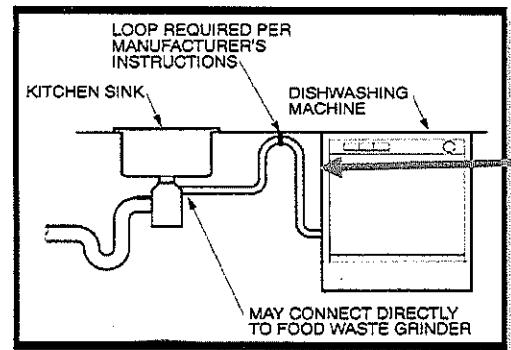
Air gap in the dishwasher drainpipe is not installed, when installed properly the air gap prevents the potential backflow of contaminants from the disposer back into the dishwasher. The dishwasher drainpipe should be secured to the underside of the counter to create an upside down "U" in the drainpipe.

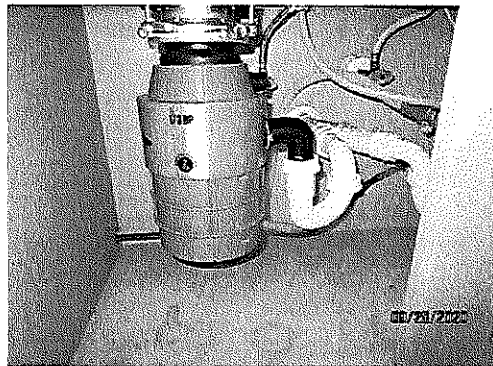
Surface rust was observed on the interior of the disposal.

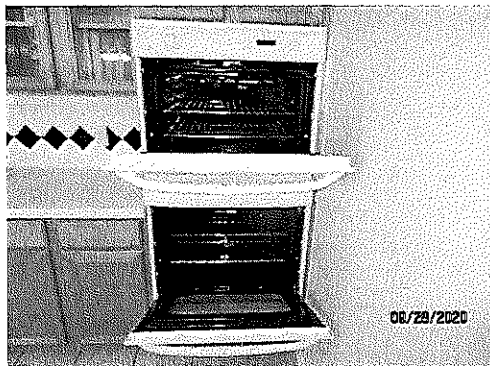
The ovens were turned on to 350 degrees and allowed to cycle through the preheat function, a temperature reading was performed and read 325 degrees at the top oven & 330 degrees at the bottom, a variance of 25 degrees is considered acceptable. Recommend recalibrating the oven to the correct temperature as required.

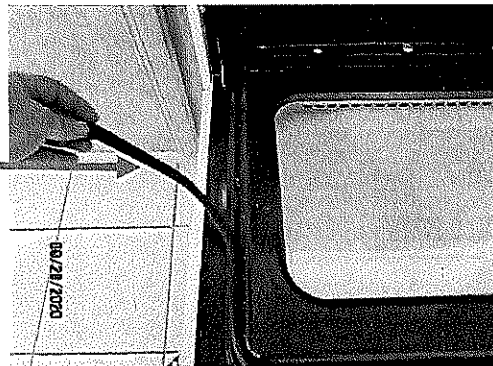
seal was replaced

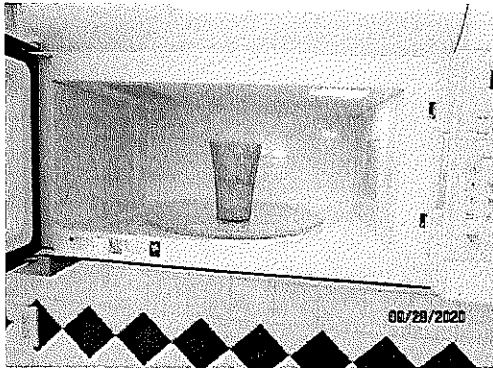
The door pull is broken. Recommend replacing.

Door pull was replaced

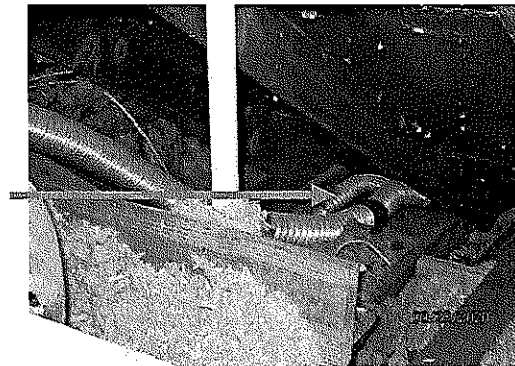
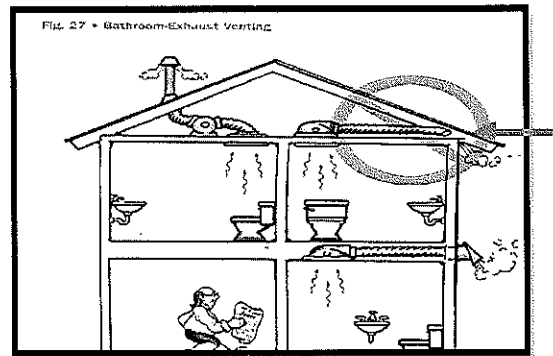
The upstairs bathroom exhaust vents are vented to the soffit and not through the roof deck or exterior wall as required.

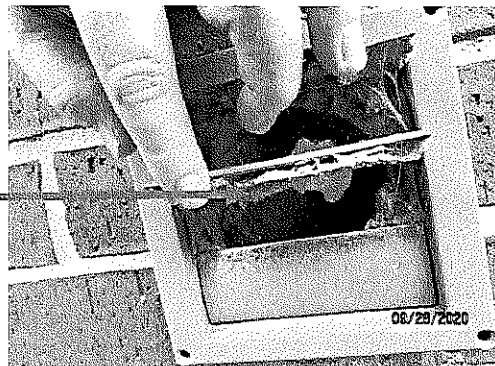
Dryer vent is dirty/filled with dryer lint. This is a potential fire hazard & should be properly cleaned.

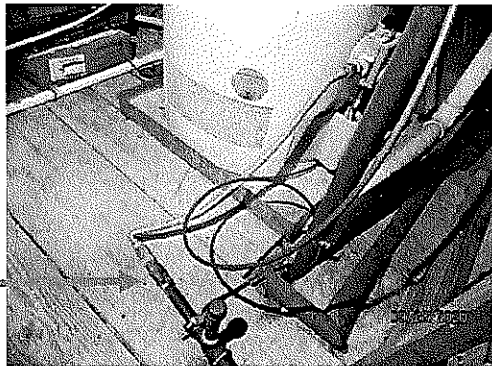
Sediment traps (drip legs) are missing for the gas supply lines at the heaters & water heater. Sediment traps (T fitting with a short leg in the down position) are intended to trap moisture in the gas supply line. Where a sediment trap is not incorporated as part of the appliance, a sediment trap shall be installed downstream of the appliance shutoff valve as close to the inlet of the appliance as practical. The sediment trap shall be either a tee fitting having a capped nipple of any length installed vertically in the bottommost opening of the tee as illustrated in Figure 408.4 or other device approved as an effective sediment trap. Illuminating appliances, ranges, clothes dryers, decorative vented appliances for installation in vented fireplaces, gas fireplaces and outdoor grills need not be so equipped.
