1st Rate Inspections

Property Inspection Report

10511 Windriver Dr, Houston, TX 77070

Date of Inspection: 6/12/2019 Time: 8:30 AM

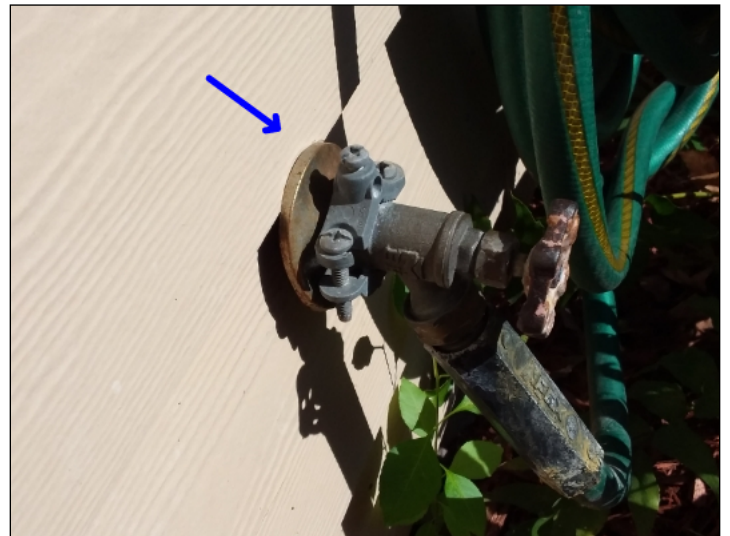
Bonding was noted on the water line.

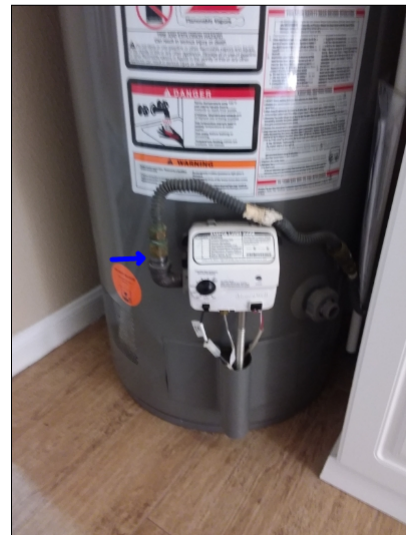
-No drip leg or sediment trap for gas line on water heater. This helps prevent trash from clogging jets.
