Property Inspection Report

Concerning:
11633 Grandview Dr,
Montgomery, TX 77356

By:
Cory Alan Haddox, P.E.
Professional Real Estate Inspector
License No.: 20464
2635 North Spring
Spring, TX 77373

Issued: 15 May 2021
Revision: 0

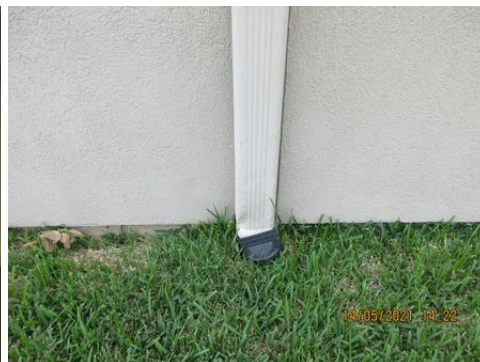
Photo 2

1. A bird's nest was observed in the gutter on the left side of the front entry. See Photo 1.
2. One of the gutter downspouts on the left side of the house was found to be dented. See Photo 2.
3. Some of the gutters were noted to have signs of leaking.

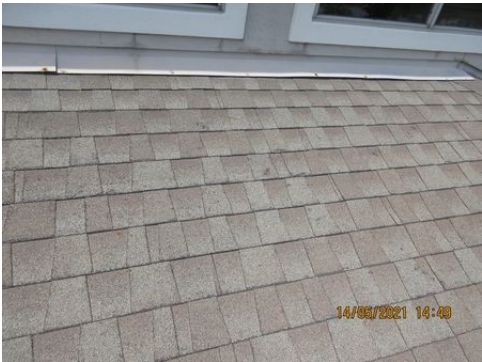
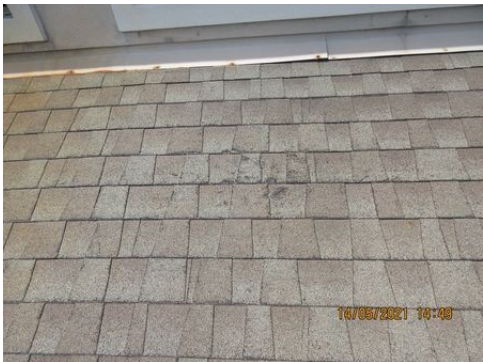
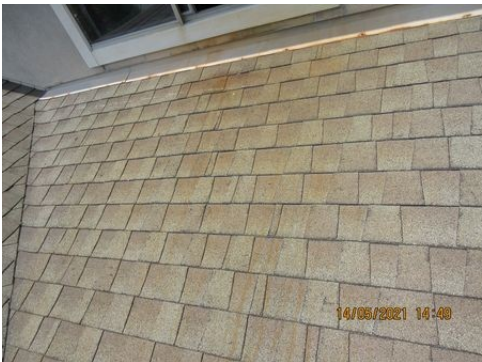
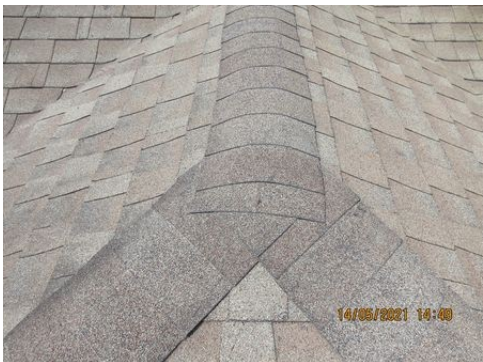
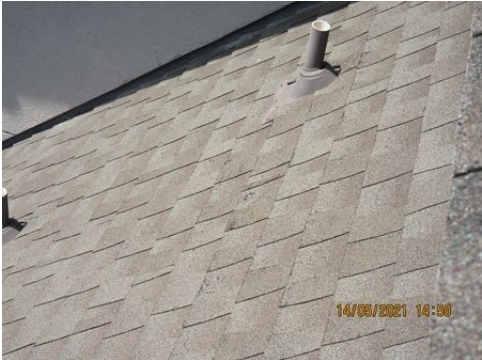
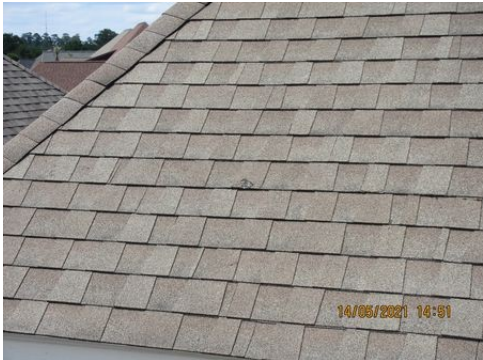
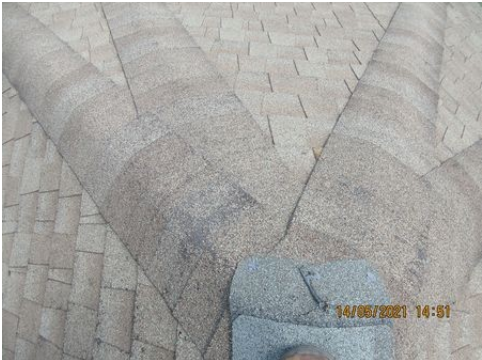
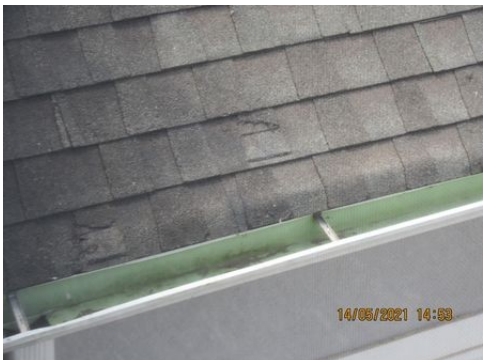
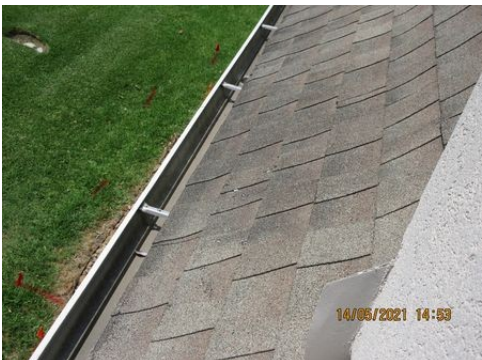
1. Damaged and deteriorated shingles were noted in a number of places on the roof. See Photos 3 through 17.
2. Several areas of patched shingles were observed on the roof. See Photos 18 through 20.

8. A hole was observed in the roof at the peak. See Photo 40.
9. It is recommended to have the roof further evaluated by a qualified roofing contractor.

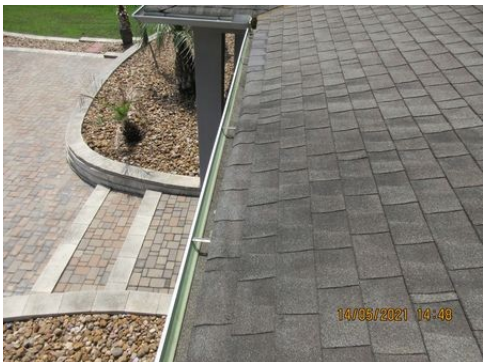
Photo 21

3. A significant amount of the ultra-violet protection (gravel) was found in some of the gutters. See Photos 21 and 22. This could be a sign of shingle deterioration.

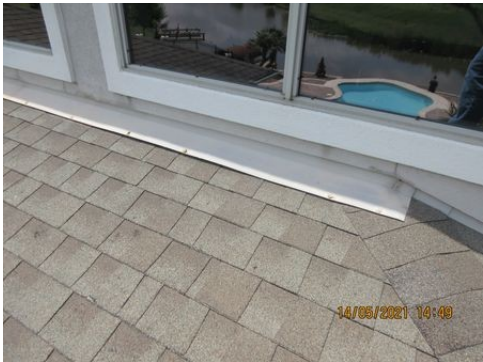
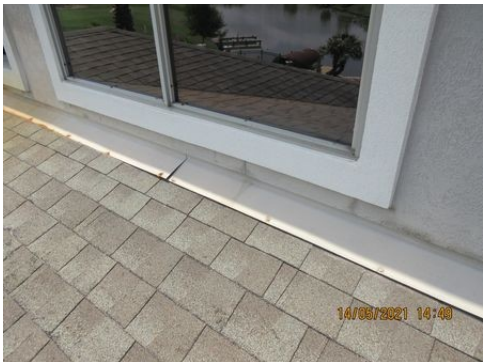
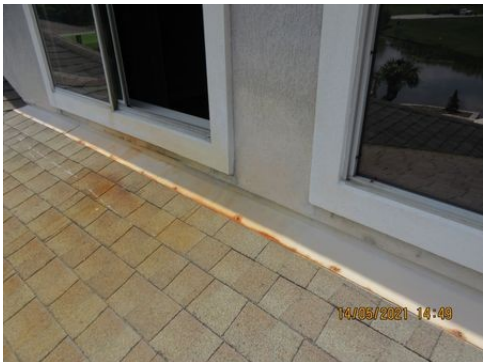
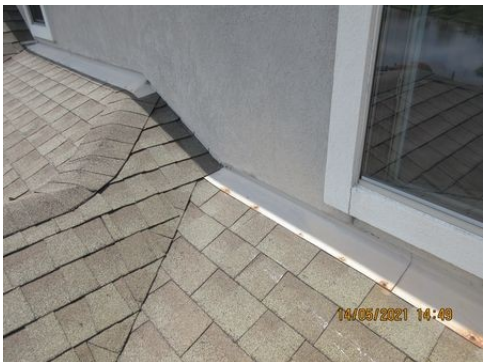
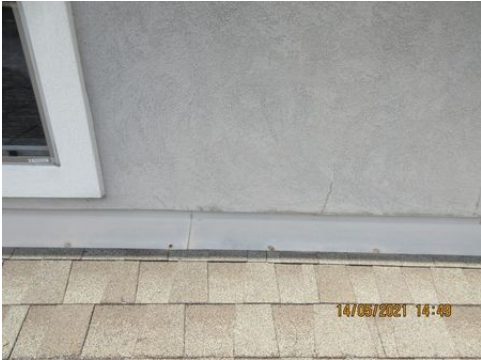
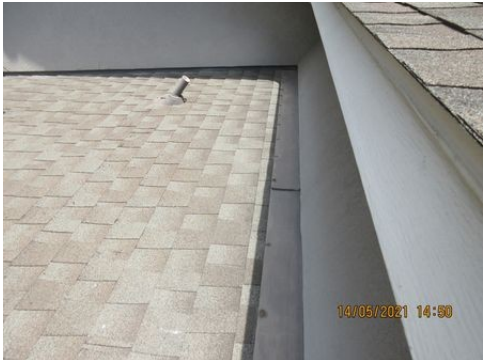
4. Deteriorated, lifted and rusted flashing was noted at the back of the house, with several exposed and rusted nails. See Photos 23 through 31.
5. The vent covers were observed to be deteriorated and lifted with exposed and rusted nails. See Photos 32 through 38.

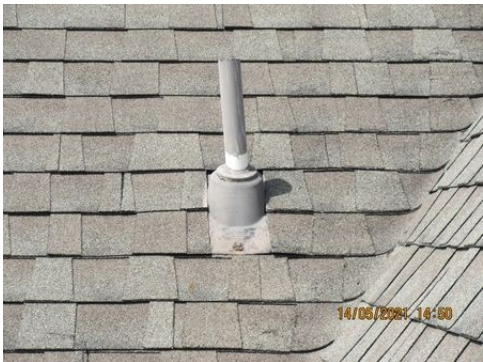
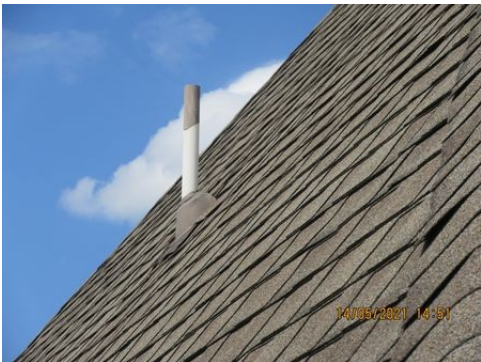
6. Some of the vent pipes were found to not be painted. See Photos 37 and 38.
7. A vent pipe was noted to be missing from one of the vent pipe covers at the back right of the upper roof. See Photo 39.

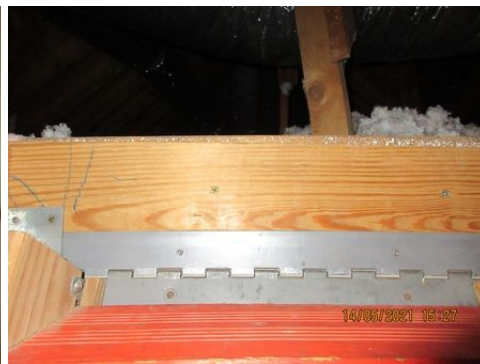
Photo 42

1. The attic access ladder was observed to be without insulation or an air seal. See Photo 41.
2. As well, water stains were noted on the attic access ladder. See Photo 41.
3. The attic access ladder was found to not be secured in place with the appropriate fasteners. See Photo 42.
4. The upper section of the attic was observed to be without collar ties. See Photo 43 and Illustration 1.

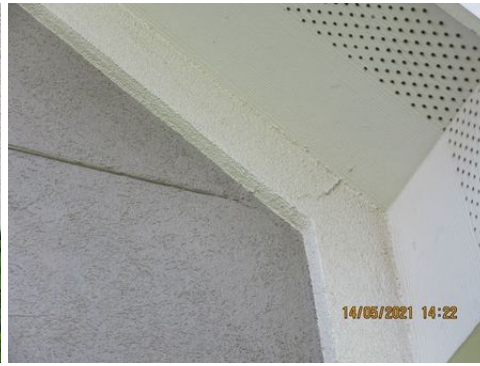
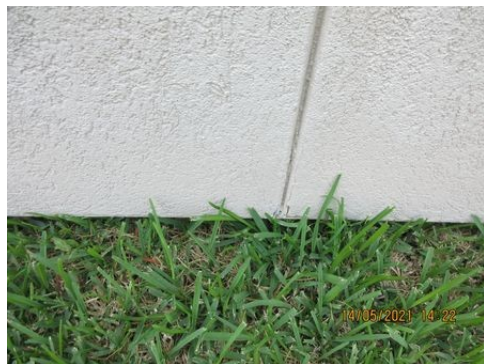
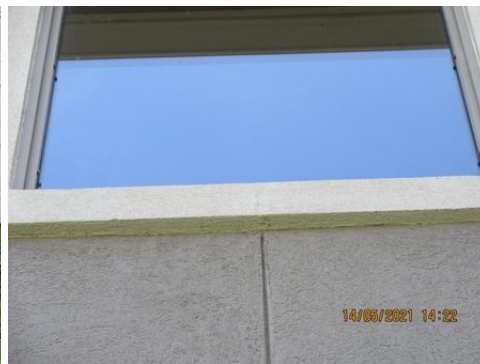
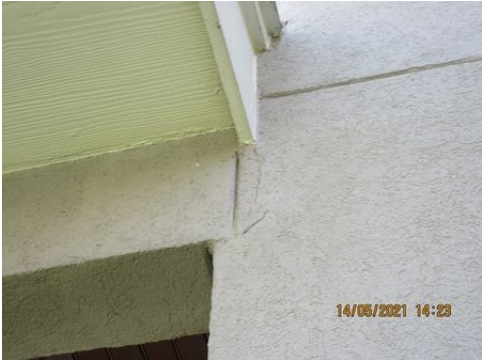
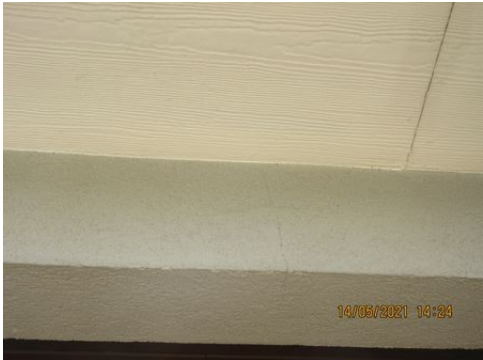
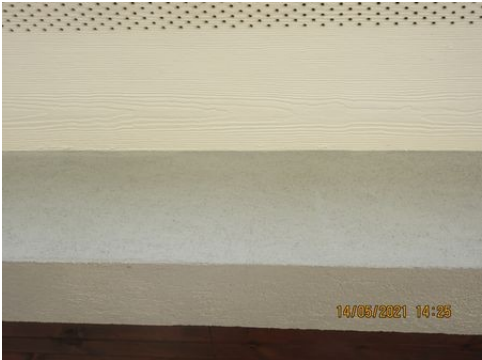
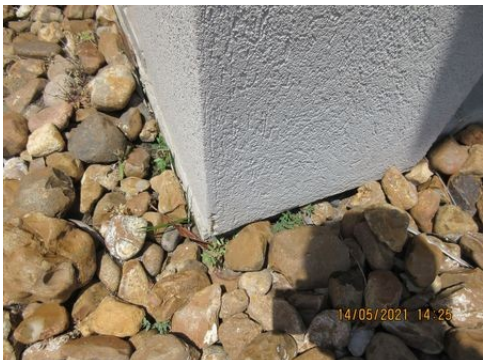
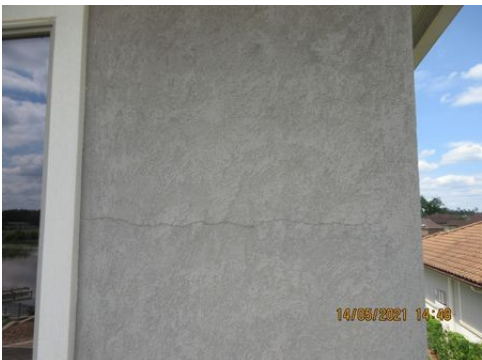
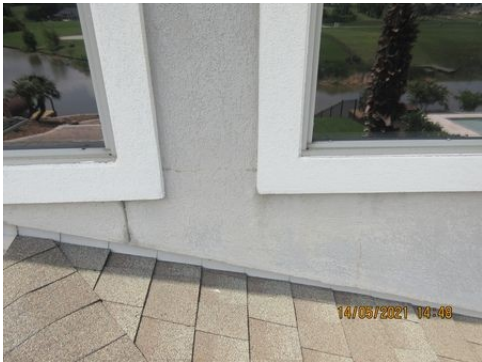
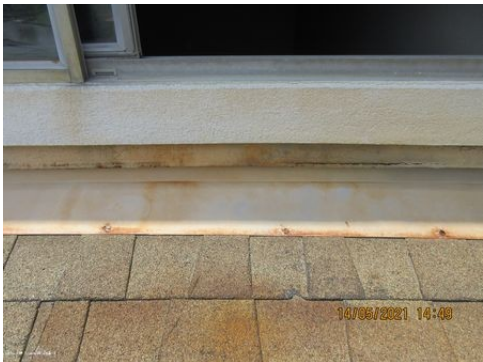
1. The stucco finish was found to be cracked in a number of places. See Photos 45 through 58.
2. Drywall separations were noted in the dining room and in the under stair closet. See Photos 59 and 60.
3. The master bathroom shower was observed to have several tile grout separations and missing tile grout. See Photos 61 through 70.
4. As well, the tile grout around the master bathroom bathtub was found to be separated. See Photos 71 through 74.
5. Some grout separations were also noted in the upstairs guest bathroom bathtubs. See Photos 75 through 77.
6. The tile grout was observed to be separated on the end of the kitchen bar. See Photo 78.

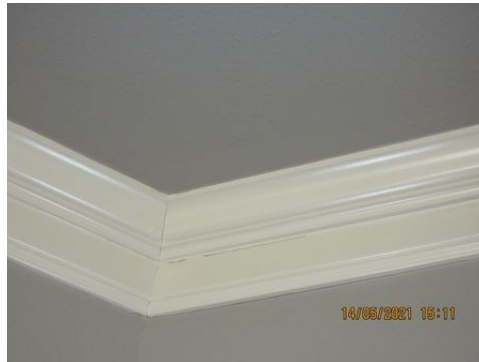
Photo 80

1. The ceiling trim was found to be separated in a number of places throughout the house. See Photos 79 through 83.
2. Several drywall separations and uncovered ceiling drywall nails were noted. See Photos 84 through 95.
3. A drywall patch and water stains were observed on the ceiling at the front of the garage room. See Photos 96 and 97.
4. Water stains and deterioration were found on the ceiling in the upstairs hall closet and on the living room ceiling. See Photos 98 and 99.
5. The upstairs floor was noted to make a noise when walked upon.
6. The floor trim was observed to be deteriorated and separated in a number of places throughout the house. See Photos 100 through 105.

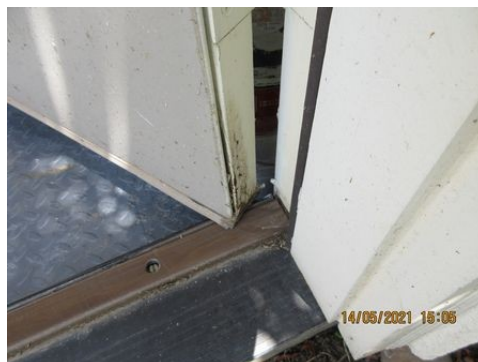
Photo 107

1. The garage back door trim and door were noted to be deteriorated and damaged at the bottom. See Photos 106 and 107.
2. Some of the doors throughout the house were found to be without or to have damaged door stops. See Photos 108 and 109.
3. A garage entry door is expected to be 1-3/8 inches thick and to be self-closing. This garage entry door was noted to be less than the expected thickness at the insets and to not be self-closing. See Photo 110.
4. One of the master bathroom closet doors was found to have been removed. See Photo 111.
5. Some of the door knobs were observed to not be secured in place properly. See Photos 112 through 114.
6. The upstairs front middle bedroom door was noted to not latch.
7. The stationary side of the office double doors was found to not shut completely. See Photo 115.

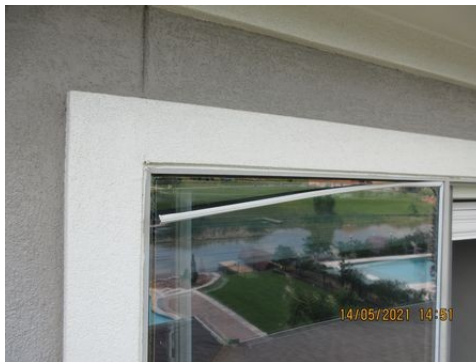
Photo 117

1. Some of the window seals were noted to be damaged or separated. See Photos 116 and 117.
2. Windows that are larger than nine square feet are expected to be made of safety glass. A number of the windows throughout the house were found to be more than nine square feet, but to not be made of safety glass or labeled as such.
3. One of the windows on the right side of the house was observed to be without a window screen. See Photo 118.
4. Some of the screens were noted to be damaged. See Photos 119 through 121.
5. The window sill was found to be significantly separated from the wall in the upstairs front middle bedroom. See Photos 122 and 123.
6. The window sill was observed to be damaged in the upstairs back right bedroom. See Photo 124.

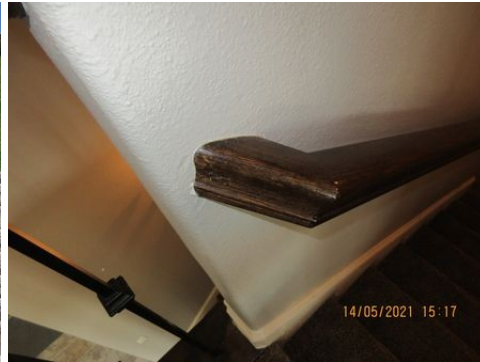
Photo 126

1. The back yard stairs were noted to be without a handrail. See Photo 125. This could be a safety hazard.
2. The handrail for the stairway in the house was found to be loose at the top. See Photo 126.

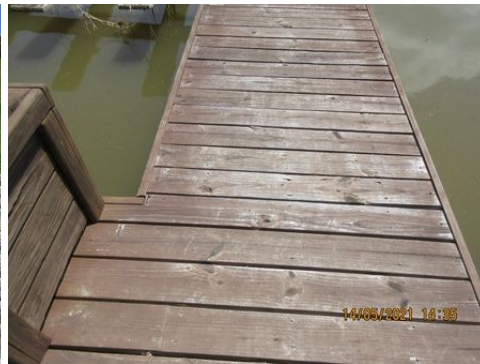
Photo 130

1. The back retaining walls were noted to be without handrails. See Photo 129. This could be a safety hazard.
2. The boat launch pier was found to have several deteriorated and lifted boards. See Photos 130 through 135. These lifted boards could be tripping hazards.
3. The boat launch piers were observed to move when walked upon.
4. The boat launch was noted to be deteriorated. The boat launch motor was found to be intact, but was not operated due to the electrical issues that were found at the boat launch pier.

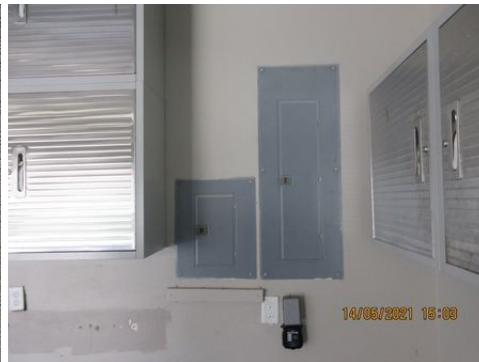
Photo 138

1. The exterior AC unit electrical disconnect boxes and light control panel box on the right side of the house were observed to not be sealed to the wall properly. See Photo 137.
2. The 200 amp panel was noted to be Brand Square D and was found to be located on the back wall of garage, which is the right wall of the house. See Photo 138.
3. The larger panel was noted to not be labeled completely. See Photo 139.

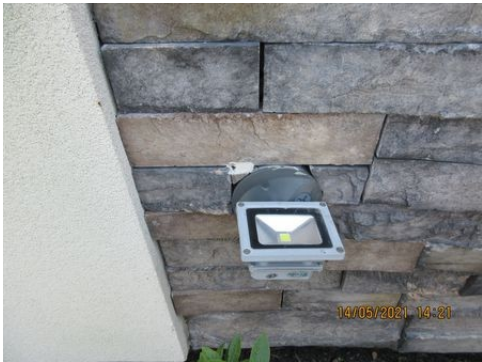
Photo 141

1. Some of the exterior light fixtures and the exterior receptacles were noted to not be sealed to the wall properly. See Photos 140 through 143.
2. A damaged conduit and junction box were found on the right side of the house. See Photo 144.

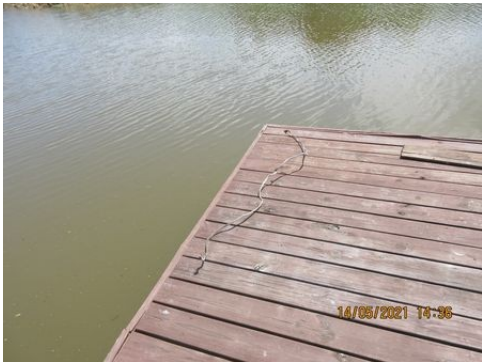
Photo 147

3. Exposed and unsecured wires were noted on the boat launch pier. See Photos 145 through 147.
4. As well, the receptacle in the boat launch motor box was found to be without a cover. See Photo 148.

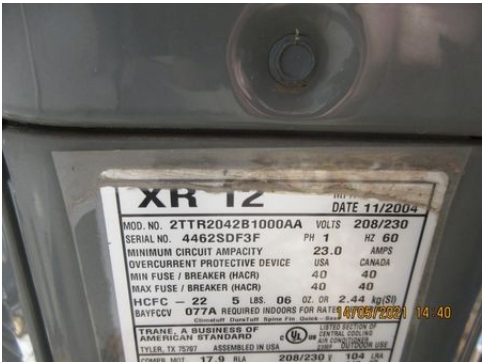
Photo 151

1. Two of the exterior AC units were noted to have been manufactured in 2006 and one was found to have been manufactured in 2004. See Photos 150 through 152.
2. Some of the exterior AC unit refrigerant line insulation was found to be missing. See Photo 153.
3. Rust was observed in all three of the overflow pans under the AC units in the attic. See Photos 154 through 156.
4. The temperature of the air coming from the downstairs unit was noted to be significantly higher than expected when the unit was operated in the cooling mode.
5. The temperature of the air coming from the upstairs units was found to be higher than expected when the units were operated in the cooling mode.
6. It is recommended that both the heating and cooling systems be serviced before use and annually thereafter.

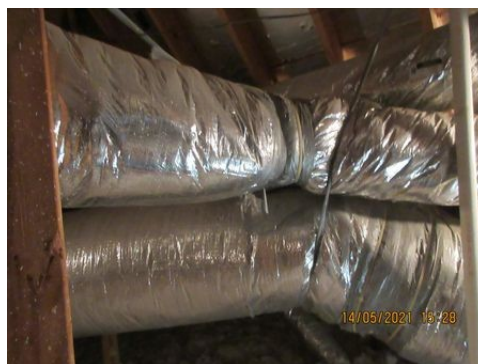
Photo 158

1. Discoloration from condensation was noted on some of the duct boxes in the attic. See Photo 157.
2. Air ducts in an attic are expected to be separated. A few of the air ducts in the attic were found to not be separated. See Photos 158 and 159.

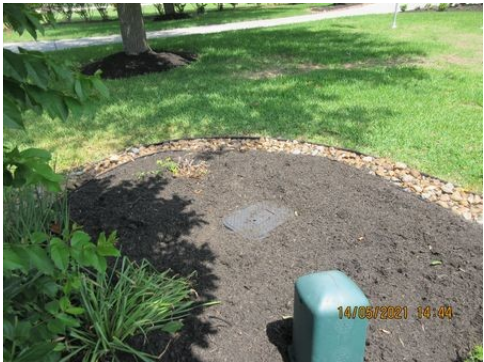
Location of water meter: Front yard to the right, see Photo 160

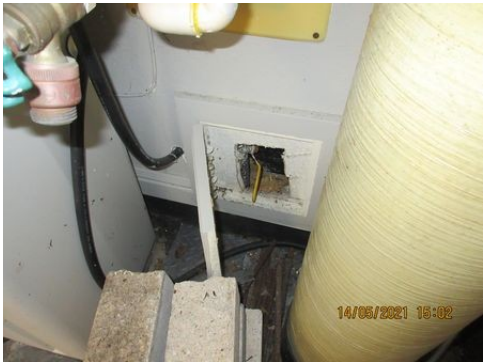
Location of main water supply valve: Front of the house, in the garage, see Photo 161

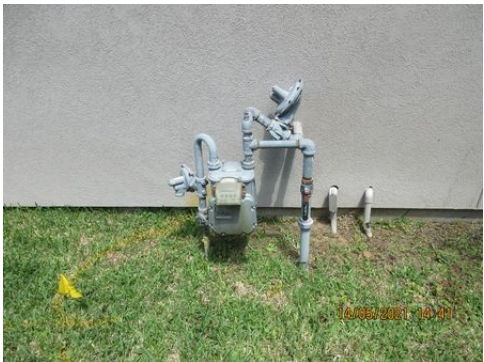
Location of main gas supply valve: Right side of the house, see Photo 162

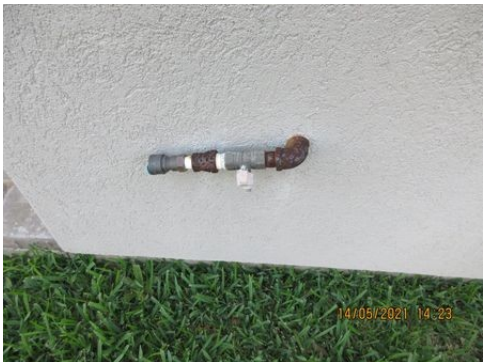
Photo 163

1. The gas supply system was observed to not be bonded.
2. A gas supply pipe at the back patio was found to be rusted. See Photo 163.
3. The exterior hose spigot on the left side of the house was noted to leak when operated.

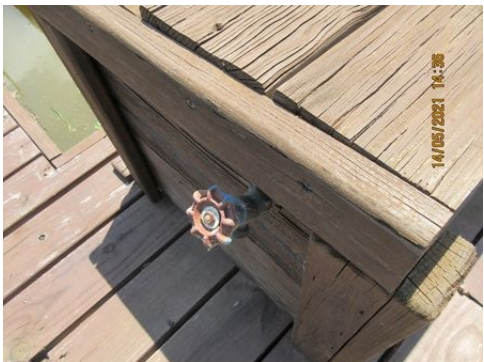
Photo 164

4. Some of the exterior hose spigots were observed to be without back flow prevention devices.
5. An out of use or non-functioning hose spigot was found at the boat launch pier. See Photo 164.

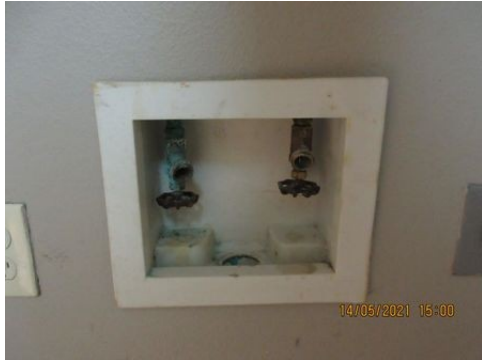
Photo 166

6. A PVC pipe connected to the exterior hose spigot at the back right of the house was noted to have damaged and missing insulation. See Photo 165.
7. One of the washing machine water supply valves was observed to be corroded. See Photo 166.

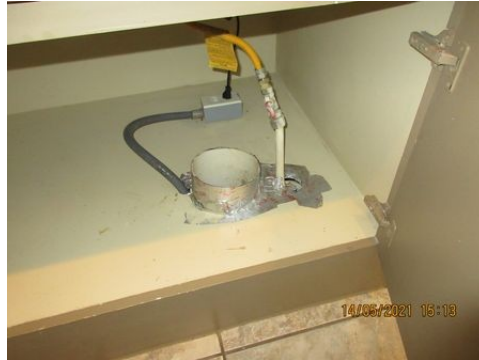
Photo 167

8. The gas supply for the kitchen island cooktop was found to be misaligned. See Photo 167.
9. The kitchen sink faucet was noted to not be functioning at the time of the inspection.

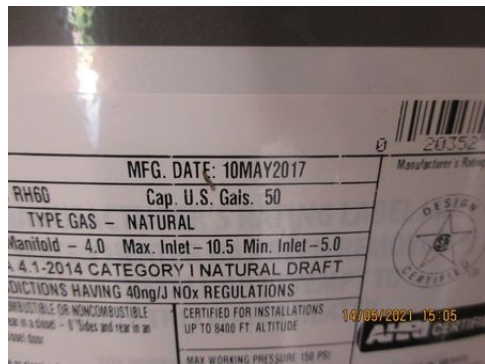
Photo 169

1. Both of the water heaters were found to have been manufactured in 2017. See Photos 169 and 170.

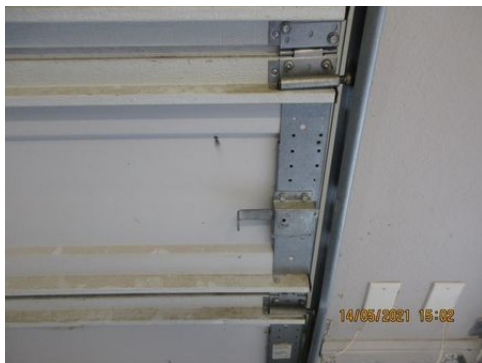
Photo 172

1. The far right garage door was noted to not be functioning at the time of the inspection, due to the automatic reverse sensors being misaligned.
2. Garage doors with automatic openers are expected to have locks that have been disabled. The far right garage door was noted to have a lock that had not been disabled. See Photo 172.
3. The manual release cord for the far right garage door opener was observed to have been cut. See Photo 173.

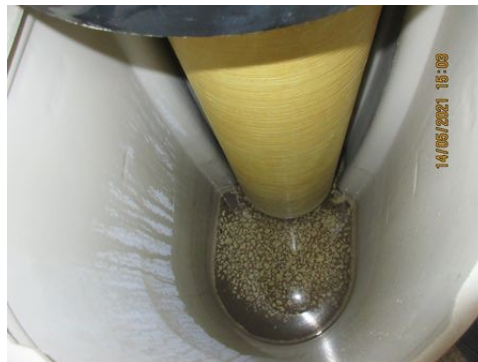
Photo 175

1. An out of use water softener was noted in the garage. See Photo 174.
2. The medium container was found to not be filled with medium. See Photo 175.

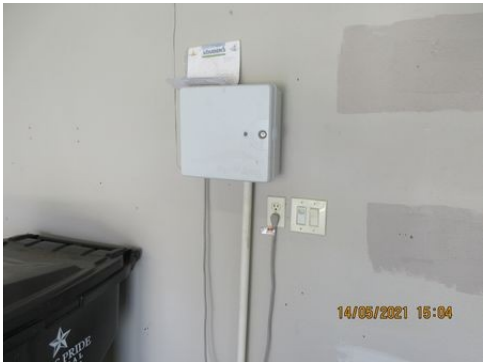
Photo 176

1. The sprinkler control panel was noted to be located on the back wall of the garage. See Photo 176.
2. A zone schedule was found to be located on the top of the control panel cabinet. See Photo 177.
3. The sprinkler system control wire conduit was observed to be damaged and not secured or sealed to the wall properly. See Photo 178.
4. The sprinkler system back flow prevention device was noted to have damaged and missing insulation, to have rusted handles and to not be secured to the wall properly. See Photo 179.
5. The sprinkler system water supply valves was found to not be turned on at the time of the inspection. Therefore, the sprinkler system was only visually inspected.

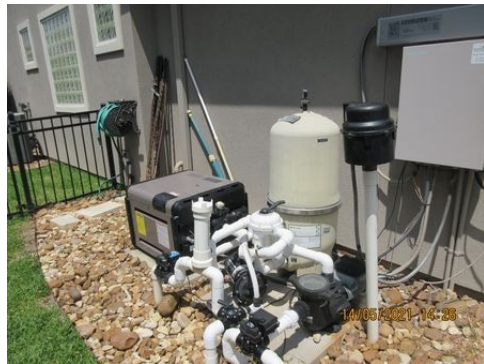
Photo 180

1. The pool equipment and control panel were noted to be located at the back right of the house. See Photos 180 and 181.
2. A number of the coping tiles around the pool were found to be cracked with one at the spa found to not be secured in place properly. See Photos 182 through 191.
3. It was observed that the pool had been maintained by a pool service company. It is recommended to contact this pool service company to discuss any issues with the pool or equipment.

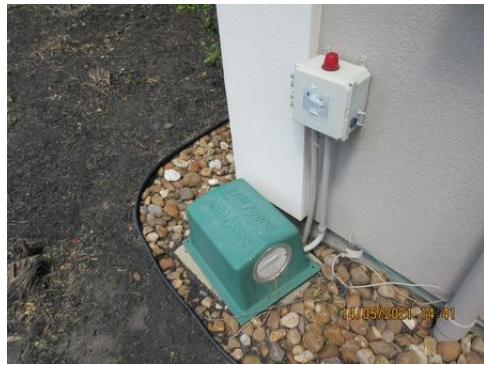
Photo 192

1. The pump and control panel were noted to be located at the front right of the house. See Photo 192.
2. The pump was observed to have been installed in 2018. See Photo 193.
3. The septic tanks were found to be located in the front yard. See Photo 194.
4. Due to the change in occupancy, it is recommended to have the septic system serviced by a qualified septic system service company.
