15603 Stone Gables Lane

PROPERTY INSPECTION REPORT

Concerning: 15603 Stone Gables Lane, Houston TX 77044
(Address or Other Identification of Inspected Property)

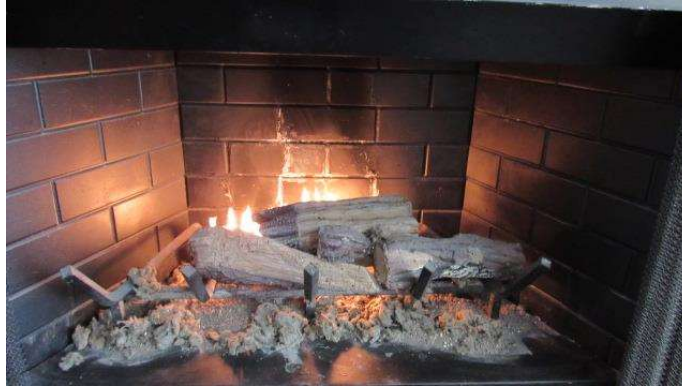
- Unit appeared to be functioning at the time of the inspection.

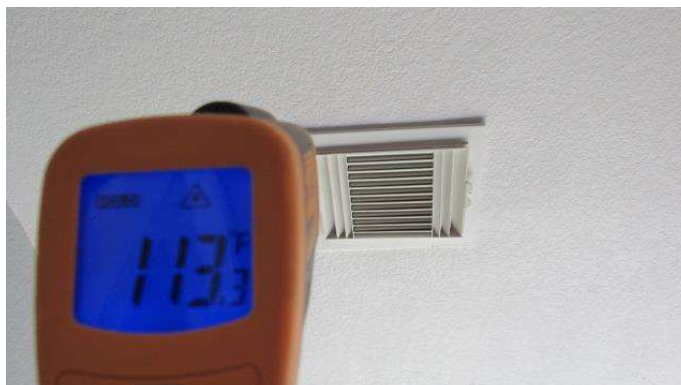
Downstairs Unit:

- Heating Unit appeared to be functioning as intended at the time of the inspection.
- Observed 113 degrees at supply registers.

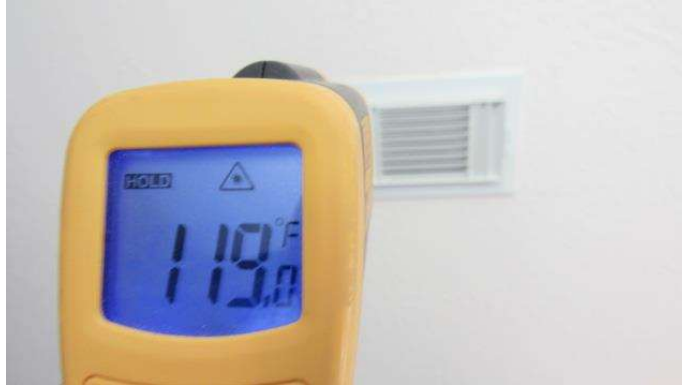
Upstairs Unit:

- Heating Unit appeared to be functioning as intended at the time of the inspection.
- Observed 119 degrees at supply registers.

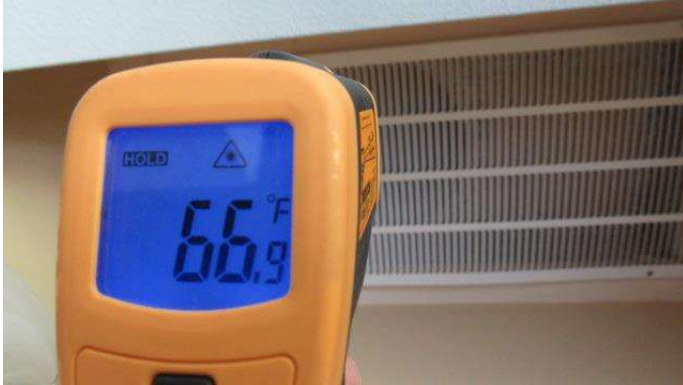
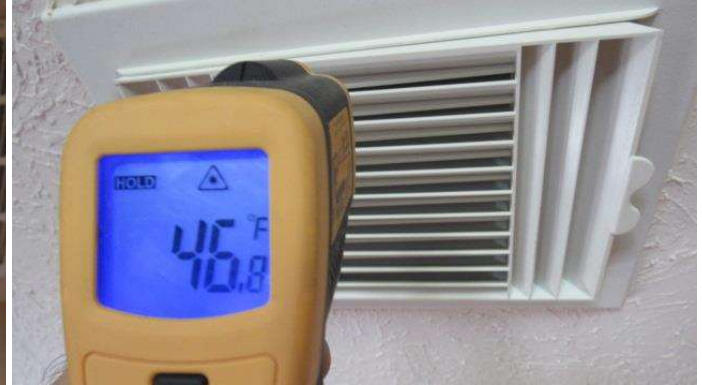
- A/C is working efficiently as evidence by a 20 degree drop between return air and supply register.
- Observed 66 degrees at return air chase and 46 degrees at supply register.

- Cooling System appeared to be functioning as intended at the time of the inspection.

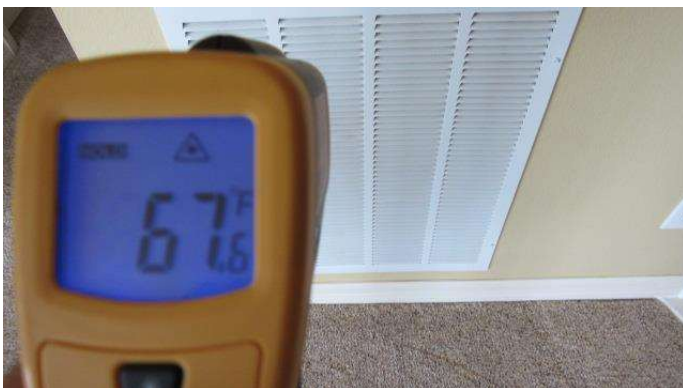
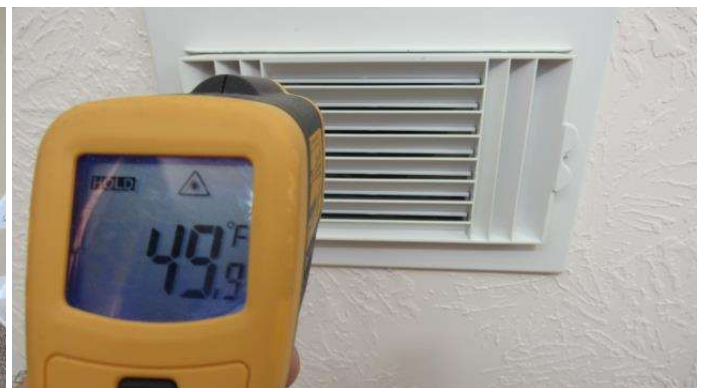
- Recommend service / repairs, and a complete inspection of the cooling system by a licensed Cooling & Heating service.
- A/C is working efficiently as evidence by an 18 degree drop between return air and supply register.
- Observed 67 degrees at return air chase and 49 degrees at supply register.

- Cooling System appeared to be functioning as intended at the time of the inspection.

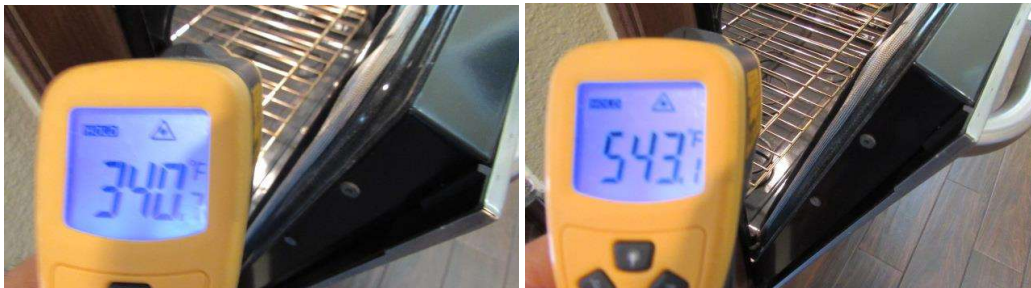
- Gas range top & electric ovens.
- Baking mode set at 350 degrees - plus or minus 25 degrees / Broiler mode set at 500 degrees.
- **Advantium Oven:** Appeared to be performing as intended at the time of the inspection.
- **Bottom Oven:** Baking mode reads 340 degrees. Broiler mode reads 543 degrees.

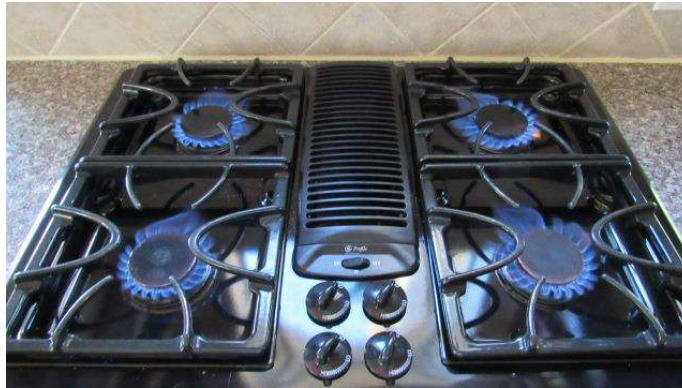
- **Range top:** No repairs noted at the time of the inspection.
