Property Inspection Report

9307 Reston Grove Ln, Houston, TX 77095

Date of Inspection: 6/29/2021 Time: 12:30

Inspector: B. Ashley Granger

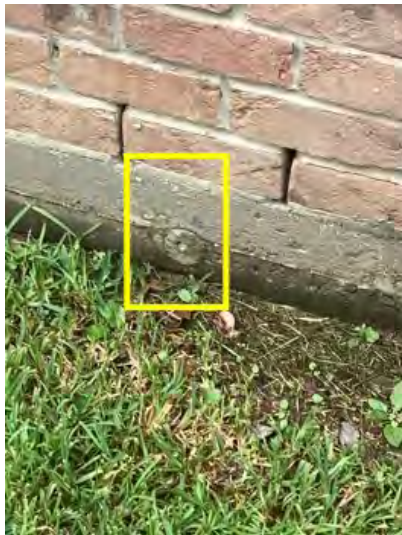
Post tension foundation penetrations noted at time of inspection. Observational an informational purposes only.

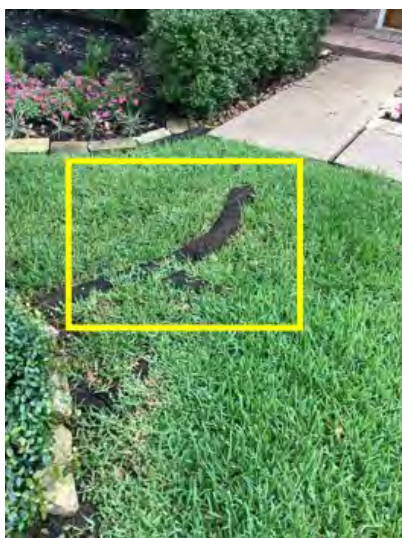
Tree roots are noted in front yard potential trip hazard recommend having a professional remove all routes that are exposed

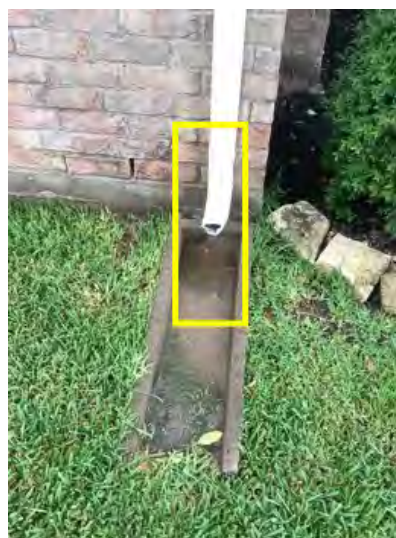
All gutters to disperse water 5 to 6 feet away from foundation. Conducive to moisture intrusion, damage and potential WGO.

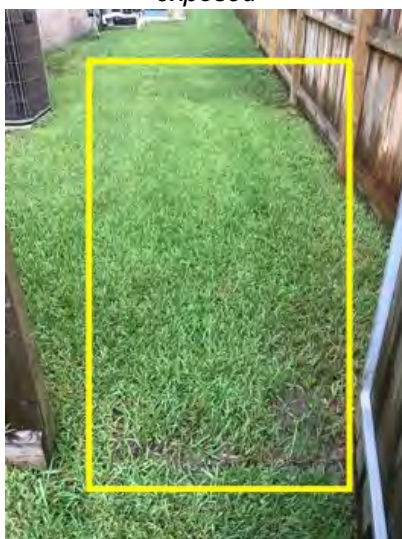
Ponding water noted on the right side of structure at time of inspection. Noted that it did rain hard today. No gutters noted on sides of house recommend adding gutters to deal with drainage

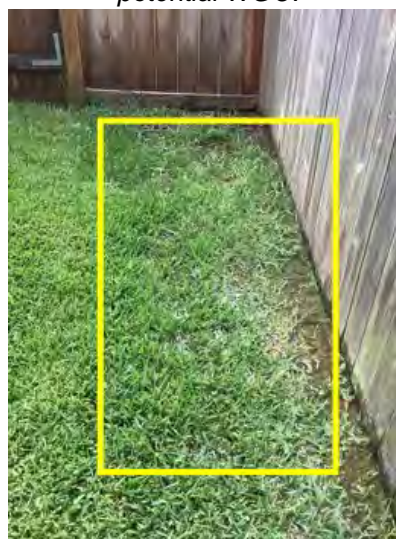
Ponding water noted on the left side of structure by fence at time of inspection. No gutters noted on that side of house. Recommend replacing or adding gutters to assist and proper drainage efficiency.

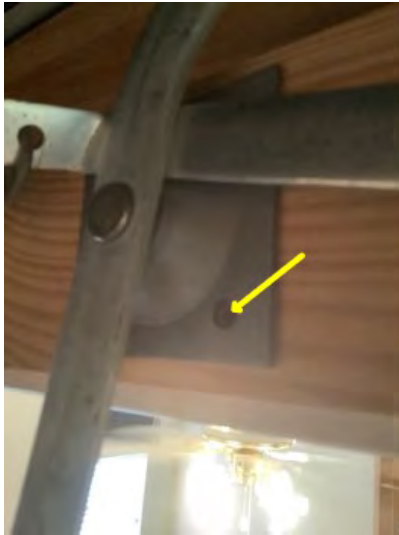
Attic ladder was missing hardware in fasteners to secure to framing recommend having a professional inspection correct potential fall hazard or damage

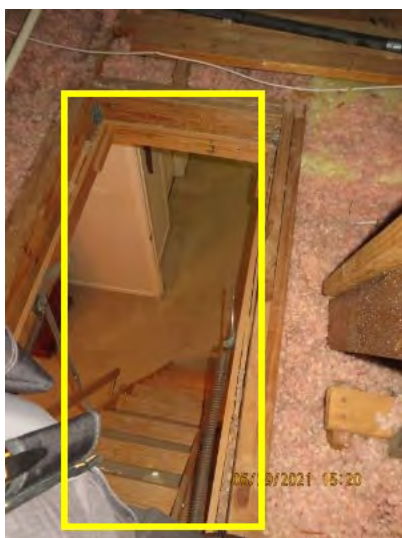
Attic ladder scuttle hole is recommended to be sealed and caulked properly. Conducive to air leaks from attic into livable space and potential condensation.

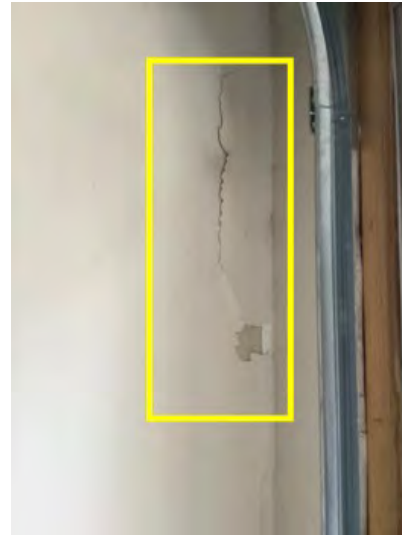
View of wall in garage by the door with paint peeling off noted. Recommend having a professional inspected

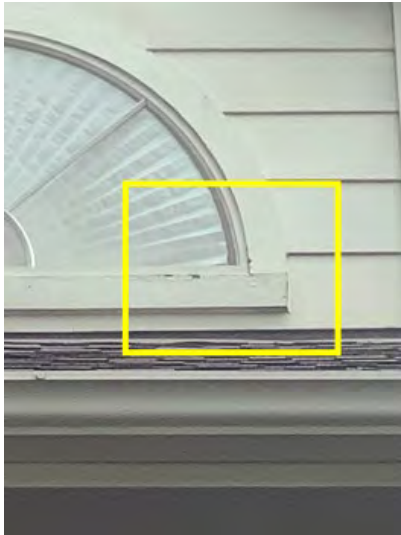
Wall systems trim and siding noted by dormer window front of house that showed signs of moisture intrusion and damage would recommend having all areas sealed caulked and painted properly in any damage wood replaced.

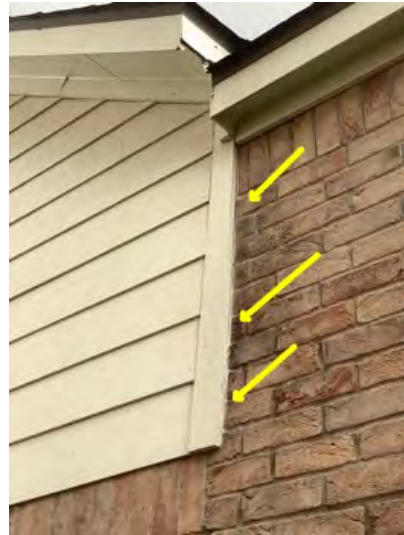
All exterior siding transition seems between brick and hardy plank siding seems need to be caulked sealed and painted properly conducive to moisture intrusion, damage and potential WDO

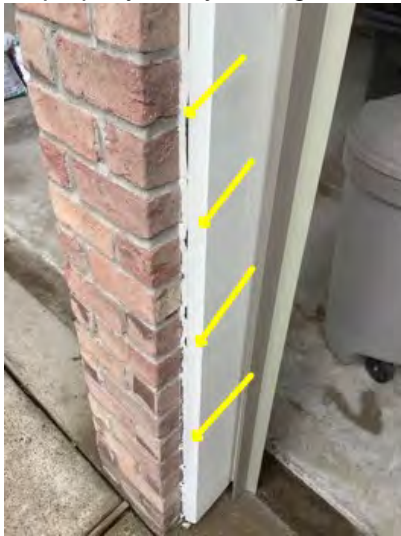
Expose penetrations on wall systems around garage should be sealed caulked and painted properly conducive to moisture intrusion, damage a potential WDO. Recommend getting a professional to expect and correct

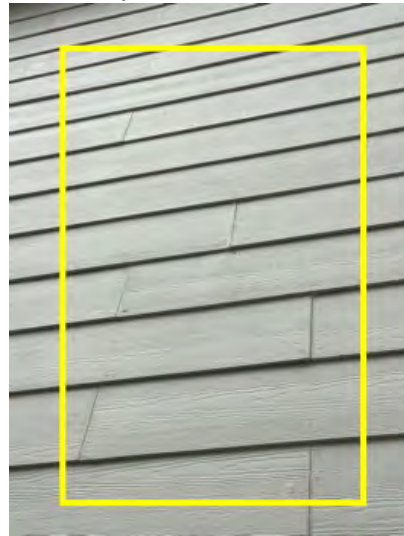
All exterior siding penetrations and seems should be sealed, caulked and painted properly. Conducive to moisture intrusion, damage and potential WDO. Recommend having a professional inspect and correct.

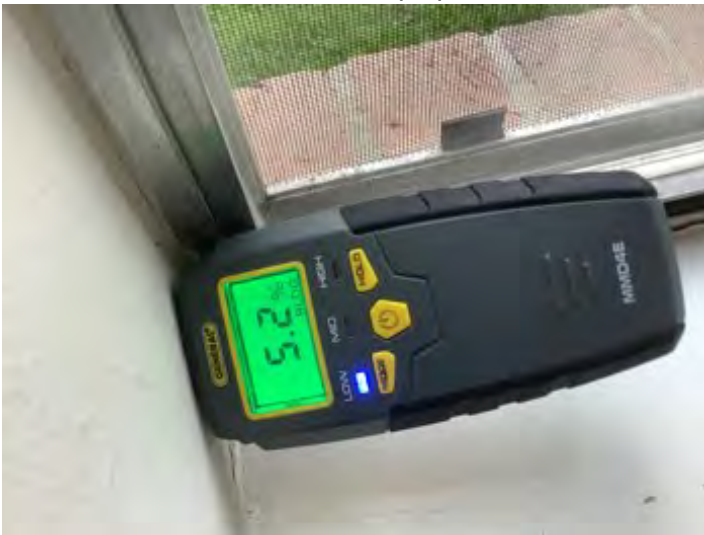
Moisture readings on window in master bedroom was a normal range observational an informational purposes only.

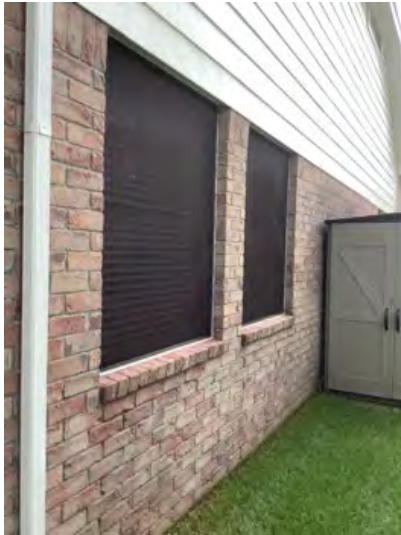
Limited inspection on exterior windows do the solar screens noted at time of inspection. Observational an informational purposes only.

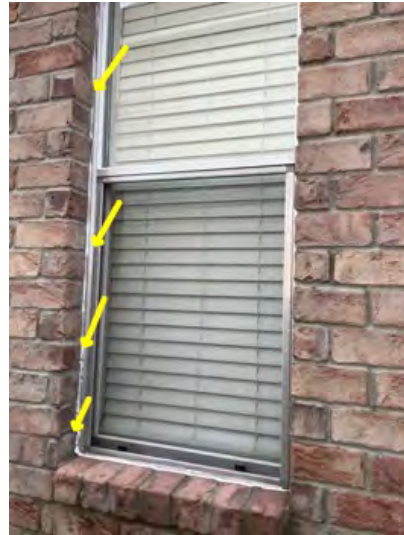
Aluminum original as built windows noted at time of inspection. Recommend ceiling all penetrations with proper caulking. Conducive to moisture intrusion, damage and potential WDO. Recommend having a professional inspected correct.

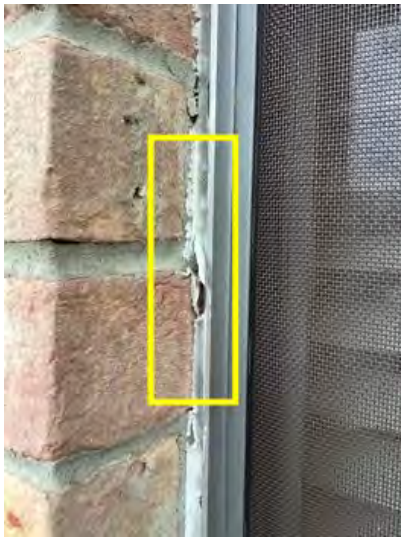
All expose window penetrations should be sealed caulked properly conducive to moisture intrusion damage of potential WDO.

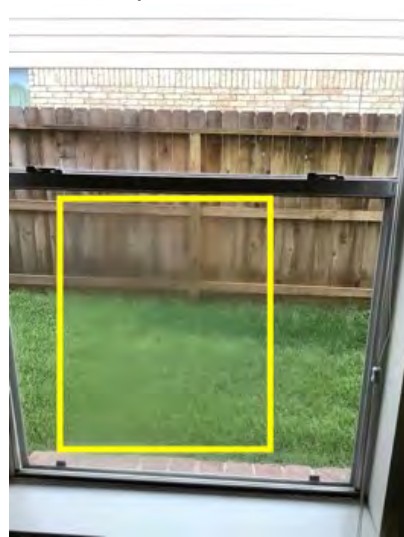
View of Haze / condensation between windows noted at time of inspection these are original as built aluminum windows noted.

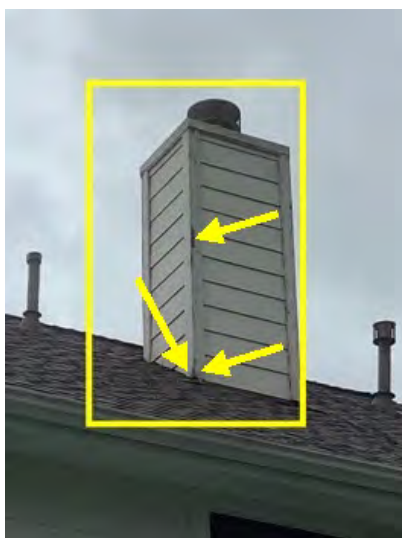
Chimney noted at time of inspection. Recommend all trim boards and siding be sealed caulked and painted properly some trim boards may need to be replaced.

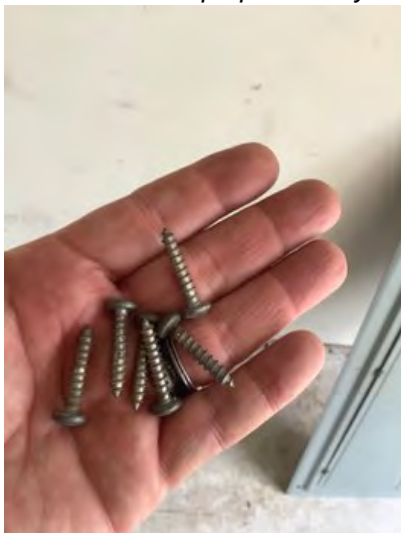
- **Wood screws noted as fasteners for electrical panel and potential hazard. Recommend having a professional install proper crews for electrical panel.**

Metal screws utilized instead of proper electrical screws. Conducive to electrical hazards and issues. Recommend replacing with proper screws.

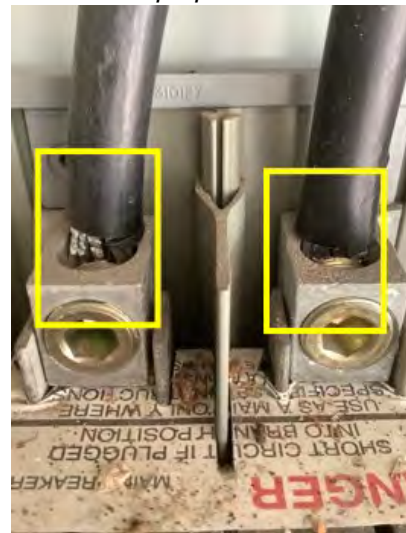
- **Electric meter and Siemens breaker box. Breakers were labeled at time of inspection. Observational purposes only.**
- **The aluminum wiring in the service panel was not treated with anti-oxidant sealant should have a professional inspect. Potential fire hazard.**

All aluminum main connector should have antioxidant jell for protective purposes. Recommend having a professional inspect and add.

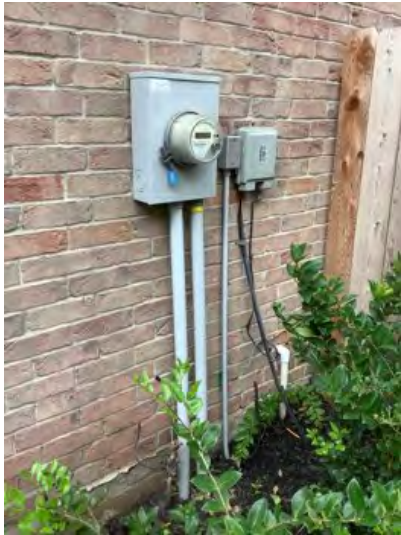
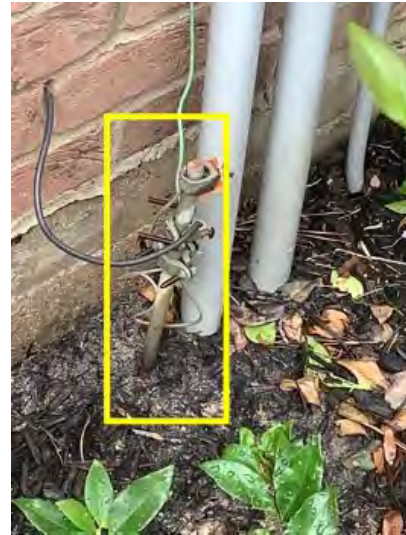
Electrical grounding rod meter and underground service noted at time of inspection. Meter located on the right side of house at time of inspectio

Grounding rod should be further in the ground noted. Recommend having a professional inspected correct.

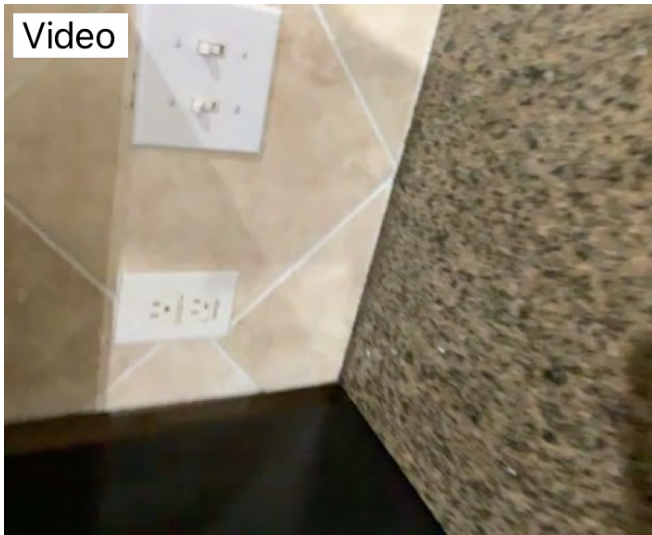
Kitchen GFCI located by refrigerator was working properly and properly labeled. Observational an informational purposes only

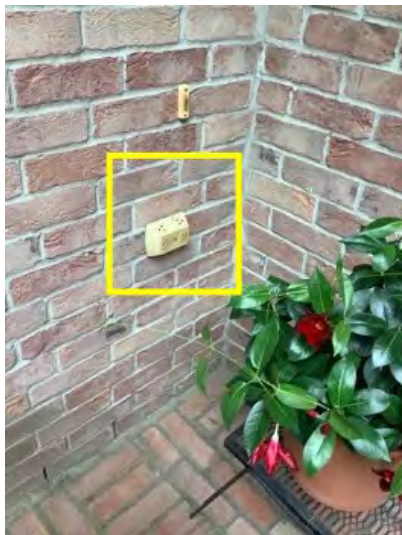
Electrical outlet by front door needs to have bubble cover to protect. Recommend have a professional inspect and install.

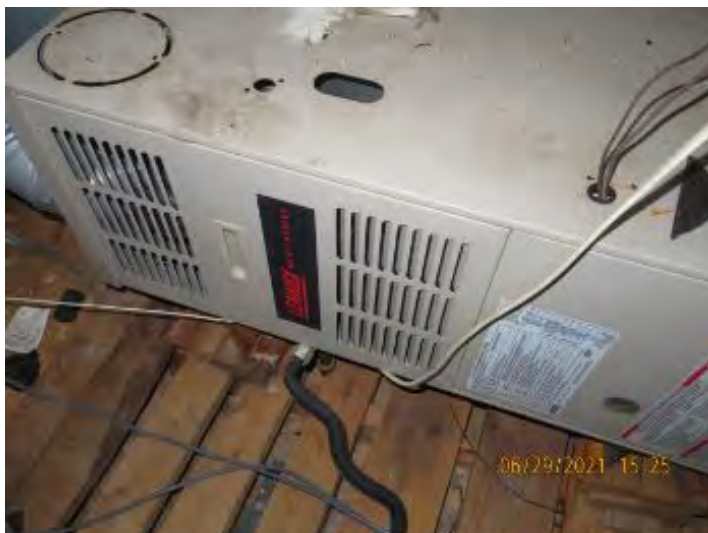
View of Gas heating (Furnace) noted. Unit not tested due to exterior temperature is above 90 degrees. Observational an informational purpose only.

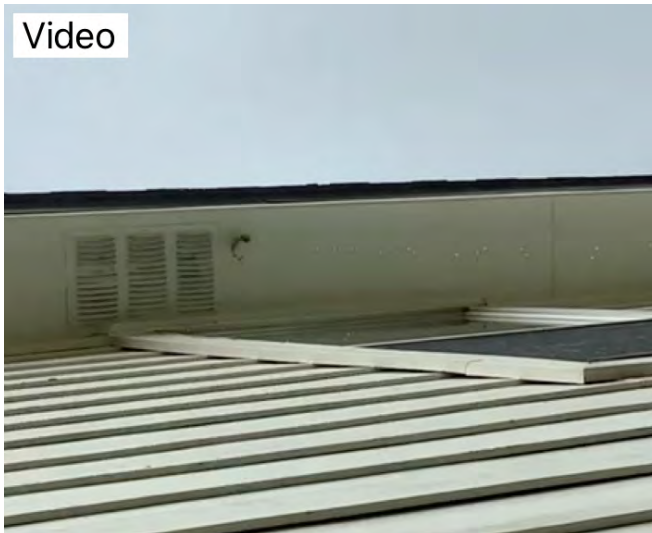
- **The secondary condensate drain was discharging water to the exterior indicating a possible problem with the primary drain**
- **Temperature Differential was 10 Degrees and not in normal range. Recommend having a professional inspect for optimum efficiency.**

Secondary drain noted on right side of house underneath soffit he's draining at time of inspection. Conducive to main drain needing to be cleaned out. Recommend having a professional inspect incorrect problem

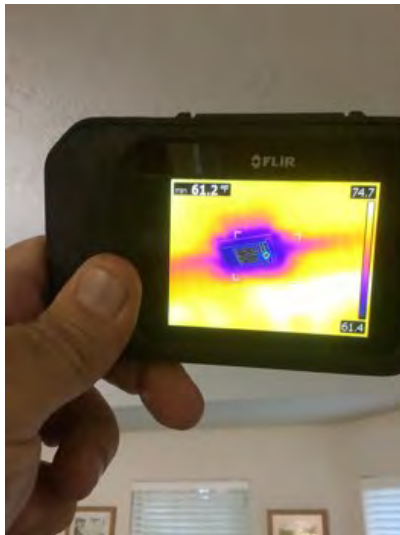
Second floor living room 61.2 slightly higher than normal temperature reading.

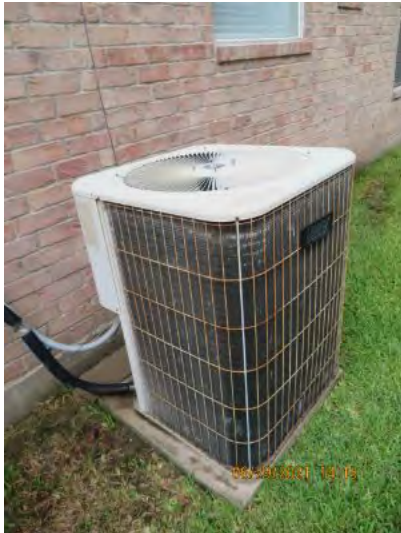
- The cooling system differential was in normal range of 14-22 degrees.
- **The cooling system appears to have reached its serviceable life expectancy**

Lennox unit appears to be at end of its life expectancy noted. 3 Ton, R22 Freon, 35 Amp Max, 12 SEER, 2002 MFD. Recommend having unit inspected by a professional for over all life expectancy. Unit was operating at time of inspection but is an 18 year old unit.

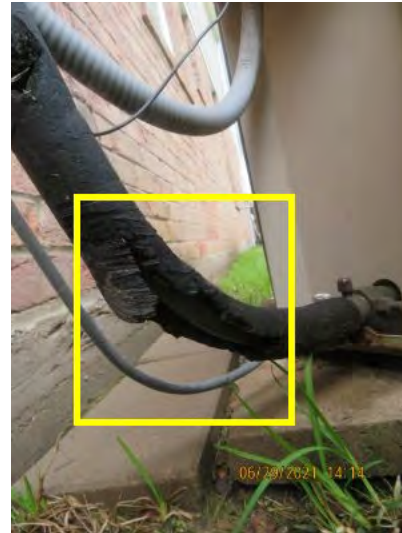
Refrigerant lines are missing insulation on exterior unit at time of inspection. Recommend having a professional inspect and correct.

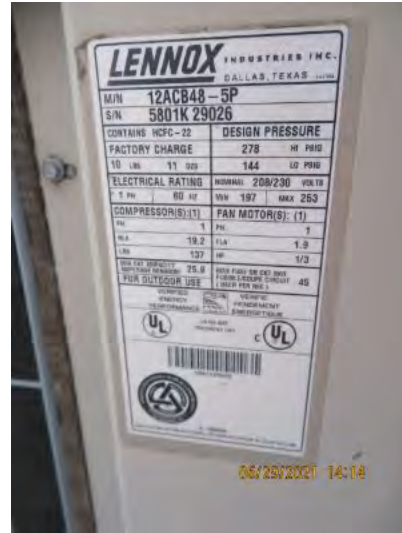
Lennox Unit # 2 HVAC exterior condenser, 4 Ton, R22 Freon, 2001 MFD, 45 AMP 12 SEER. Unit was working but appears to be at the end of its life expectancy.

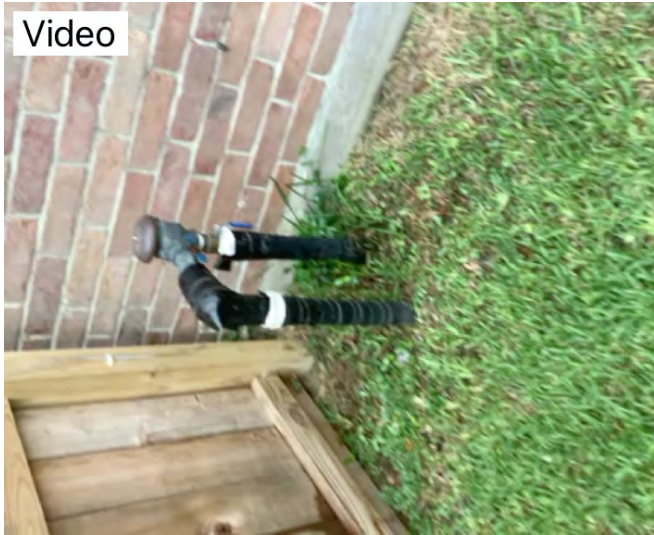
- **Sprinkler vacuum breaker plumbing was loose to the structure at time of inspection. Should have a professional plumber secure properly to the structure.**

Sprinkler plumbing system components vacuum line was not secured properly conducive to damage. Recommend having a professional inspect incorrect.

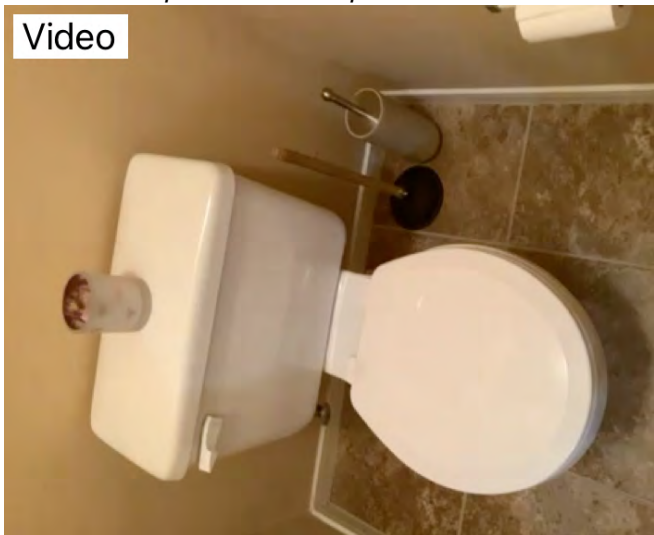
- **Toilets tank(s) were loose at time of inspection. Should have a professional plumber correct properly. Conducive to leaking and causing possible damage.**

Master bathroom toilet tank area was slightly loose inspection. Recommend having a professional titan to prevent any potential leaks

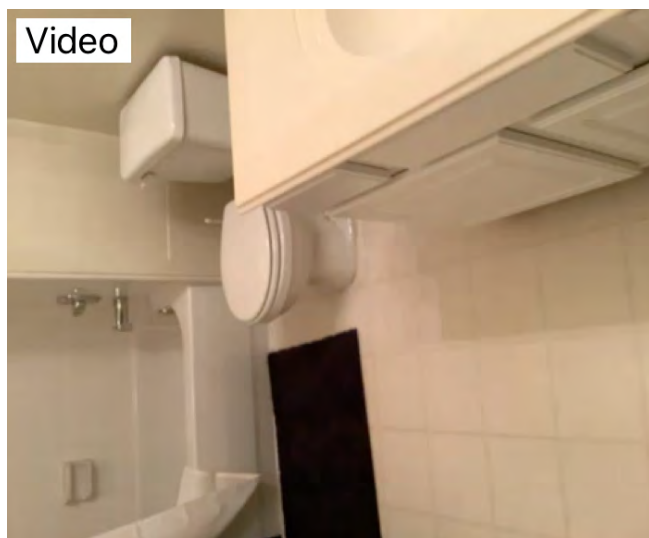
Second floor temperature reading on Guest bathroom shower on left side tub was in normal reading. Observational and information purposes I

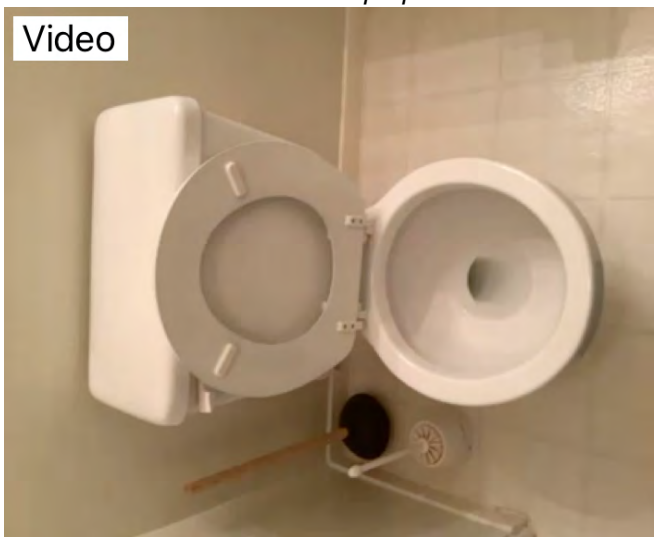
Temperature reading on second floor right side guest bathroom no the time of inspection. Observational and informational purposes only.

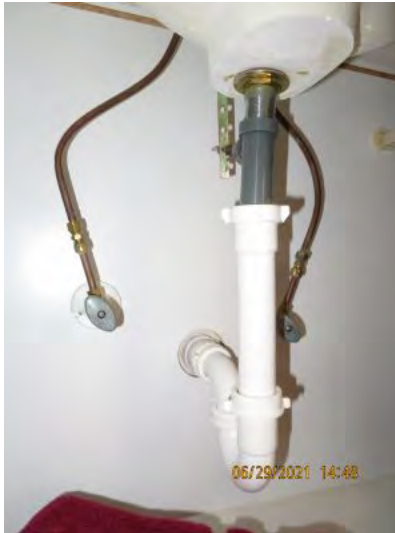
Cooper plumbing supply and PVC drains under sink noted. Observational an informational purpose only.

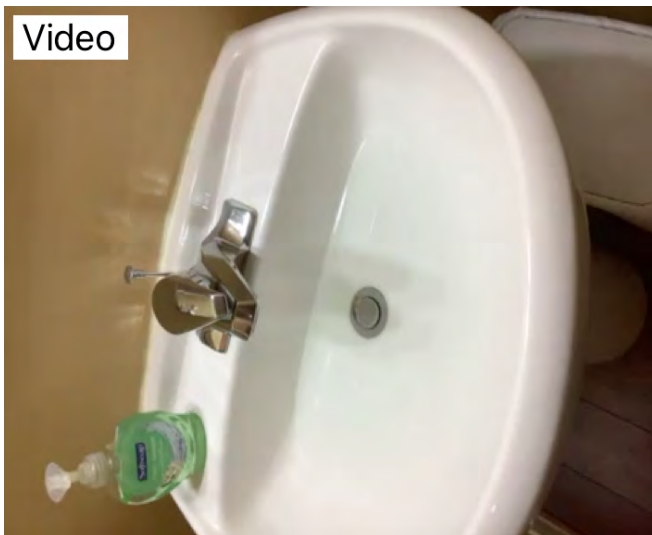
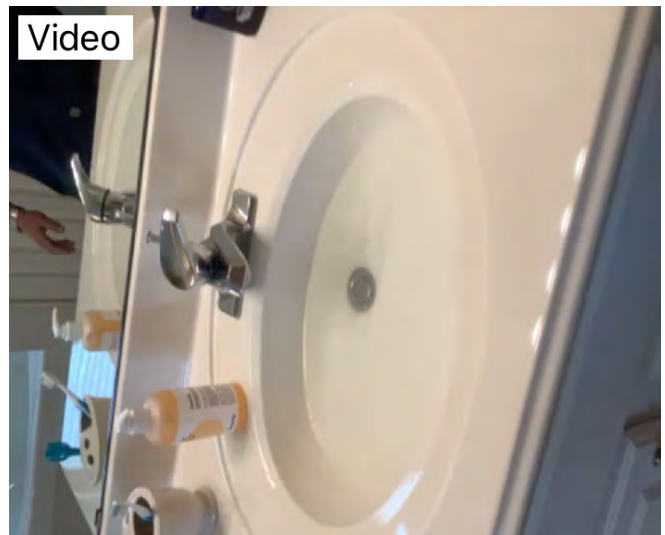
First floor half bathroom sink was draining properly at time of inspection. Observational an informational purposes only

Master bathroom sinks were draining slowly at time of inspection recommend having a professional check for any obstructions or debris for optimal flow efficiency.

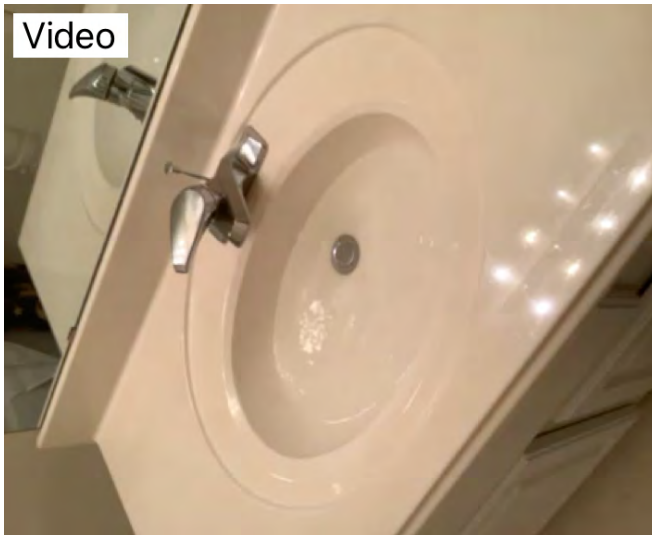
Second-floor guest bathroom right side Drain test on sink and tub or working properly. Observational an informational purposes only.

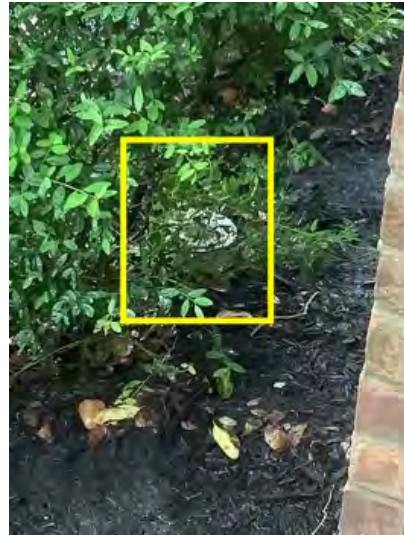
Main sewer clean out noted at time of inspection. Observational an informational purposes only.

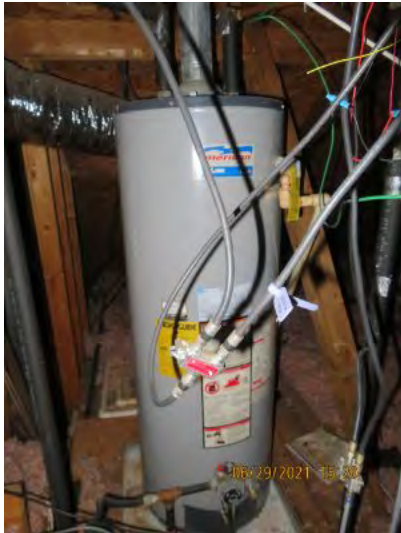
View of water heater noted. Observational an informational purpose only. 2001 Gas 50 Gallon Unit.

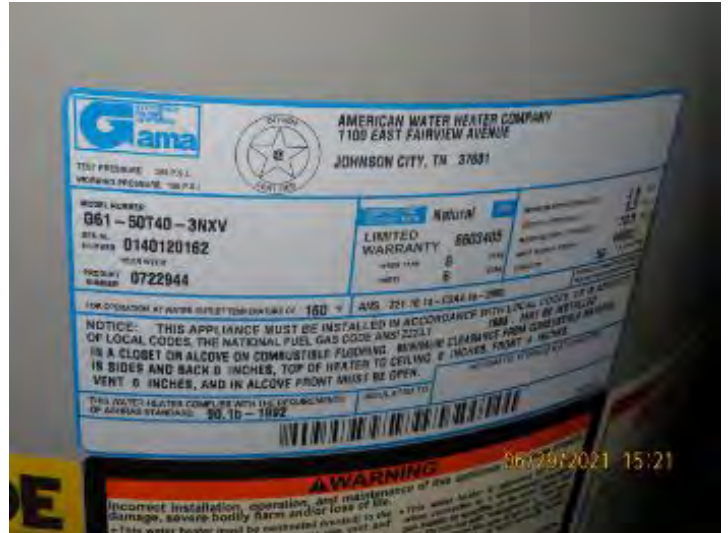
Water heater manufacture label noted. Observational an informational purpose only.

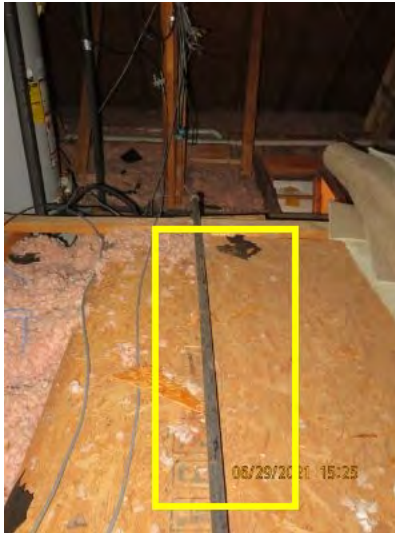
Black iron gas pipe plumbing noted. Observational an informational purpose only.

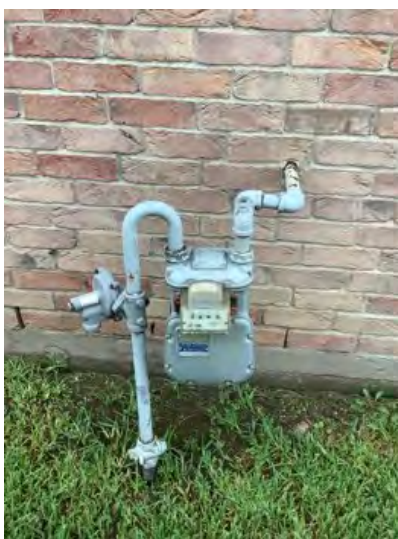
Main gas meter located on the right side of the property at time of inspection. Observational information purposes

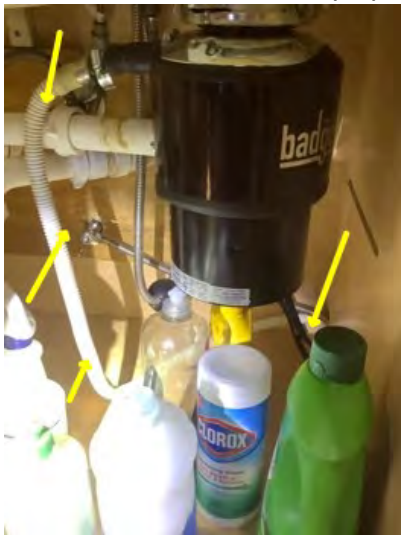
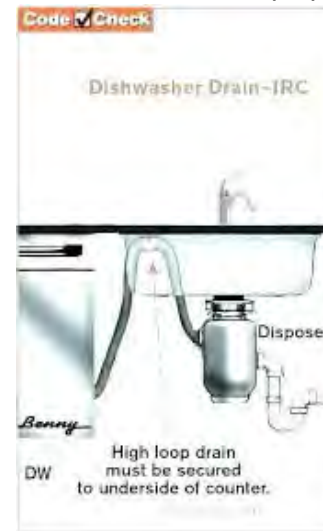
Dishwasher high Loop drain noted at time of inspection should be secured the top of the cabinet in order to prevent anti-siphon and backflow. Recommend having a professional inspection correct

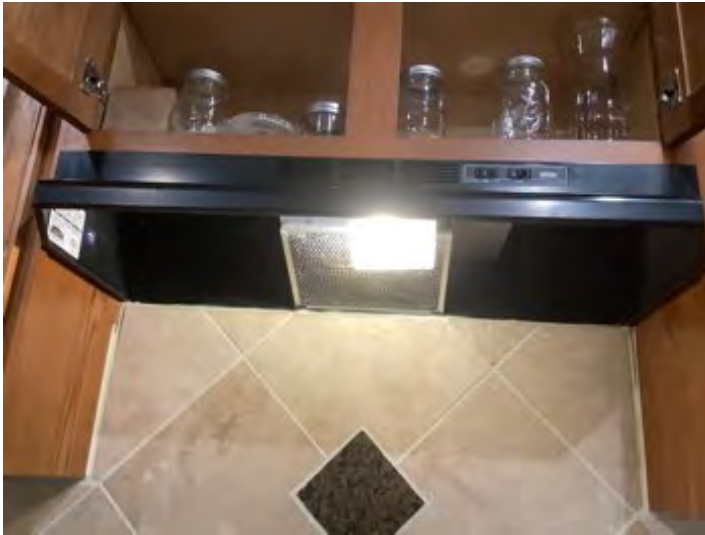
Broan brand Range hood noted at time of inspection was working properly. Observational an informational purposes only.

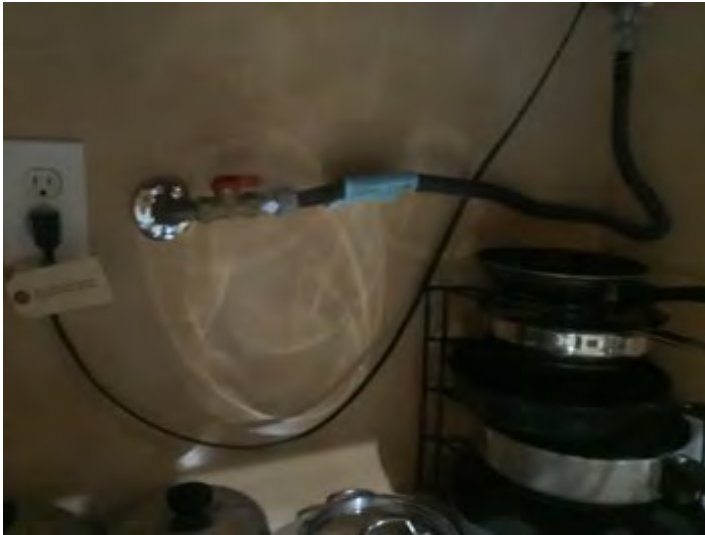
Gas cooktop flex line gas valve noted underneath unit in cabinetry. Observational an informational purposes only.

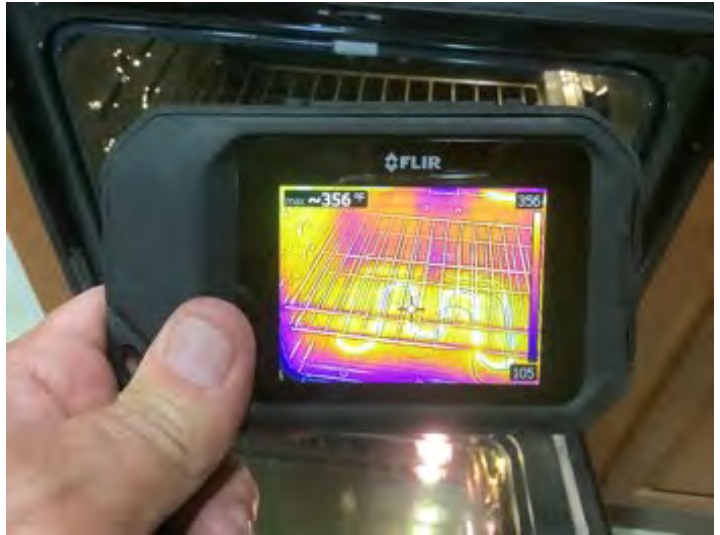
Temperature reading on electric oven was in normal range at time of inspection. Observational and informational purposes only.

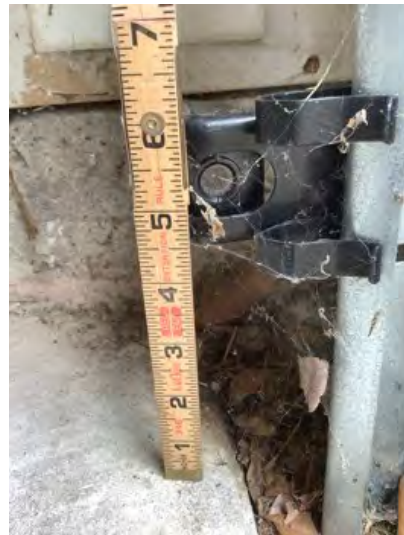
Garage door electric back up sensors one or approximate range of 6 inches noted. Observational and informational purposes only

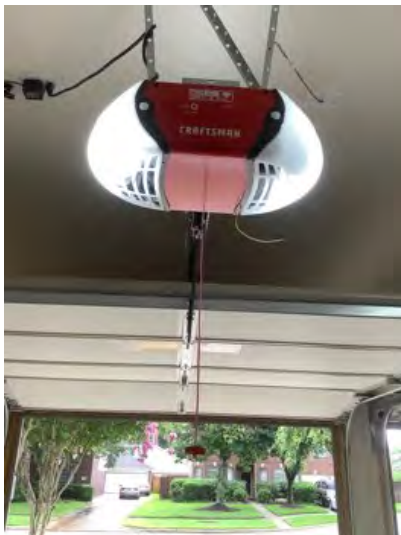
Craftsman automatic garage door opener noted at time of inspection. Observational purposes only

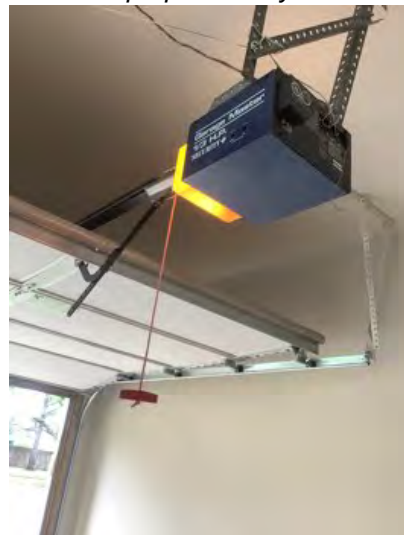
Garage master automatic garage door opener noted at time of inspection. Observational an informational purposes only.

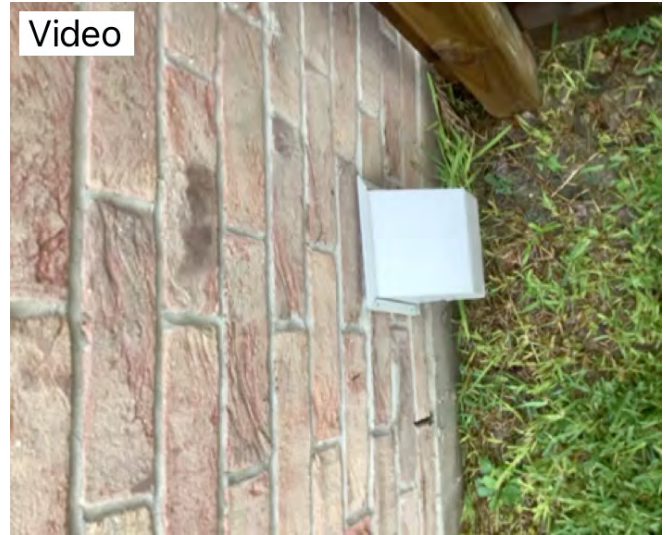
Dryer vent located on the left exterior of property noted not secured see you and talk properly to structure. Conducive to moisture intrusion, damage and potential WDO. Recommend having a professional inspect and correct

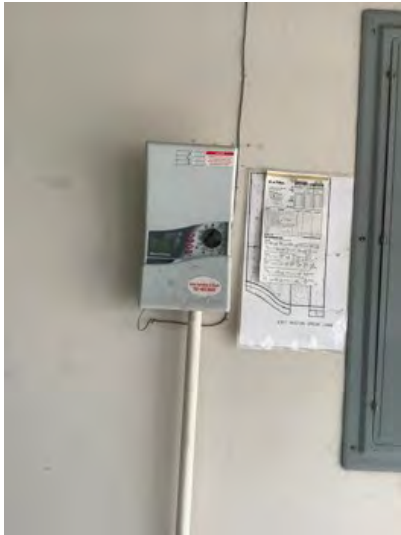
Rainbird control panel for automatic sprinkler system noted at time of inspection. Unit was not working properly.

Page 62 Item: A	Landscape Irrigation (Sprinkler) Systems	<ul style="list-style-type: none"> • The sprinkler system was not functional at the time of the inspection • One or more of the zones did not respond under manual testing
Page 64 Item: B	Swimming Pools, Spas, Hot Tubs, and Equipment	<ul style="list-style-type: none"> • One or more areas noted grout deterioration and should be repaired • One or more areas noted missing sealant between the deck surface and the coping

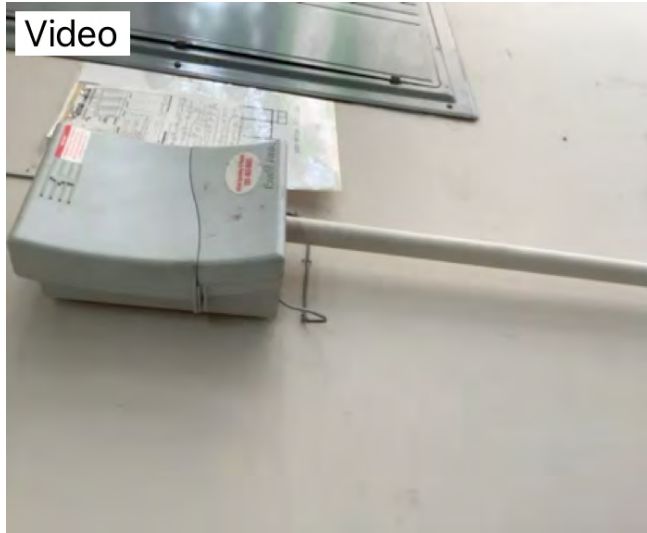
Panel for sprinkler should be secured properly at time of inspection. Observational an informational purposes only.

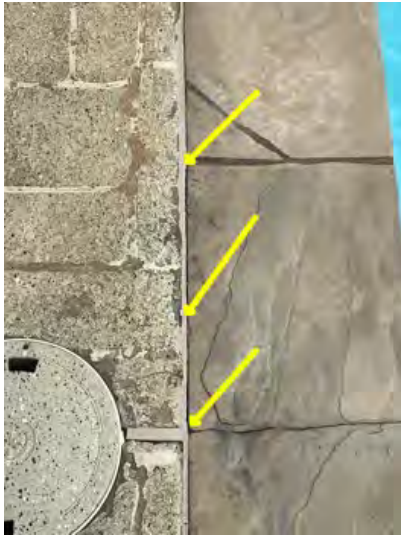
- One or more areas noted grout deterioration and should be repaired
- One or more areas noted missing sealant between the deck surface and the coping

All caulking around pool between decking and coping should be sealed properly conducive to moisture intrusion, damage, expansion and contraction. Recommend having a professional inspecting correct.

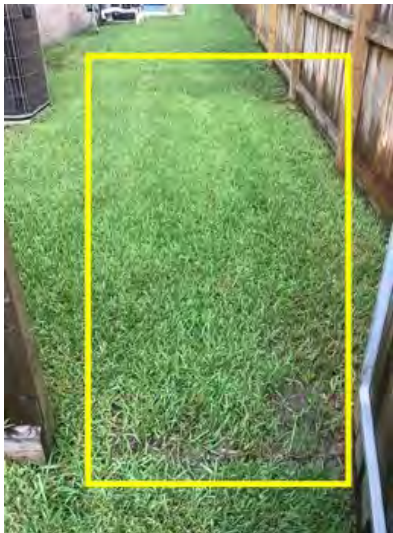
Ponding water noted on the right side of structure at time of inspection. Noted that it did rain hard today. No gutters noted on sides of house recommend adding gutters to deal with drainage

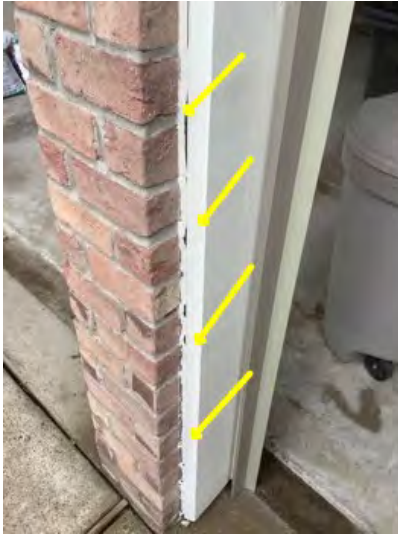
Expose penetrations on wall systems around garage should be sealed caulked and painted properly conducive to moisture intrusion, damage a potential WDO. Recommend getting a professional to expect and correc

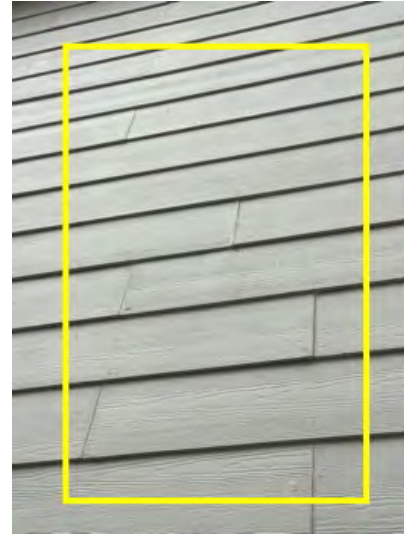
All exterior siding penetrations and seems should be sealed, caulked and painted properly. Conducive to moisture intrusion, damage and potential WDO. Recommend having a professional inspect and correct.

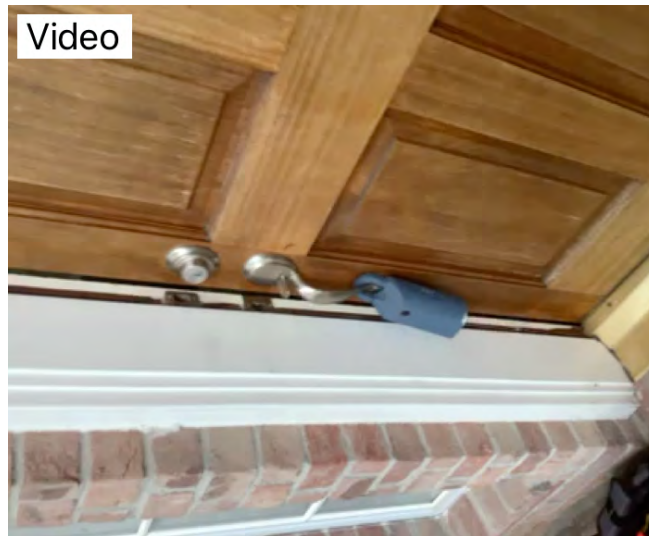
- Some doors were observed to be sticking, not closing properly, out-of-level, frame damage or missing and/or non-functional hardware.

Front door not closing properly at time of inspection noted. Observational an informational purpose only.

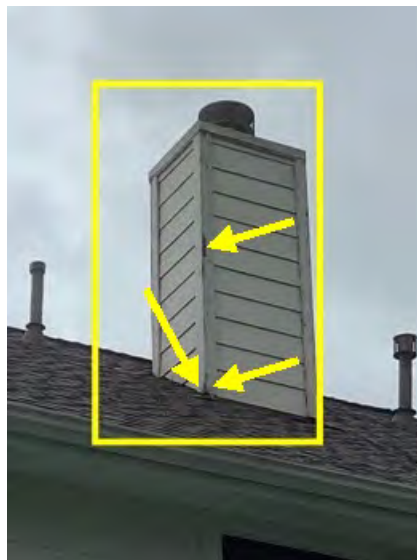
Chimney noted at time of inspection. Recommend all trim boards and siding be sealed caulked and painted properly some trim boards may need to be replaced.

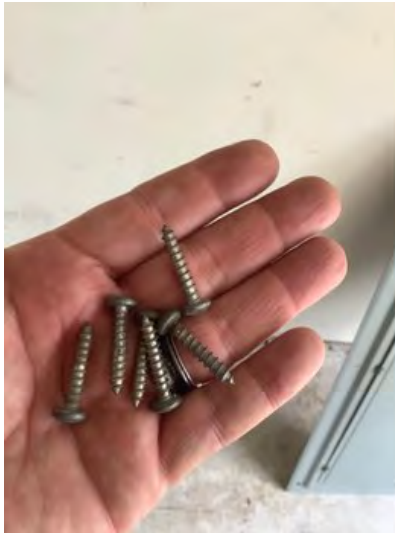
Metal screws utilized instead of proper electrical screws. Conducive to electrical hazards and issues. Recommend replacing with proper screws.

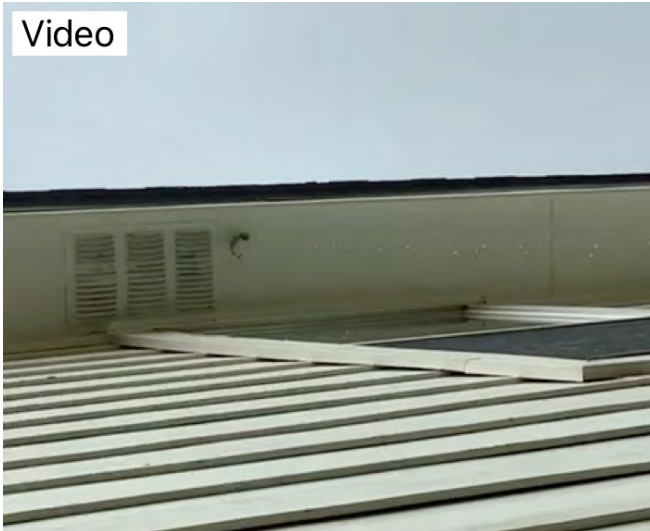
Secondary drain noted on right side of house underneath soffit he's draining at time of inspection. Conducive to main drain needing to be cleaned out. Recommend having a professional inspect incorrect problem

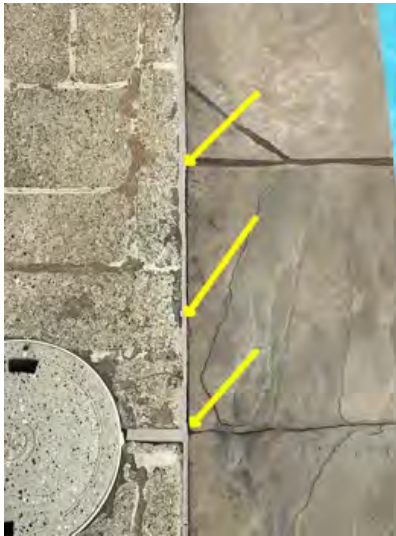
All caulking around pool between decking and coping should be sealed properly conducive to moisture intrusion, damage, expansion and contraction. Recommend having a professional inspecting correct.
