# American Dream Home Inspections, LLC

9307 Reston Grove Ln, Houston, TX

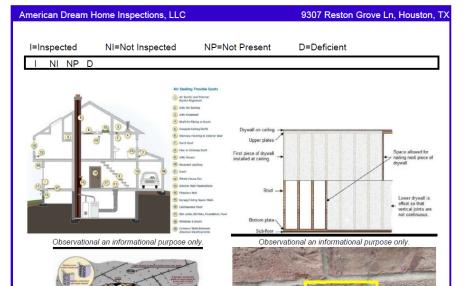
Galvanized plumbing at gas meter penetration into wall systems should be sealed properly. Conducive to moisture intrusion, damage and potential WDO. Observational an informational purpose only.

• Repairs completed on gas meter penetration
