Property Inspection Report

20115 Twilight Canyon Rd, Katy, TX 77449

Date of Inspection: 6/21/2018 Time: 1500

Inspector: Robert M Saji
License #10287

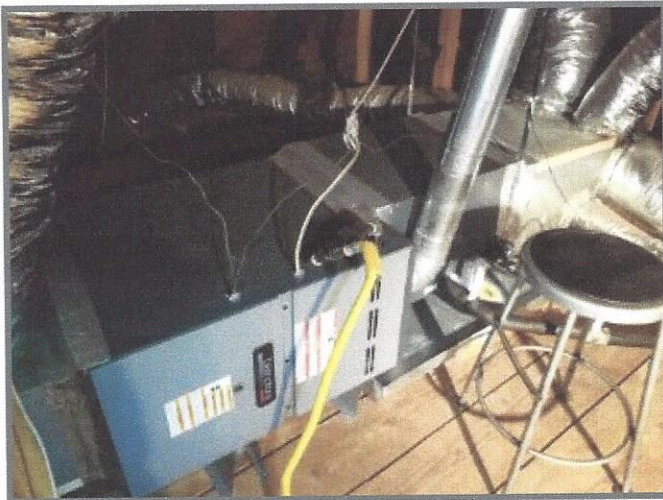
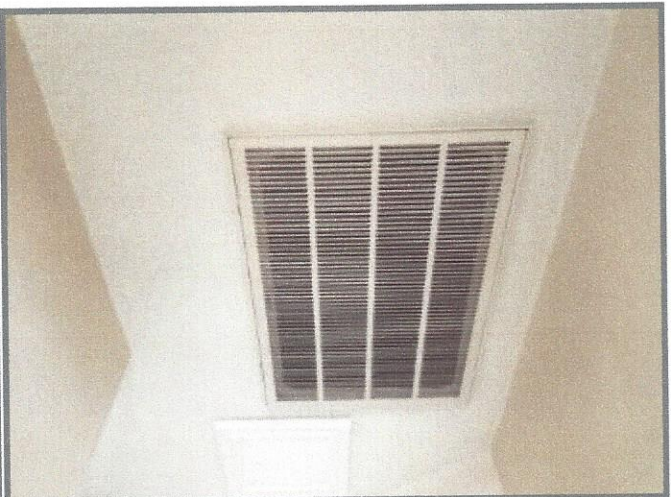
- The furnace has been recently updated with good workmanship found or noted.

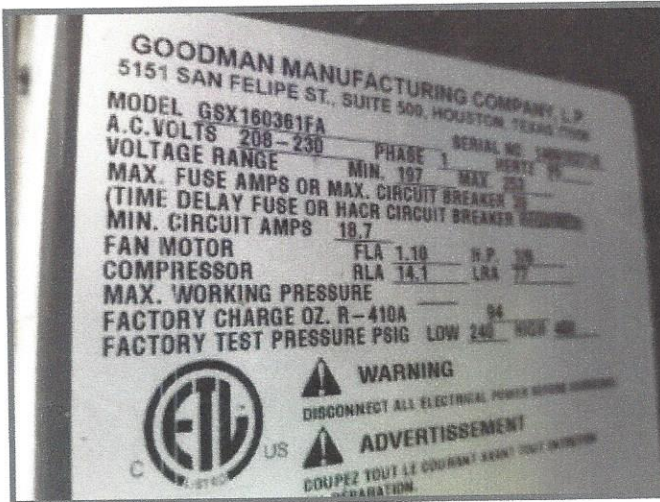
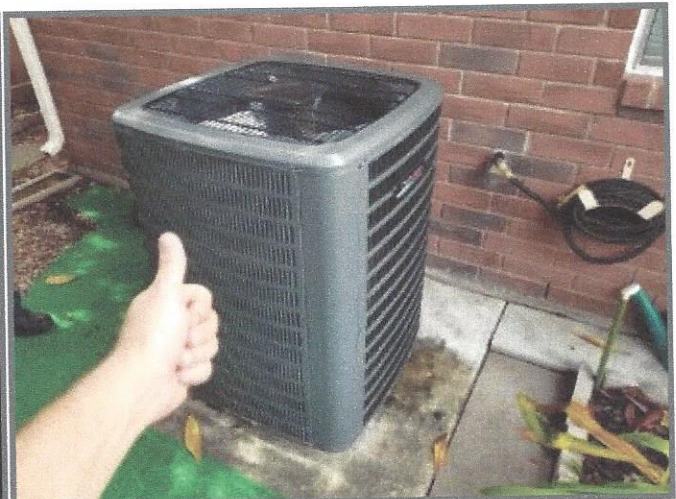
- The insulation on the refrigerant line for the cooling system was noted present and in good condition.
- The typical temperature differential split between supply and return air in an air conditioner of this type is 15 - 21 degrees F. This system responded and DID achieve an acceptable differential Temperature.
- MAINTENANCE: Remember to properly clean the primary drain line from the evaporator. (Located in the attic) It is recommended to clean this line with bleach every other month or as needed to prevent clogging / water damage.
- The secondary drain line for the evaporator was noted exiting at the LEFT of the home. (If this pipe ever drips then the primary line is clogged and needs cleaning)

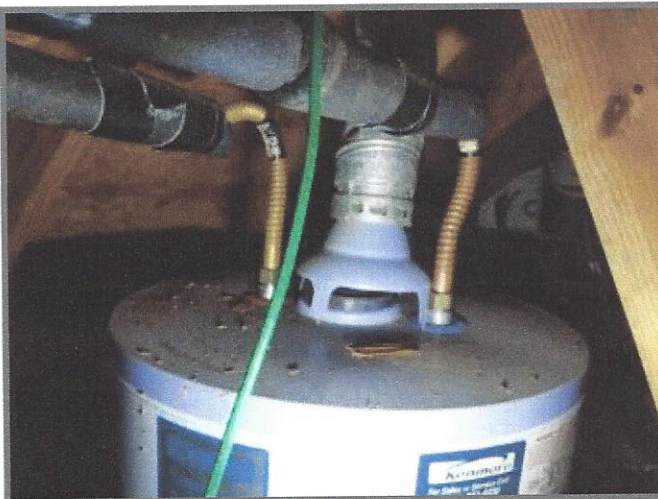
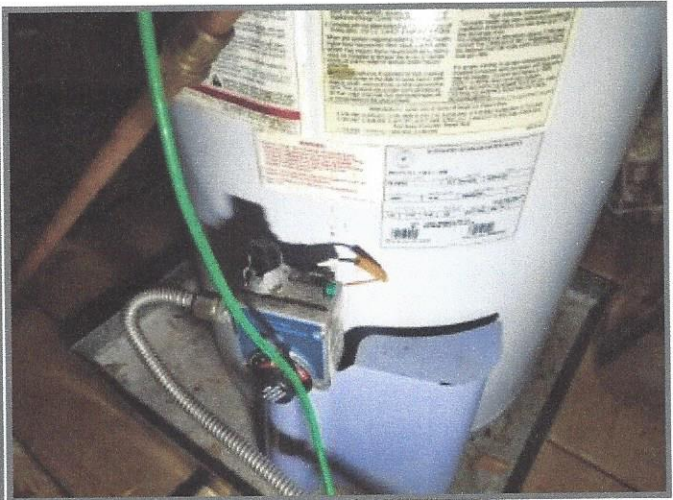
- The water heater appears to be operating as intended.
- No deficiencies observed at the visible portions of the supply piping.
- Most of the piping is concealed and cannot be identified.
- The metal "B" vent or flue from the heater was noted incorrectly installed / secured. (not properly secured over the exhaust chamber). Signs of overheating have been also found. Recommend proper repairs and updates as needed to prevent issues or hazard.

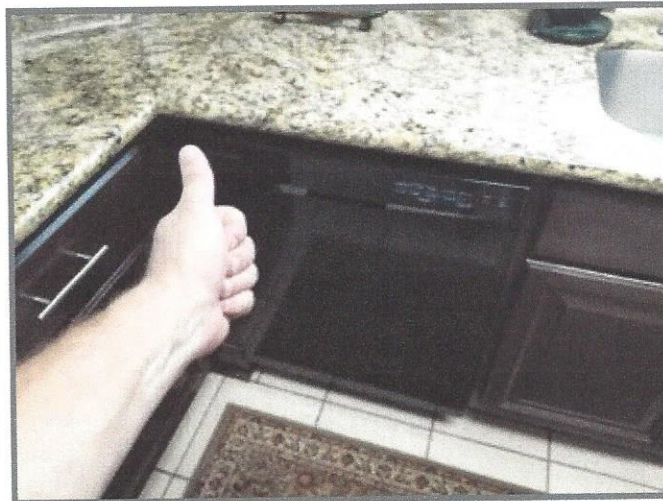
- The dishwasher is operating as intended.

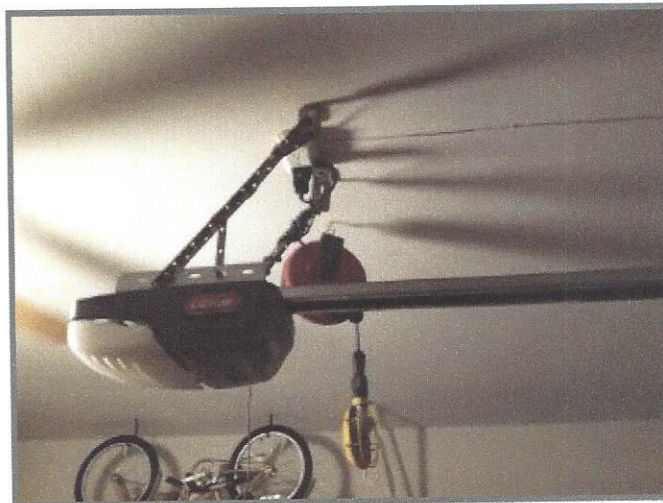
- The garage door opener was noted present and in good operating condition.
- The safety features required were also noted present with no concerns found.
