## PROPERTY INSPECTION REPORT

**Concerning:** 4547 Brinkley Street, Houston, TX, 77051  
(Address or Other Identification of Inspected Property)

**By:** Martin Lavergne TREC #8717 December 20, 2021  
(Name and License Number of Inspector) (Date)

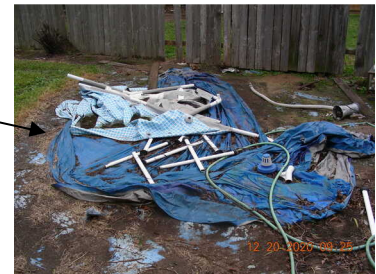
- There is some bare ground and holes in the side and back yards of the home that should be filled with soil and covered with grass sod to prevent any further erosion in the yard. In addition, there is debris in the backyards that should be removed. Also, the fence boards are damaged in various locations and are in need of repair. It should also be noted that the fence gates do not have latches allow the fence gates to be opened from inside the back yard, therefore, the fence gates should have latches installed that allow the gates to be opened from either side of the gate so that a person does not get trapped inside the back yard when the gate closes.

Examples of debris and bare earth in backyards

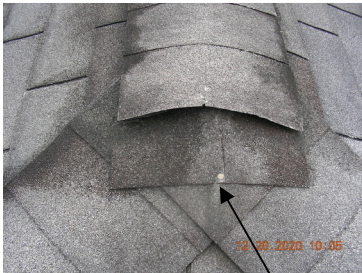
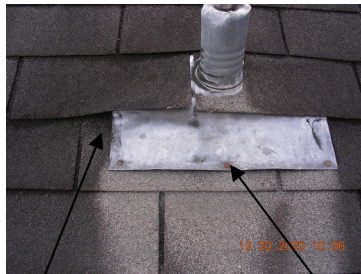
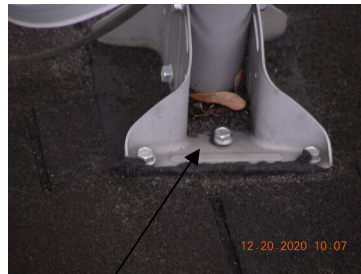
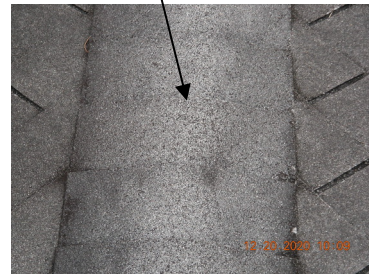
- The asphalt composition shingles appear to be performing as intended. However, the shingles appear to be reaching the end of their useful life, as the shingles are starting to delaminate (granules on shingle surface wash off) and deteriorate in various locations and there are damaged shingles that are in need of repair/replacement. In addition, there are raised roof jack flanges and exposed nail heads that should be repaired so that the roof jack flanges lie flat on the roof to prevent the flanges from being removed by wind lift and to prevent any water from penetrating beneath the shingles and nail heads. It is recommended that the roof get evaluated by a roofing specialist as it appears that the roof is in need of replacement.
- The PVC pipes extending through the roof jacks need to be painted to prevent any premature deterioration from the sun's ultraviolet rays.

Examples of delaminated shingles

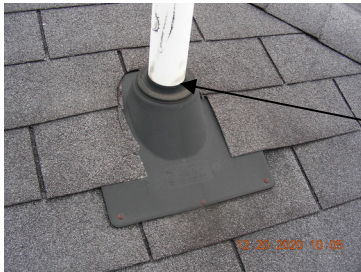
Examples exposed nail/bolt heads and raised roof jack flanges

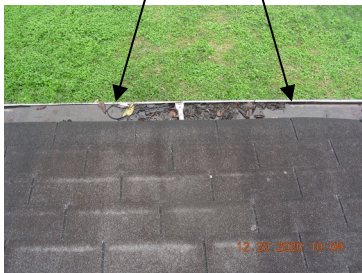
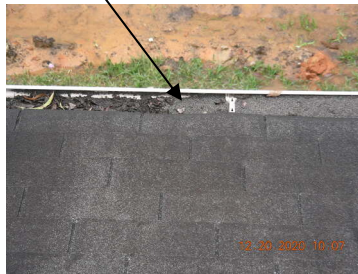
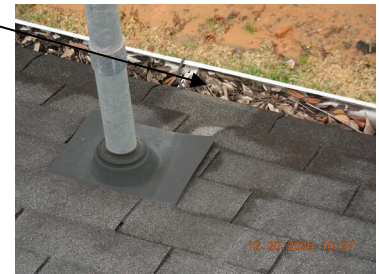
- Gutters are installed at the front and over the entryways of the home. The gutter brackets (used to fasten the gutters to the fascia boards) are starting to detach from the gutters in various locations and the gutters are filled with debris in various locations. The gutters should be repaired so that they do not fully detach from the fascia boards or leak and the gutters should be cleaned so that the gutters can handle the full capacity of water and not obstruct the flow of water through the gutters and gutter downspouts. In addition, the homeowner may want to install gutters along the sides and rear of the home. Gutters would help prevent splashing (which promotes algae growth and premature deterioration of the siding and trim around the windows and doors) and excess water buildup, erosion, and trenching near the foundation.

Example of detached gutter bracket

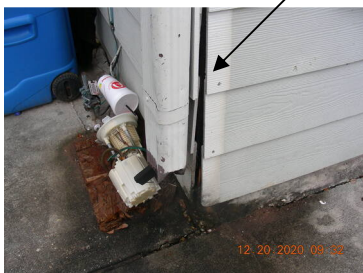
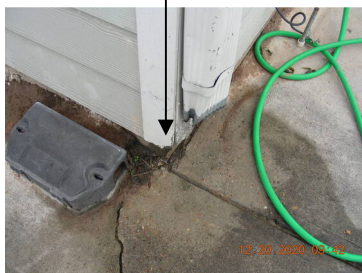
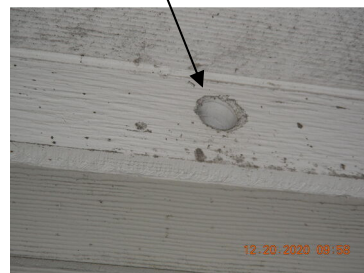
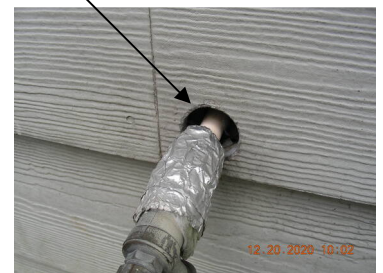
- The interior sheetrock walls are performing as intended. However, the interior walls have some blemishes/scuffs/minor damage in various locations that need repair and paint.
- The exterior cement fiber board siding walls are performing as intended; however, there is some damaged siding and trim in various locations that is in need of repair/replacement and paint. In addition, there are some areas that need sealant where pipes protrude through the walls to prevent any moisture or pest intrusions into the home. Also, there is some algae growth in various locations that should be cleaned off.

Examples of exterior wall areas that need repair, sealant, cleaning, and paint

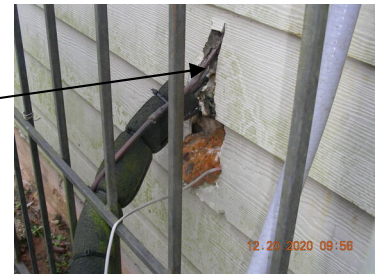
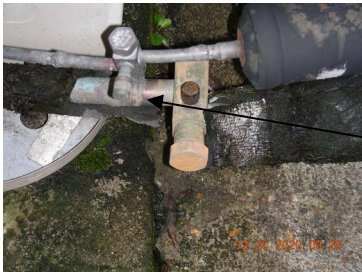
Hooded shields needed over A/C lines

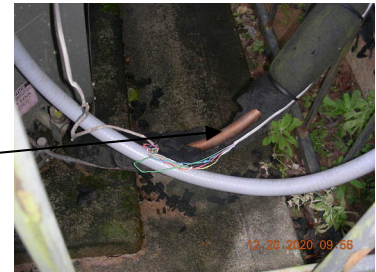
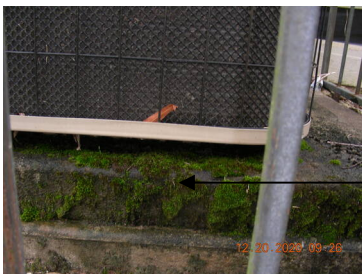
More insulation needed on A/C refrigerant lines

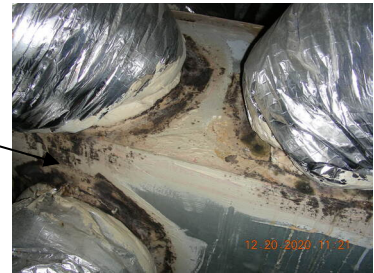
Mildew staining on A/C air boxes in attic on both units

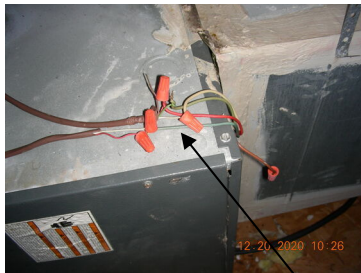
- The refrigerant line to the evaporator (in the attic) in Unit A is not sealed to its evaporator box. The evaporator line should be sealed to its evaporator box to prevent air from leaking out of the A/C system and into the attic. In addition, the low voltage wires (in the attic) on both of the A/C units are exposed and should be protected.

Refrigerant line is not sealed against evaporator box in unit A

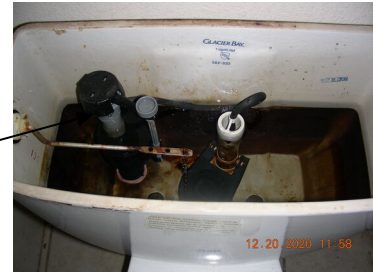
Unit A toilet fill valves are in need of replacement

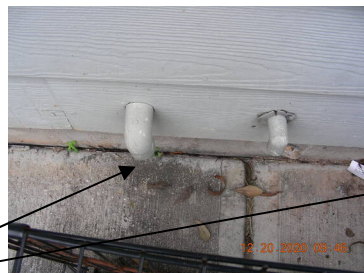
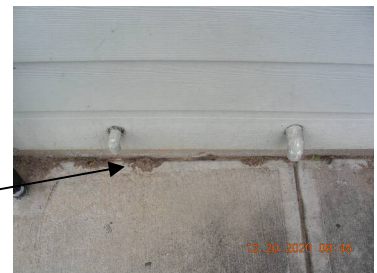
Water heater drain lines

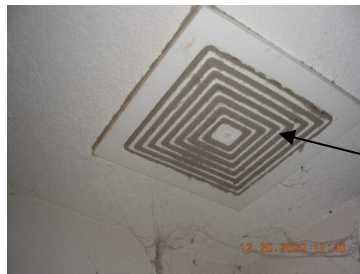
- The laundry room and bathroom exhaust fans in both units function as intended and are ducted to the outside of the home through soffit vents.
- The fan grill on the bathroom exhaust fan in Unit A primary bath is filled with debris.

Unit A primary bath exhaust fan grill is filled with debris

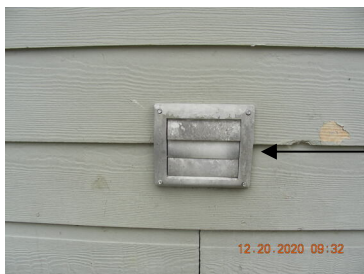
- The dryer vent pipes in both units are installed and ducted to the outside of the home through wall vents. Lint buildup in the dryer vents should be removed from time to time as a part of general maintenance to keep the clothes dryers optimally performing.
- The dryer vent exhaust dampers should be metal, single-hinge, flap style dampers with a hood instead of the louvered style dampers that are currently installed. The louvered style damper tends to trap more lint and increases the frequency that lint must be removed and prevents the dryer from optimally performing. In addition, the louvers tend to stick open and do not close, thereby, allowing moisture to enter the dryer exhaust vent pipe.

Clothes dryer damper should be metal without louvers
