## PROPERTY INSPECTION REPORT

Concerning: 2207 Bernardo De Galvez Avenue, Galveston, TX 77550  
(Address or Other Identification of Inspected Property)

By: Danny Marlow Lic.#: 23187 03/25/2021  
(Name and License Number of Inspector) (Date)

**Inspection No. 521350-643**

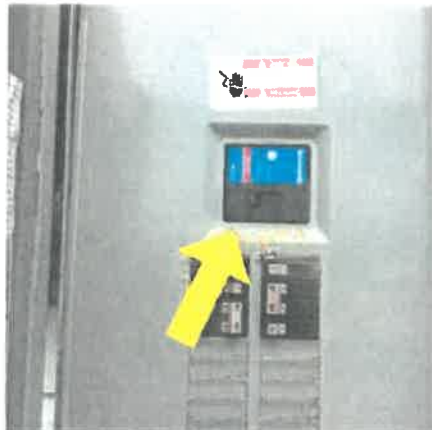
- 120/240 volt, 200 amp service.
- Grounding is through grounding rod to earth.
- Main disconnect is located in in service panel on back exterior of garage.
