PROPERTY INSPECTION REPORT

Prepared For: BRITTNIE ADAMS
(Name of Client)

Concerning: 12803 FAIRLANE DRIVE, BROOKSIDE, TX 77581
(Address or Other Identification of Inspected Property)

By: Stephen Perry, Lic #7854 04/06/2021
(Name and License Number of Inspector) (Date)

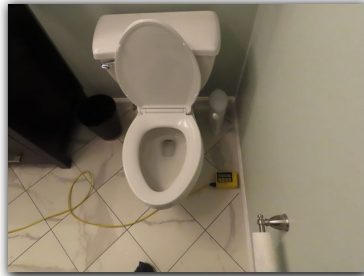
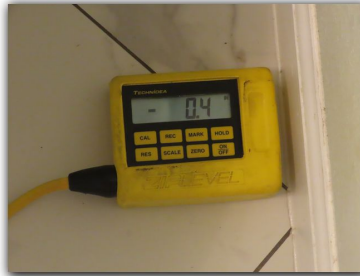
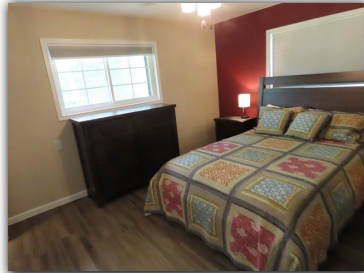
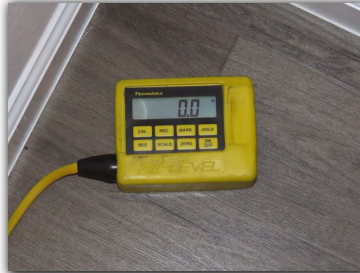
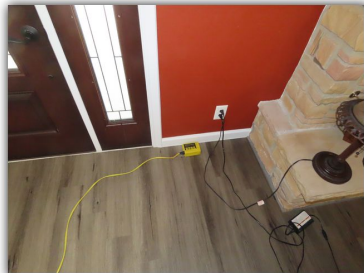
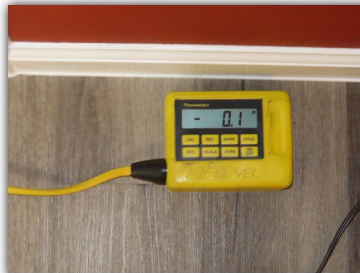
- Cracks in brick, hairline cracks in the brick in some locations below windows
- Floors not level, -1 inches low on the front right corner of the home and -3/4 inches low at the back left corner of the home, but not considered excessive
- Splits in the rafters in the attic
- Cracks in wall(s) and / or ceiling, previously patched and painted over
- Door / window frames out of square, some doors rubbing on the frame, and doors not latching, some windows have broken seals

- Structural movement and/or settling noted; however, the foundation is supporting the structure at this time.**

CONSIDERED EXCESSIVE, BUT TO INDICATE SOME SETTLEMENT. RECOMMEND MONITORING FOR ANY FURTHER SIGNS OF SETTLEMENT. IN ADDITION, THERE IS WATER DRAINING NEAR THE HOMES PERIMETER FOR THE KITCHEN AND LAUNDRY DRAIN PIPES AND CAN AFFECT FOUNDATION PERFORMANCE IF NOT CORRECTED, IMPROVEMENTS TO THE DRAINAGE AROUND THE HOME AND ROOT BARRIER SYSTEMS FOR THE LARGE TREES NEAR THE HOME AS WELL IS RECOMMENDED FOR FOUNDATION PERFORMANCE.

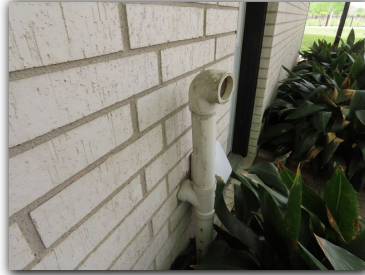
- Improper drainage from foundation, PLUMBING ACTIVELY DRAINING NEAR THE HOME ON THE BACK LEFT CORNER FROM THE KITCHEN SINK AND LAUNDRY. IN NEED OF REPAIRS BY A PLUMBER/SEPTIC EXPERT.**

- I DO RECOMMEND FRENCH DRAINS ON THE LEFT, BACK, AND RIGHT SIDES OF THE HOME FOR IMPROVED DRAINAGE, IMPROVEMENTS TO THE LOW UNEVEN AREAS OF THE GRADING NEAR THE HOMES SLAB, AND IN THESE LOCATIONS THAT APPEAR TO HAVE WATER PONDING, ROCKS/GRAVEL INSTALLED ALONG THE HOMES PERIMETER, GUTTER DOWN SPOUTS TERMINATING TO THE FRENCH DRAINS AS WELL; IN NEED OF FURTHER EVALUATION BY A LANDSCAPE AND IRRIGATION EXPERT**

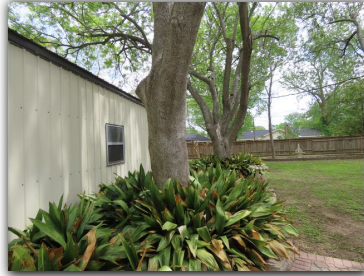
Inadequate grading clearance to exterior wall surface

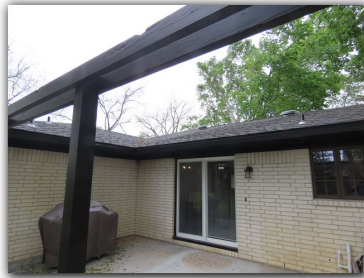
Roof decking deflection and / or sagging ; recommend evaluation and repairs by a roofing expert.(DEFICIENCY)

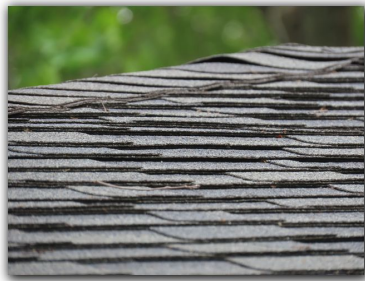
- **THERE IS SOME RAISED SHINGLES DUE TO PROTRUDING NAILS THAT NEEDS TO BE REPAIRED BY A ROOFING EXPERT. (DEFICIENCY)**

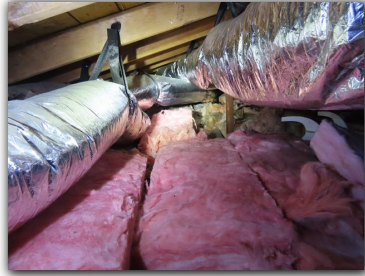
THERE IS SOME LOW SPOTS AND SOME LOW AREAS OF MISSING INSULATION ON THE ATTIC FLOOR THAT NEEDS ADDITIONAL

INSULATION ADDED. (FOR INCREASED ENERGY EFFICIENCY IT WOULD BE RECOMMENDED TO HAVE 14-16 INCHES OF BLOWN-INSULATION, TOTAL DEPTH)(DEFICIENCY)

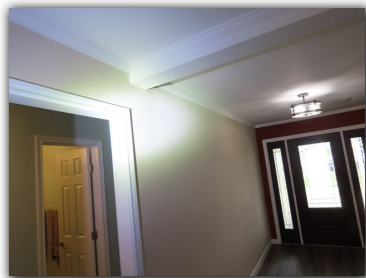
There are some settlement cracks in drywall previously patched and painted over (DEFICIENCY)

- **INDICATING STRUCTURAL SETTLEMENT THAT NEEDS TO BE PATCHED/FINISHED/TEXTURED AND MONITORED FOR ANY FURTHER CRACKING**

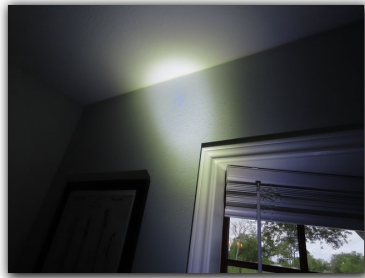
Freshly Painted/re-textured and recently painted

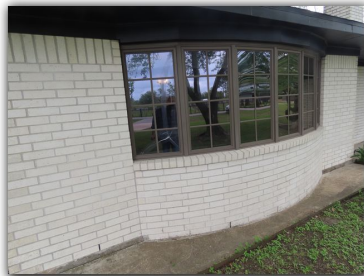
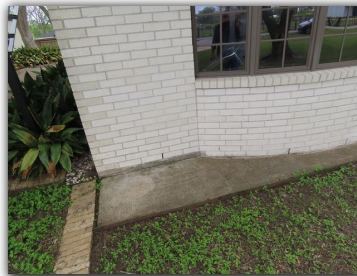
☑ Some cracks at the brick, hairline cracks in the brick on the front left corner of the home below the garage conversion window location indicating some settlement that needs to be pointed by a masonry repair expert and monitored for any further cracking or signs of structural settlement.(DEFICIENCY)

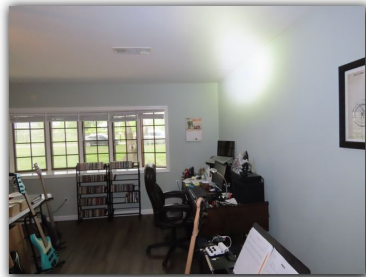
SOME PATCHWORK ON THE GARAGE CONVERSION WORK SHOP CEILING INDICATING POTENTIAL PREVIOUS LEAKS; RECOMMEND EVALUATION BY A DRYWALL REPAIR EXPERT AND ALSO A ROOFING EXPERT TO ENSURE THERE NO REMAINING LEAKS STILL PRESENT.(DEFICIENCY)

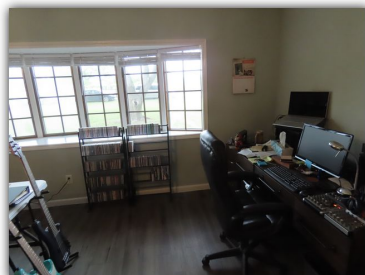
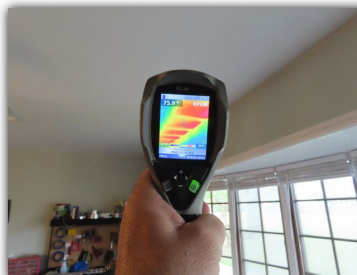
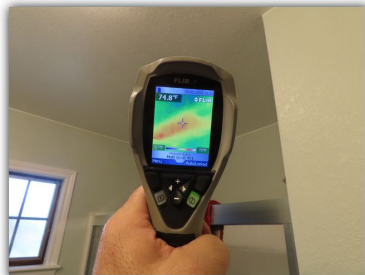
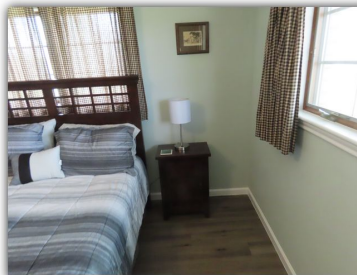
INFRARED CAMERA DID SHOW SEVERAL LOCATION OF MISSING/LOW INSULATION OR INSULATION VOIDS IN THE ATTIC ON THE CEILING IN MANY LOCATIONS THAT NEEDS TO BE PROPERLY INSULATED.(DEFICIENCY)

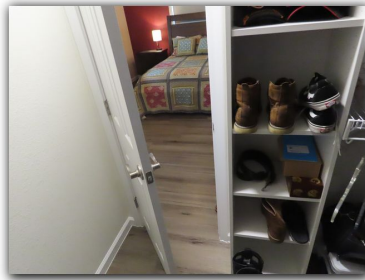
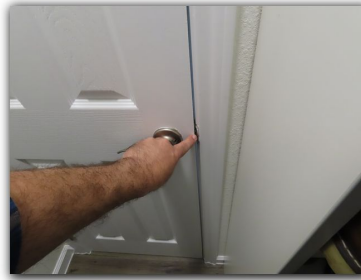
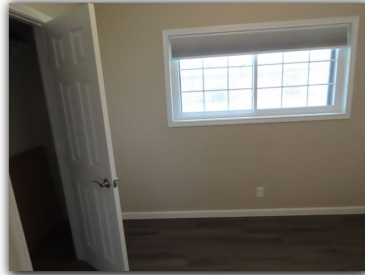
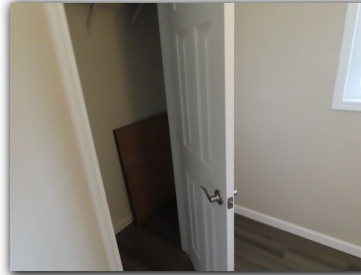
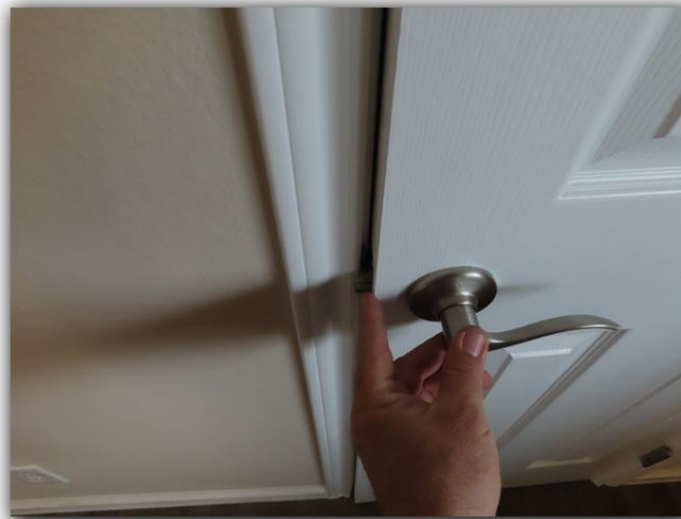
- Doors rub, stick or hit frames: _____
- SOME BEDROOM DOORS ARE RUBBING ON THE FRAME AND ALSO NOT LATCHING PROPERLY. THIS IS A SIGN OF STRUCTURAL SETTLEMENT AND IN NEED OF REPAIR BY A DOOR INSTALLATION EXPERT. (DEFICIENCY)**

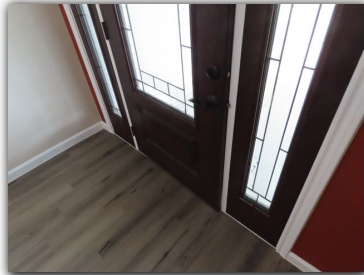
THE FRONT DOOR IS RUBBING ON THE FRAME AT THE BOTTOM; A SIGN OF STRUCTURAL SETTLEMENT AND IN NEED OF REPAIR BY A DOOR INSTALLATION EXPERT.(DEFICIENCY)

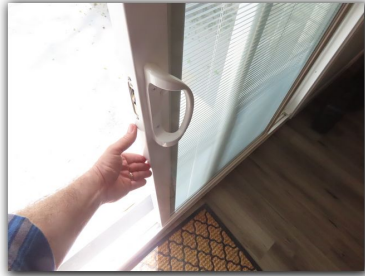
THE BACK SLIDING GLASS DOOR IS HARD TO OPEN

AND CLOSE; IN NEED OF REPAIR.(DEFICIENCY)

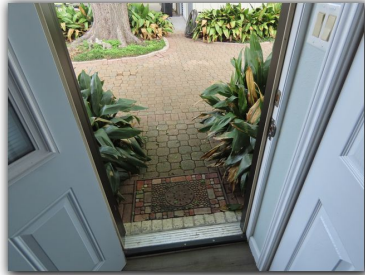
- **THE BOTTOM OF THE EXTERIOR DOOR FRAMES AT THE LOWER JAMBS NEEDS TO HAVE SMALL SQUARE FOAM RUBBER WEATHER STRIPS THAT DO PREVENT THE INSIDE JAMB FROM BECOMING ROTTED FROM WATER PENETRATIONS (DEFICIENCY)**

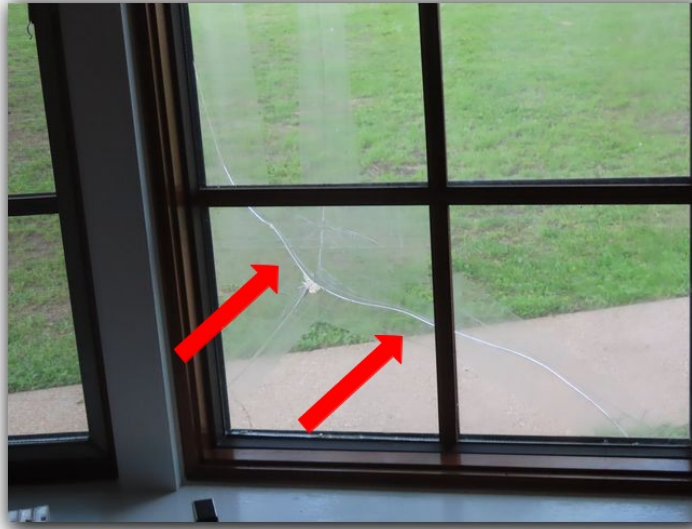
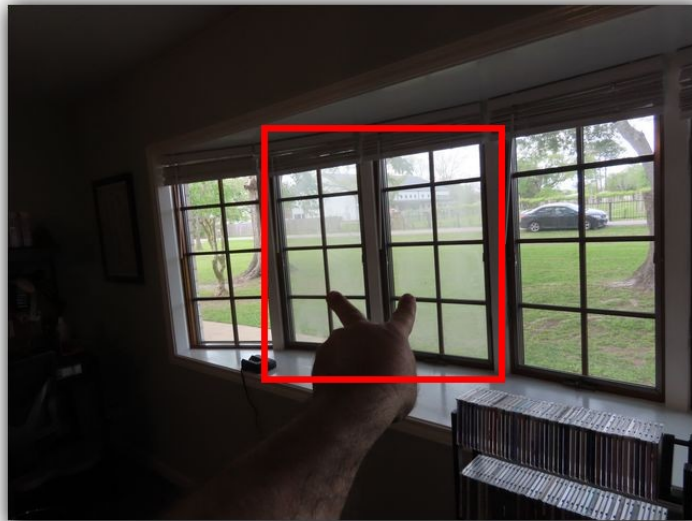
Some glass panes are damaged (DEFICIENCY)

Thermal pane window seals have failed, moisture is

present; Several windows in the front left corner workshop (garage conversion) and one window has cracked glazing as well. These windows will need replacement.(SEVERAL CASEMENT INSULATED GLASS WINDOWS WILL NEED TO BE REPLACED)(**DEFICIENCY**) **NEEDS FURTHER EVALUATION OF THE WINDOWS AND REPLACEMENT BY A WINDOW REPAIR EXPERT.(*THESE TYPE WINDOWS ARE VERY COSTLY)**

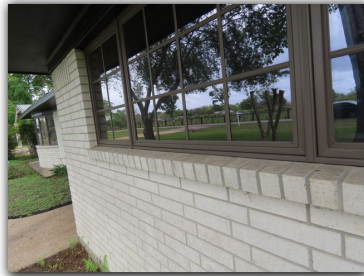
Caulking / plastic , etc. damaged and / or missing (DEFICIENCY)

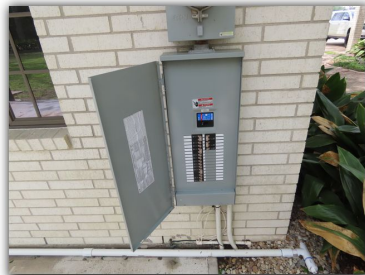
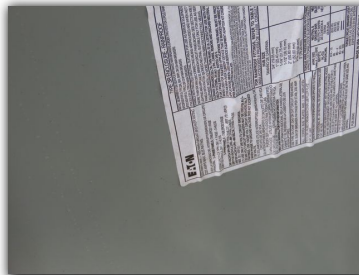
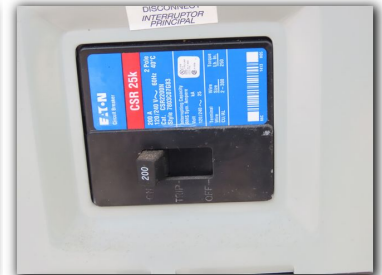
Main Disconnect Panel

200 AMP "EATON" SERVICE PANEL PRESENT, A MORE RECENT INSTALLATION LOCATED ON THE BACK WALL OF THE HOME.

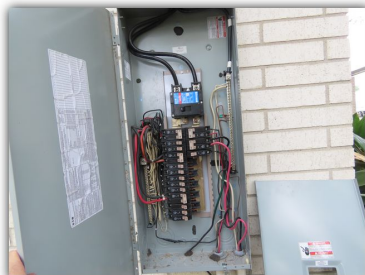
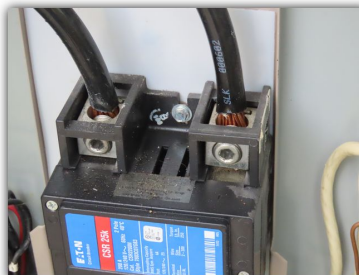
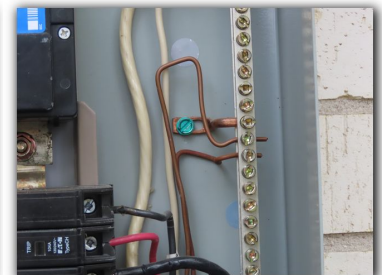
MAIN HOT LEGS ARE COPPER AND THE GREEN BOND SCREW IS PRESENT AS REQUIRED

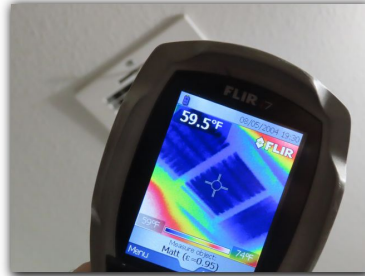
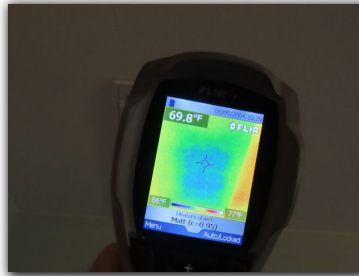
Temp. Differential: 10 °F

(DEFICIENCY) Temperature differential is NOT within range of 15-20 degrees Fahrenheit)

- **IN NEED OF EVALUATION AND REPAIR BY A LICENSED HVAC PROFESSIONAL(DEFICIENCY)**

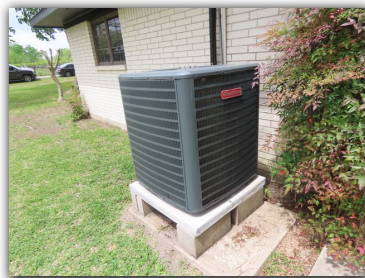
THE AIR CONDENSER IS A "GOODMAN" 16 SEER, 4-TON UNIT; MANUFACTURED IN 2020.

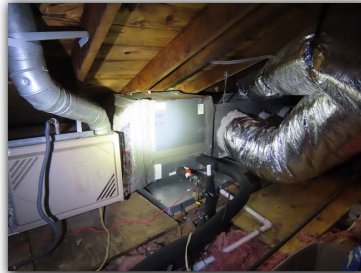
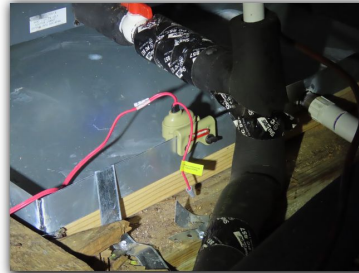
THE EVAPORATOR COILS WERE MANUFACTURED IN 2020, A FLOAT SWITCH IS PRESENT ON THE WATER PAN AS IS RECOMMENDED.

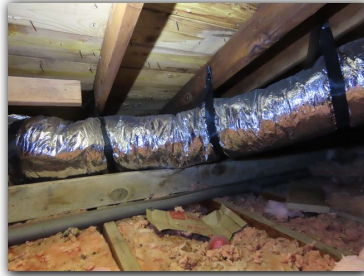
- **(DEFICIENCY) THE DUCTWORK THAT IS MAKING DIRECT CONTACT WITH EACH OTHER NEEDS TO HAVE BATT INSULATION PLACED BETWEEN THEM TO PREVENT CONDENSATION FROM FORMING.**

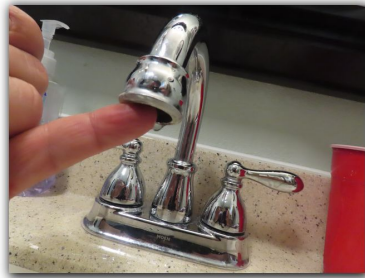
☑ THE HOME DOES HAVE SOME GALVANIZED STEEL PLUMBING SUPPLY PIPES STILL VISIBLE AND PRESENT. GALVANIZED STEEL PLUMBING IS KNOWN FOR CORRODING ON THE INSIDE, REDUCED WATER FLOW, CLOGGED FIXTURES, AND PIN-HOLE LEAKS. THERE WAS EVIDENCE OF CORROSION, OR REDUCED WATER FLOW THAT WAS VISIBLE AT THE TIME OF INSPECTION. SOME PIPES IN THE ATTIC WERE COVERED WITH INSULATION AND NOT VISIBLE AND NOT ABLE TO GAIN ACCESS IN THE ATTIC TO THE MASTER BATHROOM OR KITCHEN LOCATIONS ONLY THE HALL BATH LOCATION. RECOMMEND OVERALL EVALUATION OF THE HOMES PLUMBING BY A LICENSED PLUMBER.

GALVANIZED STEEL PIPES UNDER THE MASTER BATH SINK THAT HAVE SOME CORROSION AND IN NEED OF REPAIRS OR REPLACEMENT BY A PLUMBER. (The hot water pipe appears to be possibly black steel used for gas piping, recommend evaluation by a plumber)

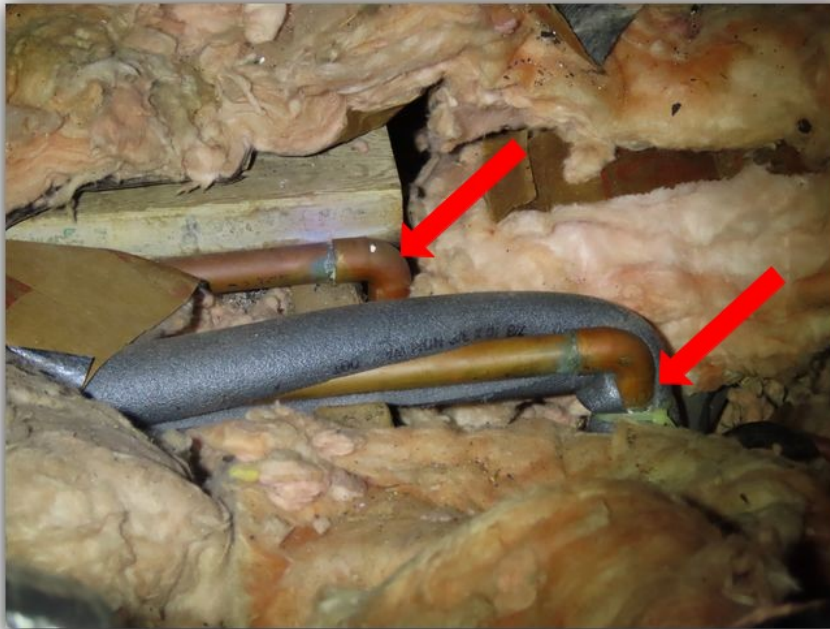
☑ PIPES GOING DOWN THE WALL FOR THE HALL BATH
IS COPPER

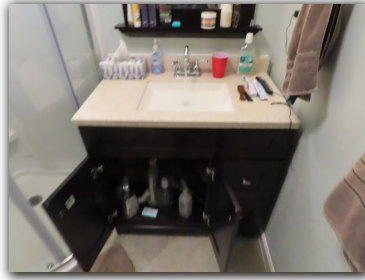
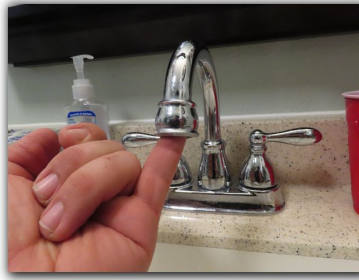
☑ THE KITCHEN SINK FIXTURE HAD WATER PRESSURE THAT WAS INCREASING AND DECREASING. RECOMMEND EVALUATION BY A PLUMBER AND ALSO A WELL INSPECTION AS WELL. (DEFICIENCY)

☑ THE AERATOR IS MISSING FOR THE MASTER SINK FIXTURE AND COMMON WITH GALVANIZED STEEL PIPES, CORROSION, OR HARD WATER THAT CLOGS THE AERATORS. IN NEED OF EVALUATION AND REPAIRS BY A PLUMBER.(DEFICIENCY)

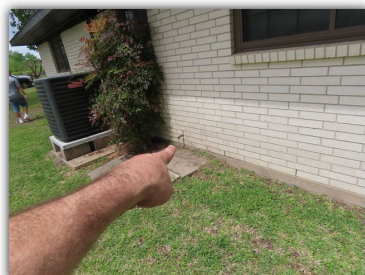
Faucet handles are loose, damaged or missing; NEEDS REPLACEMENT (COPPER SUPPLY PIPES AT THE HOSE BIB LOCATIONS) (DEFICIENCY)

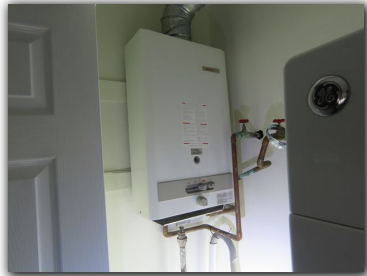
- **DEFICIENCY- Corrosion and/or signs of an intermittent leak at isolation valve and/or plumbing connections; IN NEED OF REPAIRS BY A LICENSED PLUMBER.(DEFICIENCY)**

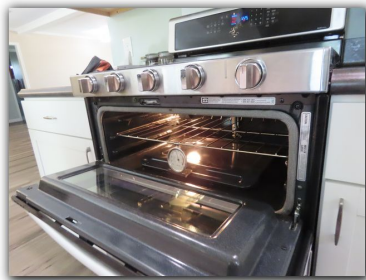
TOP OVEN WAS SHOWING 27 COLD; RECOMMEND REPAIRS BY AN APPLIANCE REPAIR PERSON. **(DEFICIENCY)**
