## **Inspection Report**

225 Narcissus

Lake Jackson, TX 77566

**By:** Jeff M Spencer, Lic #6365 11/28/2018  
(Name and License Number of Inspector) (Date)

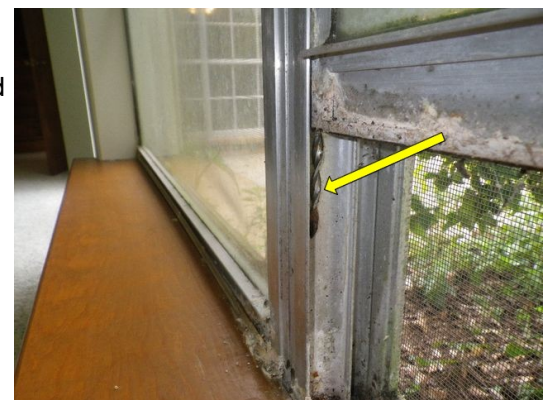
- Right sash of the north group of windows on the north wall of the sunroom;
- Center sash of the north group of windows on the east wall of the sunroom;

Screens are missing from windows listed below. Replacement is recommended if use of the windows is anticipated. Locations include:
